JOURNEY RISK MANAGEMENT (JRM) STUDY

Gorakhpur LPG BP TO SHREE AARUSH INDANE

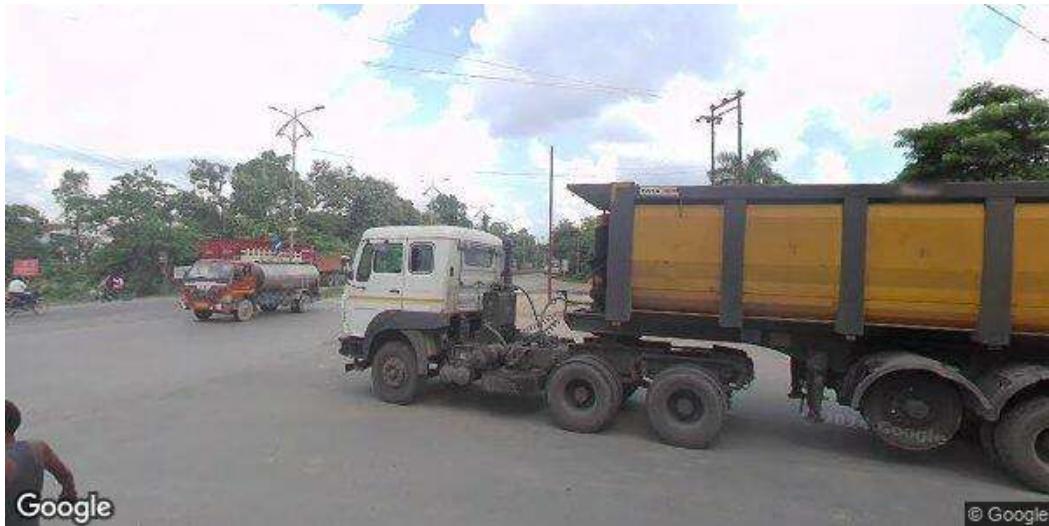
Risk Type: Blind Spot

Risk Level: Blind Spot

Speed Limit: 10 KM/Hr

Distance from Start: 2.16 km

Coordinates: 26.75126, 83.22476

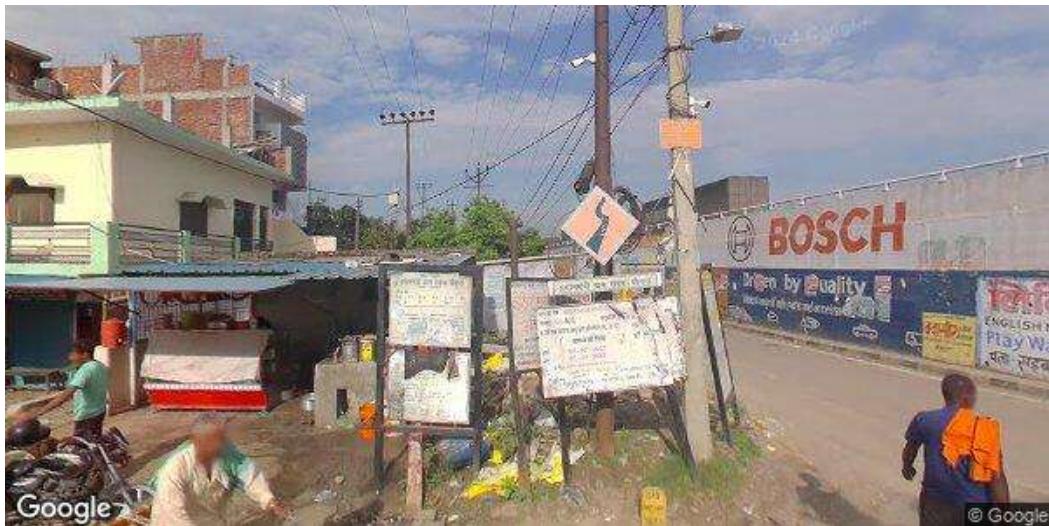
Risk Type: Blind Spot

Risk Level: Blind Spot

Speed Limit: 10 KM/Hr

Distance from Start: 4.22 km

Coordinates: 26.75353, 83.20457

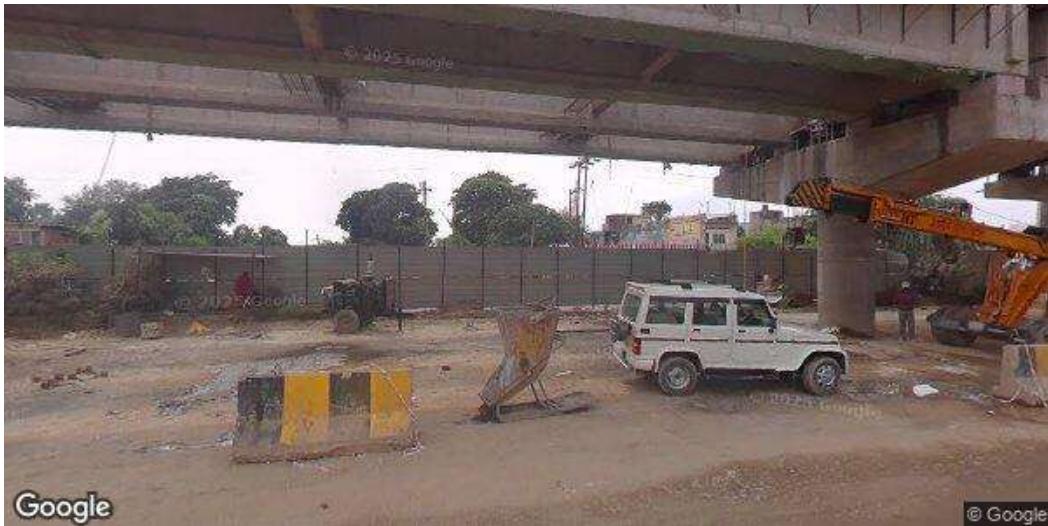
Risk Type: Turn**Risk Level:** High**Speed Limit:** 15 KM/Hr**Distance from Start:** 81.41 km**Coordinates:** 26.73919, 83.92809

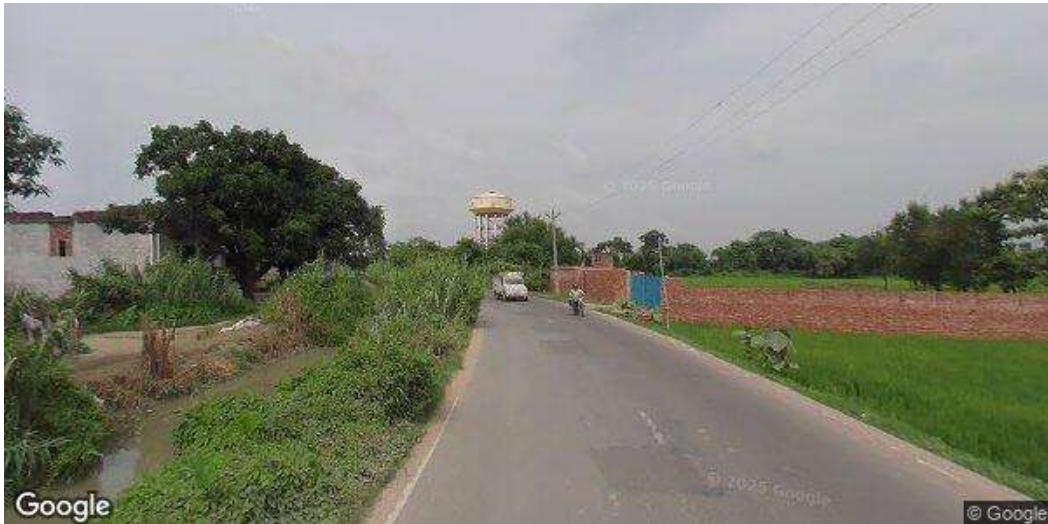
Risk Type: Turn**Risk Level:** Medium**Speed Limit:** 30 KM/Hr**Distance from Start:** 81.71 km**Coordinates:** 26.74132, 83.92916

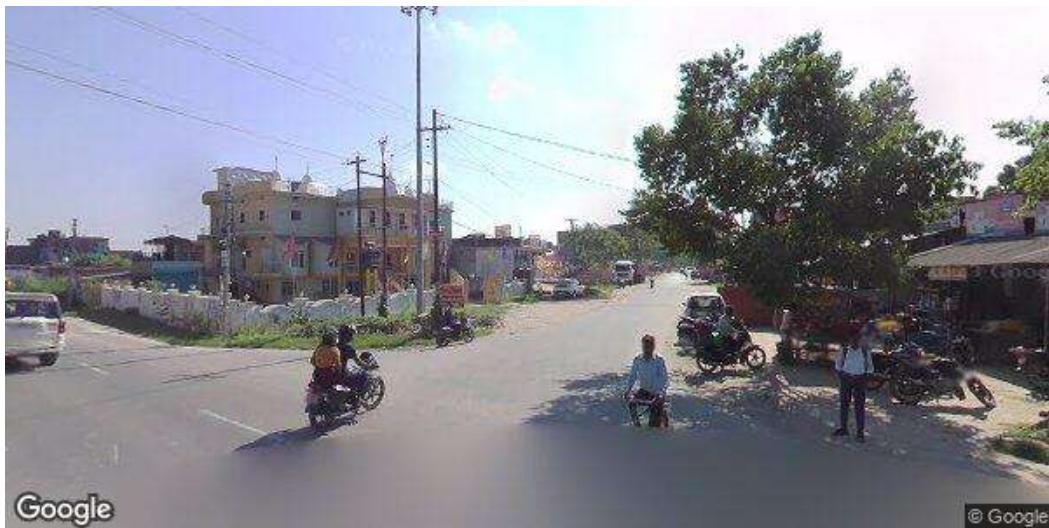
Risk Type: Turn**Risk Level:** High**Speed Limit:** 15 KM/Hr**Distance from Start:** 82.89 km**Coordinates:** 26.75149, 83.92601

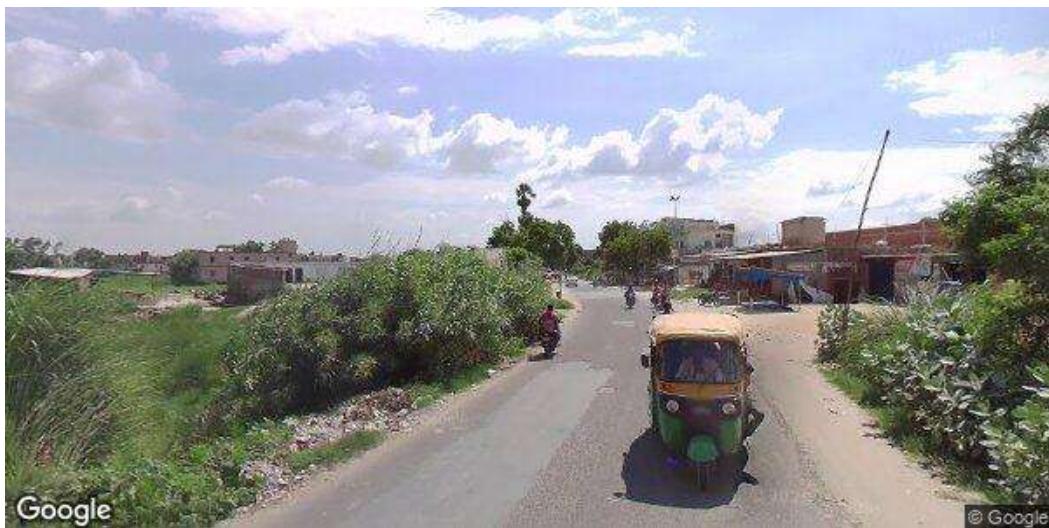
Risk Type: Turn**Risk Level:** Medium**Speed Limit:** 30 KM/Hr**Distance from Start:** 87.04 km**Coordinates:** 26.75972, 83.96613
