# Software Design Description 011

## ## LoRa Bench Test Protocol & Debug

This document describes the design of the LoRa bench test framework used to validate the RF link between the **ESP32-DevKitV1 (TX master)** and the **ESP32-S3 (echo slave)** prior to integrating the full coefficient packet pipeline.

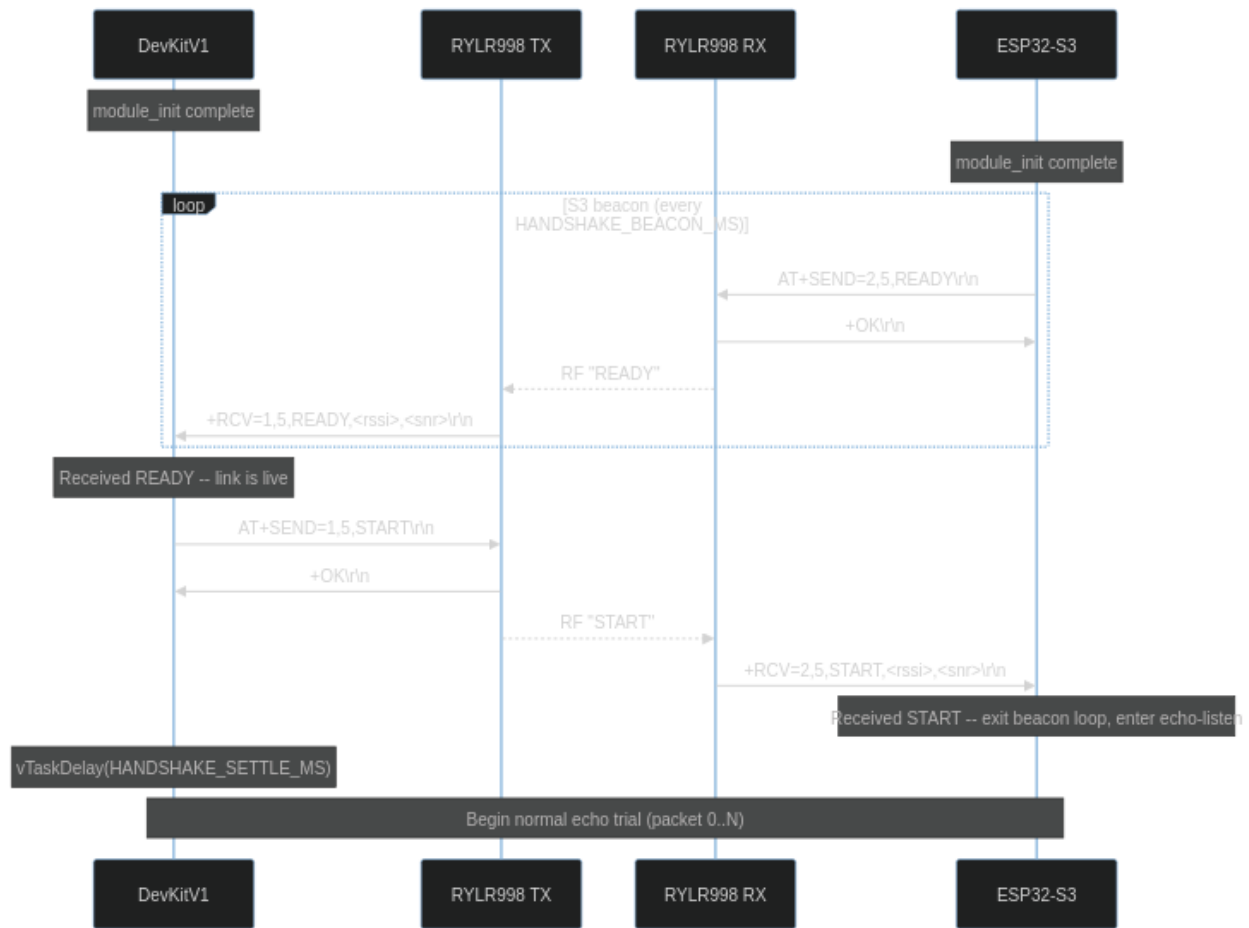
DevKitV1 sends all 50 packets, receives +OK for each (local module accepted the AT command), but never receives a +RCV echo. 100% timeout. Meanwhile the S3 log shows it received only one packet – and that packet was **seq 2**, not seq 0. Packets 0 and 1 were transmitted over RF while the S3 was still in its post-init delay and not yet calling `readline`.

The RYLR998 +OK response is **not a link-layer acknowledgment**. It means only that the local module accepted the AT+SEND command and will begin RF transmission. LoRa is a broadcast PHY – there is no pairing, no connection state, and no indication from the module that a remote receiver exists or is ready. The DevKitV1 has no way to know whether the S3 is listening.

The S3 is ~573 ms late. At the bench test’s pace (~10.2 s per packet due to timeout + inter-packet delay), this only costs the first 1-2 packets. But those lost packets start the DevKitV1’s timeout cascade, and any secondary failure (USB disconnect, module lockup from an unread +RCV in the S3’s UART buffer) turns the rest of the trial into 100% loss.

Since the RYLR998 provides no link-layer readiness signal, the application must implement one. The protocol is:

1. **S3 (echo slave)** completes `module_init`, then enters a beacon loop: it sends a short **READY** packet to the DevKitV1’s address every `HANDSHAKE_BEACON_MS` (e.g., 1000 ms) and listens for a **START** response between beacons.
2. **DevKitV1 (TX master)** completes `module_init`, then enters a handshake-wait loop: it calls `readline` with a short timeout, looking for a +RCV containing the **READY** payload. Upon receiving it, it sends a **START** packet back to the S3’s address.
3. **S3** receives the **START** packet (via +RCV during its listen window between beacons), exits the beacon loop, and enters the normal echo-listen state.
4. **DevKitV1** waits a short settle time after sending **START** (so the S3 has time to transition to listen mode), then begins the 50-packet trial.

If either board is not yet ready, the handshake simply hasn't completed – there is no timeout cascade, no wasted packets, and the trial only starts when both sides have confirmed link connectivity.
