Checking Slow Piezo Amplifier Card

Symptomatics

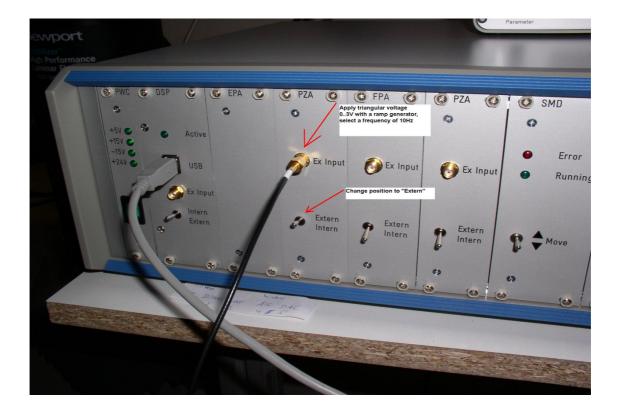
- 3. Connect an SMA cable to the slow piezo amplifier card, for safety check in the manual which one is it. (see also picture above)
- 4. Flip the switch to "Extern"
- 5. Take a ramp generator and select a triangular voltage with 0..3V range.
- 6. Select a frequency of ~ 10 Hz
- 7. Disconnect the SMA connection between the slow piezo and Matisse cabling (see picture)

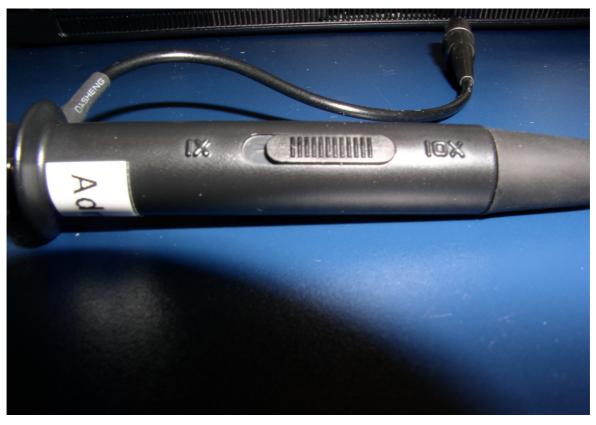
9. Select on the probe factor "10x" on the probe tip and on the oscilloscope too!

- 10. After that turn on the electronics and observe the voltage on the oscilloscope. You should see following values:
 - When applied voltage is OV (voltage from the ramp generator) you should see
 - \sim -12V on the scope.
 - When applied voltage is 3V (voltage from the ramp generator) you should see $\sim +140\mathrm{V}$ on the scope.
