## List of SAMCO Reference Projects

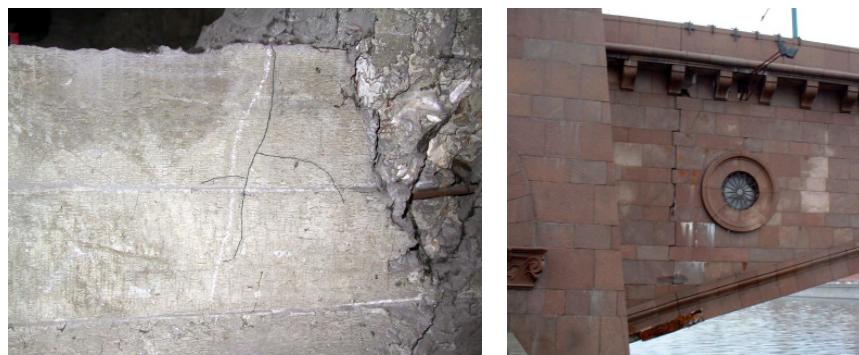
The bridge has eight vehicle lanes and two sidewalks separated from them by curbs. Two types of degradation are noticed on the bridge: settlement of an abutment provoking cracking of the stone lining as well as the structural elements and chlorides penetration into the structures leading to reinforcement corrosion.

Example of defects: cracks on structural elements and external facing
