### SEISMIC RETROFITTING PROJECT

CASA ARONES  
Cusco, Perú

Structural Prospection  
IIW-3

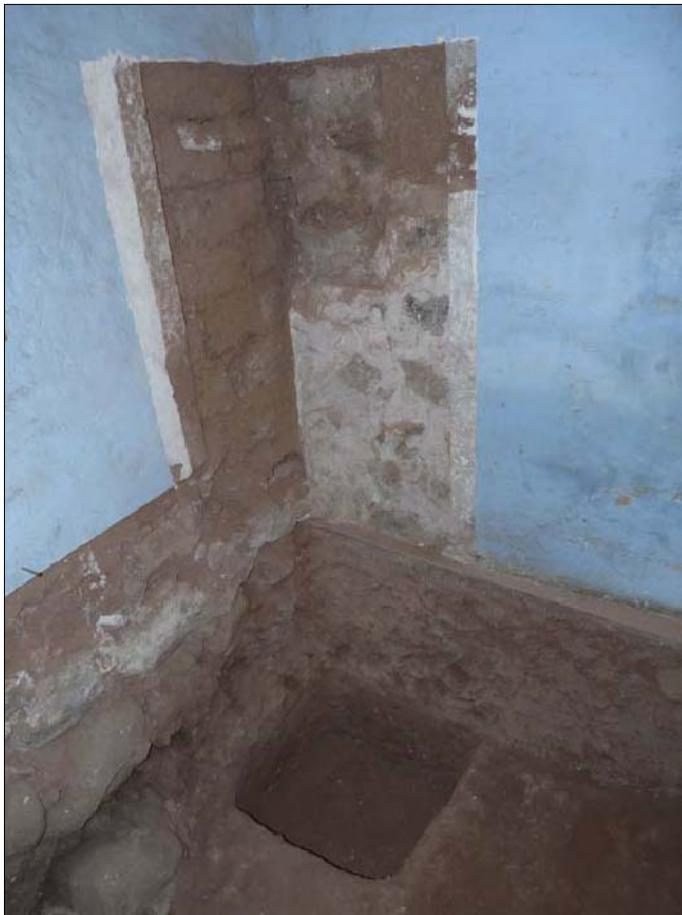
IS-1

TAKING ADVANTAGE OF A PREVIOUS ARCHEOLOGICAL OPENING, THIS PROSPECTION IS LOCATED AT THE INTERSECTION OF THE WALL SEPARATING ROOM A-110 FROM THE ENTRY HALL (ROOM A-100) AND THE PERPENDICULAR WALL SEPARATING ROOMS A-110 AND C-109. WE WERE ABLE TO SEE THE FOLLOWING:

THE ENTRY HALL WALL (BETWEEN ROOMS A-110 AND A-100) IS MADE OF ADOBE WITH A 0.50 m DEEP STONE FOUNDATION WITH A MUD AND LIME MORTAR. UNDERNEATH THIS FOUNDATION THERE IS A FILL OF LOOSE SOIL AND STONES. IN THE MIDDLE OF THIS FILL IS THE END OF A CERAMIC PIPE. ACCORDING TO THE ARCHAEOLOGICAL DATA, THIS PORTION OF THE FOUNDATION WAS REMOVED AT SOME POINT TO INSTALL THE PIPE.

PIPE. ACCORDING TO THE ARCHEOLOGICAL DATA, THIS PORTION OF THE FOUNDATION WAS REMOVED AT SOME POINT TO INSTALL THE PIPE. THE PERPENDICULAR WALL DIVIDES ONE ROOM FROM ANOTHER. IT HAS VIRTUALLY NO FOUNDATION, RATHER IT RESTS DIRECTLY ON THE GROUND; HOWEVER, IT HAS A VERY HIGH "SOBRECIMIENTO," OR BASE COURSE, - 2.00 m TALL - AND IS CONSTRUCTED OF STONES BONDED WITH A MUD AND LIME MORTAR. THE CONNECTION BETWEEN THE TWO WALLS IS VERY WEAK, APPARENTLY BECAUSE THE ADOBE WALL ALONG THE ENTRY HALL WAS BUILT FIRST AND WAS LATER FOLLOWED THE PERPENDICULAR STONE WALL. AT APPROXIMATELY EVERY SECOND COURSE OF STONE, A STONE IS EMBEDDED INTO THE ADJACENT ADOBE WALL.

BOTH WALLS ARE COVERED WITH A 0.040 m THICK MUD AND STRAW PLASTER UNDERCOAT, OVER WHICH A PLASTER FINISH COAT IS APPLIED.

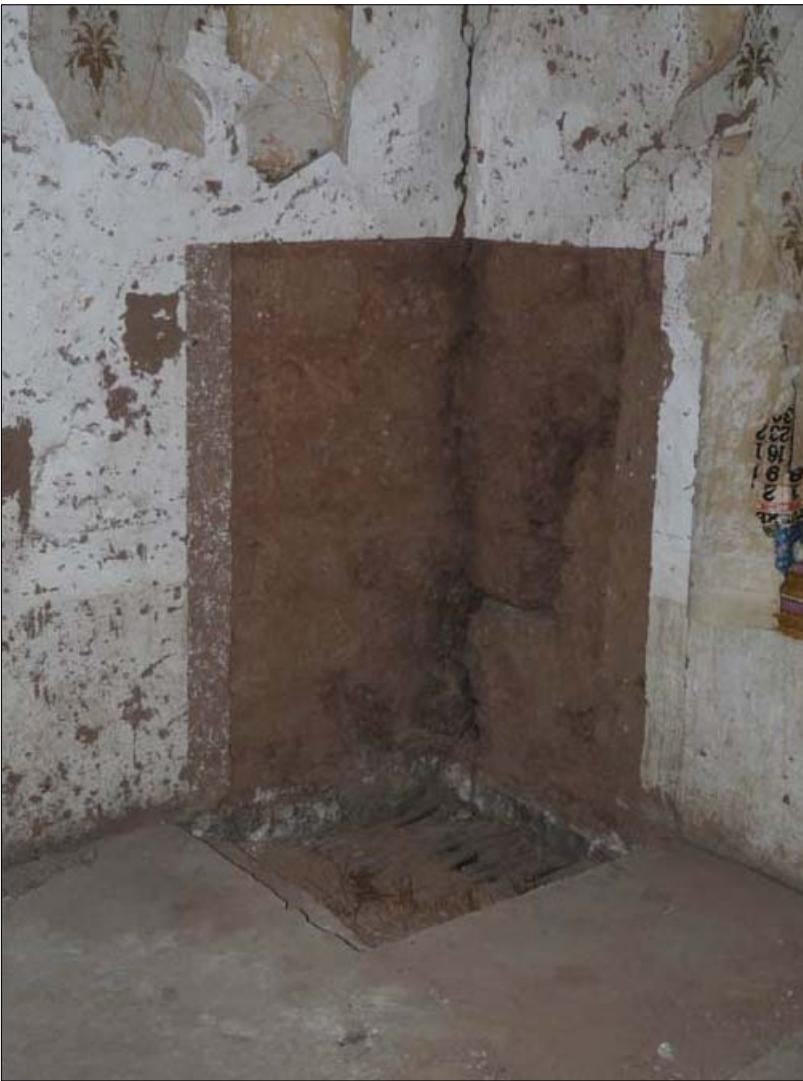
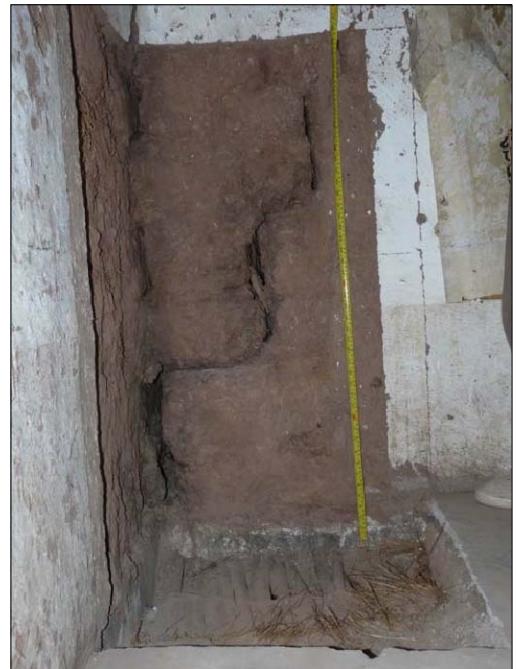
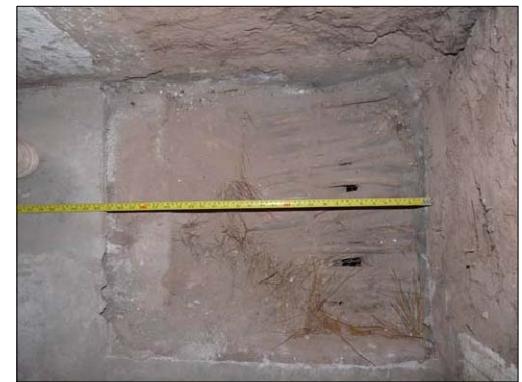
IIW-2

THIS OPENING IS LOCATED ON THE SECOND FLOOR, AT THE INTERSECTION OF THE MAIN FAÇADE AND THE WALL ALONG THE ADJACENT PROPERTY AFTER REMOVING THE WALLPAPER AND 0.04 m OF MUD PLASTER WITH AN ABUNDANT AMOUNT OF STRAW IN IT, WE WERE ABLE TO SEE THE CONNECTION BETWEEN THESE TWO WALLS. THERE IS A CRACK AT THIS CORNER, PROBABLY RESULTING FROM A PAST EARTHQUAKE. THIS OPENING IS LOCATED AT THE END OF THE PRINCIPAL ROOM ON THE SECOND FLOOR, ABOVE A SHOP ON THE FIRST FLOOR. THE FLOOR IN THIS ROOM IS SEVERELY SETTLED OR WARPED, RESULTING FROM DAMAGE TO THE SUPPORTING BEAMS BELOW. SHORING HAS BEEN INSTALLED AT THE FIRST FLOOR TO SUPPORT THE BEAMS AND FLOOR.

THIS OPENING ALSO ALLOWED US TO OBSERVE THE FLOOR / CEILING STRUCTURE BETWEEN THE FIRST AND SECOND LEVELS: THE FLOOR SURFACE IS MADE OF A LIME, SAND AND GYPSUM MORTAR, FOLLOWED BY A LAYER OF STRAW WITH SOME MUD IN IT. UNDERNEATH THESE LAYERS THERE ARE NEATLY-ARRANGED SMALL TRUNKS OR BRANCHES OF "CHACHACOMO" WOOD, TIED WITH LEATHER STRAPS TO ONE ANOTHER AND ALSO ATTACHED TO THE ALDER (BIRCH) WOOD JOISTS. THE BOTTOM PART OF THE STRUCTURE CORRESPONDS TO THAT OF THE FIRST FLOOR CEILING, AND IT IS FINISHED WITH GYPSUM PLASTER.

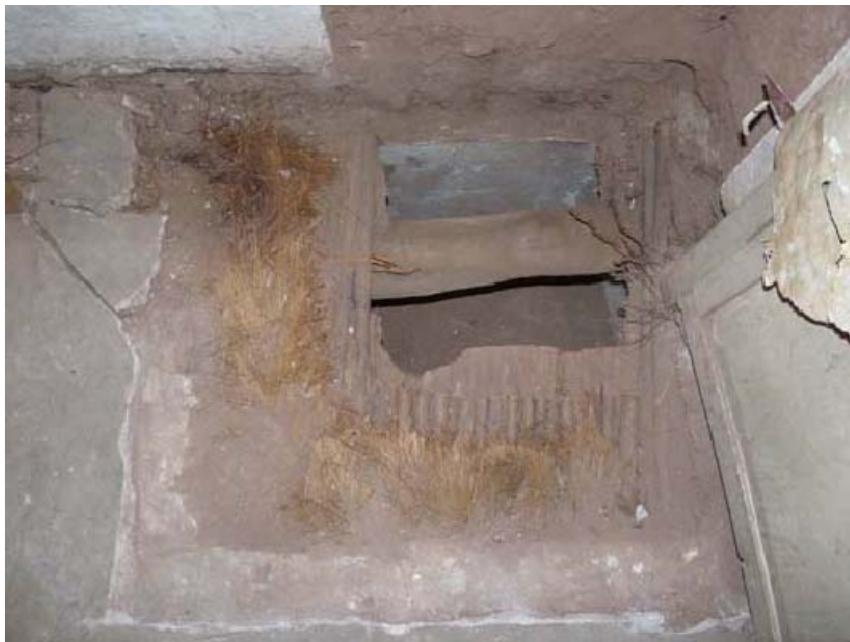
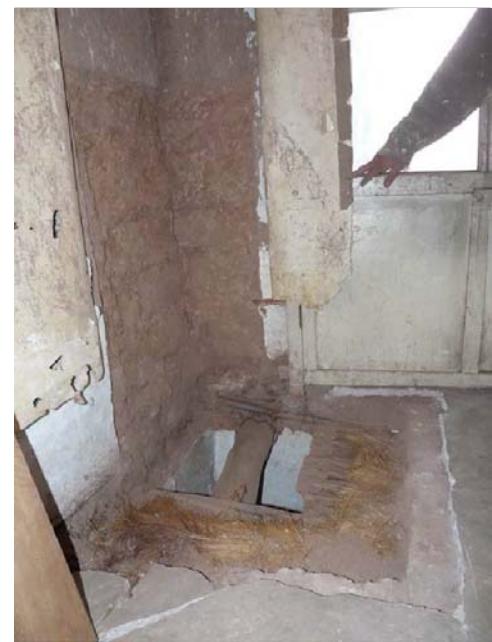
IIW-1

ON THE CORNER BETWEEN THE PRINCIPAL FAÇADE WALL AND LATERAL FAÇADE WALL OF THE SECOND FLOOR IT'S LOCATED THIS OPENING. THERE IS EVIDENCE OF STRUCTURAL CONNECTION BETWEEN THESE TWO WALLS. ALSO THERE IS STRAW AND MUD PLASTER OF 1" (25 mm) THICK, GYPSUM AS A FINISH COAT AND WALLPAPER.

THERE IS OTHER OPENING AT THE BOTTOM OF THIS ONE, WHICH ALLOWS US TO SEE THE FLOOR STRUCTURE OF THE SECOND LEVEL. UNDERNEATH THE CARPET THERE IS A SMOOTH FINISH COMPOSED WITH A LIME, SAND AND PLASTER MORTAR, FOLLOWING BY A THICK LAYER OF MUD AND STRAW, UNDERNEATH THIS THEY ARE SMALL TRUNKS OF "CHACHACOMO" TIED WITH LEATHER STRAPS NEXT TO EACH OTHER AND ATTACHED TO THE BIRCH/ALDER WOODEN JOIST, THESE JOISTS ARE EMBEDDED INTO THE WALL AND IN OTHER CASES ARE SUPPORTED BY A 8" (0.20 m) WOODEN BEAM. THIS WOODEN BEAM IT'S ALSO A BIRCH/ALDER ROUNDED WOOD BEAM, THE GIRDER HAS BEEN MODIFIED WITH OTHER PIECES OF WOOD TO GIVE IT A RECTANGULAR APPEARANCE AND ITS BEEN PAINTED. FURTHERMORE ALL THE CEILING OF THE FIRST FLOOR HAS BEEN COVERED WITH A GLUED FABRIC, THAT IT'S BEEN STRETCHED TO COVER ALL THE ROOM AND ITS BEEN NAILED TO THE WALLS WITH SOME WOODEN STRIPS.

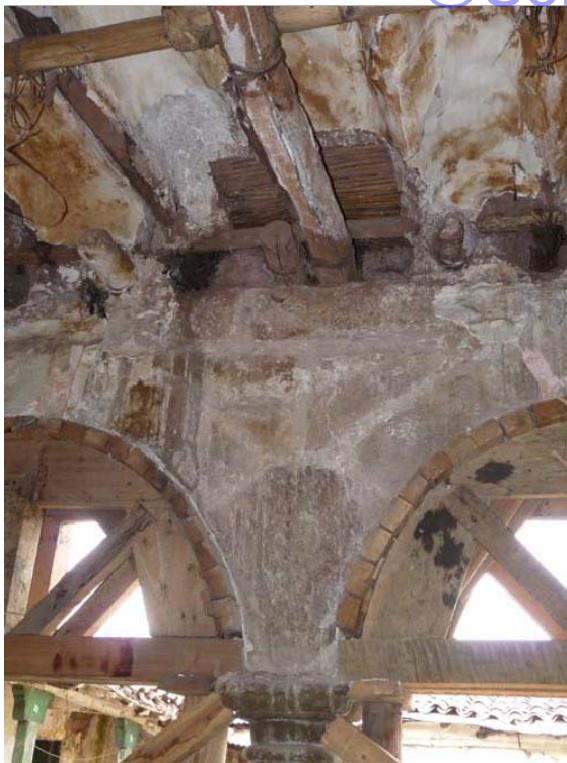
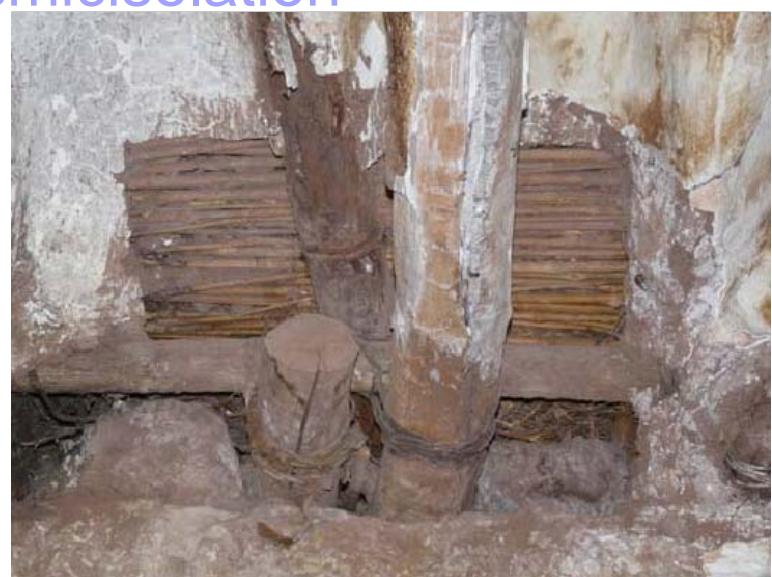
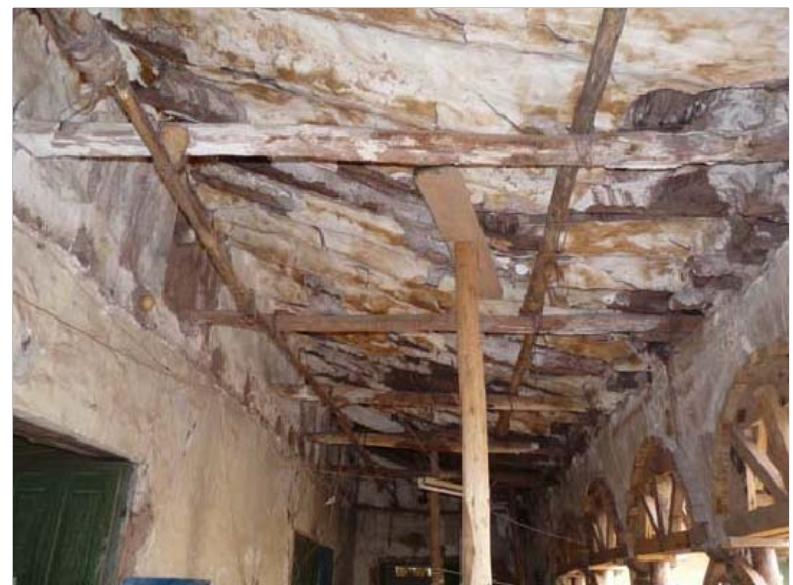
IIC-6

THIS OPENING IS LOCATED AT THE SECOND FLOOR GALLERY (ROOM 210). THE GALLERY ARCADE AT THE SOUTH SIDE OF THE ROOM IS CONSTRUCTED WITH CUT STONE LAID IN A LIME AND SAND MORTAR. THE ARCADE SUPPORTS THE ROOF STRUCTURE ABOVE. HORIZONTAL BEAMS OR TIE BEAMS CROSS THE GALLERY. THE SOUTH ENDS OF THE TIE BEAMS REST ON TOP OF THE STONE ARCADE, AND THE NORTH ENDS ARE EMBEDDED IN THE ADOBE WALL OPPOSITE THE ARCADE. ABOVE THE ARCADE, A LOOKOUT (A SHORT JOIST THAT PROJECTS BEYOND THE WALL OF A BUILDING AND SUPPORTS THE EAVES) IS TIED TO THE END OF THE TIE BEAM; AND THIS LOOKOUT CROSSES THE WALL AND PROJECTS APPROXIMATELY 0.40 m BEYOND ITS EXTERIOR FACE TO CREATE AN EAVE OVER THE PATIO BELOW. ADDITIONAL LOOKOUTS ARE PROVIDED IN THE SPACE BETWEEN EACH TIE BEAM. A PURLIN, RUNNING PARALLEL TO THE ARCADE, SITS ON TOP OF THE NORTH ENDS OF LOOKOUTS AND IS TIED TO THEM WITH LEATHER STRAPS. TWO OTHER ROUND BEAMS, LOCATED ABOVE THE TIE BEAMS, PROVIDE LONGITUDINAL BRACING. IN THE AREA WHERE THE TIE BEAM, LOOKOUT, AND PURLIN MEET, THERE IS A FOURTH ELEMENT - AN INCLINED RAFTER - WHICH RESTS ON AND IS TIED TO THE OTHER THREE ELEMENTS. OTHER RAFTERS ARE LOCATED IN THE SPACE BETWEEN THE TIE BEAMS. OVER THE RAFTERS ARE WOVEN "KUR KUR" CANES, WHICH ARE ATTACHED TO SMALL CANES RUNNING IN THE TRANSVERSE DIRECTION THAT PROVIDE SOME REINFORCEMENT AND PREVENT COLLAPSE. OVER THE "KUR KUR" CANES IS A THICK LAYER OF MUD AND STRAW THAT SUPPORTS THE ROOF TILE. THE UNDERSIDE OF THE STRUCTURAL ELEMENTS AND CANES IS COVERED WITH MUD PLASTER AND A GYPSUM FINISH COAT, WHICH FORMS THE GALLERY CEILING.

IT APPEARS THAT THERE WAS ONCE A DROPPED FLAT CEILING IN THE GALLERY. BELOW THE LEVEL OF THE EXISTING TIE BEAMS, THE CUT ENDS OF ROUND JOISTS AND JOIST POCKETS ARE VISIBLE. THE JOIST ENDS AND POCKETS SUGGEST THAT JOISTS ONCE SPANNED BETWEEN THE ADOBE WALLS AND ARCADE, AND THAT THEY PROVIDED A FRAMEWORK FOR A FABRIC CEILING.

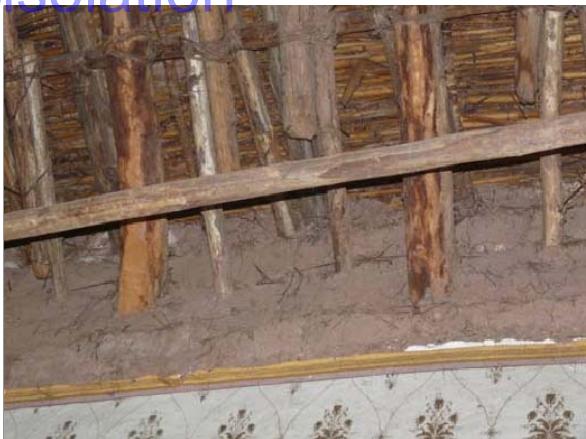
IIIC-1

THIS OPENING IS LOCATED AT THE INTERSECTION OF THE ROOF FRAMING AND THE ADOBE WALL.

THE TIE BEAM IS EMBEDDED INTO THE ADOBE WALL. UNDERNEATH THIS TIE BEAM ARE JOISTS THAT SUPPORT THE CEILING, WHICH IS CONSTRUCTED WITH "KUR KUR" CANES TIED WITH LEATHER STRAPS AND COVERED WITH A LAYER OF MUD PLASTER AND FINISHED WITH A GYPSUM COAT. ABOVE THE TIE BEAMS, THE ENDS OF THE PRINCIPAL AND SECONDARY RAFTERS ARE EMBEDDED IN THE ADOBE WALL. AN ADDITIONAL SET OF RAFTERS ABOVE THAT GIVE SHAPE TO THE ROOF SIT ON TOP OF THE ADOBE WALLS; BUT THERE IS NOT A WALL PLATE.

ABOVE, THAT GIVE SHAPE TO THE ROOF, SIT ON TOP OF THE ADOBE WALLS; BUT THERE IS NOT A WALL PLATE. PURLINS TRANSVERSELY SPAN ACROSS THE RAFTERS. ON TOP OF THE RAFTERS ARE "KUR KUR" CANES TIED WITH LEATHER STRAPS, FOLLOWED BY A LAYER OF STRAW AND MUD WHICH SUPPORTS THE ROOF TILES.

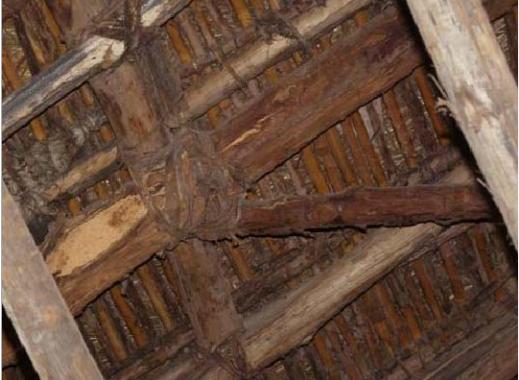
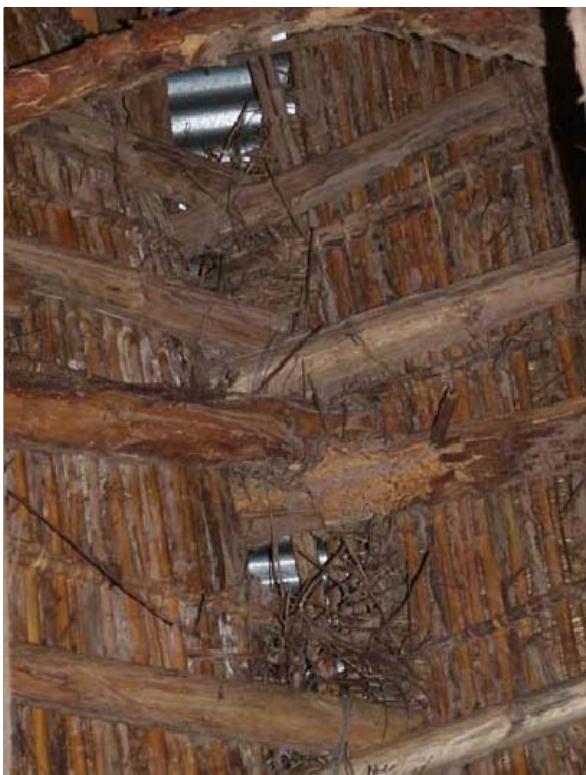
IIC-3

THIS OPENING SHOWS THE STRUCTURE OF THE ROOF RIDGE, WHICH HAS THE SAME CHARACTERISTICS AS THE RIDGE OVER THE ADJACENT ROOM A-203 AND THE ROOMS ALONG THE LATERAL FAÇADE.

THE PRINCIPAL RAFTERS MEET AT THE RIDGE AND ARE JOINED WITH HALF-LAP JOINTS AND ARE ALSO TIED WITH LEATHER STRAPS. THE SECONDARY RAFTERS ARE NOT JOINED WITH HALF-LAP JOINTS - THEY ARE ONLY TIED TOGETHER WITH WIRE. THE USE OF WIRE INDICATES THE SECONDARY RAFTERS ARE NOT ORIGINAL. THE RIDGE BEAM IS LOCATED ABOVE THE RAFTERS' MEETING POINT. IN THE UPPER THIRD PART OF THE PRINCIPAL RAFTERS, THERE IS A COLLAR TIE WHICH IS TIED TO THE RAFTERS WITH LEATHER STRAPS.

IT IS ALSO POSSIBLE TO OBSERVE THAT THE ROOF IN THIS AREA HAS SUFFERED FROM RECENT INTERVENTIONS, WHICH CHANGED ITS HEIGHT BY 0.60 M.

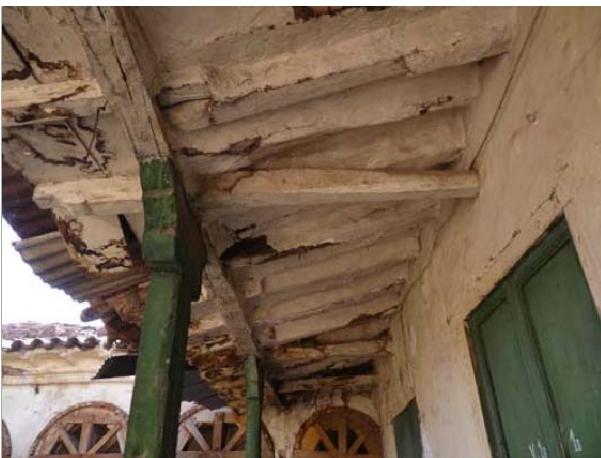
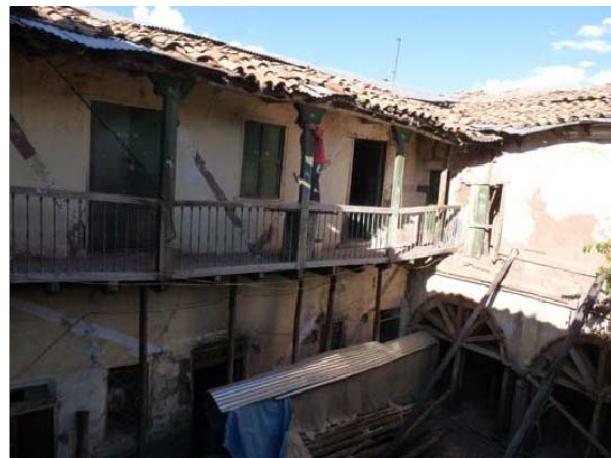
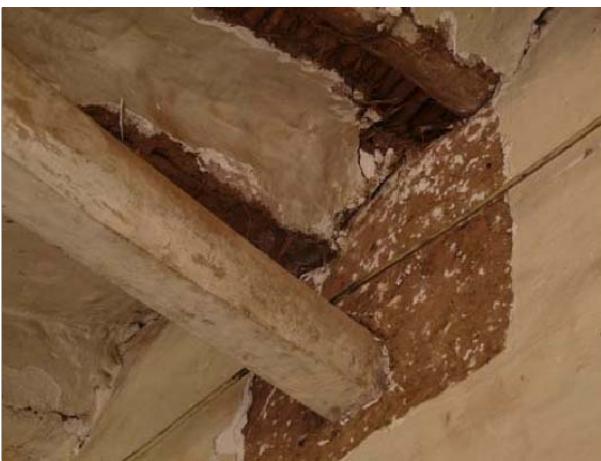
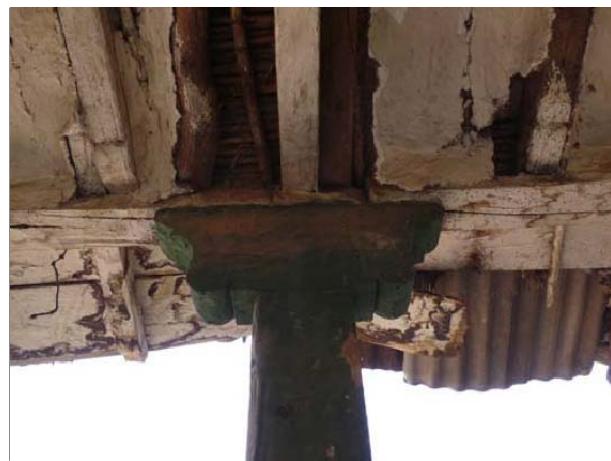
IIC-4

THIS OPENING IS LOCATED AT THE ROOF OVER THE SECOND FLOOR BALCONY AT THE EAST SIDE OF THE PATIO. THE ROOF STRUCTURE IS SUPPORTED BY WOOD COLUMNS WITH HAND-SAWN WOOD CAPITALS. THE CAPITAL SUPPORTS TWO BEAMS. THERE IS A GAP BETWEEN THE BEAM ENDS; AND THIS GAP IS CENTERED OVER THE COLUMN BELOW. IN THIS GAP THERE IS A BLOCK OF WOOD THAT SUPPORTS THE TIE BEAM. UNLIKE OTHER AREAS OF CASA ARONES, THIS TIE BEAM HAS A SQUARE PROFILE. THE CONNECTION BETWEEN THE TIE BEAM AND BLOCK IS MADE BY A HALF-LAP JOINT, ALLOWING THE TIE BEAM TO CONTINUE THROUGH TO THE EAVES. THE OTHER END OF THE TIE BEAM IS EMBEDDED INTO THE ADOBE WALL AT THE OPPOSITE SIDE OF THE BALCONY. THUS, EACH TIE BEAM ALIGNS WITH A WOOD COLUMN.

THE MEETING OF THE WOOD BLOCK AND TIE BEAM ALSO CORRESPONDS TO THE LOCATION OF THE RAFTER ENDS. THE TOPS OF THE RAFTERS ARE FLUSH WITH THE TOP OF THE ADOBE WALL AT THE OPPOSITE SIDE OF THE BALCONY. OTHER RAFTERS FILL THE SPACE BETWEEN THE TIE BEAMS; HOWEVER, THEIR ENDS REST ON THE BEAM OVER THE COLUMN CAPITALS. THE PROJECTION OF THE EAVES IS CREATED WITH RAFTER TAILS, WHICH ARE TIED TO THE RAFTERS WITH LEATHER STRAPS.

CANES, RUNNING PARALLEL TO THE RAFTERS, FILL THE SPACE BETWEEN THE RAFTERS. THESE CANES ARE WOVEN AND TIED TO "KUR KUR" CANES ABOVE. OVER THIS IS A THICK LAYER OF MUD AND STRAW ("TORTA") THAT SUPPORTS THE ROOF TILES. THE UNDERSIDE OF THE ROOF STRUCTURE IS COATED WITH A THIN LAYER OF MUD FINISHED WITH GYPSUM.

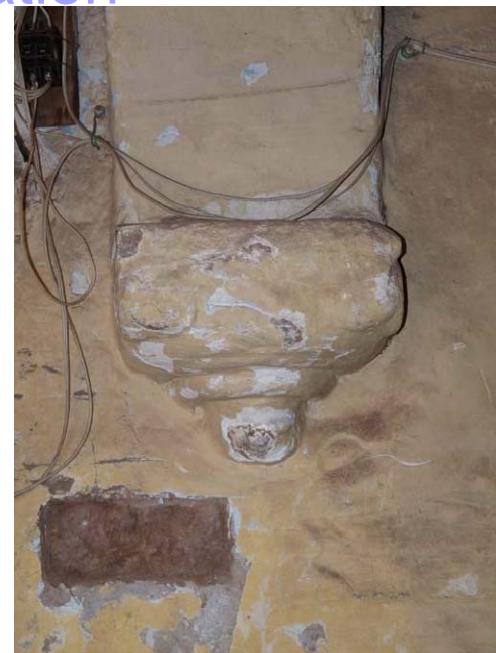
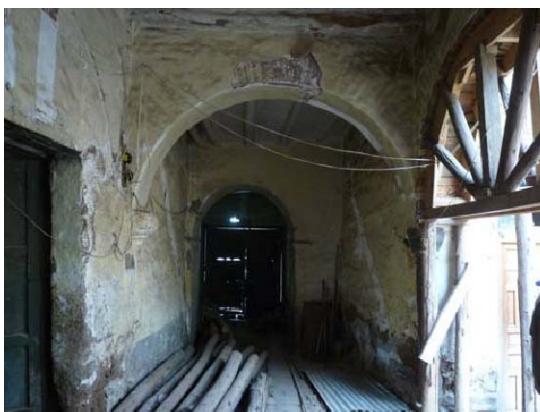
IW-3

THIS OPENING IS LOCATED AT THE ARCH IN THE ENTRY HALL. THE BRICK ARCH IS SUPPORTED BY A STONE COLUMN ON ONE SIDE AND A STONE CORBEL ON THE OTHER SIDE. TWO-THIRDS OF THE LENGTH OF THIS CORBEL IS RECESSED INTO THE ADOBE WALL.
