CHAPTER 4

Cathedral of Ica

4.1 Summary

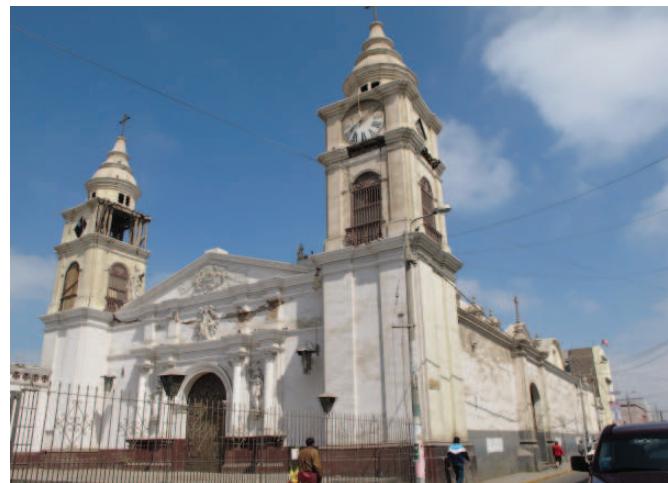
**FIGURE 4.2**

The Cathedral of Ica, as viewed from the main plaza to the north-east.

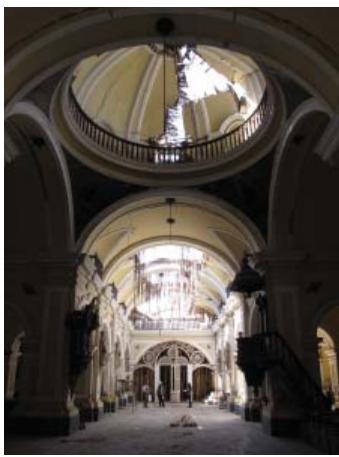
**FIGURE 4.3**

View of damages to the dome and vault resulting from the 2007 earthquake.

1813 and 1942 earthquakes, which led to the rebuilding of its façade, including the two bell towers, in fired brick masonry. The structure has been at risk since the 2007 earthquake, which led to the collapse of sections of the barrel vault near the façade, partial collapse of the central dome, total collapse the roof over one bay of the south side aisle, and loss of plaster at the pillar and pilaster bases (Fig 4.3).

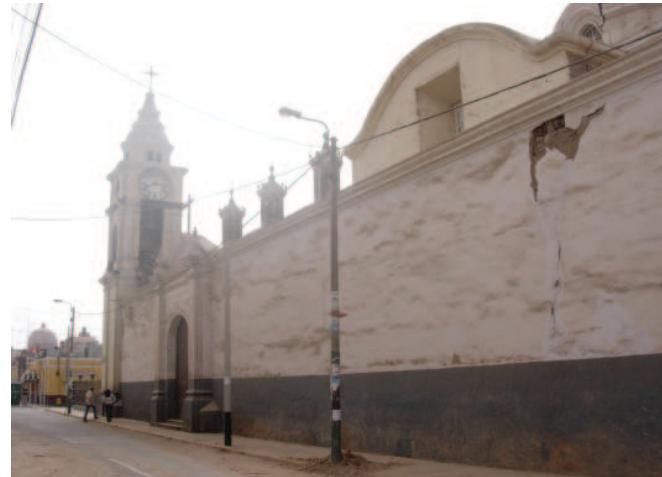
**FIGURE 4.9**

North lateral wall along Jirón Cajamarca, 2007.

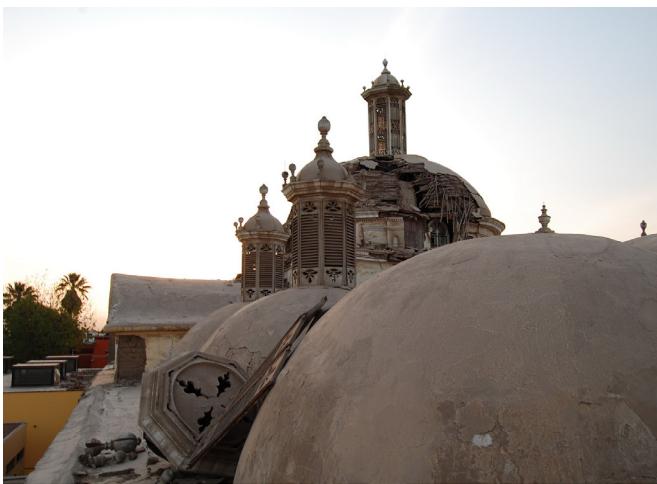
FIGURE 4.13

View of domes over south lateral aisle, with damaged main dome in the distance, 2007.

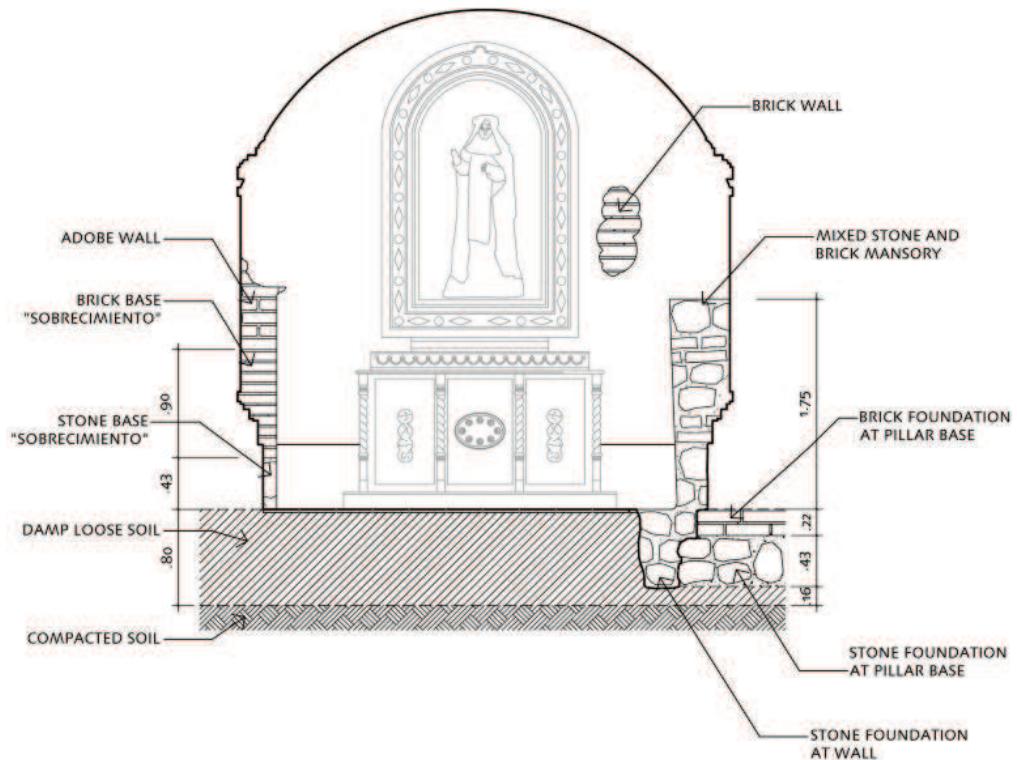
FIGURE 4.19

At the mud brick north lateral wall, there is a 0.90 m high fired brick masonry base course over a 0.40 m high rubble stone masonry wall (prospection IW-2). Rubble stone masonry is also used for the foundation below; however, its depth was not confirmed through any prospections along this wall. The width of the base course is the same as the mud brick wall above. Both the base course height and material composition changes at the east end of the north lateral wall, in the transitional zone between the fired brick north bell tower and the mud brick lateral wall. In this area the stone base course is interspersed with courses of fired brick and continues to a height 1.75 m above the interior floor level. Above this, fired brick construction continues up to 3 m above the interior floor level—approximately to the height of the ceiling over the side aisle. According to architect Mirna Soto, who was responsible for carrying out the prospections, this transitional technique is also extant in a church located two blocks away and dating to the same period as the cathedral (Fig. 4.19).

Prospection IW-2-IS-1, elevation view showing the foundation at the north lateral wall, adjacent to the bell tower.
Drawing: Mirna Soto, for the GCI.

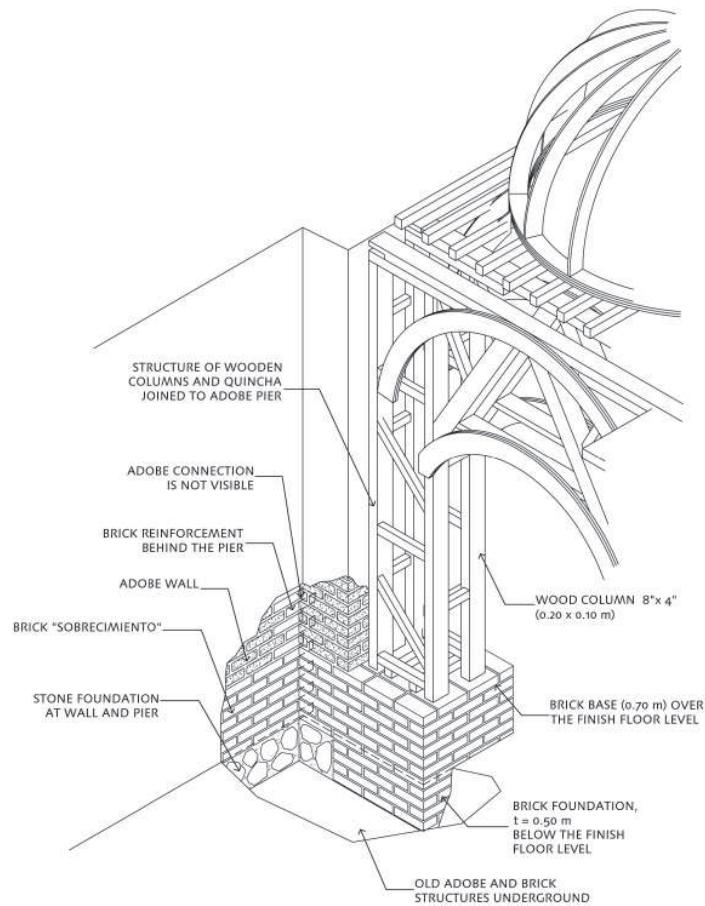
Prospection IS-2-IW-6, showing the fired brick reinforcing behind the mud brick piers along the south lateral wall.

The lateral walls are constructed of mud brick masonry with a mud mortar. There are a series of mud brick piers along each of the lateral walls, behind each of the wood-framed pilasters in the side aisles. Fired brick reinforcing, within the mud brick walls, is used behind each of the piers (Fig. 4.20).

- Bricks at the pier bases do not interlock with the brick base course along the lateral wall. The lack of connection is thought to explain the vertical cracking that was observed between the pilasters and lateral walls.

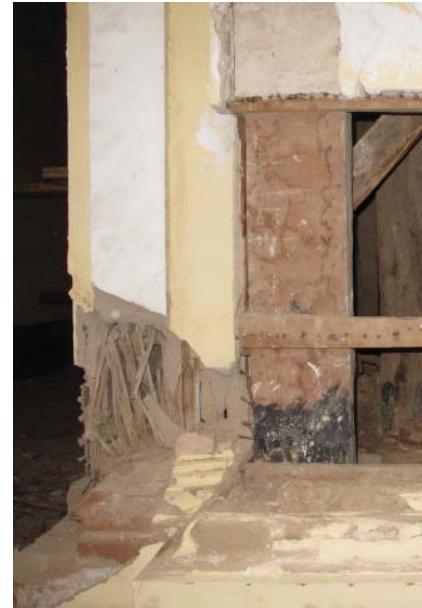
FIGURE 4.24
View of pillar base, above brick base.
Image: Sara Lardinois.

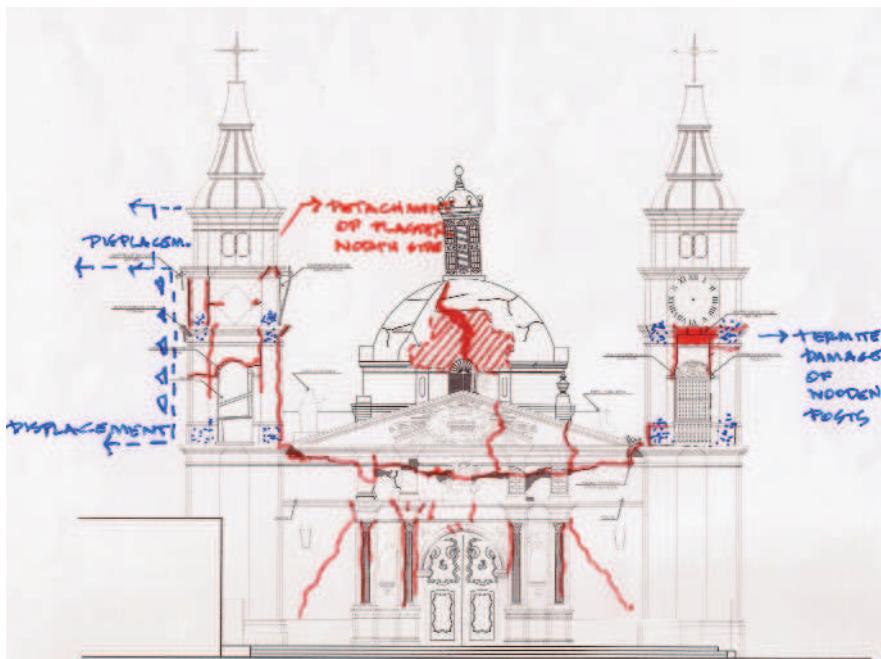
FIGURE 4.40

- The principal façade is in fair to poor condition. There are horizontal cracks between the lower façade and the pediment. Diagonal cracks were observed between the upper cornice and the base of the bell towers. This diagonal cracking suggests pounding of the towers during the earthquake (Fig. 4.40).
- The wood-framed portions of the towers are in poor condition and thus present a threat to the cathedral's roof system to the west. Damages include the failure of some connections, displacement of the wood elements at the south tower from their original positions, and loss of plaster. Thus, the wood posts are exposed and show signs of severe termite damage. (Fig. 4.41).

Front façade, graphic condition survey indicating cracks and areas of plaster loss in red and displacement and termite damage in blue.

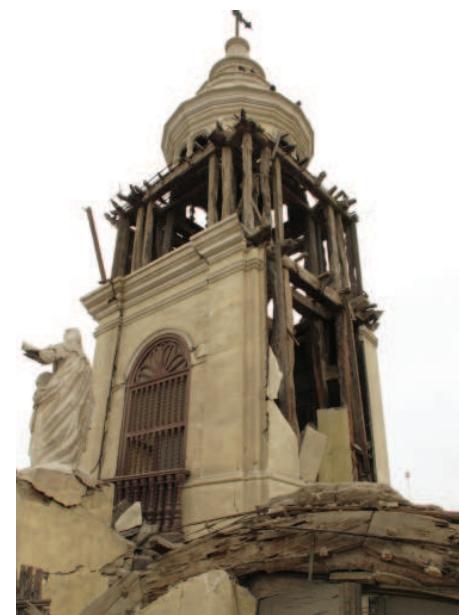
FIGURE 4.41

Loss of plaster at the south bell tower.
Image: Sara Lardinois.

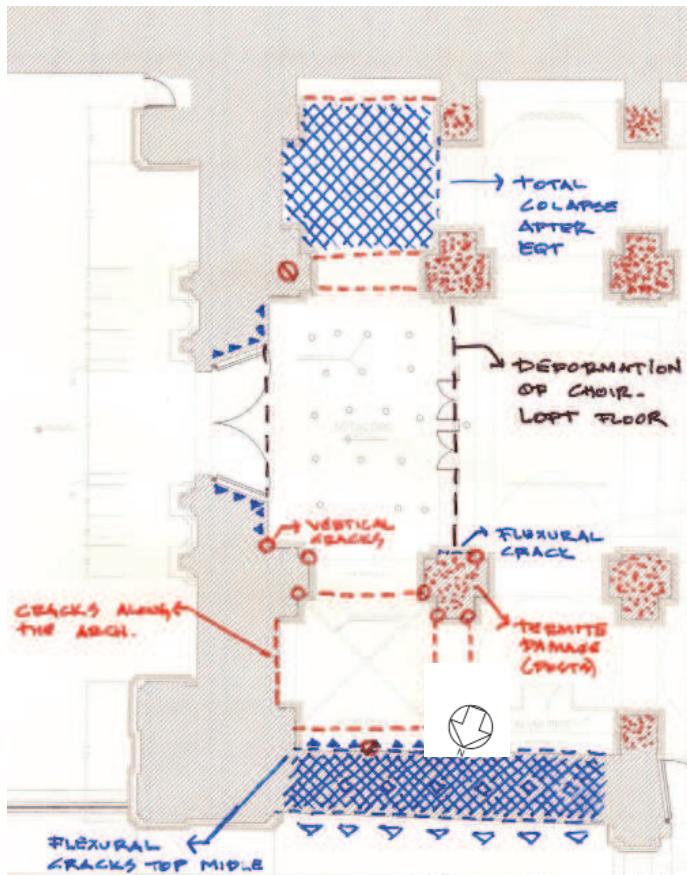
**FIGURE 4.42**

- Horizontal and vertical cracking along the perimeter of all arches and piers at the north lateral wall, in the altarpiece J (Saint Rose of Lima) space.
- Disconnection between the rib vault at the northeast corner and the north lateral wall.
- Deformation of the choir loft floor and the choir screen below.
- Vertical cracking along the pillars separating the sotacoro from the nave and structural disconnection between the pillars and adjacent choir screen.
- Total collapse of the rib-vaulted ceiling and flat roof above the altarpiece K space (southeast corner), occurring after the 2007 earthquake sometime between November 2007 and May 2009 (Figs. 4.43, 4.44).
- Collapse of the barrel vault that originally covered the choir loft.

Sotacoro: Graphic condition survey.
Drawing: Claudia Cancino.

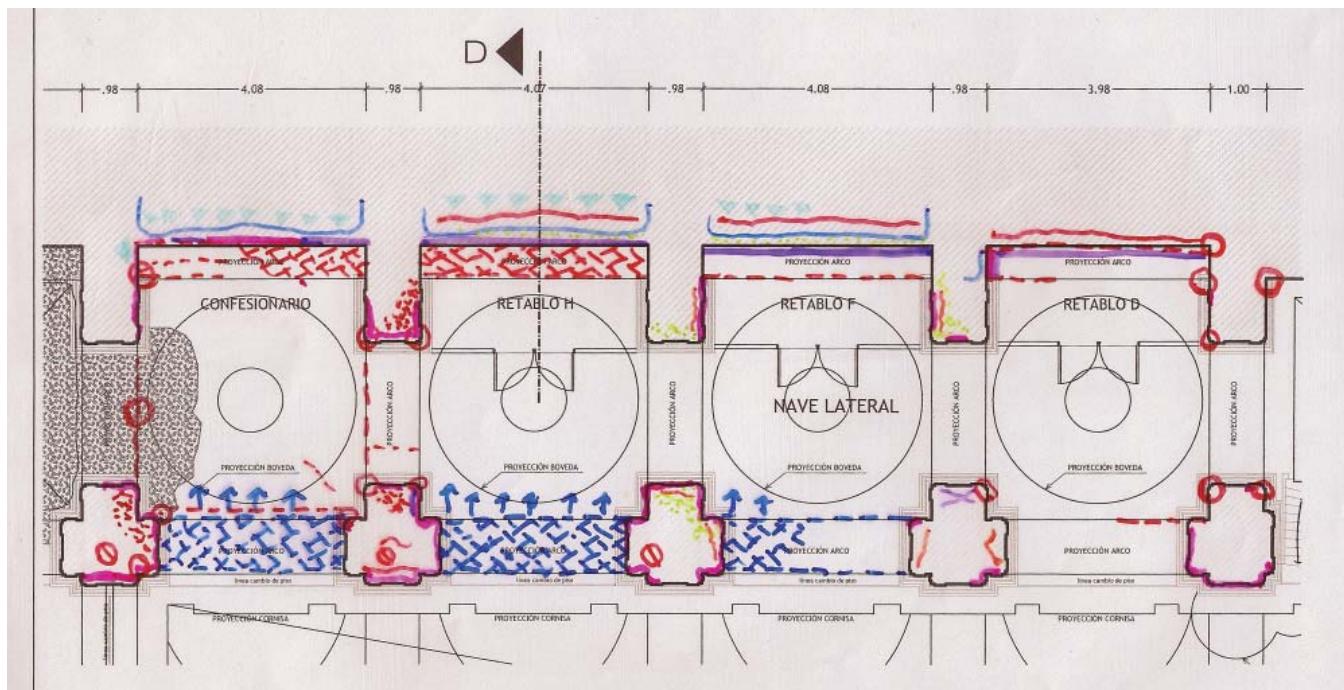
FIGURE 4.45

- Horizontal cracking along the south mud brick wall.
- Minor out-of-plane displacement of the pillar wall, towards the south side aisle.
- Structural disconnection between the pillars and their bases and between the pillars and the arches above.

- Vertical cracking at the west pillar in altarpiece D space.

Sector B: South side aisle graphic condition survey. The dark blue hatch pattern and small dark blue arrows show the out-of-plane displacement at the arches between the side aisle and nave; the large, light blue arrows show areas of moisture damage; the red lines show areas of horizontal cracking; and the red circles show areas of vertical cracking.

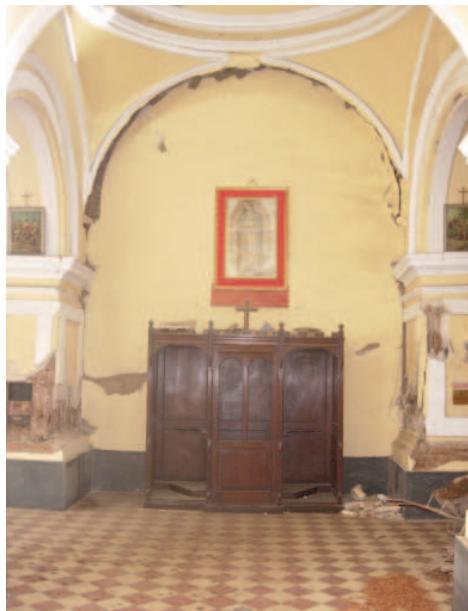
**FIGURE 4.47 (RIGHT)**

Sector B: Cracking and partial collapse at arches at the top of the wall, altarpiece H space, 2007.
Image: Philippe Garnier.

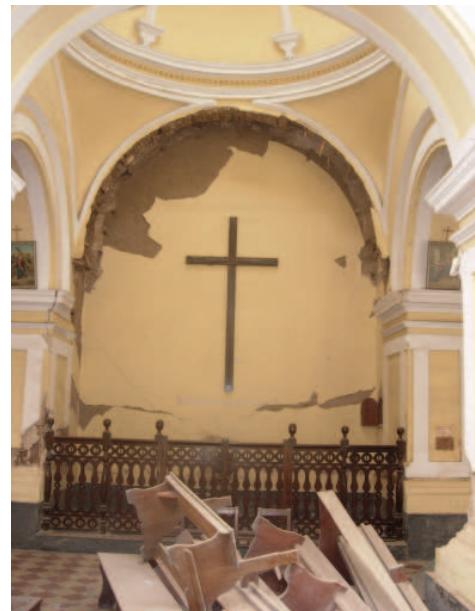
**FIGURE 4.48**

Sector B: Detail of cracking and partial collapse at arches along the south lateral wall.
Image: Sara Lardinois.

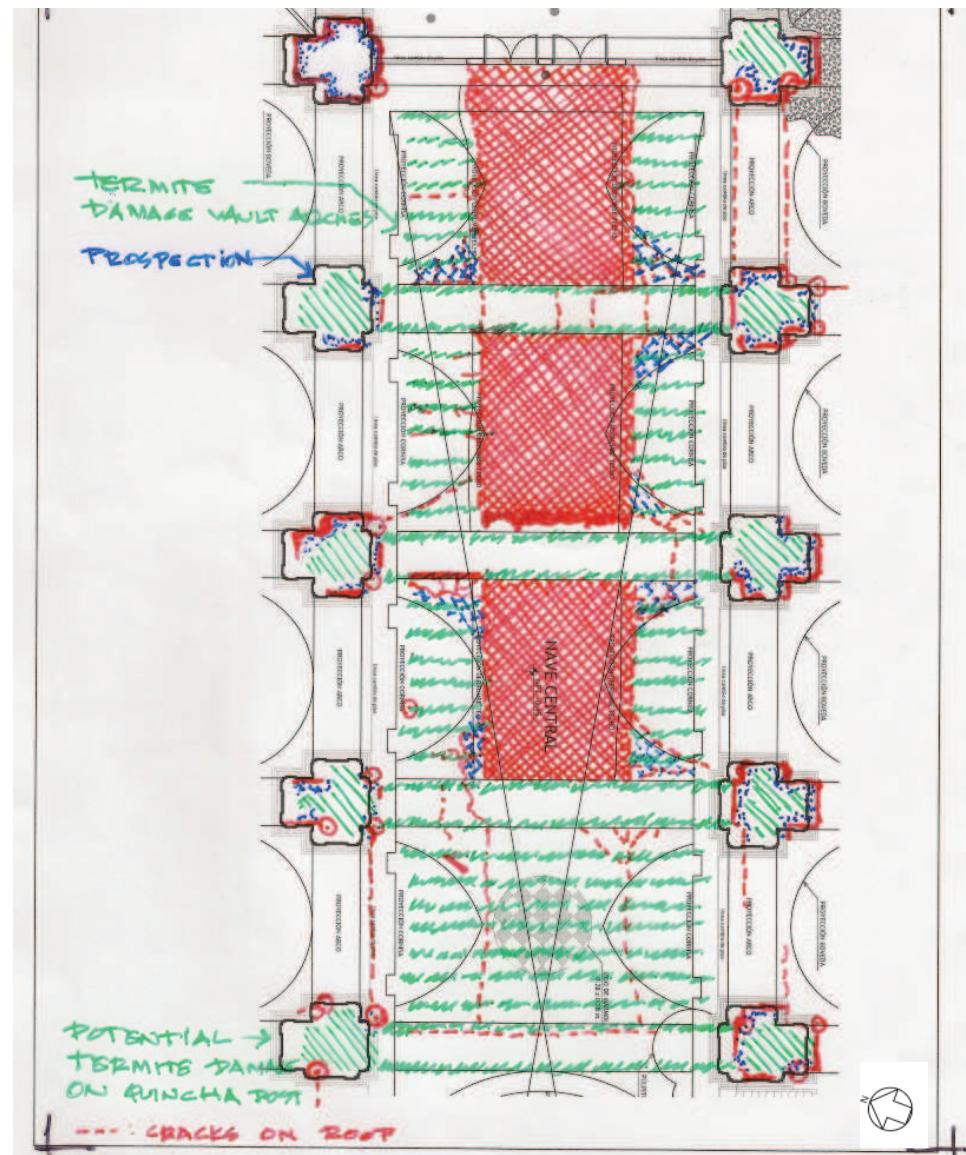
**FIGURE 4.49**

- Partial collapse of the central portion of the barrel vault, between the 3" × 10" (0.08 × 0.25 m) wood beams at the tops of the lunettes, in the three bays at the east end of the nave (Fig. 4.50). Based upon the GCI's photographic records from November 2007, the central portion of eastern-most nave vault collapsed several months after the August 2007 earthquake, as photos taken in November 2007 show the vault intact but with cracking in the area that would later collapse. Heavy termite damage to the wood members and corrosion of the connecting nails is thought to have contributed to this collapse (Fig. 4.51). During the 2007 earthquake, the rocking of the pillars added tension to the already deteriorated wood vault arches, breaking them into pieces and leading to failure of the mortise-and-tenon joints. The lateral wood beam at the tops of the lunettes that runs perpendicular to the principal arches may have prevented total collapse of the barrel vault in these bays (Fig. 4.52).

Sector C: Graphic condition survey. Collapsed portions of the barrel vault are shown in the red hatch pattern.

- All of the pillars are in poor condition, showing signs of structural deterioration. The wood posts, diagonal reinforcements, and sill plate exhibit heavy termite damage and rot from rising damp in the brick bases below (Fig. 4.53). The connections between the posts and the wood arches in the upper part appear to be in fair condition, but some termite damage is present. Most of the plaster exhibits vertical cracking and detachment; and, in areas where the plaster has been lost, the wood elements are exposed to further deterioration. The only element of the pillars that remains in good condition is the huarango tree trunk, which probably helped to prevent collapse of the structure during the 2007 earthquake.
- Minor outward out-of-plane displacement of pillar walls.
- Vertical cracking along the lunettes in all bays.

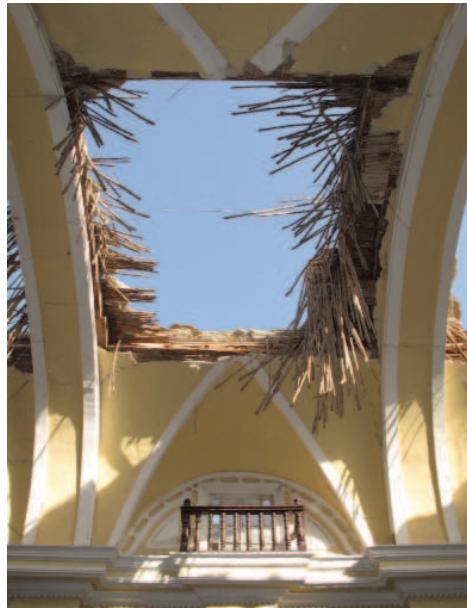
FIGURE 4.50
Sector C: View of a collapsed bay of the nave barrel vault.
Image: Sara Lardinois.

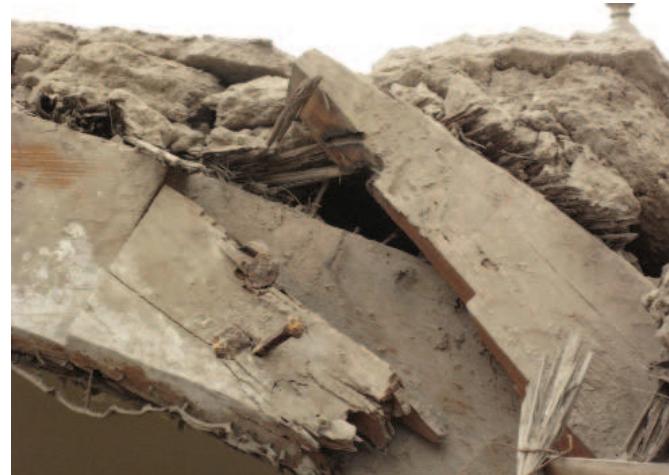
FIGURE 4.51 (TOP)
Sector C: Damage to wood arches forming the nave barrel vault, with corrosion at the nails connecting the arch segments.
Image: Claudia Cancino.

- The main cause of collapse of the roof structure appears to be the heavy deterioration of the timber elements, especially at the connections.
- Horizontal cracks in the mud brick walls were caused by lateral vibrations during the earthquake, but they do not reduce the walls' stability and resistance.

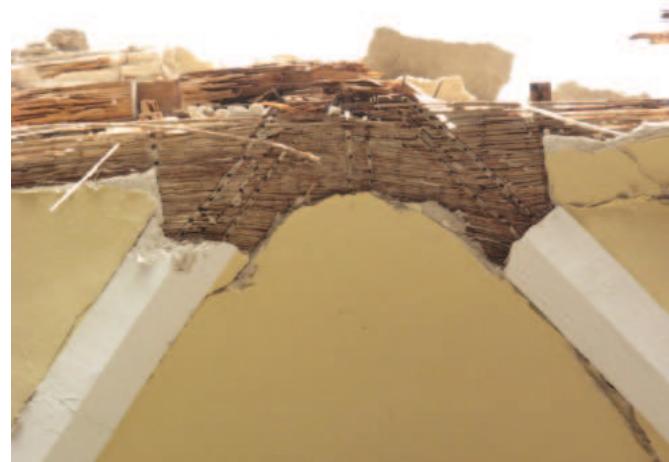
FIGURE 4.52 (BOTTOM)
Sector C: Top of nave lunette, where the wood beam spanning between the nave arches may have prevented total collapse of the vault.
Image: Claudia Cancino.

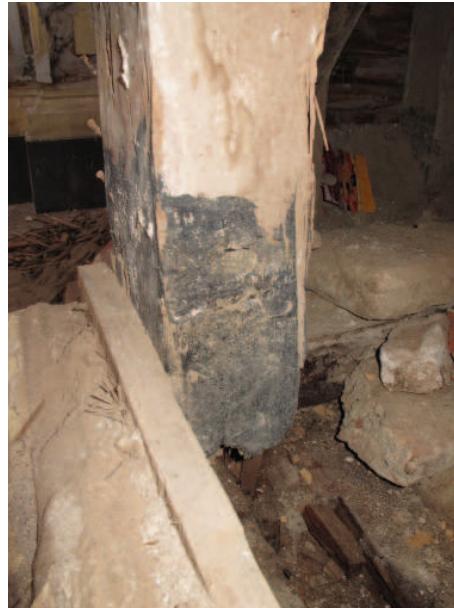
**FIGURE 4.53 (NEAR RIGHT)**

Sector C: View of pillar base, showing deterioration of the wood post and sill.

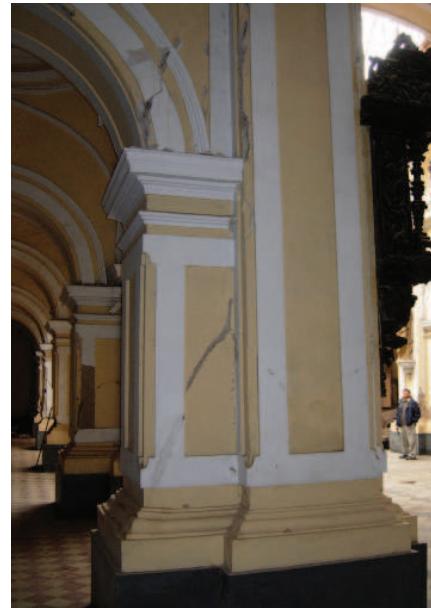
Sector D: Cracking in west pillar at the north side aisle.

- Partial collapse of the arch adjacent to the north lateral wall in the altarpiece I space.
- Horizontal cracking at the upper and lower levels of the north lateral wall in all altarpiece spaces.
- Minor inward out-of-plane displacement of the pillar wall.
- Vertical cracks at the west piers of altarpiece E space (Fig. 4.54).

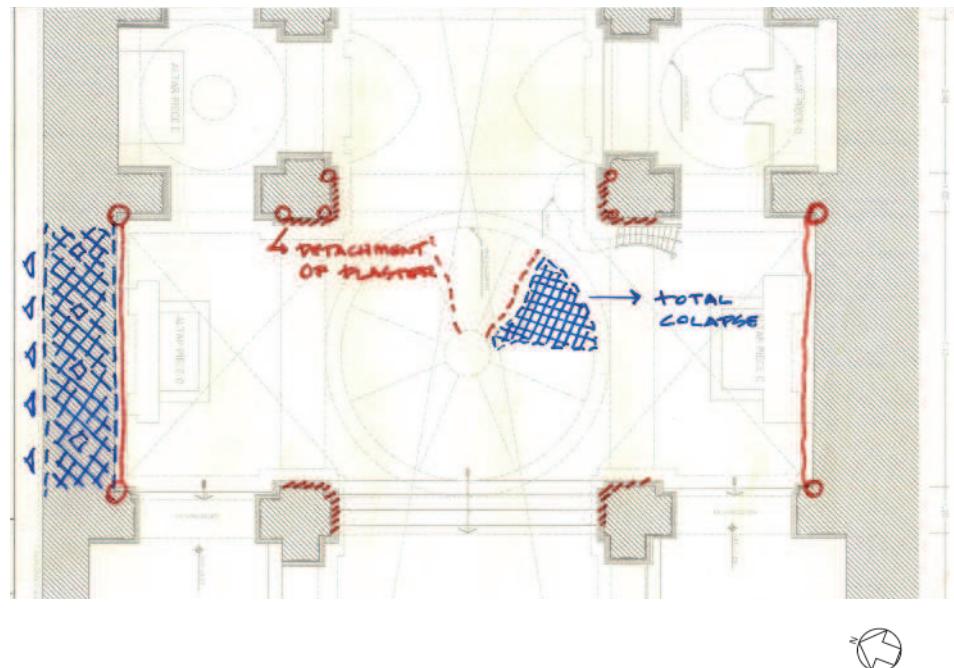
- Partial collapse of the southeast section of the umbrella dome over the crossing (Figs. 4.56, 4.57). Termite damage to the wood elements is thought to have contributed to this collapse; however, the circular rings running parallel to the base of the dome and interwoven with the wood ribs, as well as the strong connection between the collar ring and wood frame at the base of the dome, provided strength for the dome structure which ultimately kept it in place.
- Cracking parallel to the dome ribs in the remaining portions of the dome.
- Vertical cracking at the dome pendentives (Fig. 4.58).
- Cracking and disconnection between the transept and the two altarpiece spaces.
- Horizontal cracking at the lower portions of the north and south end walls in the transept.

Sector E: Graphic condition survey. The combination of the dark blue hatch pattern and small dark blue arrows show out-of-plane displacement; the smaller dark blue hatch pattern alone shows areas of collapse at the main dome; the red lines show areas of horizontal cracking; and the red circles show areas of vertical cracking.

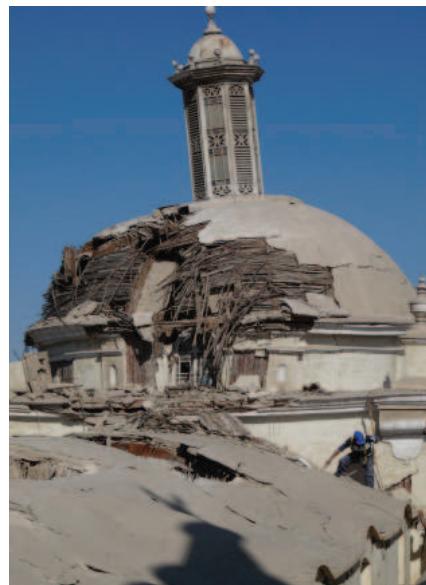
**FIGURE 4.56**

Sector E: View of partial collapse of quincha dome.

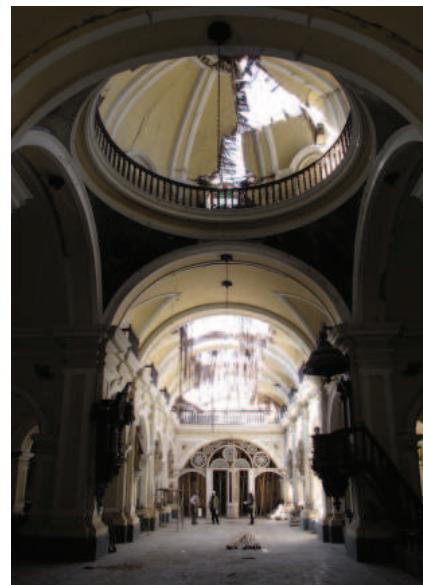
**FIGURE 4.57**

Sector E: Interior view, looking east, showing the partial collapse of the dome and barrel vault.

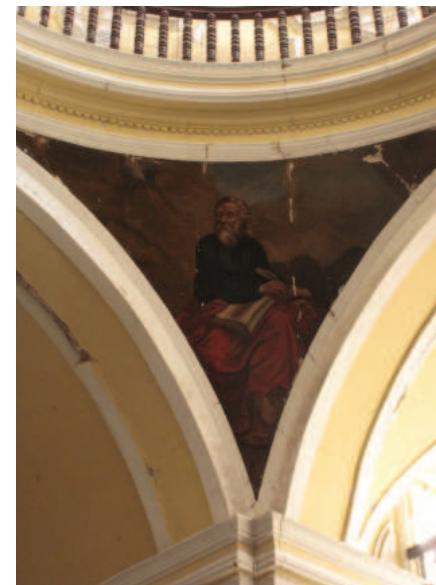
**FIGURE 4.58**

Sector E: View of the vertical cracks in a pendentive at the main dome.

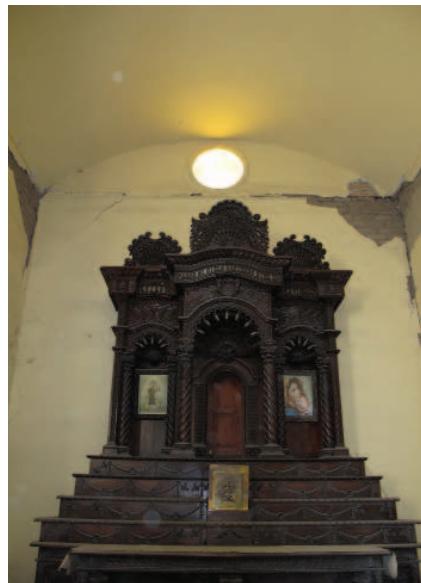
FIGURE 4.59
Sector F: The upper west wall behind the altar exhibits out-of-plane displacement and cracking.
Image: Sara Lardinois.

- Outward out-of-plane displacement, disconnection, and cracking at the upper levels of the west end of the altar and the south side chapel, altarpiece A space (Fig. 4.59).
- Cracking parallel to the direction of the vaults in the vaults covering the altar and the side chapel spaces.
- Vertical cracking at the corners of both side chapels (altarpiece A and B spaces) and at the west wall of the altar (Figs. 4.60, 4.61).
- Horizontal cracking at the upper levels of the north and south walls of the altar, as well as at the south and west walls of the altarpiece A space.

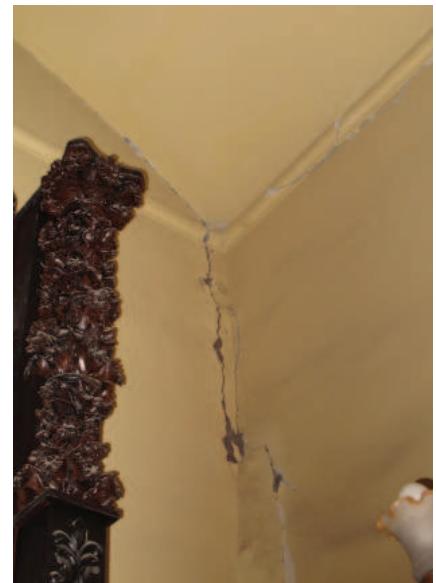
FIGURE 4.60
Sector F: View of vertical cracking in either corner at west wall of the north side chapel, behind altarpiece B.
Image: Sara Lardinois.

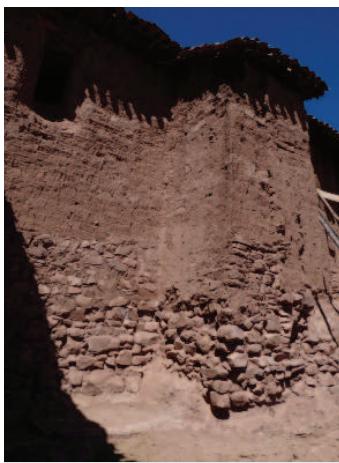
**FIGURE 5.12**

View of erosion at east side of church.

The church (lat 13°39'38" S; long 71°51'26" W) is built on a natural rock outcropping, with some compacted clay fill used to level the site. Thus, depending on the topography, the foundation either bears directly on the rocky soil or the compacted clay fill. As a result of the steep topography and use of clay fill, some portions of the interior finish floor are significantly higher than the adjacent exterior grade level. The most extreme differential is at the east side of the church, where the interior floor elevation is approximately 2 m higher than the adjacent grade and large portions of the natural rock outcropping are visible below the base course. The visible outcropping in this area shows signs of sedimentary rock erosion (Fig. 5.12). This erosion may be the result of improper site drainage, which is made worse by the natural slope of the site; however, the water source(s) contributing to the erosion were not immediately clear, as the construction assessment survey was carried out during the dry season. Possible drainage sources include surface water runoff from the upper village, falling water from the roof eaves, or a combination of those two factors. Alternatively, this erosion may be the result of excavations carried out in the past.

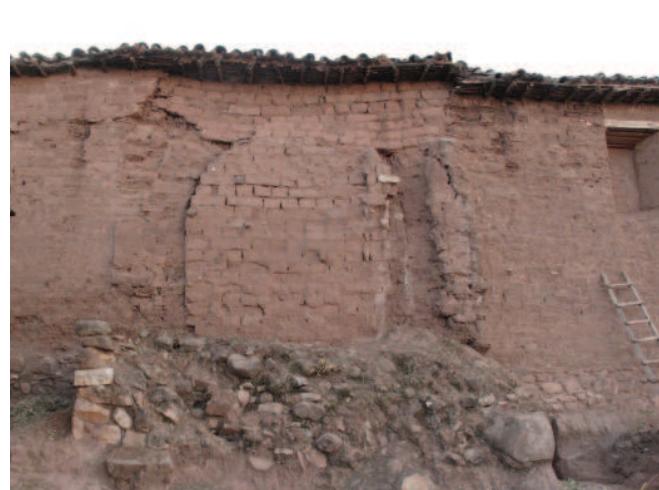
**FIGURE 5.21**

West lateral wall of main church, showing the infilled opening and collapsed buttresses.
Image: Claudia Cancino.

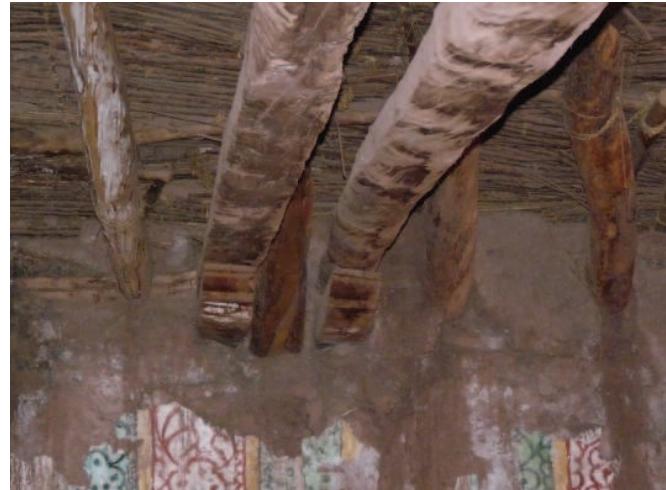
FIGURE 5.32

The main church roof consists of 47 *pares y nudillos* trusses and six wood tie beams. The ends of the rafters at the main roof are cut at a 90° angle and sit on 0.17 × 0.17 m wood plates embedded in the lateral mud brick walls (Figs. 5.30, 5.31). These wall plates are neither continuous nor tied together. Therefore, the plates do not function as bond beams; rather, their primary function is to support the rafter ends. The transverse tie beams are made from alder, or birch, tree trunks and also have an approximate diameter of 8" (0.20 m). The tie beams sit on wood corbels, and both the beams and corbels extend approximately 0.60 m into the depth of the mud brick wall. In the central portion of the nave, two of the tie beams are closely placed together, almost forming a pair. There is a gap in the wall plate between the two tie beams, and the rafter ends at the south side of the tie beam pair are at a lower vertical elevation (Fig. 5.32). There are not any tie beams at the far south end of the main roof.

View of the pair of tie beams over the nave.
Image: Mirna Soto, for the GCI.

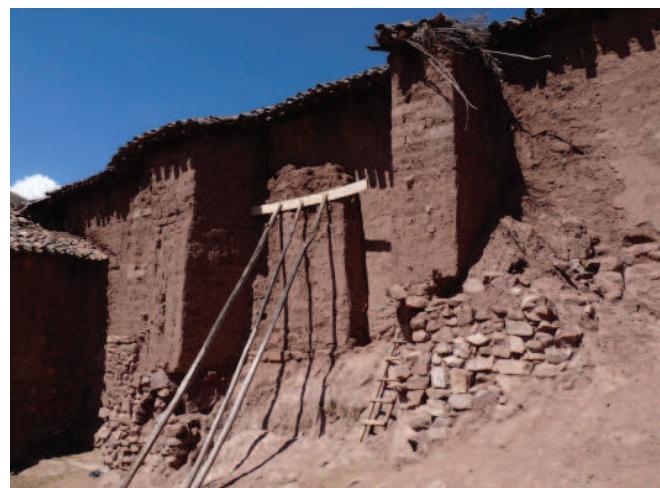
In those sections of the base course that are visible from the exterior or through prospections carried out as part of the survey, the base course was observed to be in fair to good condition. The mortar is generally cohesive; however, in some locations, the stones have become loose. There has been some loss of face stones and mortar at the exterior side of the base course. This deterioration is greatest at the east wall of the church and baptistery. The base course of the north buttress at the east wall has been severely compromised by loss of material at its southeast corner. Improper site drainage, erosion, and/or excavation of the rock outcropping in this area may be contributing to the damage (Figs. 5.33, 5.34).

Deterioration of base course at east lateral wall and buttresses. Also note the modifications and shoring at the former arched opening between the buttresses.

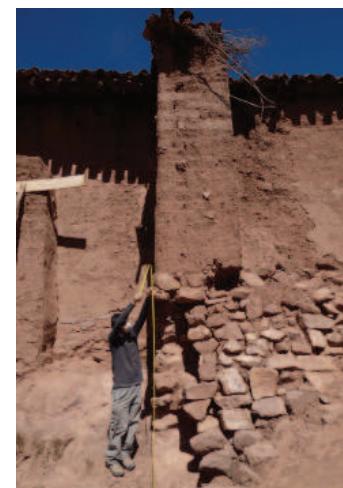
FIGURE 5.34 (RIGHT)

Detail view of deteriorated base course at north buttress, east lateral wall.

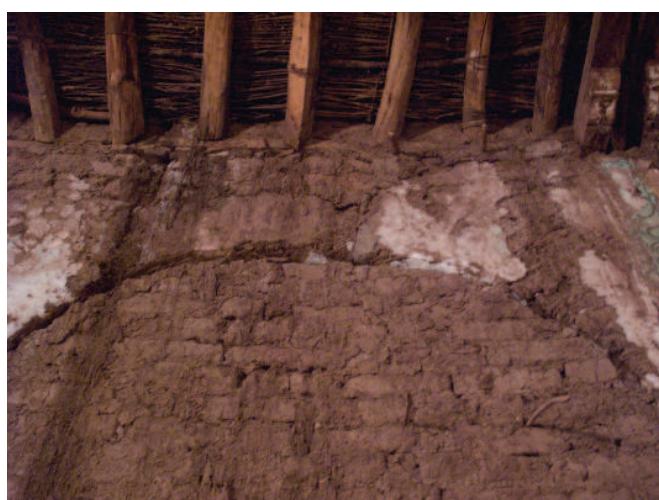
FIGURE 5.35

- The large arched door opening at the west lateral wall has been infilled with mud bricks, which are not structurally connected to the adjacent walls. These mud bricks have not been plastered or painted and thus are visible from the interior (Fig. 5.35).

Infill construction at former arched opening in west lateral wall. Note that infill is not connected to adjacent wall construction.

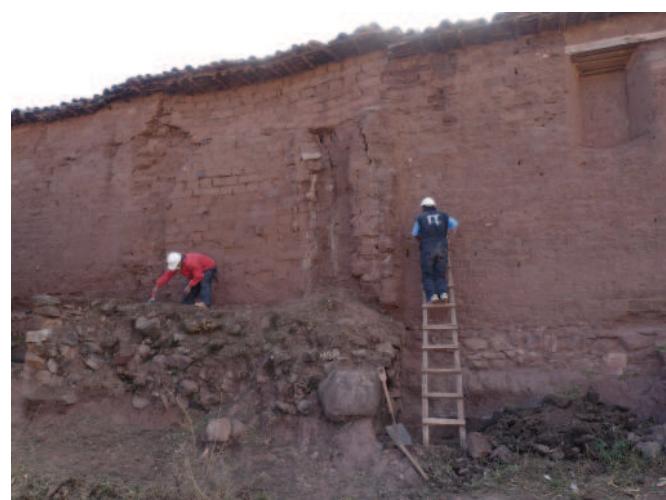
FIGURE 5.36

into the wall construction. The instability of the stone and mud mortar base may have led to the collapse of the buttresses (Fig. 5.36).

View of collapsed or dismantled buttresses at west lateral wall.

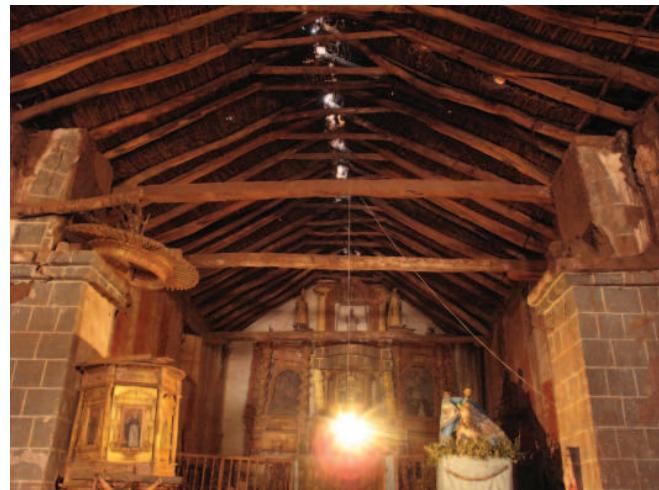
FIGURE 5.38

It is assumed that the church originally had a quincha arch separating the nave from the presbytery, based upon the extant damage at the top of the remaining earthen piers and the existence of an arch in the nearby Church of Rondocán, which is of a similar overall design to the church of Kuño Tambo (Figs. 5.37, 5.38). The arch has since collapsed or been dismantled, and the remaining west pier exhibits cracking (Figs. 5.39, 5.40).

View of remaining mud brick piers at the Church of Kuño Tambo. It is likely that the piers originally supported an arch above.

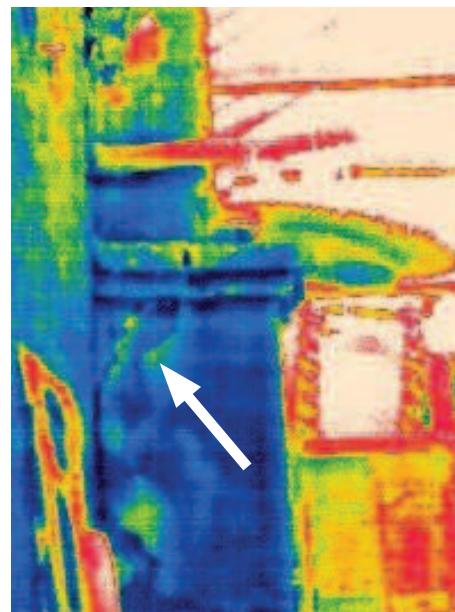
FIGURE 5.39 (LEFT)

Thermal image, showing crack in west mud brick pier of the Church of Kuño Tambo, as viewed from the nave.

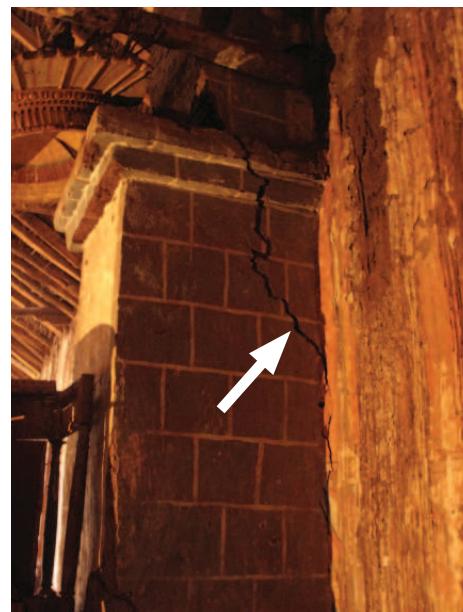
FIGURE 5.40 (RIGHT)

Crack in west mud brick pier of the Church of Kuño Tambo, as viewed from the presbytery.

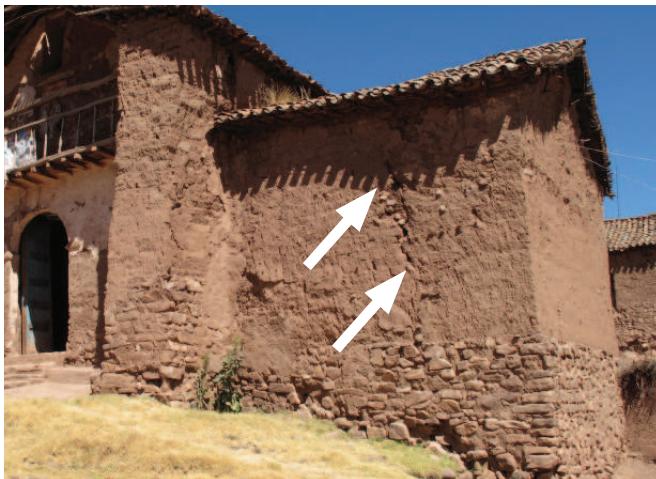
FIGURE 5.41
Crack in the south façade of the baptistery wing.
Image: Wilfredo Carazas, for the GCI.

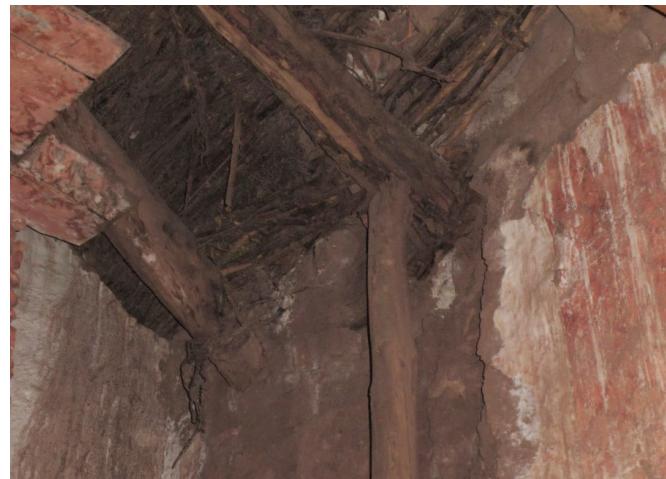
- As previously mentioned, the interior piers exhibit diagonal cracking.
- At both the base and tops of the east, south, and west walls, the mud bricks are water-damaged and partially eroded, with an average depth of loss of 50 mm. A leaking roof and rising damp are the presumed sources of this damage. The walls do not appear to be unstable as a result of the water damage; however, the erosion at the top of the wall has led to failure of some roof-wall connections. This water infiltration has also led to biological growth in the tops of the mud brick walls, as well as detachment and loss of interior plaster at the base and top of walls (Fig. 5.42).

FIGURE 5.42
Erosion at the top of the mud brick wall in the northeast corner of the altar has led to failure of the roof rafter. A wood post has been installed to temporarily support the rafter end.
Image: Sara Lardinois.

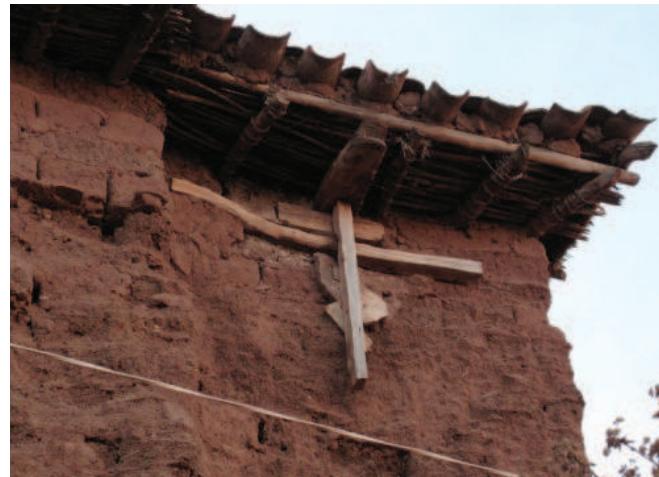
The choir loft floor framing is in fair to good condition; but, it is separating from the adjacent west lateral wall of the church. The area of separation corresponds to the location where wood keys have been installed to prevent outward displacement of the wall (see section 5.6.4 below for additional discussion).

Wood key at south end of west lateral wall.

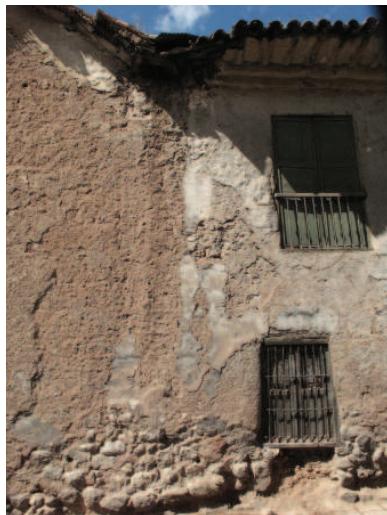
FIGURE 6.40
Erosion and loss of base course stones outside room C-109, north façade.
Image: Claudia Cancino.

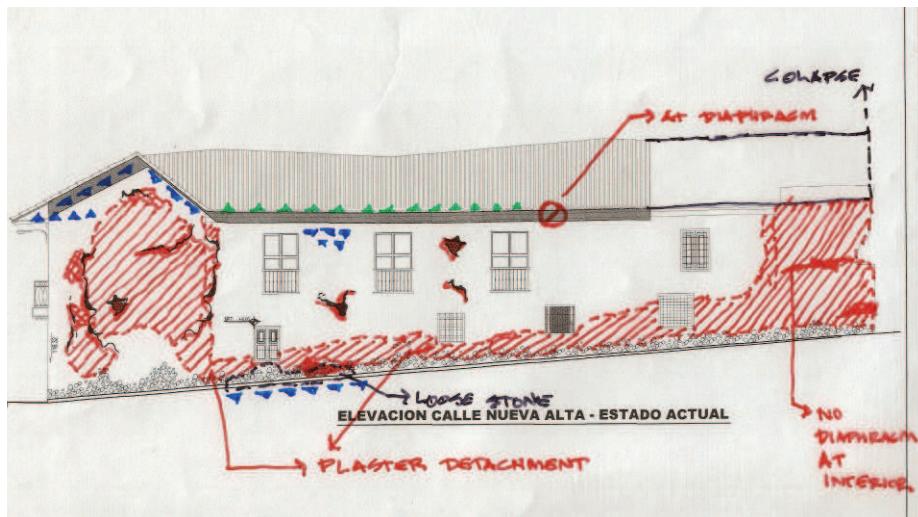
FIGURE 6.41
Graphic condition survey of north façade, indicating areas of loose and lost base course stones (in black) and plaster detachment (in red). Areas of moisture damage are indicated with the blue triangles, and green triangles mark areas where vegetation is present.
Drawing: Claudia Cancino.

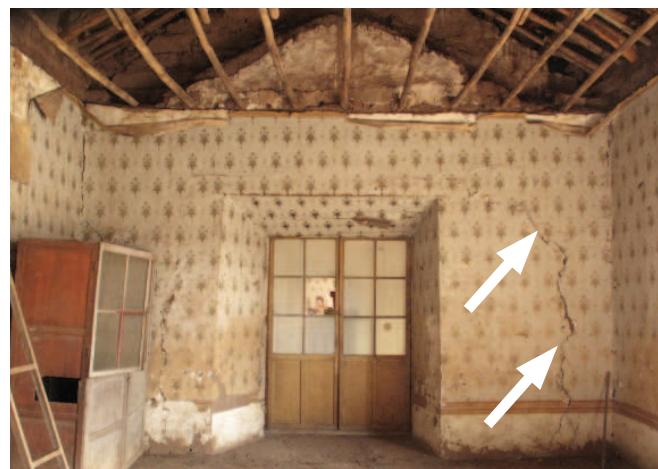
FIGURE 6.42
Vertical crack in transverse wall between rooms A-203 and A-204, adjacent to the east façade.
Image: Claudia Cancino.

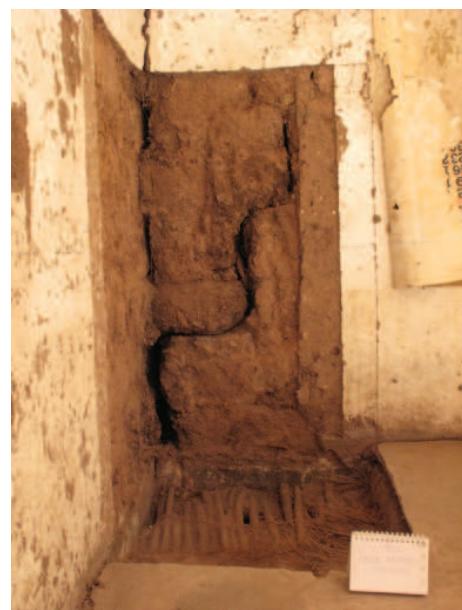
FIGURE 6.43 (LEFT)
Crack in second floor mud brick wall at southeast corner of building, indicating a disconnection between the façade at Calle Arones and the south perimeter wall.
Image: Claudia Cancino.

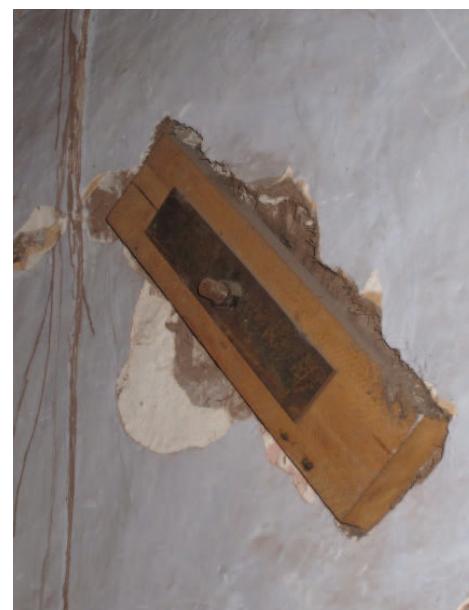
FIGURE 6.44 (RIGHT)
Threaded steel rod, plate, and wood blocking at south perimeter wall (room B-206).
Image: Sara Lardinois.

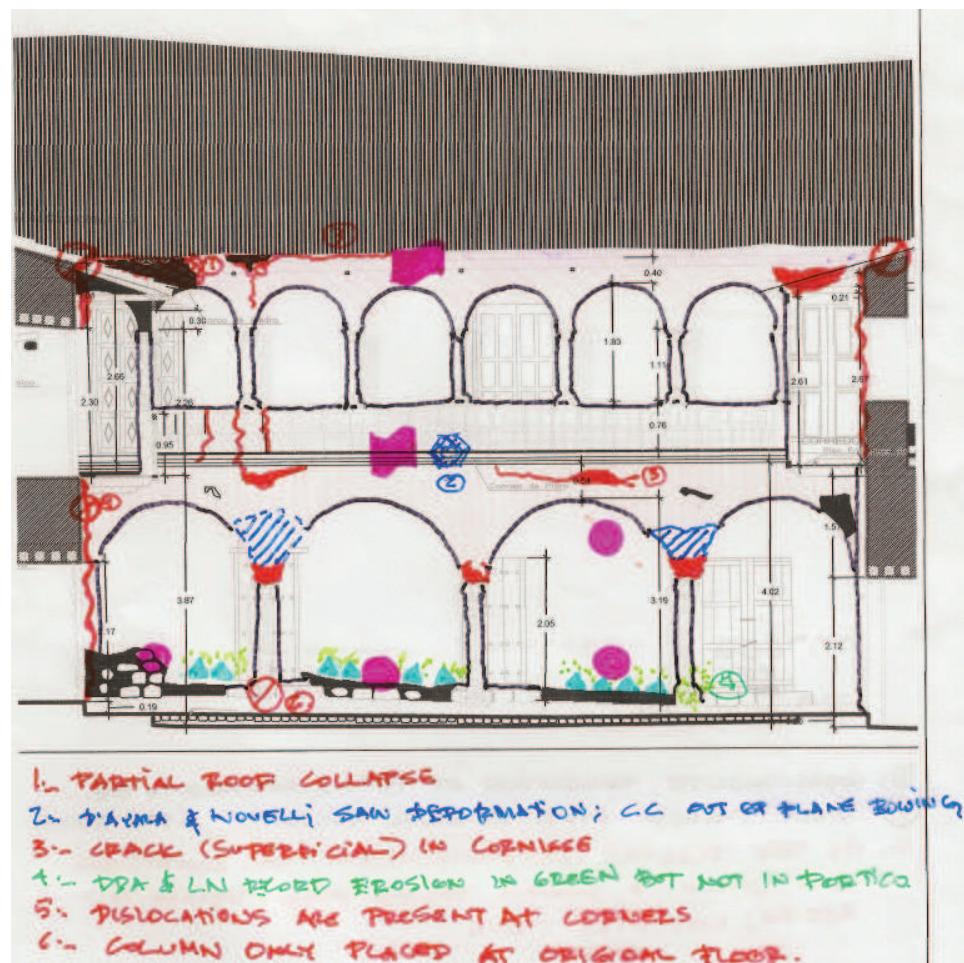
FIGURE 6.45

The fired brick and stone masonry arcades are in poor condition and unstable (Fig. 6.45). While the stones themselves are in good condition, there is significant loss of mortar. The arcade walls have long spans, which are poorly restrained. As a result, they exhibit some outward displacement and the arches themselves were in danger of collapse prior to the installation of a temporary shoring system. The west ends of both the north and south arcade walls appear to be the most unstable, with cracking and separation between the stones (Fig. 6.46). This may also be the result of displacement in the adjacent mud brick wall at the west side of the patio, brought on by the collapse and demolition of the adjacent construction. Portions of the second floor arcade at the south side of the patio have been infilled with mud bricks (Fig. 6.47).

Graphic condition survey of fired brick and stone masonry arcade wall at the north side of patio.

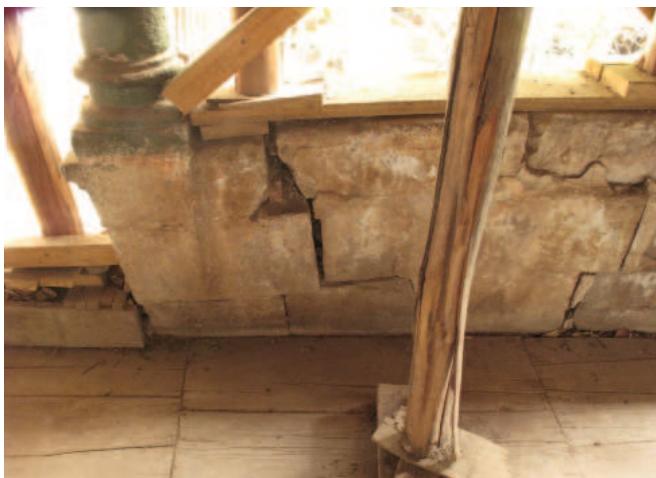
**FIGURE 6.46**

West end of stone masonry parapet wall at south arcade, as viewed from room B-206.

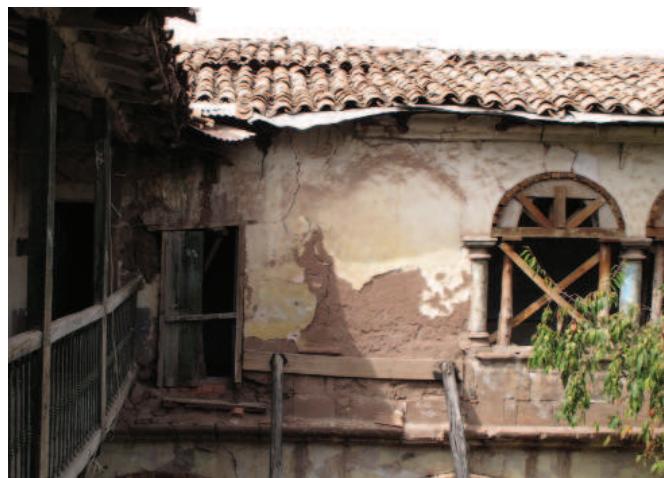
**FIGURE 6.47**

View of infilled arcade at south side of patio.
