CHAPTER 4

Cathedral of Ica

4.1 Summary

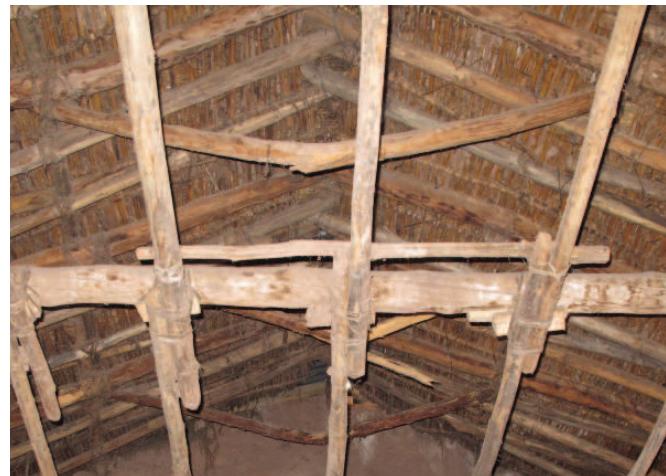
FIGURE 6.48

View of broken collar ties.
Image: Sara Lardinois.

- As a result, a large percentage of the second floor ceiling joists and plaster finish has collapsed or been intentionally removed due to its poor condition.
- The gypsum plaster ceiling finish at the underside of the roof rafters in sector B5 and other second floor galleries and porches is in poor condition, with large areas of loss.
- In some cases, the depth of erosion at the top of the mud brick walls is so great that the ends of the roof rafters and tie beams are no longer supported by the walls.
- Wood rot and beetle damage were observed in some of the wall plates and wood framing.
- At several pares y nudillos trusses, the connection between the collar ties and rafters has failed, and the collar ties are deformed or broken (Fig. 6.48).
