# Chile Earthquake of 2010

## Assessment of Industrial Facilities around Concepción

J.G. (Greg) Soules, P.E., S.E.  
Robert E. Bachman, P.E., S.E.  
John F. Silva, P.E., S.E.

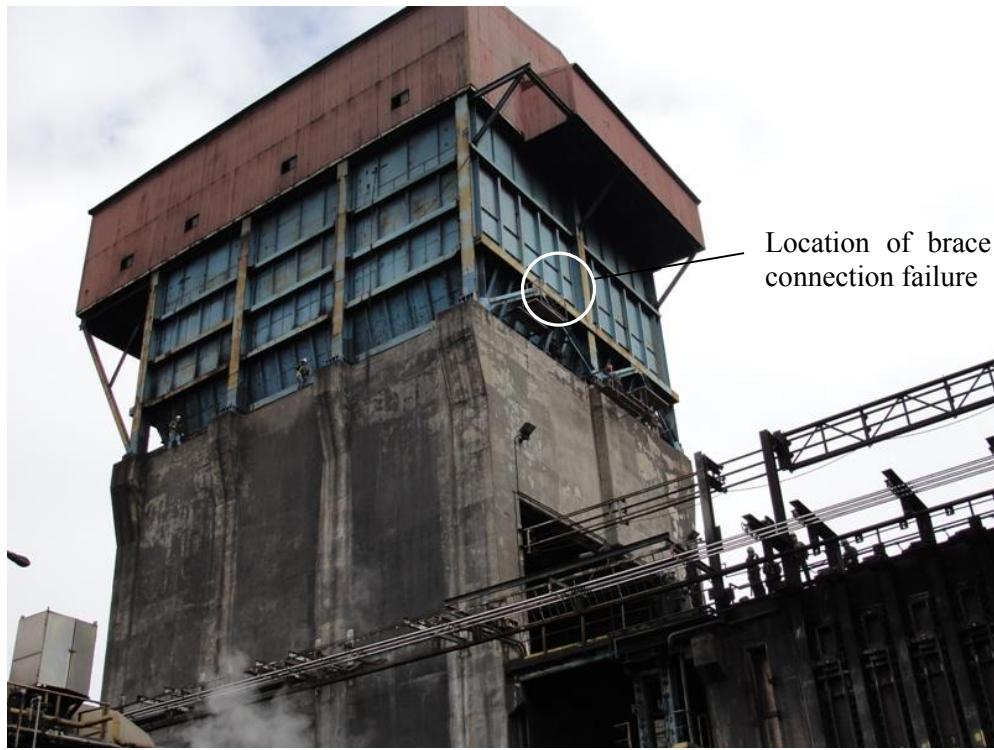
Figure 3-3: Coke plant.

The only structure investigated at the coke plant was the elevated coal bin shown in Figure 3-3 (Lat 36° 44' 16" S, Long 73° 7' 23" W). This large structure is composed of an elevated concrete base which is approximately 50 feet by 65 feet in plan and 100 feet tall. A 60-foot tall steel coal bin is located on top of the elevated base. The structural system of the coal bin is a combination of steel moment frames, brace frames and steel plate shear walls. The coke plant was constructed in 1990. See Appendix C for drawings.

The bracing connections of the coal bin failed. As can be seen in Figure 3-4, the wing plates fractured at the ends of the braces. In general, the coal bin diagonal braces and connections were

less robust than would be expected in current designs. In discussions with the plant engineers, it was learned that the bins were originally designed using a seismic mass equal to the dead weight of the bin plus only 50% of the weight of the stored coal. The use of 50% of the coal weight was based on the average level of coal in the bin at any given time. The coal bins were approximately 75% full at the time of the earthquake. The plant engineers plan to design the replacement diagonal braces and connections for 100% of the weight of the stored coal. It is not currently known what lateral seismic design coefficient the coal bin was designed for originally or what the seismic design coefficient for the new braces and connections will be.

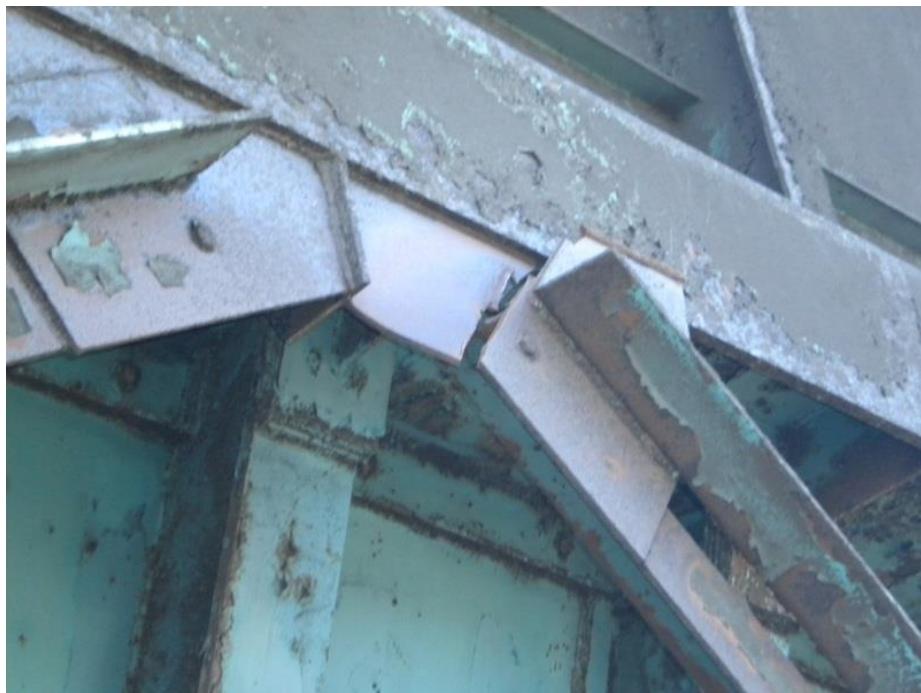
*Figure 3-4: Failed brace connection at coal bin.*

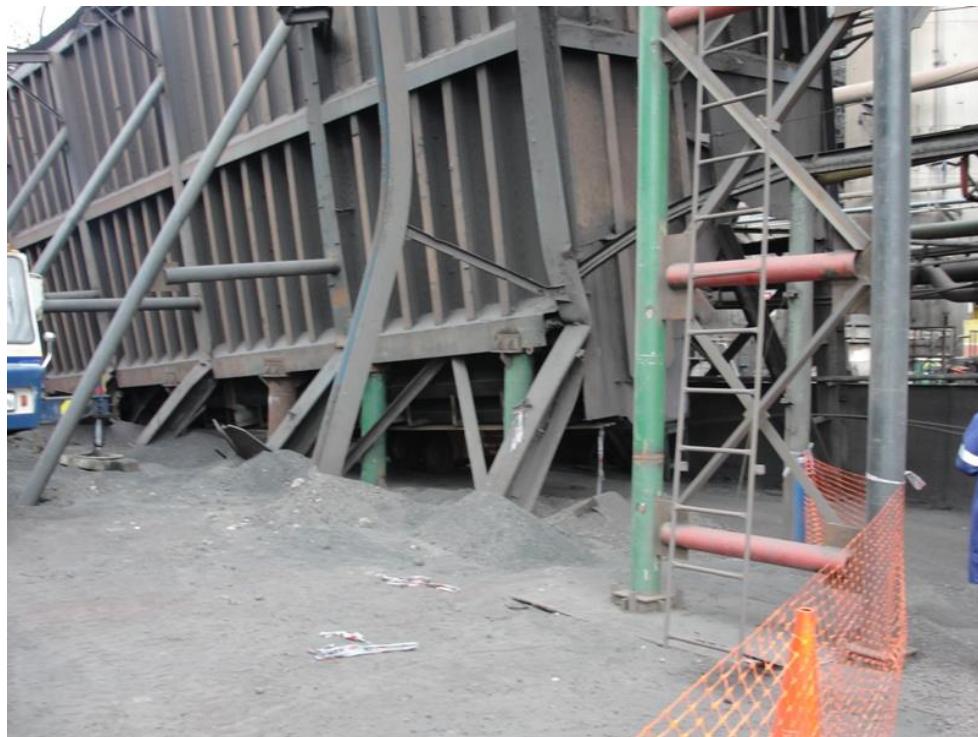
The coal bin (Figure 3-5) associated with Blast Furnace #1 partially collapsed in the transverse direction and was being stabilized by series of pipe column braces. It is not totally clear what caused the failure. It appears the column bases at the left side of the columns in Figure 3-5 shifted to the left initiating a plastic hinging of the columns. There was some localized liquefaction/lateral

spreading in the nearby area of the bins but there was no observed failure of the bin continuous footing. It is likely that the continuous footing shifted due to the observed liquefaction/lateral spreading. Also in discussions with the plant engineers, it was learned that the bins were originally designed using a seismic mass equal to the dead weight of the bin plus only 50% of the weight of the stored coal. The use of 50% of the coal weight was based on the average level of coal in the bin at any given time. The coal bins were approximately 75% full at the time of the earthquake. The plant engineers subsequently decided to design the replacement supports for 100% of the weight of the stored coal. It is not currently known what lateral seismic design coefficient the coal bin was designed for originally or what the seismic design coefficient for the repaired bin will be. For the repair, the coal bin structure was lifted as a whole with a 600-ton crane, stabilized, and supported with reinforced concrete columns. See Appendix C for coal bin drawings.

*Figure 3-5: Blast furnace #1 coal bin.*

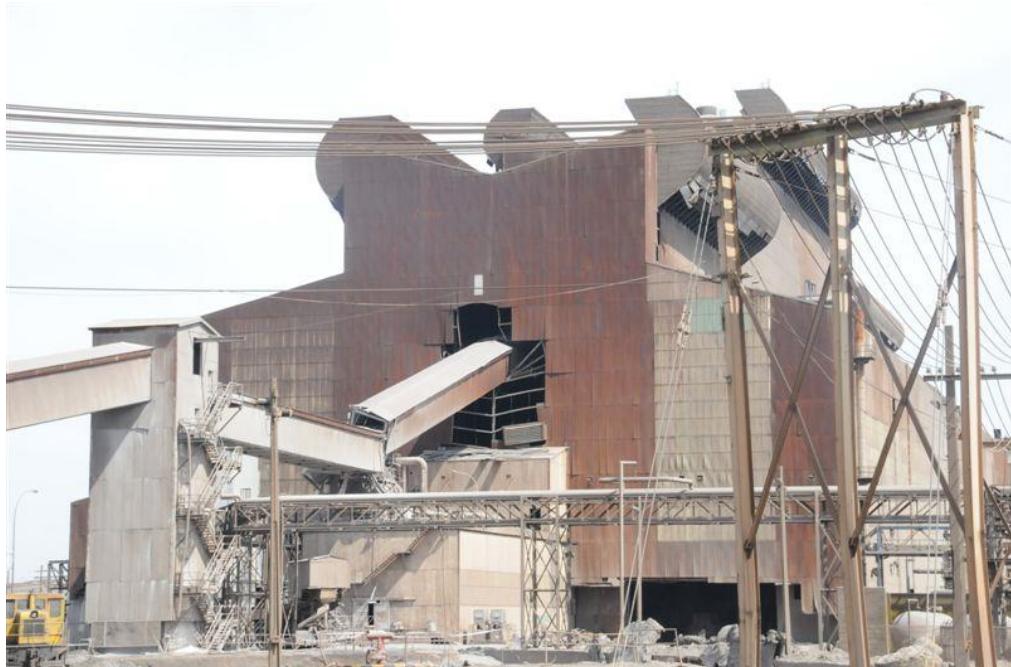
*Figure 3-6: Exterior damage to steel shop and collapsed conveyor, view from east of the conveyor.*

An intermediate support of the conveyor failed resulting in collapse of the conveyor structure (Figure 3-6 and Figure 3-7). The cause of the support failure was not readily determined from our observations. In addition, a major column (A-3) that supports the crane used to transport heavy pig iron ladles (Figure 3-8), settled, probably due to localized liquefaction (see Figure 3-9). It was noted that there had been dewatering in the vicinity of this individual foundation over a long period. Column base anchor bolts also stretched (See anchorage damage observations later in this report). Damage to the Steel Shop resulted in a four-month shut down of the overall steel plant facility with production restarted in early July of 2010.

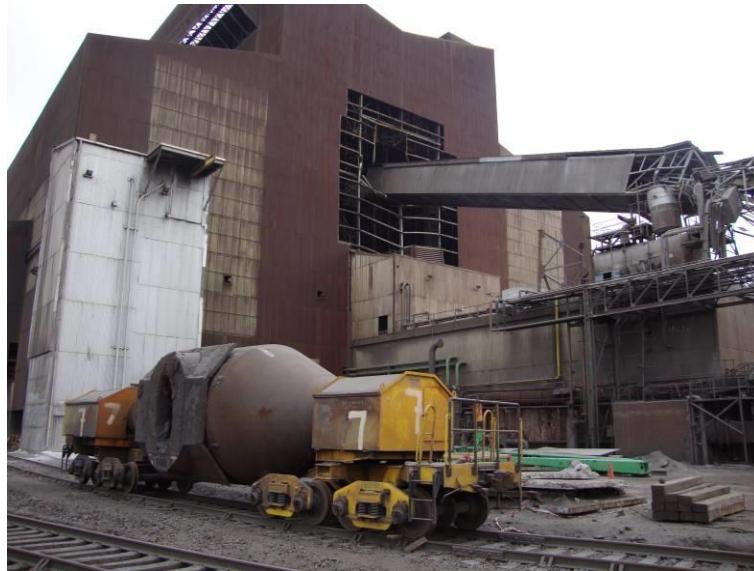
Figure 3-7: Damage to steel shop conveyor, view from the southwest.

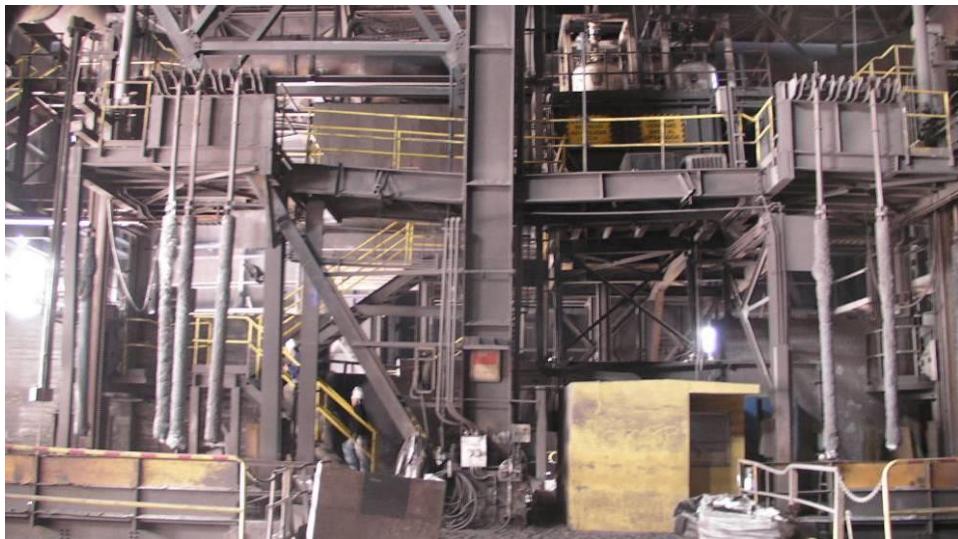
Figure 3-9: Column A-3 settlement.

Column A-3 experienced settlement on the order of 8 inches. As can be seen in Figure 3-9, the settlement caused significant deformation to the members framing into Column A-3. CAP conducted a soil investigation, which identified the supporting soil as sandy soil. Based on the Unified Soil Classification System, the sandy soil varied from SP to SM. The water table elevation was approximately 8 feet below grade. As a repair action, CAP has driven 28 micro piles under the Column A-3 footing. Some piles required modification due to interferences with existing foundations in the same area. Additionally, CAP increased the depth of the Column A-3 foundation by 20 inches using dowels (Figure 3-10). The dowels were added to reinforce the foundation so it would act as a solid block, minimizing possible cracking under it due to the differential pressure and to increase its flexural capacity.

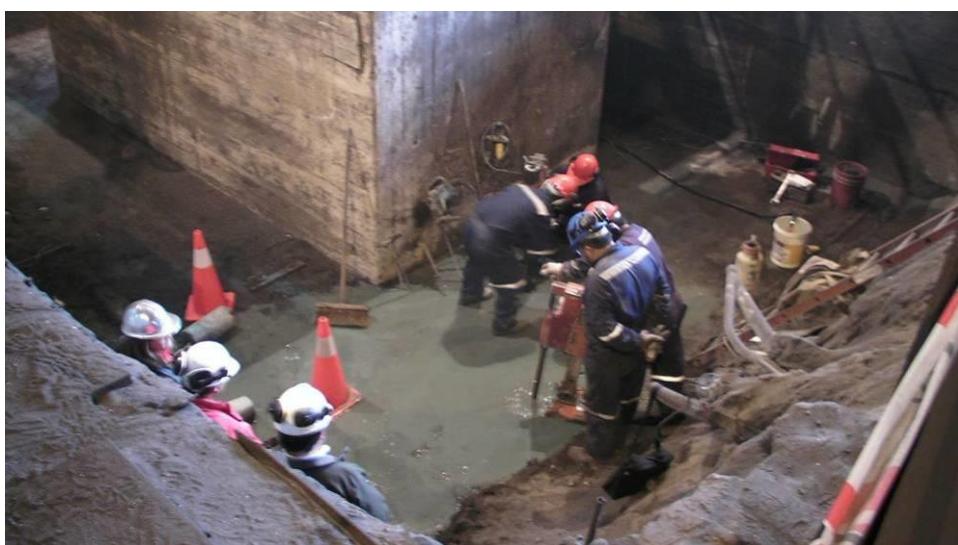
Figure 3-10: Column A-3 footing repair.

An analysis of the deformed frame was made to understand the effect of the potential repairs. The originally planned repair procedure was altered after the analysis was made. In order to level the main crane rails, the main structural beam was jacked and shimmed. Afterwards, all surrounding structures (beams, braces, platforms, etc.) were released and re-attached.

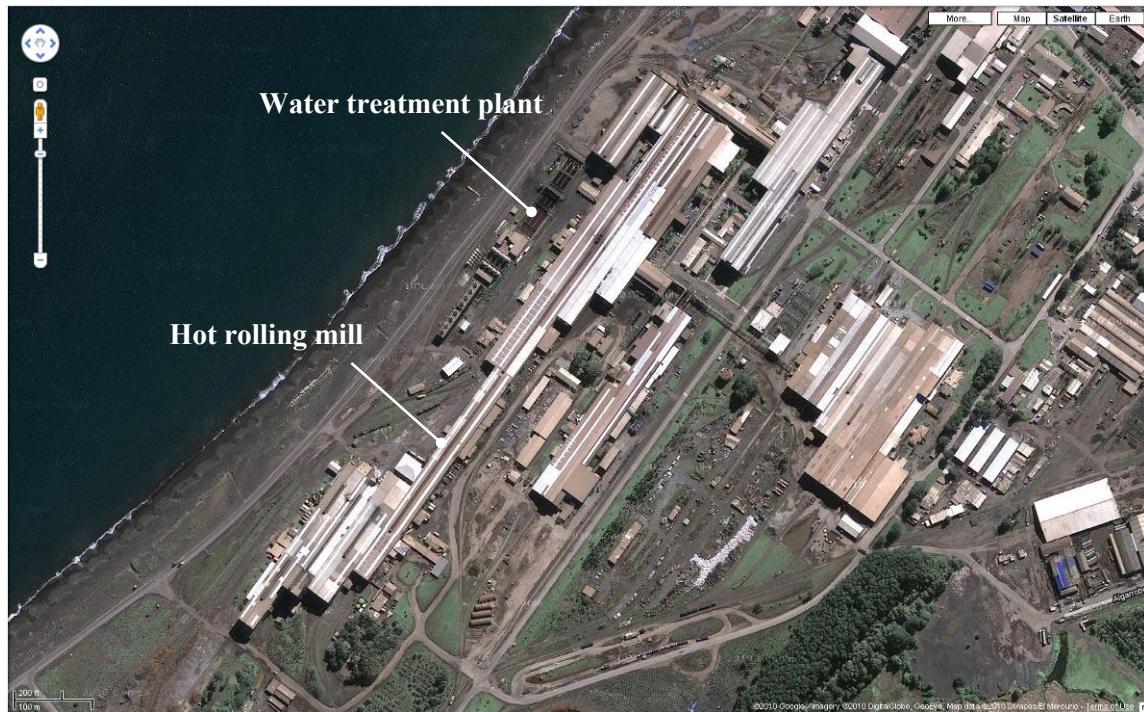
Figure 3-11: Aerial view of hot rolling mill (Source: GeoEye).

Damage to the Hot Rolling Mill appeared to be confined to the column anchorages. It consisted of stretched and ruptured anchor bolts and displaced baseplates. A detailed discussion of observations relating to anchorage performance is provided later in this report.

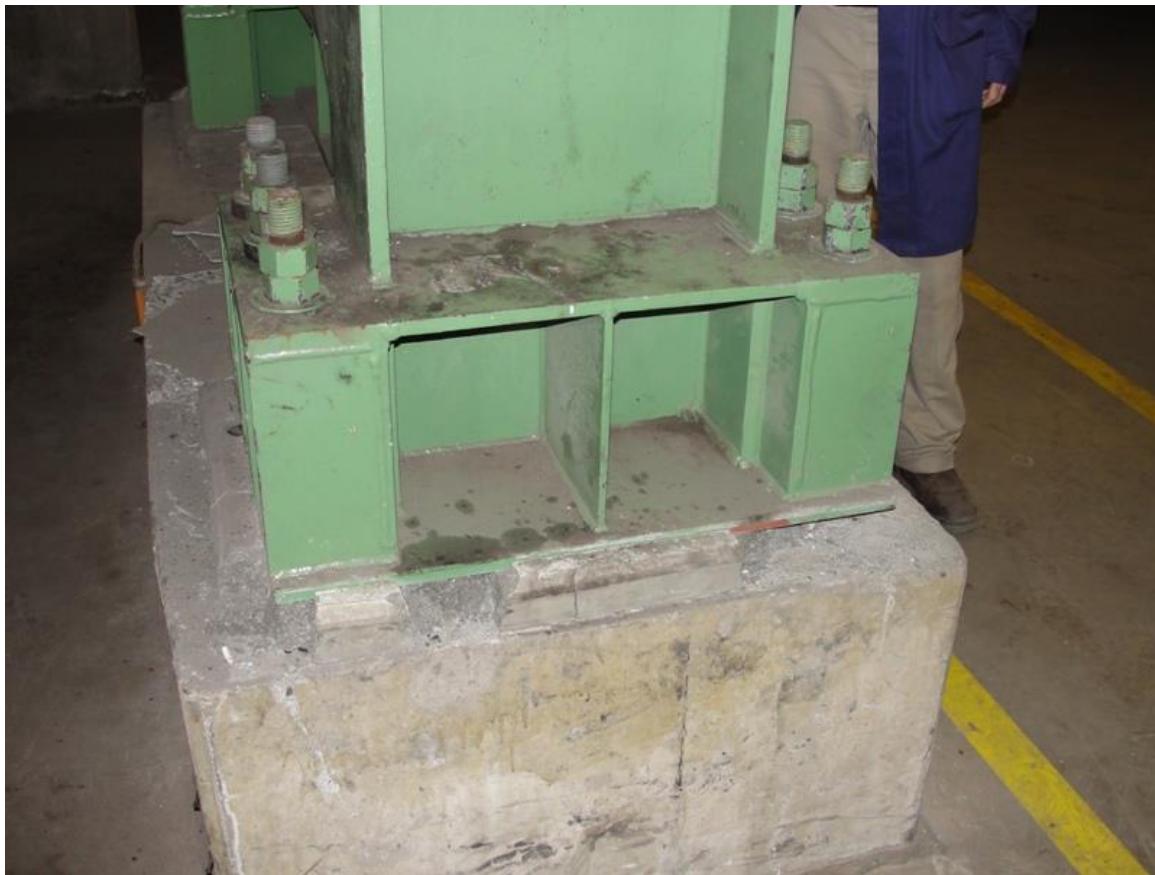
No significant damage occurred to the new Bar Mill. The performance of the structure was outstanding. The only noticeable damage was due more to workmanship than to design. Several of the interior column bases were grouted all of the way to the top of the base plate instead of the bottom of the base plate. Slight movement of the column bases during the seismic event caused the grout to crack and spall off (see Figure 3-15). Structurally, this is considered to be cosmetic damage that could have been avoided if the grouting had extended only to the bottom of the base plate.

*Figure 3-15: New Bar Mill column base grout spalling.*

A common column grouting problem due to poor workmanship was highlighted above. Proper grouting of columns to avoid incidental damage to the grout cap should be highlighted in code commentary or training materials.

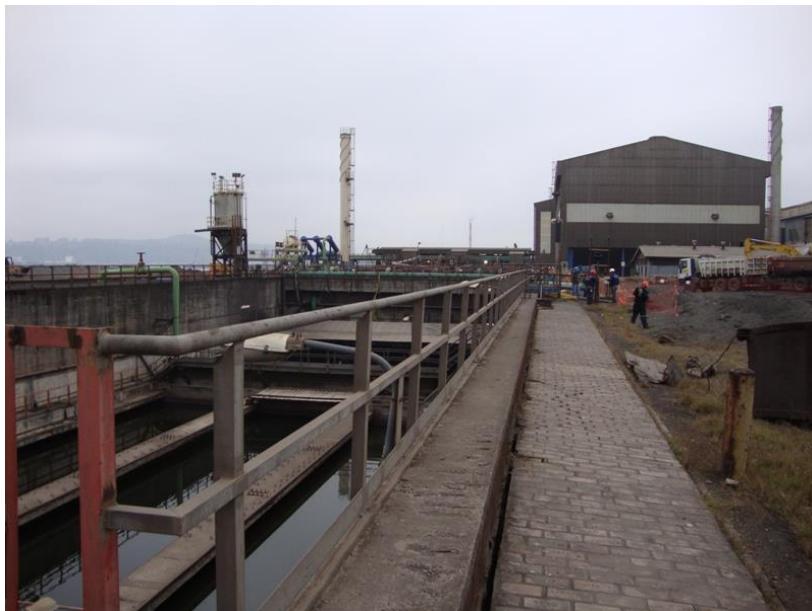
Adjacent to the Hot Rolling Mill is a water treatment plant consisting of two in-ground basins (Lat 36° 45' 6" S, Long 73° 8' 2" W) comprised of a number of reinforced concrete pits (see Figure 3-16). One of the basins is 200 feet by 70 feet in plan and 40 feet deep. The other basin, which was affected by liquefaction, is 150 feet by 60 feet in plan and 12 feet deep. Intermediate basin walls are located in the longitudinal direction. The pit is supported on a mat footing. It is estimated that the holding basins were constructed in the 1950s to 1960s. See Appendix C for drawings.

Figure 3-16: Water treatment plant in-ground basin.

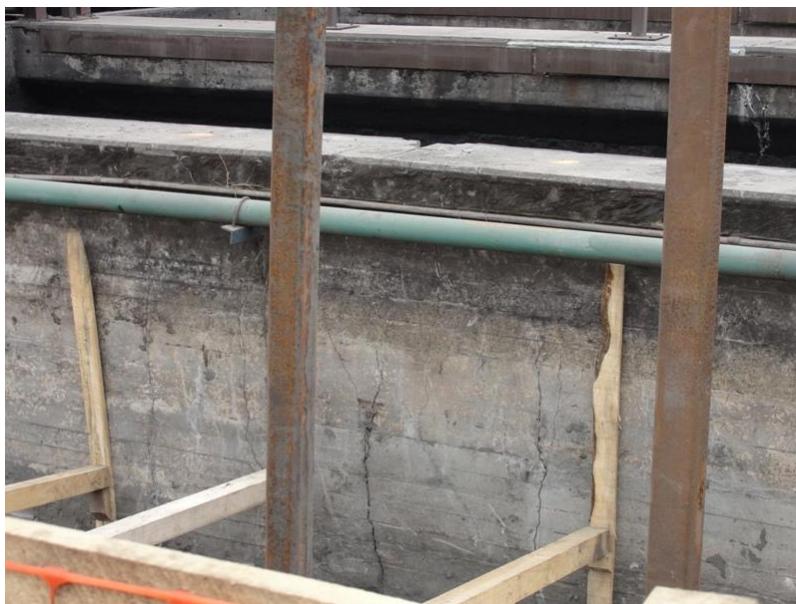
A number of vertical oriented cracks developed in the walls of the water treatment plant pits (holding basins) due to liquefaction settlement at one end as shown in Figure 3-17. The cracks were significant, extended to the base of the structure, and compromised the ability of the structure to contain liquid. The repair consisted of installation of micro piles under the end of the basin that experienced settlement, and simple repair of the cracks. See Appendix C for repair drawings.

Figure 3-17: Cracks in pit wall due to liquefaction settlement.

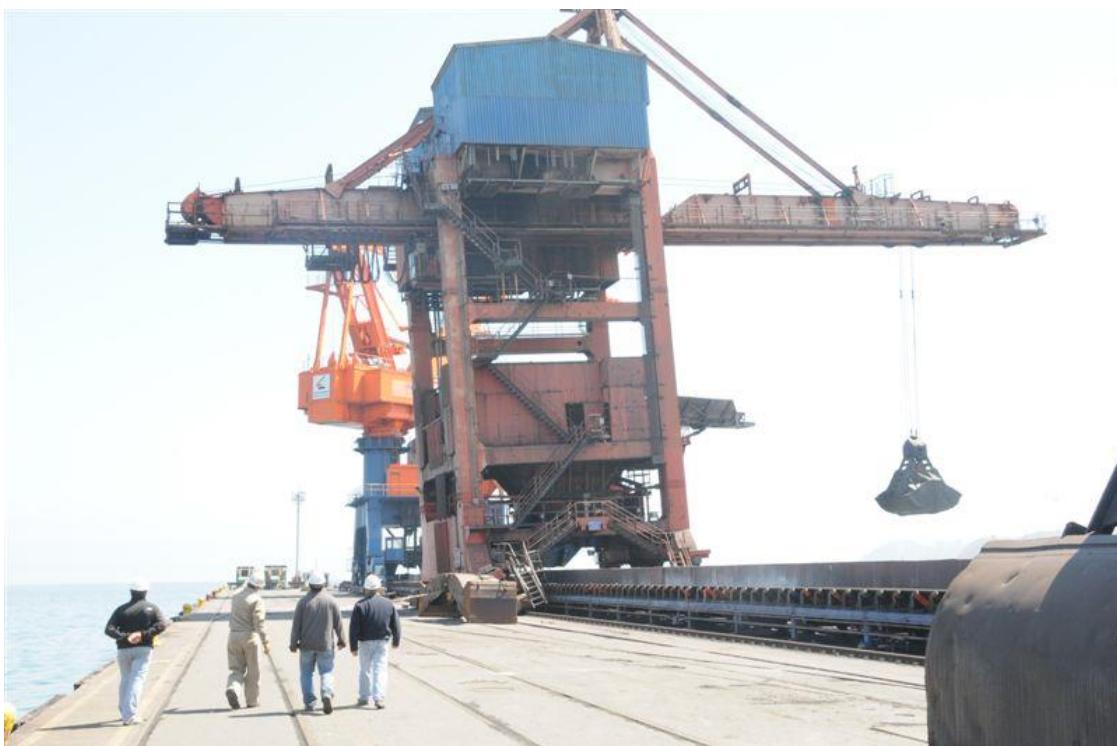
The pier (Lat 36° 44' 27" S, Long 73° 7' 42" W) used by the CAP Steel Plant was pile supported and equipped with two large cranes (Figure 3-18) that moved on rails embedded in the concrete deck of the pier. The pier deck is approximately 60 feet wide and 1500 feet long in plan.

*Figure 3-18: Pier with damaged crane (jumped tracks, wheel dolly supports failed).*

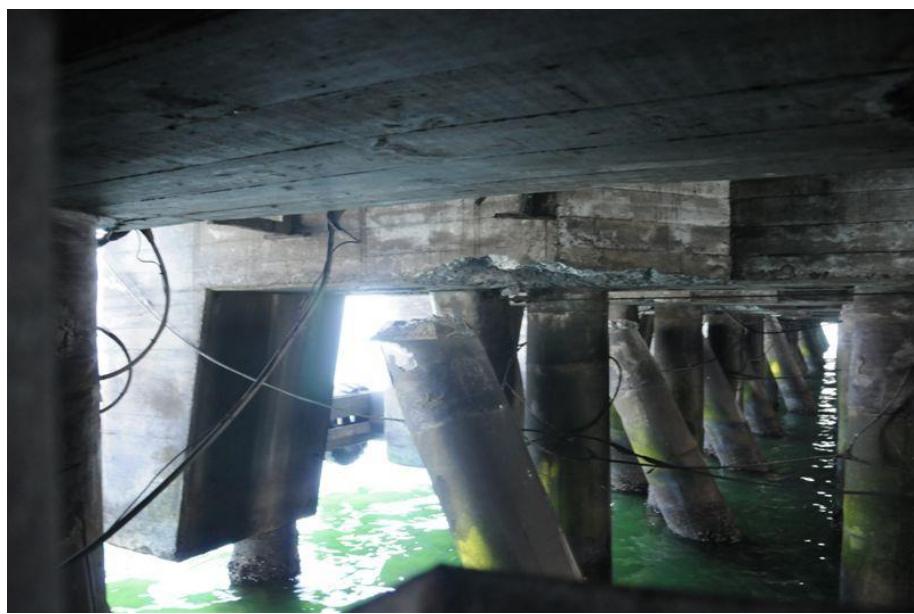
The original pier was constructed in 1950 to a length of 880 feet and was extended in 1972 to reach a length of 1210 feet. The pier was supported on vertical piles with battered steel piles designed for the lateral loads. The piles have a concrete cover for corrosion protection. The battered piles were only embedded in the pile cap approximately 4 inches. All of the battered piles failed at the pile-to-cap connection and pulled out of the pile cap (see Figure 3-20). The pile-to-cap connection was only designed for axial load and did not consider the shears and moments developed at this fixed connection. See Appendix C for drawings.

*Figure 3-20: Failed battered piles.*

It was also reported that the sea floor moved vertically upward approximately 0.8 meters to 1.0 meters during the seismic event. The failure that occurred was in the new portion of the pier where the new crane was located. It is uncertain whether the connection failure was caused by earthquake forces and displacements or the ship leaving the pier while still connected to the new crane. The

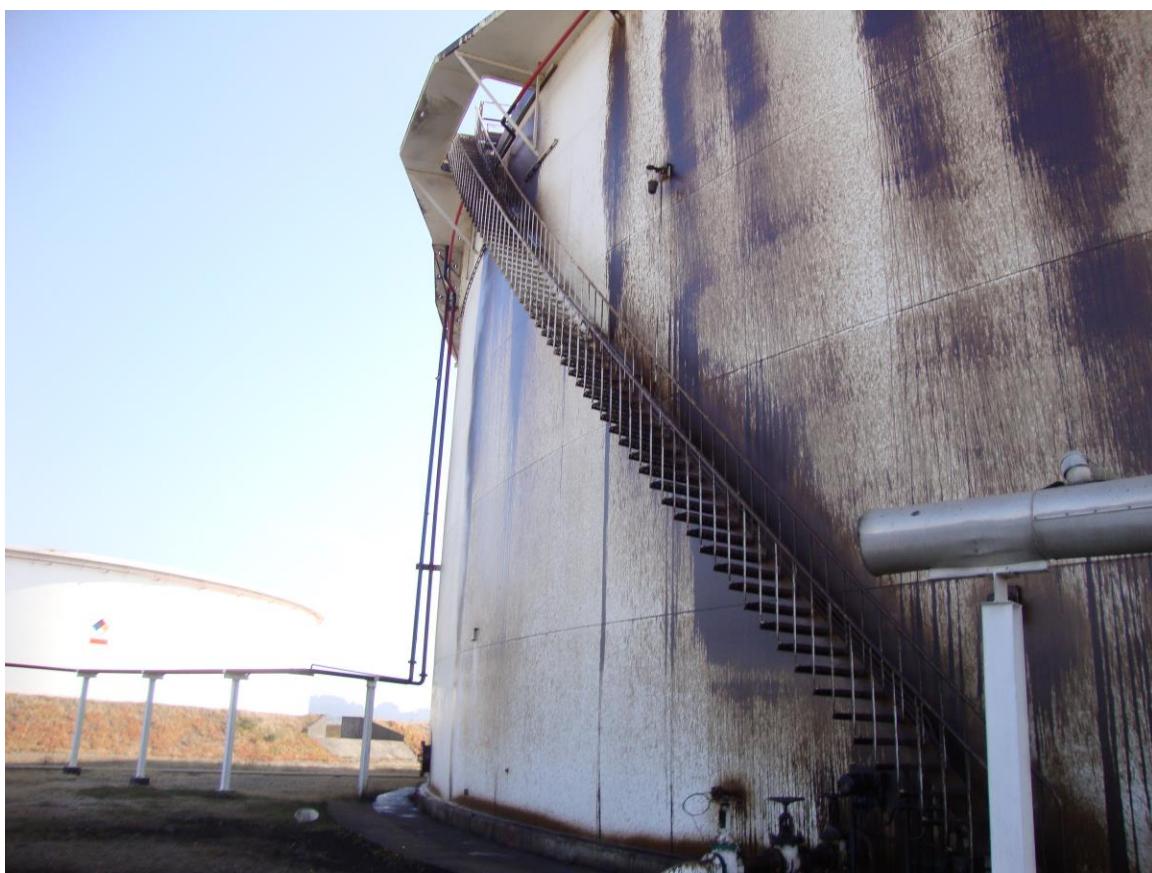
Figure 4-9 and Figure 4-10 show Tank T-6020, a 220-ft diameter by 48-ft high external floating roof tank built in 1993 to the provisions of API Standard 650 8th Edition. The tank was designed to the seismic provisions of Appendix E of API 650 based on Zone 4 with an importance factor of 1.0.

*Figure 4-9: Evidence of sloshing in tank T-6020.*

The tank was operating at its maximum liquid level of 45'-0. The actual height of the sloshing wave was not observed. The convective period of the tank is approximately 11 seconds, which significantly exceeds the period range included in the preliminary response spectra shown in Figure 2-2 and Figure 2-3. Using the measured PGA of 0.4g, the procedures in current API 650 Appendix E, and a range of  $T_L$  of 4 to 8 seconds, a very approximate range of sloshing wave heights is 3.5 to 7 ft.

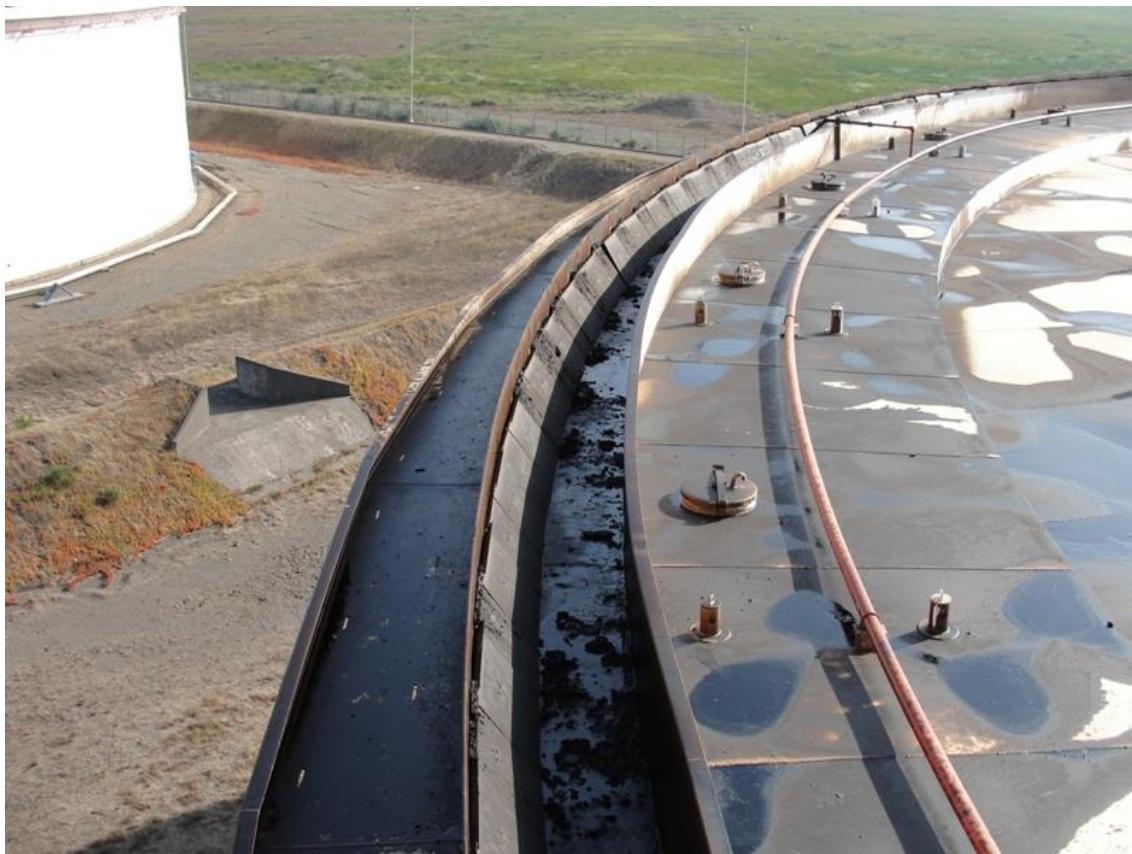
Figure 4-12 shows the condition of the floating roof rim space and weather shield. The condition of the weather shield is excellent. The condition of the floating roof seal in the rim space could not be determined. The original seal installed in 1993 was a vapor-mounted foam-filled seal. It could not be determined if the seal in the tank was the original type installed in 1993.

Figure 4-12: Tank floating roof seal damage.

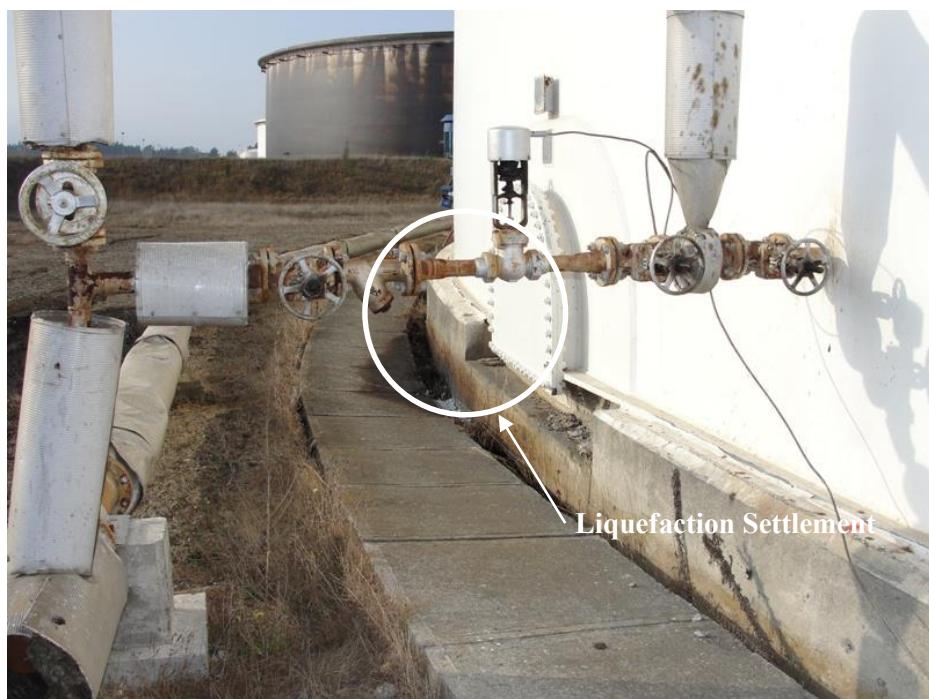
Figure 4-13 shows the approximate 2 inch tilting settlement of Tank T-6030 due to soil liquefaction. Figure 4-14 shows the lateral spreading near Tank T-6030 due to the soil liquefaction. Tank T-6030 is a 220-ft diameter by 48-ft high external floating roof tank built in 1995 to the provisions of API Standard 650 8<sup>th</sup> Edition. The tank was designed to the seismic provisions of Appendix E of API 650 based on Zone 4 with an importance factor of 1.0.

Figure 4-13: Liquefaction settlement adjacent to tank (tilting).

Tank T-6030 was only 25 percent full at the time of the seismic event. Unfortunately, the deformation of the tank bottom due to settlement from soil liquefaction resulted in a leak in the bottom plate. The leak was most likely from a cracked fillet weld in a bottom weld joint but this could not be confirmed.

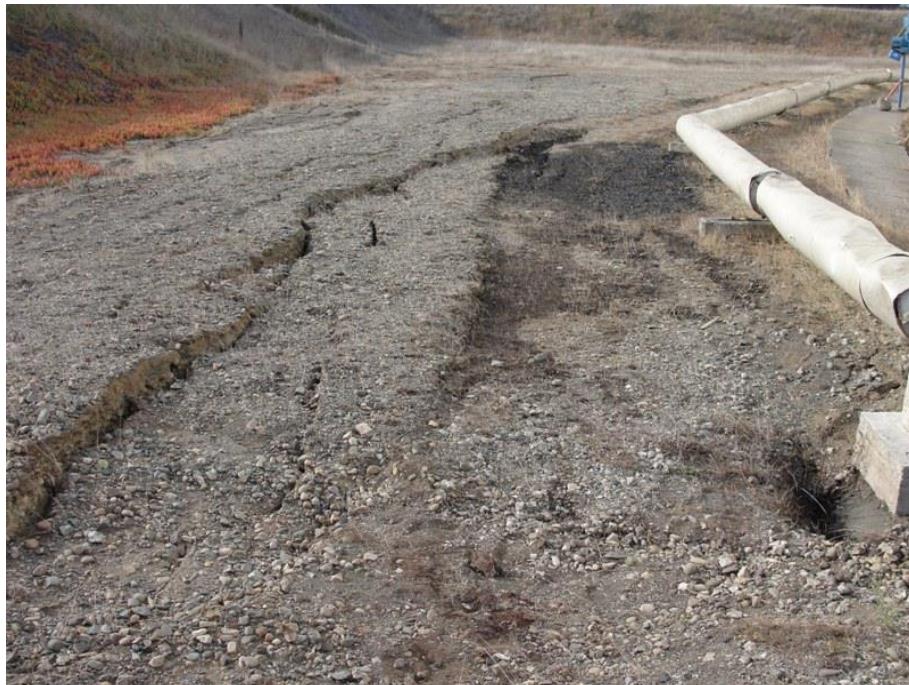
*Figure 4-14: Lateral spreading.*

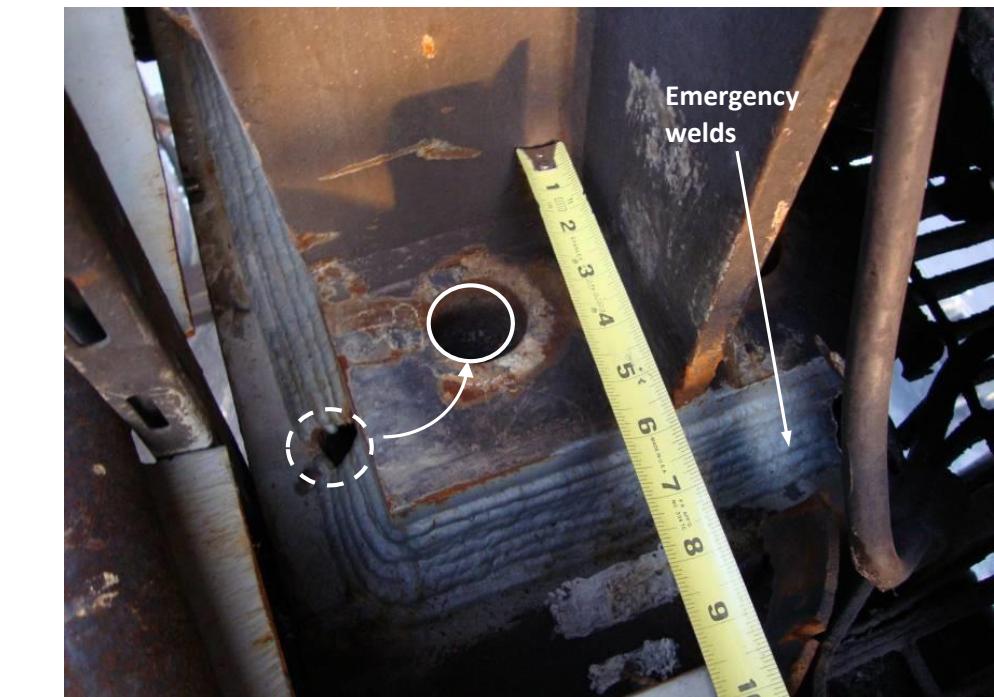
Figure 4-18: Shift of derrick leg counterclockwise.

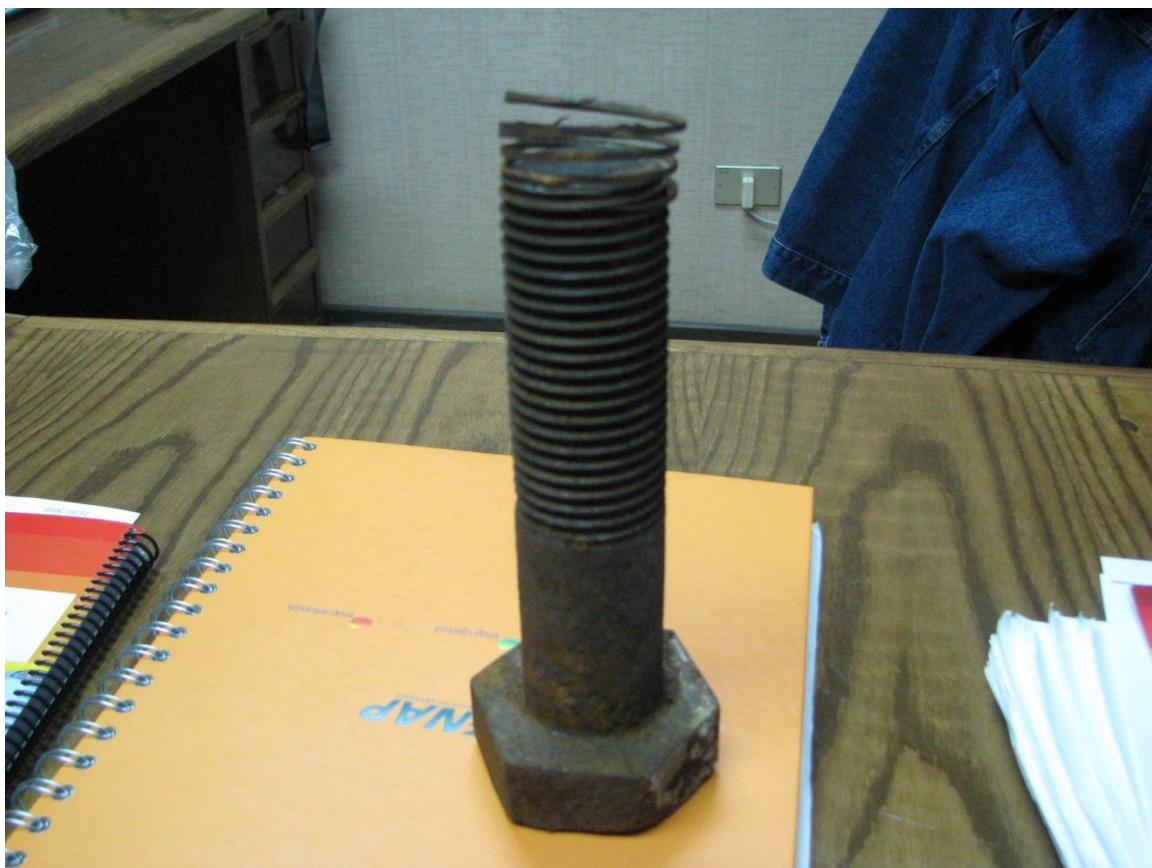
Figure 4-19: Failed derrick attachment bolt.

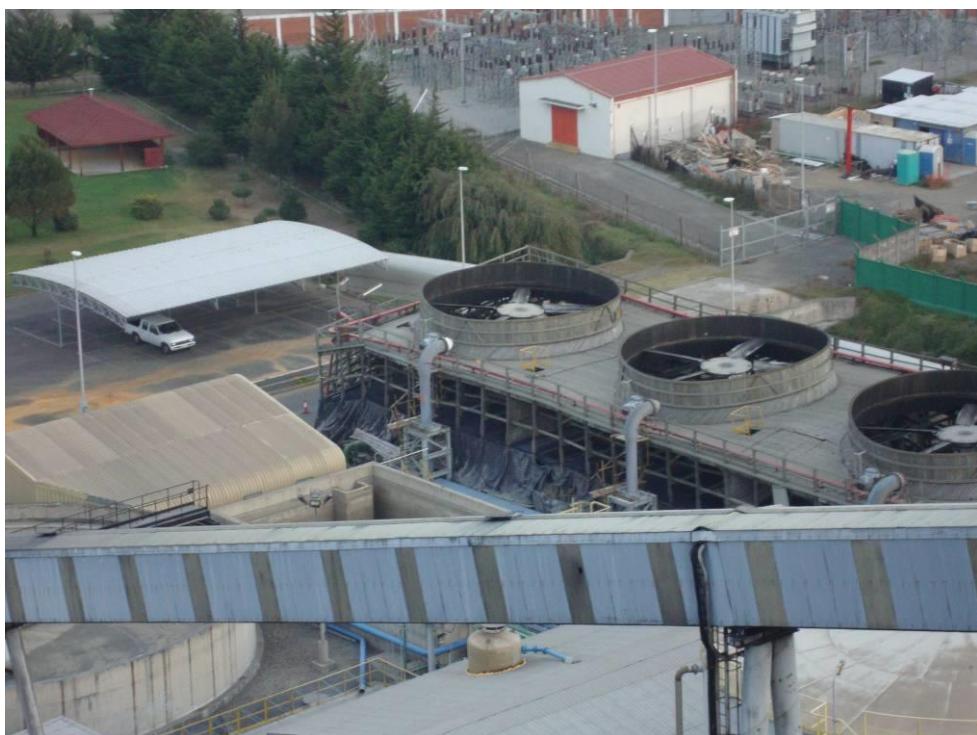
As seen in Figure 4-21 and Figure 4-22, a wooden cooling tower (Lat  $36^{\circ} 47' 13''$  S, Long  $73^{\circ} 7' 17''$  W) adjacent to the coker unit collapsed during the seismic event. The assessment team was not able to get close enough to the tower to determine what precisely initiated the collapse. We understand that this structure was subsequently replaced with a fiberglass unit.

Figure 4-21: Collapsed wooden cooling tower (from coker unit).

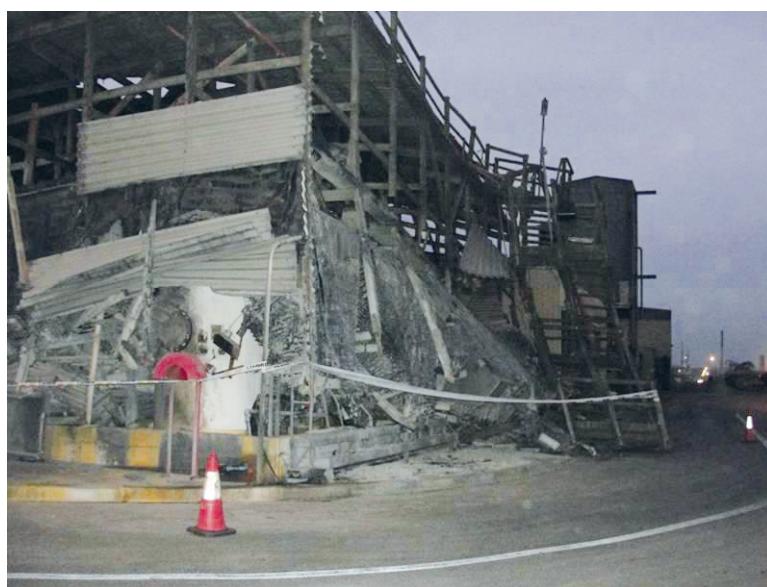
Figure 4-22: Collapsed wooden cooling tower (ground level).

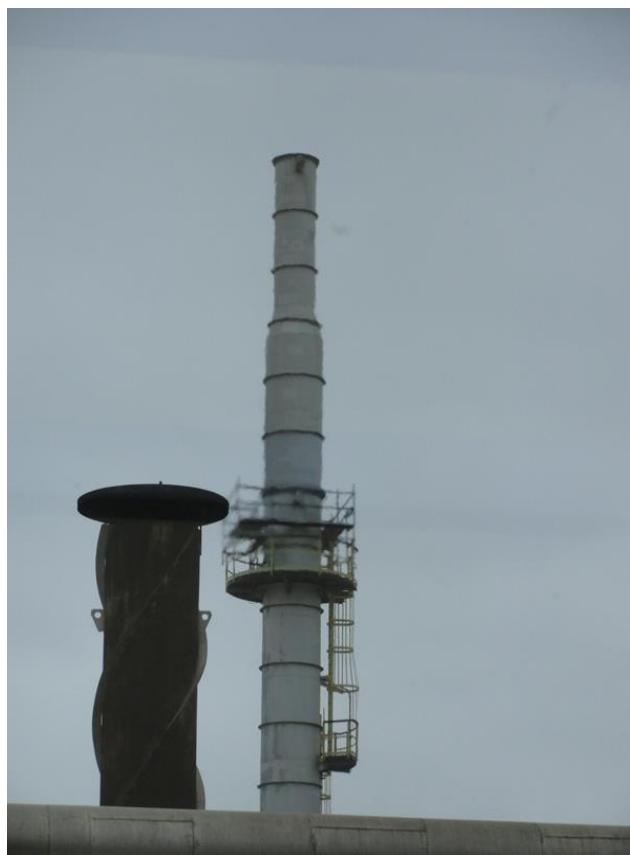
A self-supporting bolted stack (Lat 36° 46' 42" S, Long 73° 7' 10" W) shown in Figure 4-23 suffered anchorage failure and toppling of the upper 40-foot bolted portion during the earthquake. The bolts joining the stack sections were specified to be ASTM A325. However, an investigation revealed that DIN EN ISO 898 Grade 8.8 bolts were used instead.

*Figure 4-23: Bolted stack (top portion of stack is missing).*

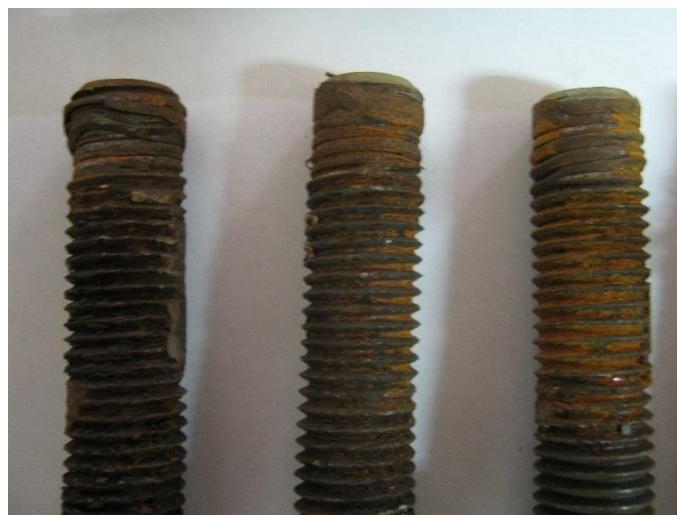
The connection bolts of the end-plate bolted connection of the upper section of the only bolted stack in the ENAP Bio Bio Refinery failed causing the upper section to fall, crushing an unoccupied pickup truck and blocking a road. Fortunately, the stack section did not hit any other structure in the refinery when it fell. Investigation of the failure revealed that the bolts (Figure 4-24) in the failed connection had suffered severe corrosion and thread stripping. The corrosion contributed to the failure of the bolts under load.

*Figure 4-24: Failed ISO 898 8.8 stack bolts exhibiting thread stripping.*

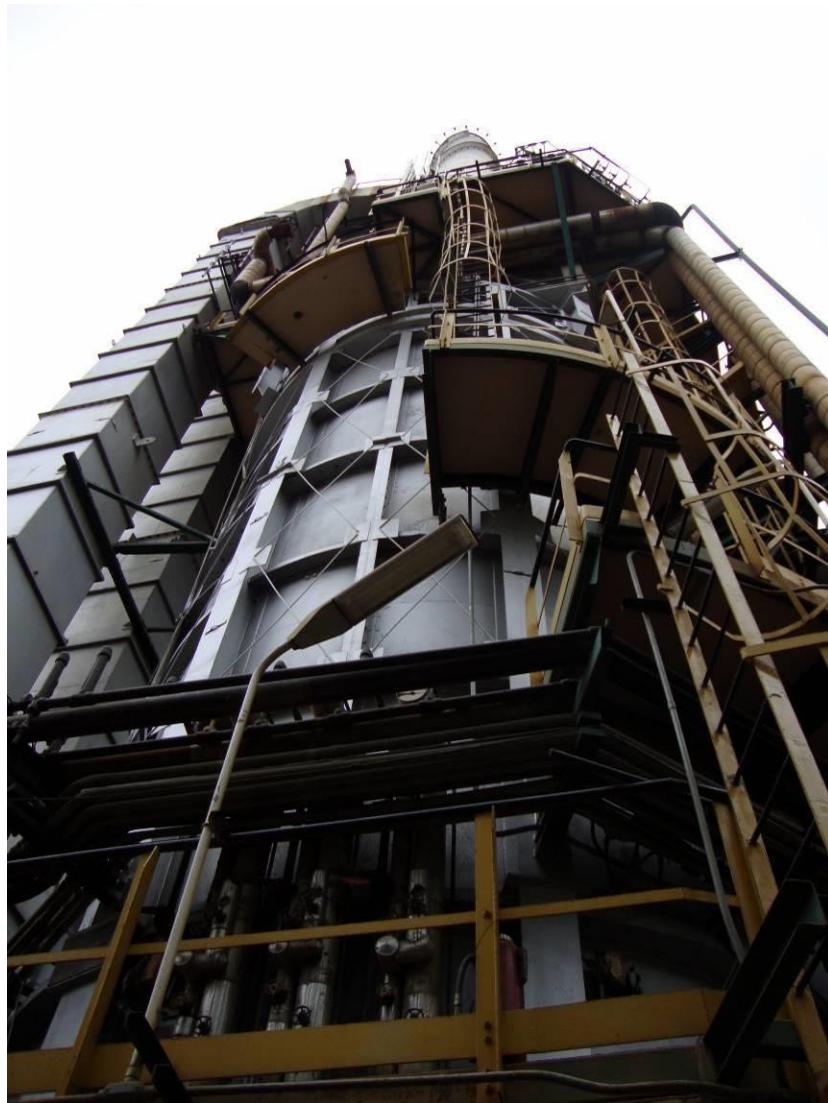
Figure 4-26: Fired heater (part of topping and vacuum I).

The primary structure in the Hydrocracking Unit is the large hydrocracking vessel, which is supported on concrete pedestal columns. Also included are fired heaters (furnaces) which in this installation suffered pedestal damage (see Figure 4-26, Figure 4-27, and Figure 4-28). (Appendix H contains a soil report for the Hydrocracking Unit.)

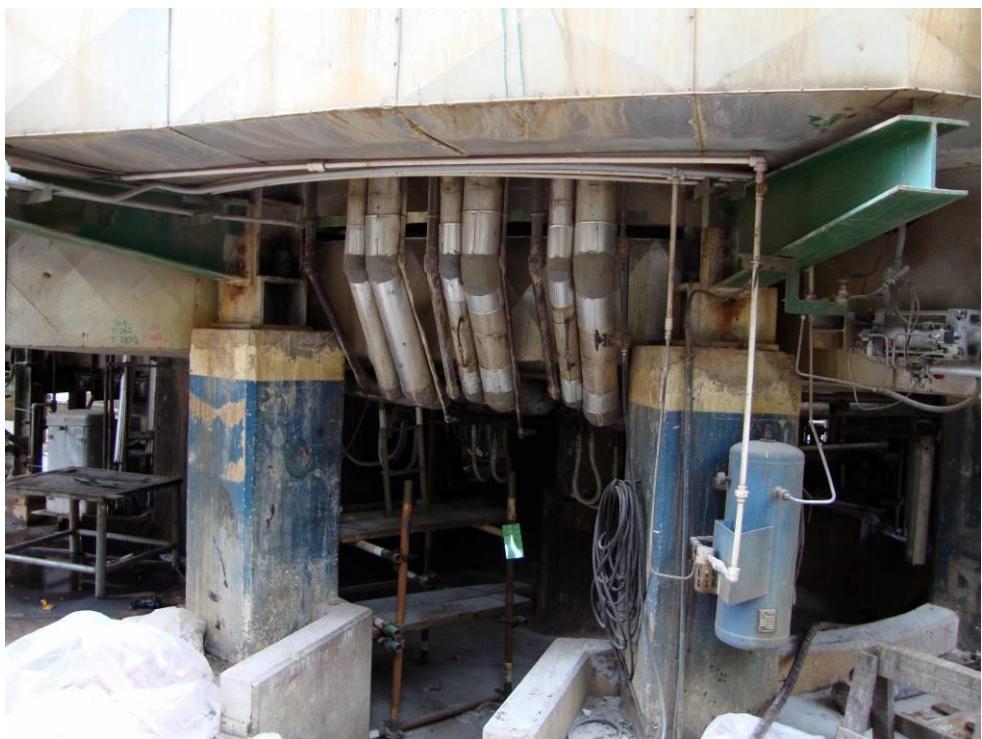
Figure 4-27: Fired heater unit supports.

Many of the pedestal supports showed evidence of having sustained large compression forces resulting in spalling of the concrete below the baseplate (see Figure 4-28). This structure was likely designed in the 1960s or 1970s and the column pedestals were sized with four bolt diameter edge distances and provided with confinement steel consisting of #4 hoops at one foot on center, typical of detailing in that era. Pedestals designed later with larger bolt edge distances and closer tie spacing performed well. Similar damage was observed in many heater vessels supports of older vintage.

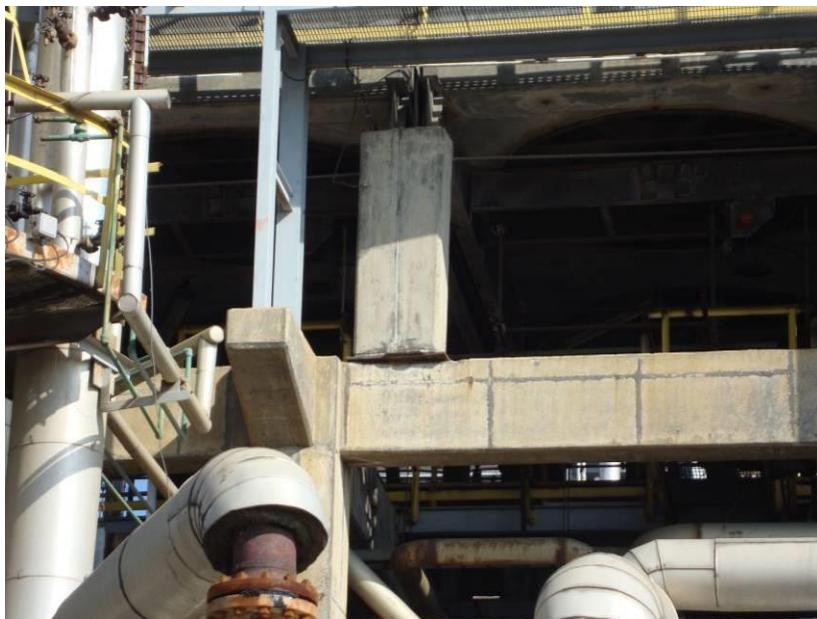
*Figure 4-30: Displaced fin fan unit support.*

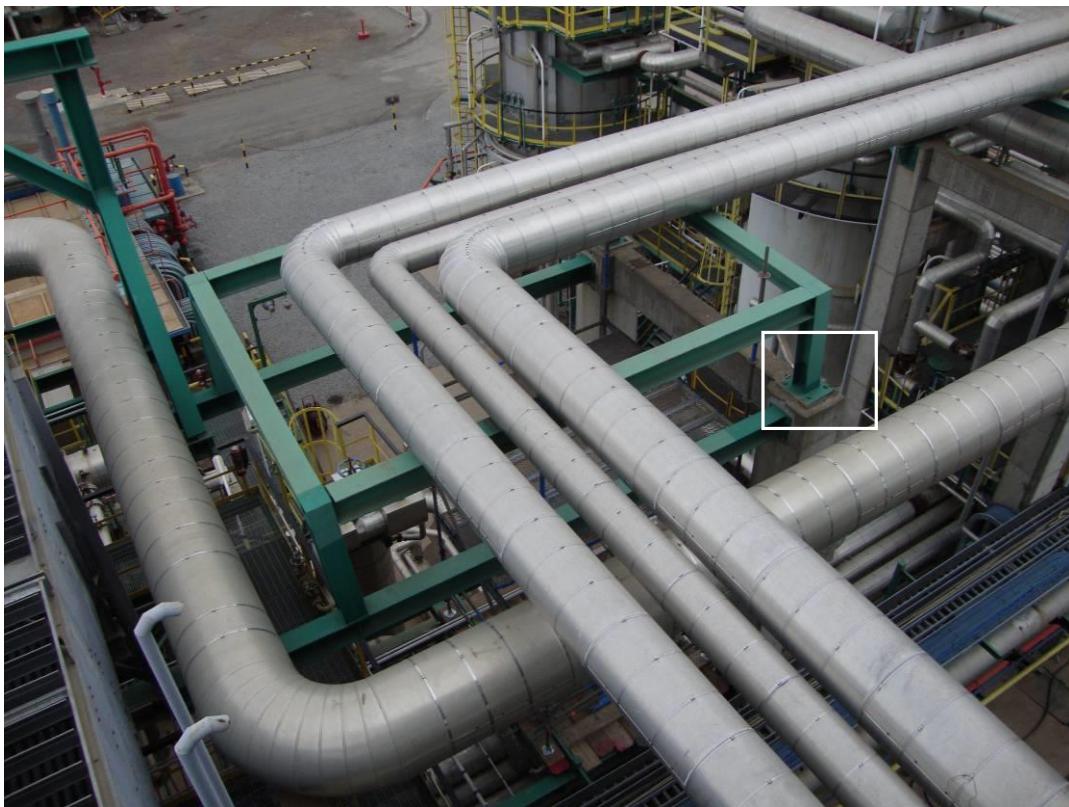
In some cases, large piping runs between vessels and other structures sustained significant distortions due to the relative movement of the attachment points (see Figure 4-31). This caused consequential damage to the piping supports. Figure 4-32 shows damage to a support anchorage, probably resulting from movement of the supported piping and the short column length of the supporting frame. The horizontal vessel shown in Figure 4-33 is supported high in a concrete structure. Damage to the vessel support was caused by forces induced in the vessel by movement of a large pipe attached with a flanged connection. The pipe in question is attached at its other end near the top of an adjacent tall vessel.

Figure 4-31: Large pipe supports with significant lateral displacement.
