# Chile Earthquake of 2010

## Assessment of Industrial Facilities around Concepción

J.G. (Greg) Soules, P.E., S.E.  
Robert E. Bachman, P.E., S.E.  
John F. Silva, P.E., S.E.

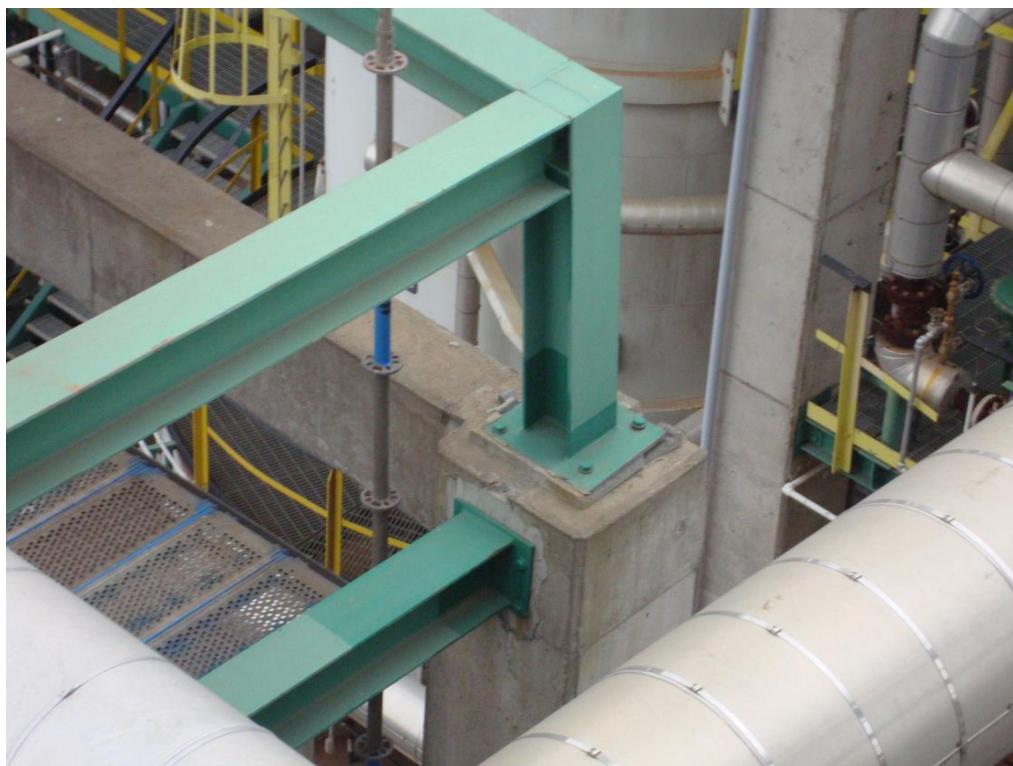
Figure 4-32: Damage to pipe support anchorage.

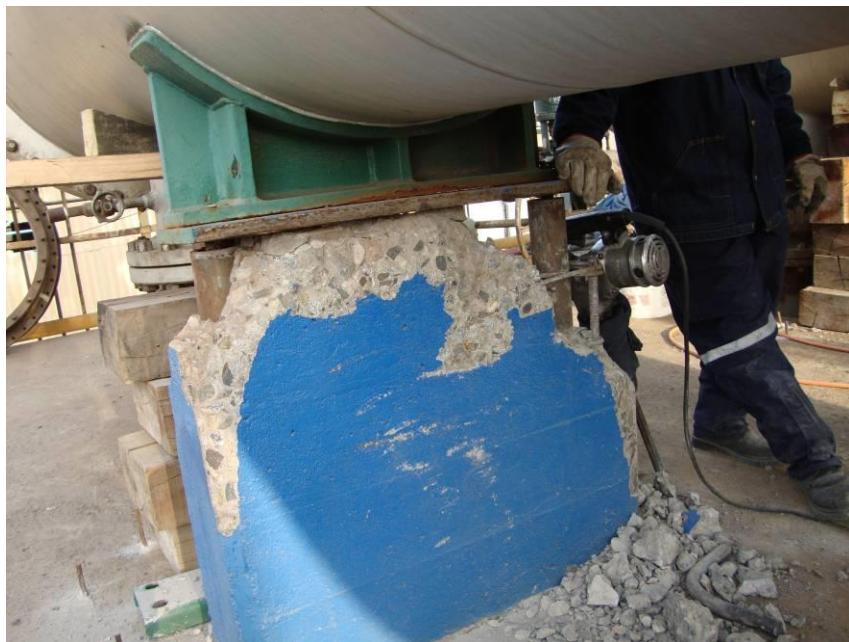
Figure 4-33: Damage to vessel support caused by piping-induced lateral forces.

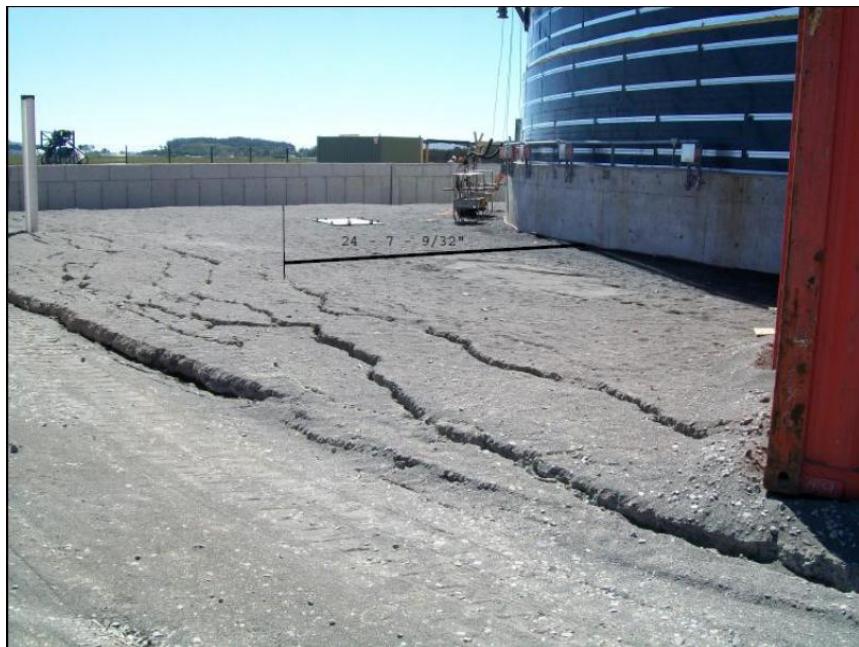
Because the LPG tank was empty at the time of the seismic event, no conclusions can be drawn on the possible seismic performance of the tank. However, the performance of the improved soil beneath the LPG tank can be evaluated. The Abastible facility sits on liquefiable soil. As can be seen in Figure 5-9, lateral spreading due to soil liquefaction did occur near the tank. The lateral spreading stopped at the point where the improved soil began. The soil improvement must be viewed as a success.

Figure 5-9: Lateral spreading near LPG tank arrested by improved soil. (Courtesy of CB&I Inc.)

The seismic design provisions in ASCE/SEI 7 and its referenced documents for nonbuilding structures, such as tanks and spheres, appear sound. Soil improvement to prevent damage from liquefaction performed well during the seismic event. Therefore, soil improvement should be one of the options considered to mitigate the effects of liquefaction.

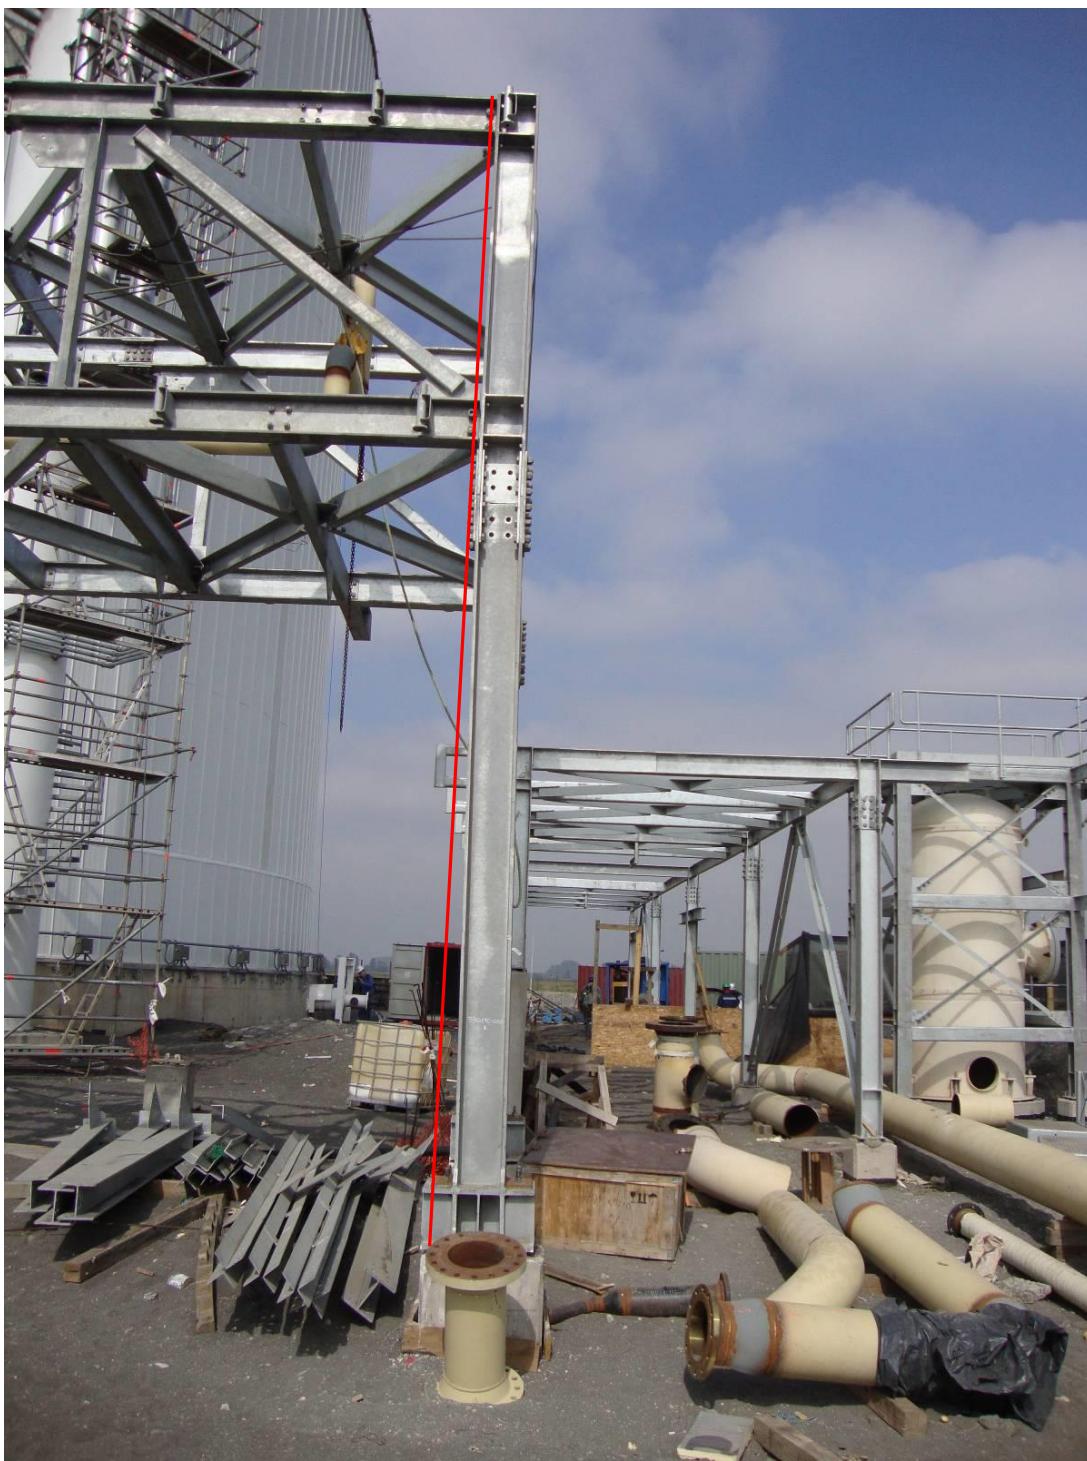
marsh areas. The lateral displacement was greater nearer the marsh, creating significant horizontal relative displacements between the pipe rack footings. Care must be taken to ensure that soil improvements cover the entire area of potential liquefaction that the structure is constructed upon.

Figure 5-11: Effect of lateral spreading on pipe rack column.

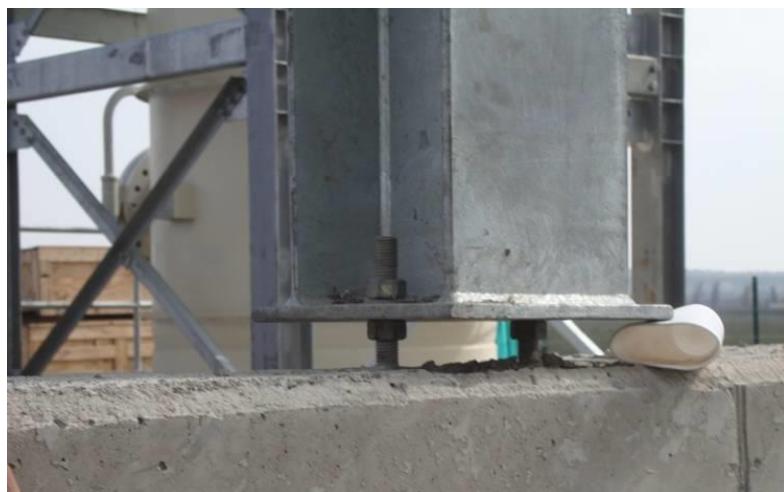
The wall was constructed near the outside edge of the improved soil of the tank area. Although not obvious in Figures 5-12 and 5-13, the wall was observed to have settled a few inches due to liquefaction of the soil. The pipe support structure settled with the wall.

*Figure 5-12: Settlement of wall (under construction).*

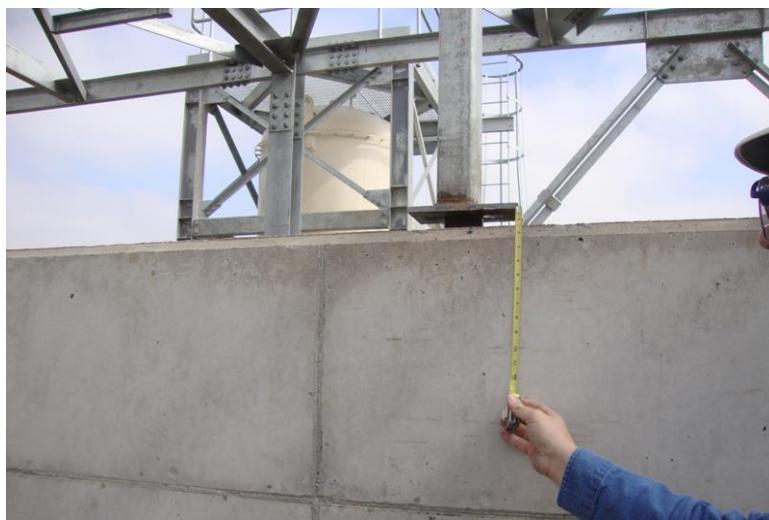
*Figure 5-13: Settlement of wall (additional view).*

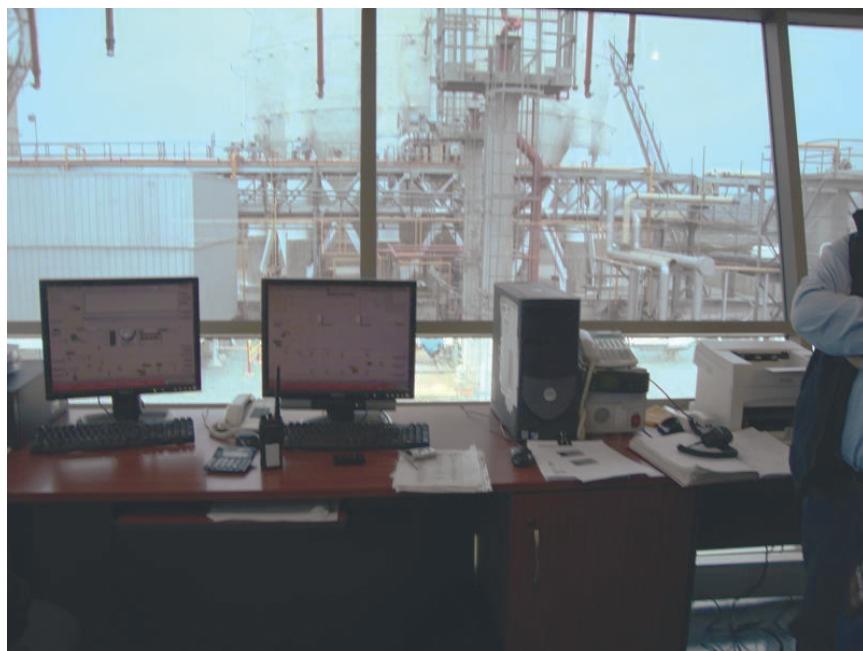
The control room suffered no structural damage and only minor nonstructural damage. According to the plant personnel, the only nonstructural issue they had during the seismic event was toppling of the computer monitors (Figure 5-14).

*Figure 5-14: Control room computers.*

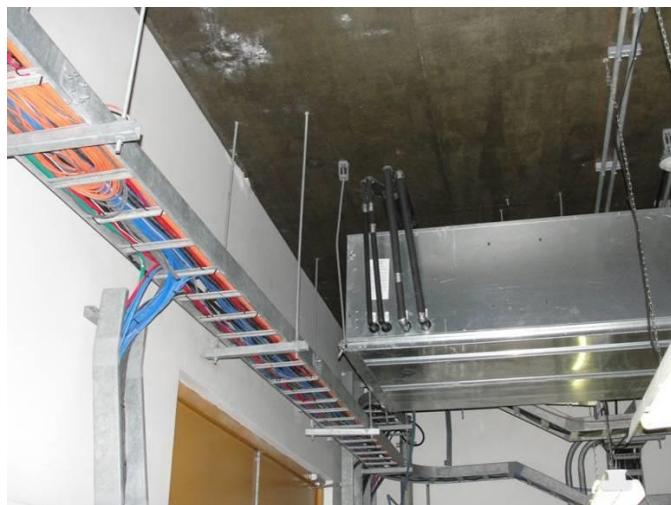
The electrical and mechanical rooms did not have any structural damage and suffered only minor nonstructural damage occurred in the electrical room as shown in Figure 5-15 and Figure 5-16. In Figure 5-15, hanging threaded rods that supported an item of suspended equipment were significantly bent. The equipment was not laterally supported. In Figure 5-16, a suspended light fixture was damaged by swinging and impacting an adjacent item.

*Figure 5-15: Bent support rod of suspended equipment support.*

Nonstructural elements of the mechanical and electrical rooms performed well during the seismic event. The only damaged items were suspended equipment and lighting that were not laterally braced. These items would have required bracing per ASCE/SEI 7. Therefore no code changes appear to be warranted based on the observed performance in the mechanical and electrical rooms.

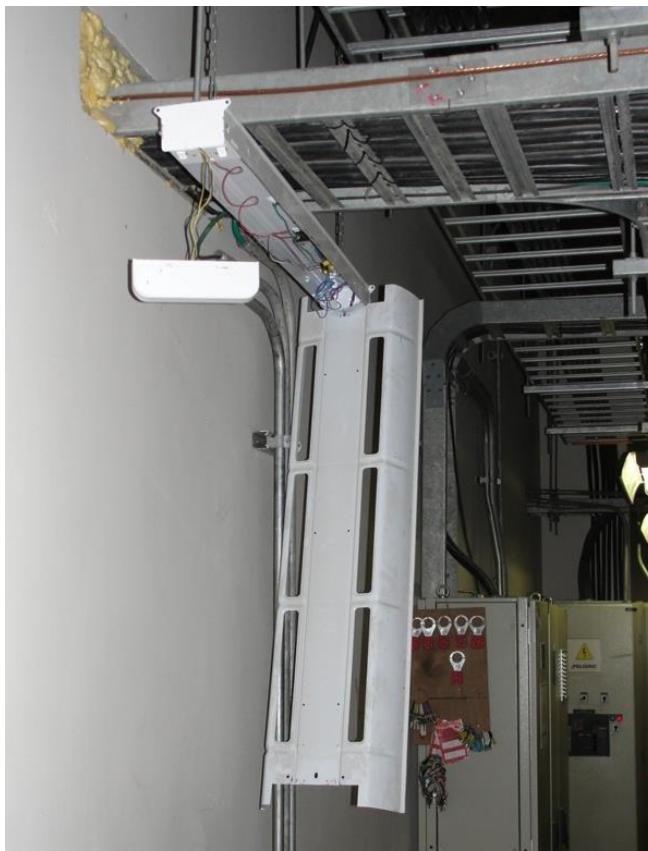
*Figure 5-16: Damaged light fixture.*

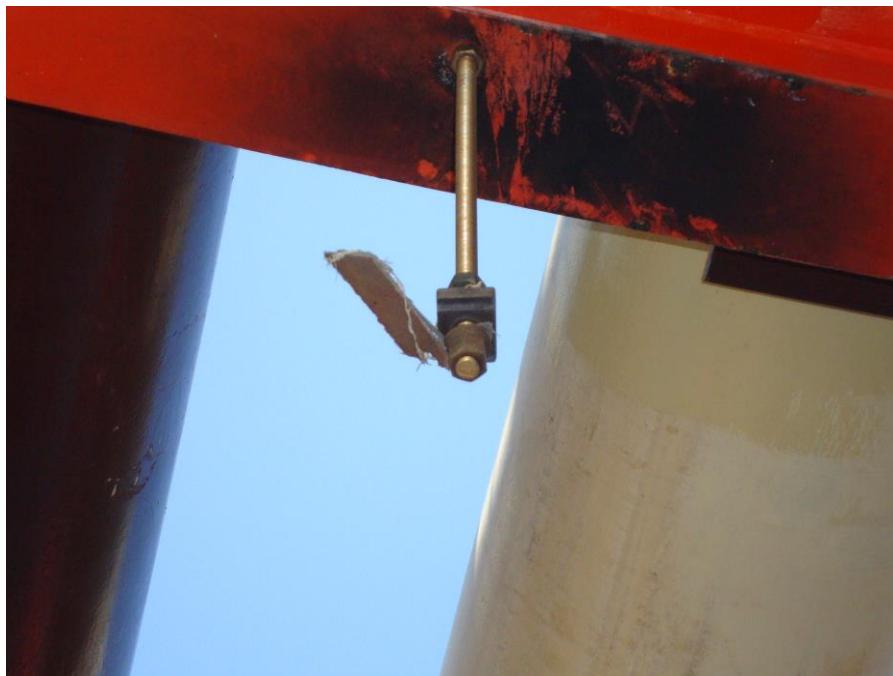
Figure 5-22: Fragment of channel on hanger.

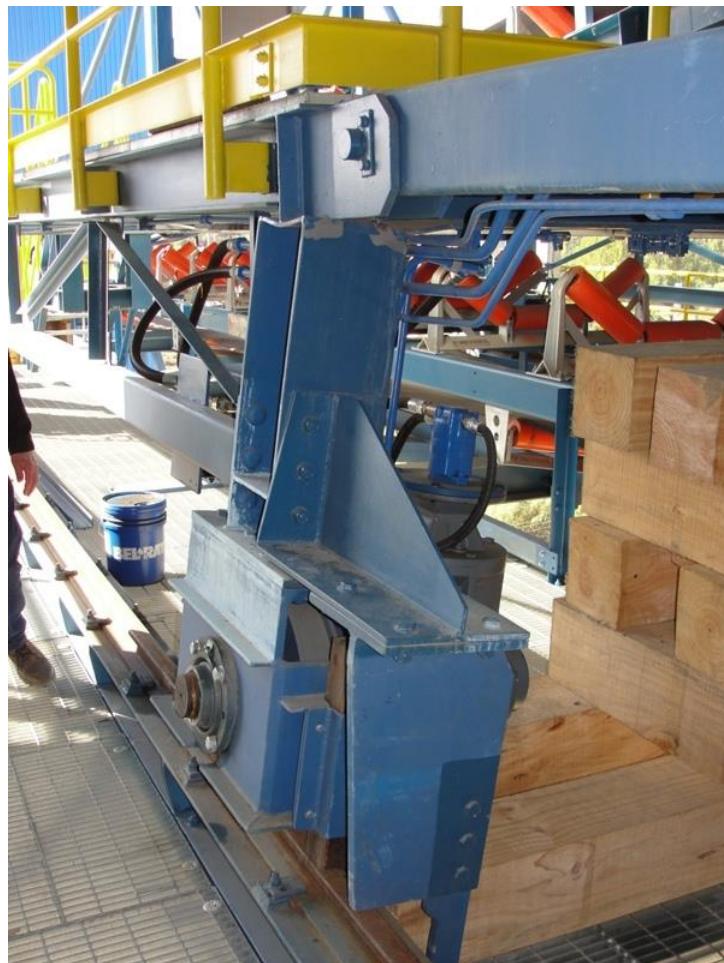
Figure 6-6: Damaged transfer car wheels (notice extremely poor transverse moment connection detail).

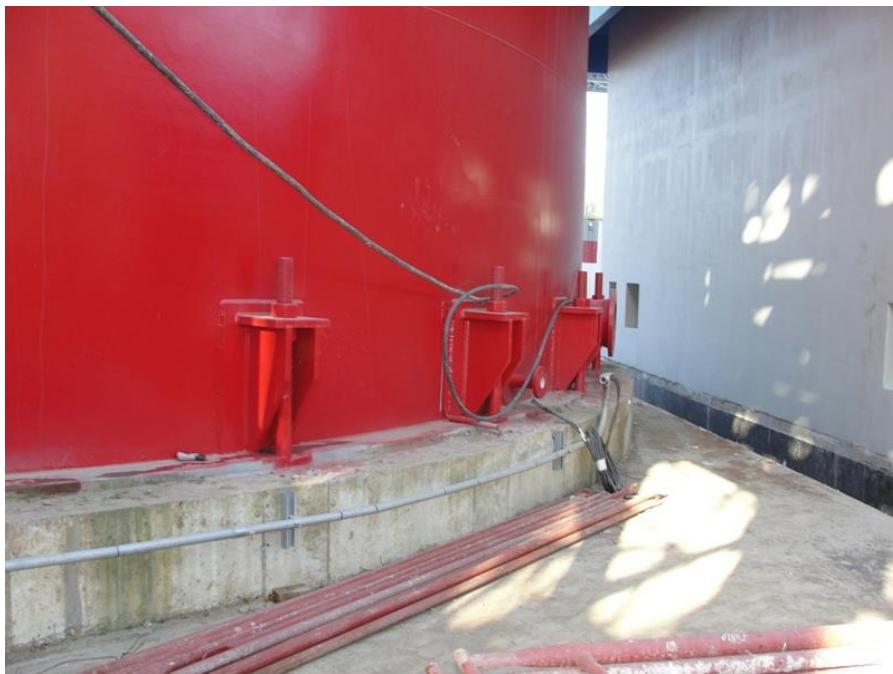
Figure 6-13: Tilted tank mat footing resulting from liquefaction.

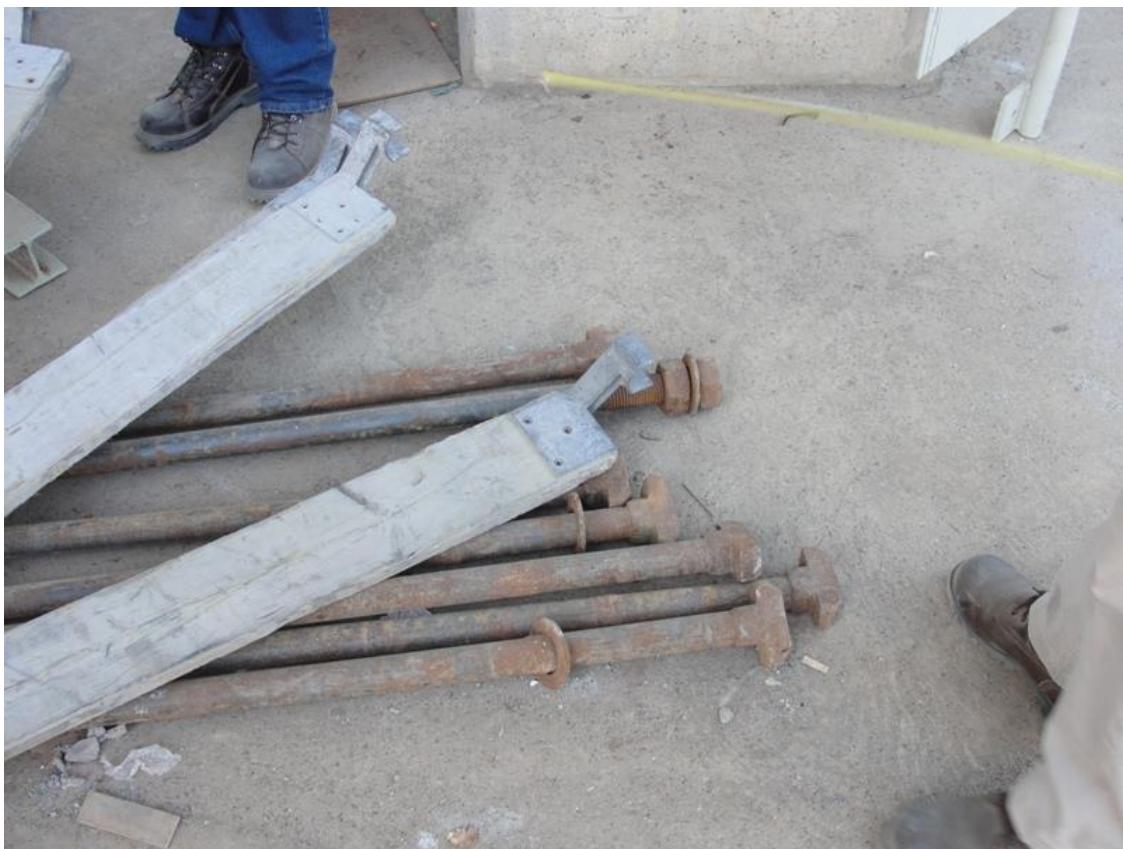
One of the more innovative design approaches used in the design of some of the large structures, was removable anchor bolts. The concept is to provide bolt details where the large diameter anchor bolts can be removed and if necessary replaced after a large earthquake. These bolts have Tee Heads (Figure 6-14) that are connected to special sockets in the concrete with large sleeves. These bolts can be simply loosened, twisted and removed. Several of the bolts were checked after the earthquake and none had permanently stretched. Therefore, none of the bolts needed to be replaced.

Figure 6-14: Removable tee head anchor bolts.

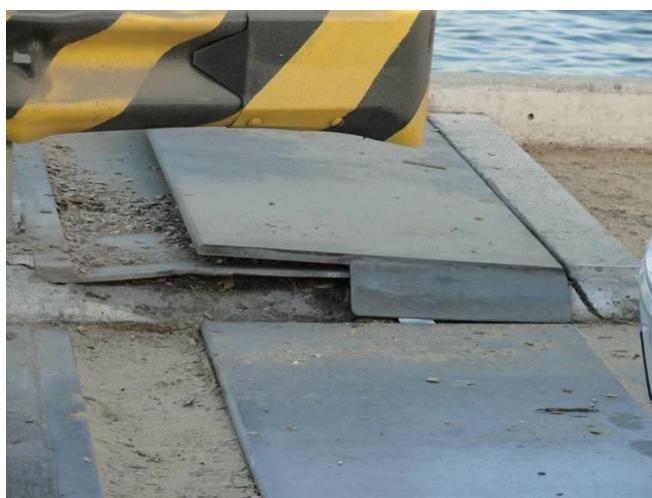
Evidence of significant movement in both longitudinal and traverse directions was observed in the isolation joint between the pier and land (Figures 7-2 through 7-5). It appears there was some lateral spreading at the shoreline causing a permanent reduction in the isolation gap in the longitudinal direction of several inches. Significant movement, such as that observed, would normally be expected.

*Figure 7-3: Isolation joint at edge.*

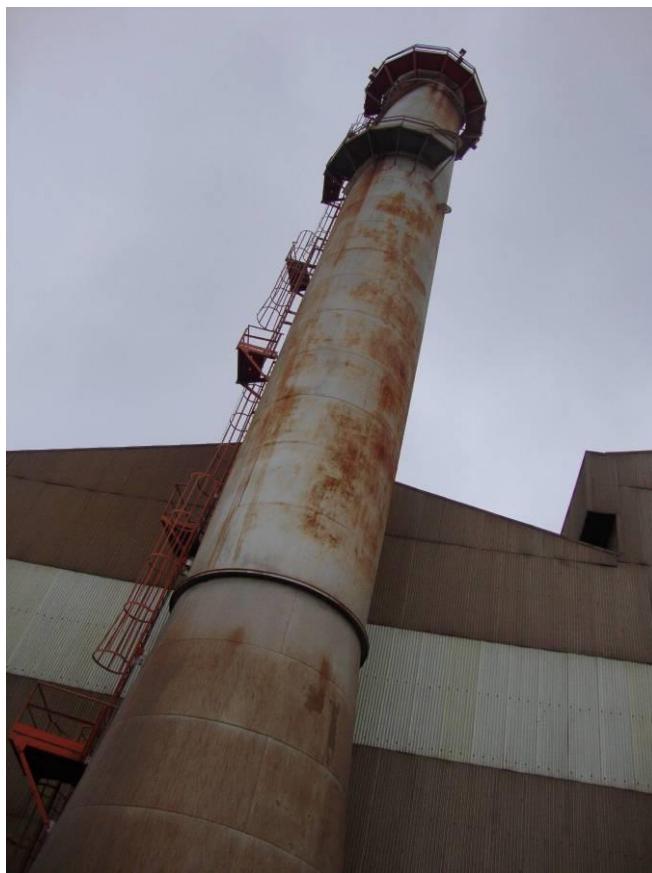
The stretching (yielding) of anchor bolts is a primary source of ductility in the seismic response of tanks, vessels and large one story moment frame structures. Figure 8-1 depicts a large stack at the CAP Acero Steel Plant. Figure 8-2 shows the amount of inelastic deformation experienced by the 30 1.75-inch anchor bolts arrayed around the circumference of the stack. Figure 8-3 shows the shimmed bolts. The amount of permanent stretch in the bolts tends to be uniform around the base indicating oscillation of the stack around the circumference of the base, much like the precession of a spinning coin on a flat surface. This is a phenomenon observed with stacks in past earthquakes. Anchor embedment design at the CAP Acero facility typically used the procedures found in Appendix B of ACI 349-76, which are somewhat less conservative than those contained in current codes. The bolts are reported to have a specified yield of 40 ksi and an ultimate strength of 60 ksi and are threaded only at their upper end. Their performance was generally quite good and intermediate stabilization of the stack could be achieved by the simple use of shims. There was also some damage to the foundation in the vicinity of the upper embedded portion of the bolts, probably caused by the oscillation of the stack (see Figure 8-4).

Figure 8-1: Large Stack at CAP Acero steel plant.

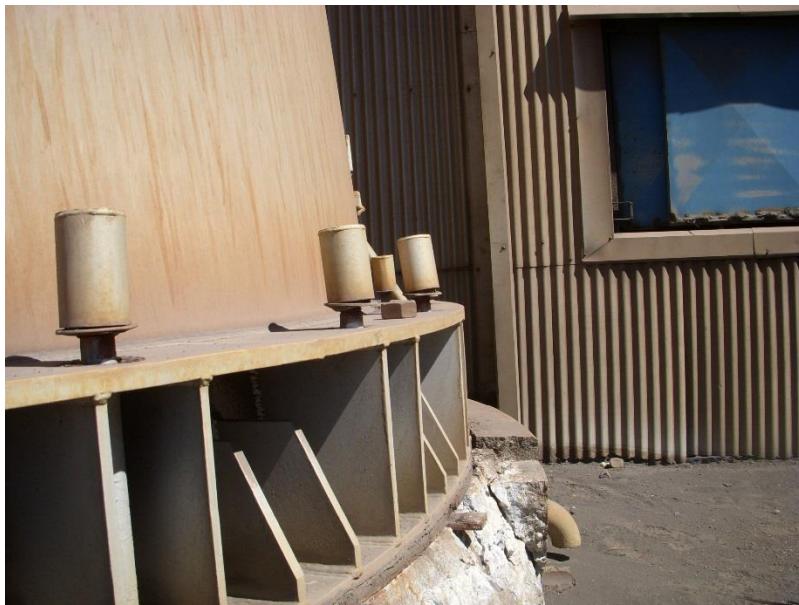
*Figure 8-2: Stretched anchor bolts on stack. (Source: Courtesy of S. Otero, CAP Acero)*

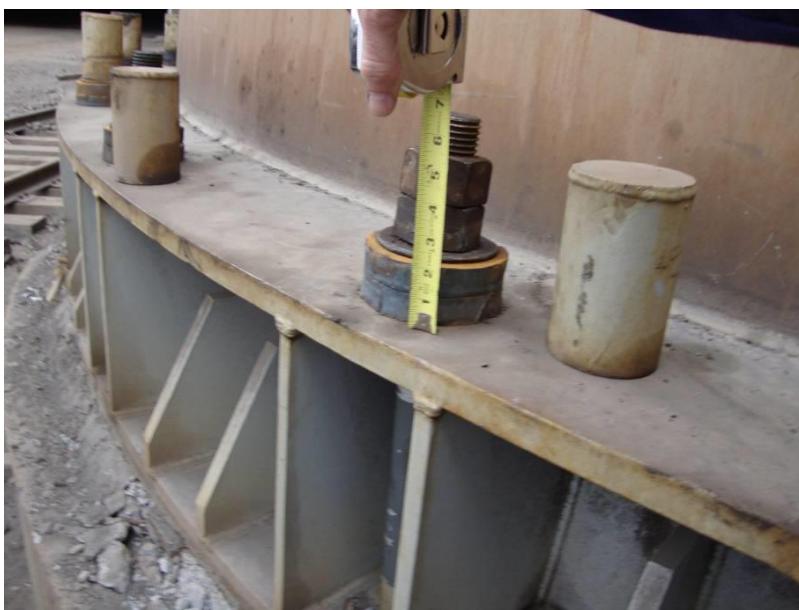
*Figure 8-3: Stretched anchor bolts on stack with shims.*

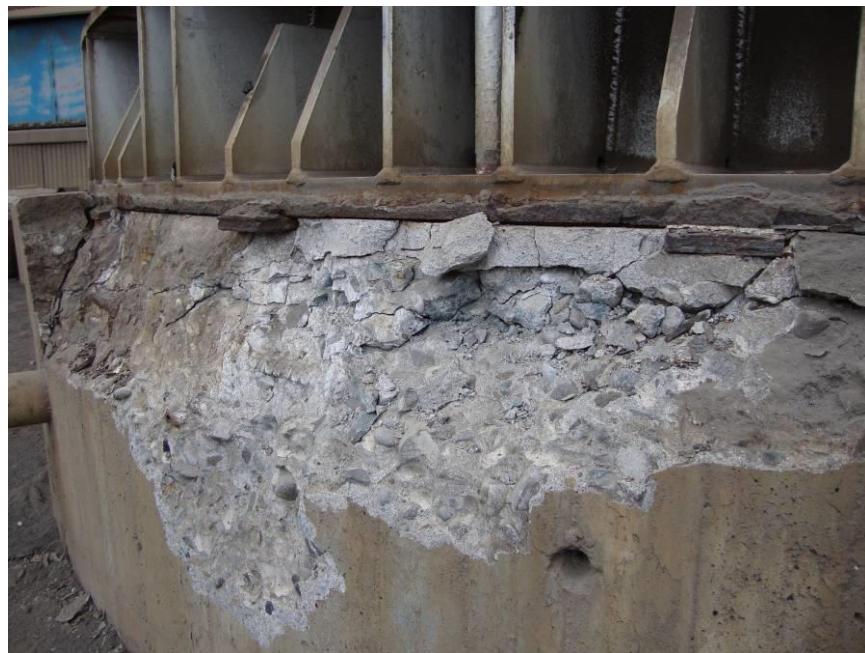
Figure 8-4: Damage to stack foundation.

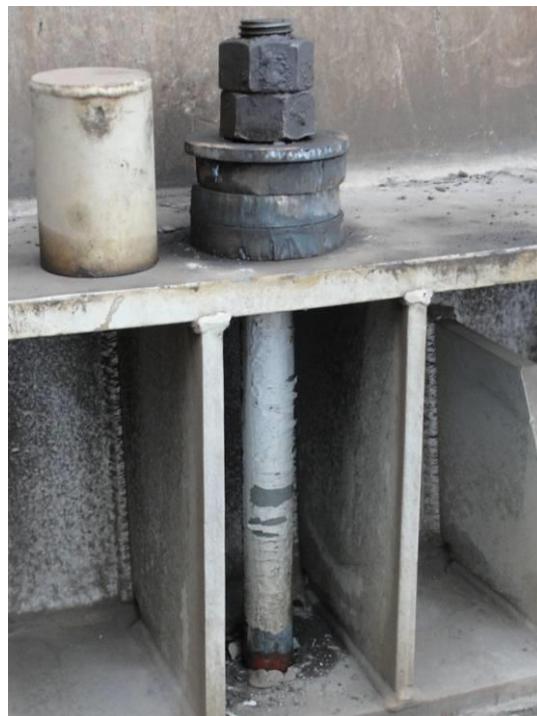
The stretch length afforded by the anchor chair for these anchors is on the order of eight bolt diameters. The actual stretch length was probably longer due to significant strain penetration into the foundation. Figure 8-5 shows the typical remedial procedure for intermediate stabilization used. If the threads were not damaged and the bolt shank was not necked down, shim washers were added under the nuts and the bolts retightened. However, since the stretch of the bolts (6-7%) exceeded the value considered by CAP Acero to be acceptable from the standpoint of energy dissipation (5%), and since replacement of the bolts in situ was deemed to be quite complicated and expensive, it was decided to construct a secondary anchor ring around the foundation with the new foundation doweled back to the original structure (see Figure 8-6). See Appendix C for drawings.

Figure 8-5: Stretched anchor bolt with shims.

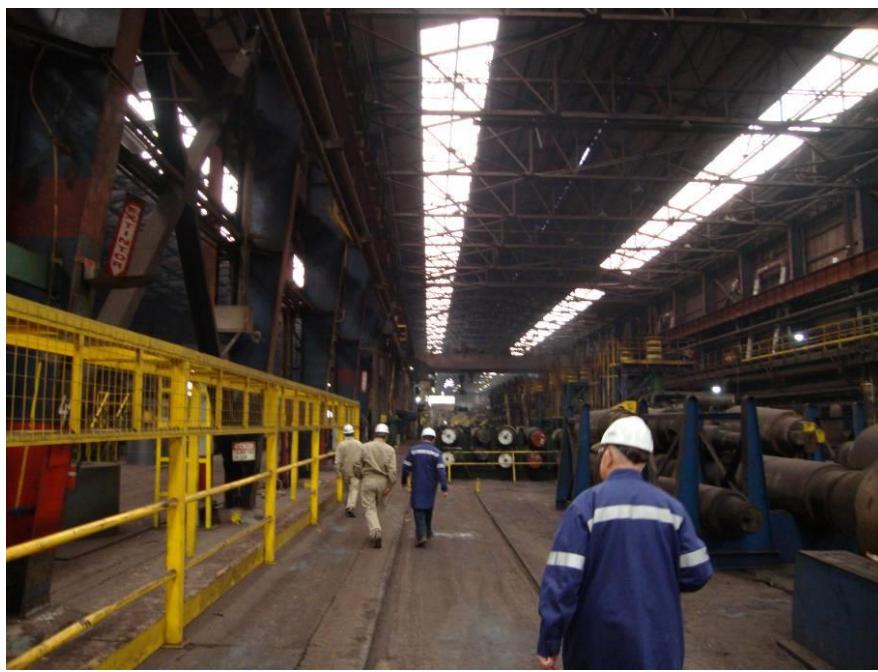
Yielding was widely observed in baseplate anchors in the Hot Rolling Mill (Figure 8-7) at the CAP Acero facility. The anchors in the moment frames predicated the 1960 Valdivia earthquake and many experienced yielding in both that event and this one (Figures 8-8 and 8-9). Many of these anchors must now be replaced either because the degree of necking is extreme or because the anchors experienced fracture below the baseplate (Figure 8-10).

Figure 8-7: Hot rolling mill.

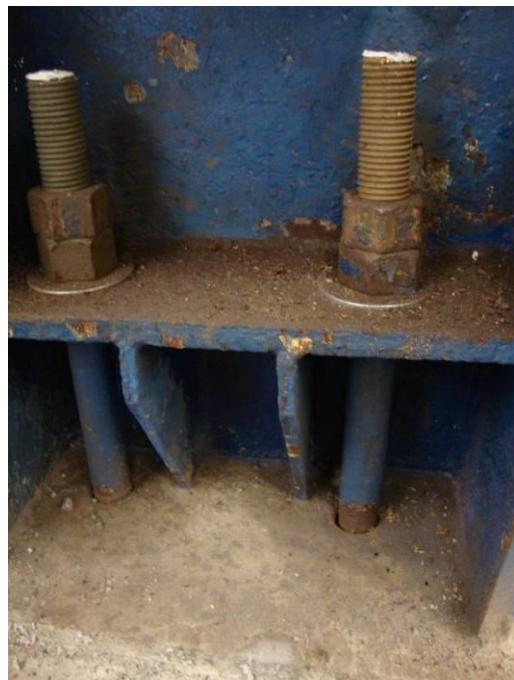
Figure 8-9: Yielded frame anchor bolts in hot rolling mill.

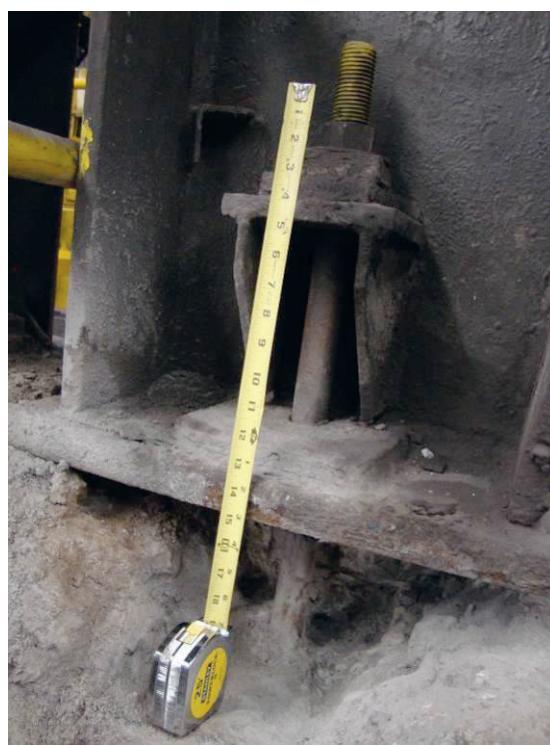
Figure 8-10: Remedial work on anchor bolts in hot rolling mill.

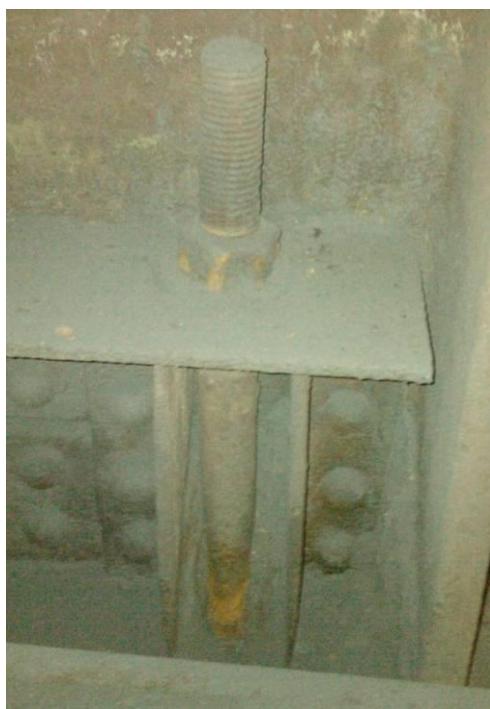
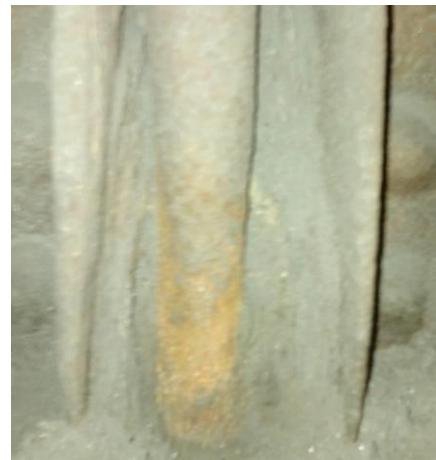
*Figure 8-11: Yielded anchor bolt, baseplate without shear lug. (Source: Courtesy of CAP Acero)*

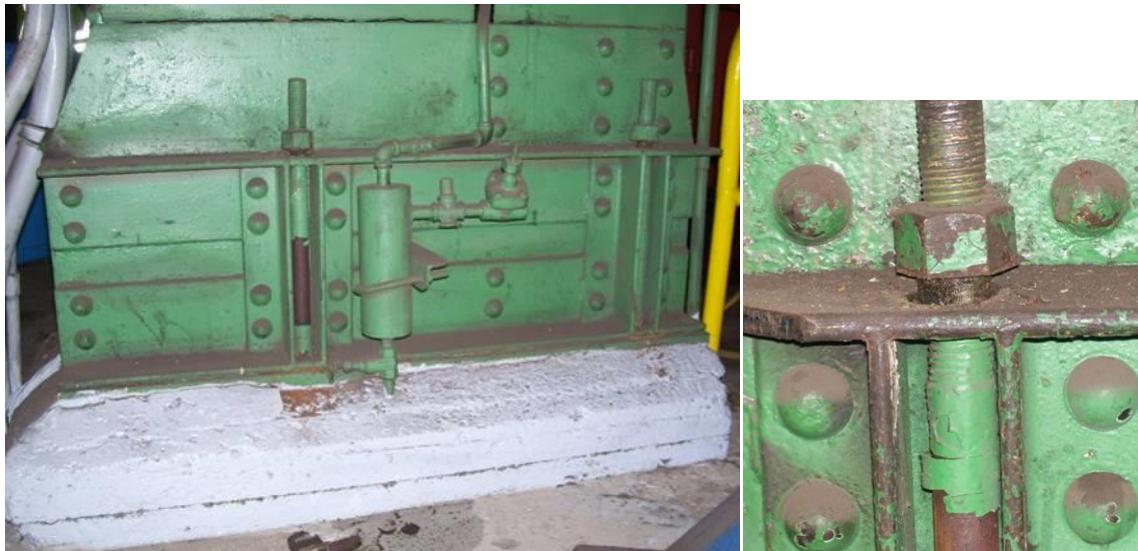
Figure 8-12: Yielded anchor bolts, estimated stretch of 20 mm (7/8 in.). (Source: Courtesy of CAP Acero)

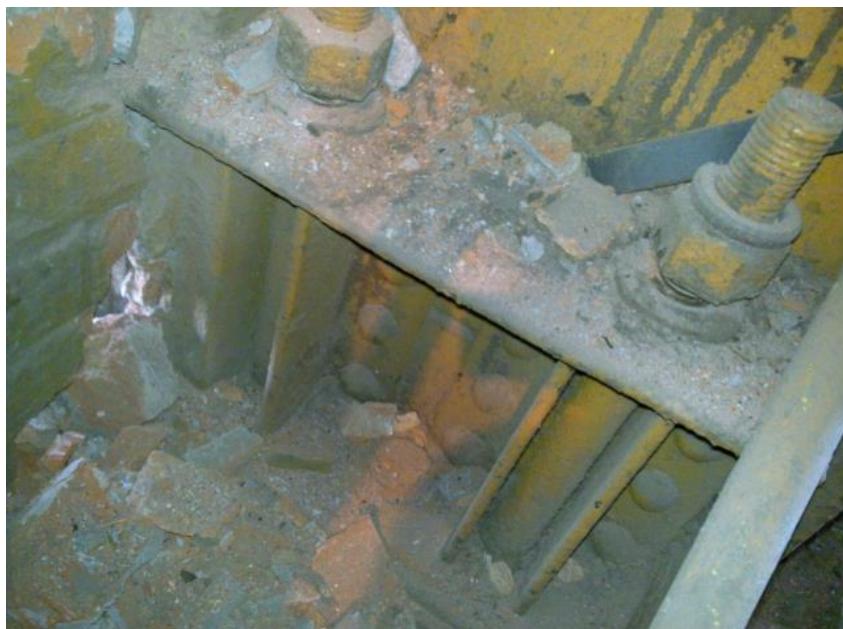
Figure 8-13: Yielded anchor bolts, estimated stretch of 18 mm (11/16 in.). (Source: Courtesy of CAP Acero).

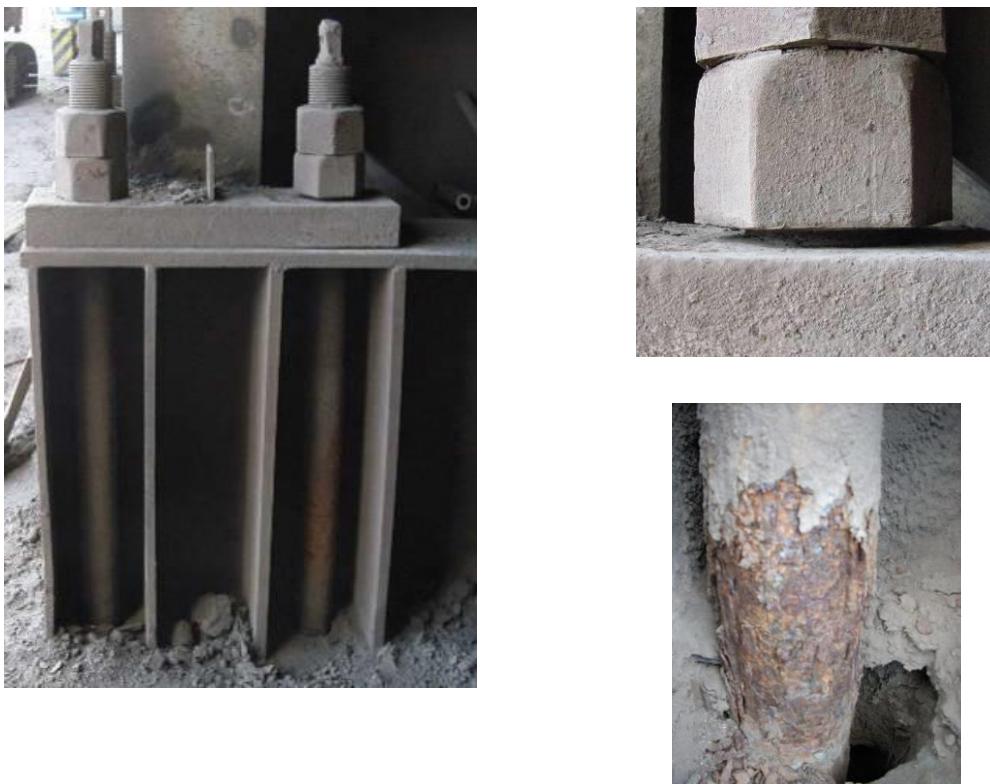
Figure 8-14: Yielded anchor bolts, estimated stretch of 10 mm (3/8 in.) (Source: Courtesy of CAP Acero).

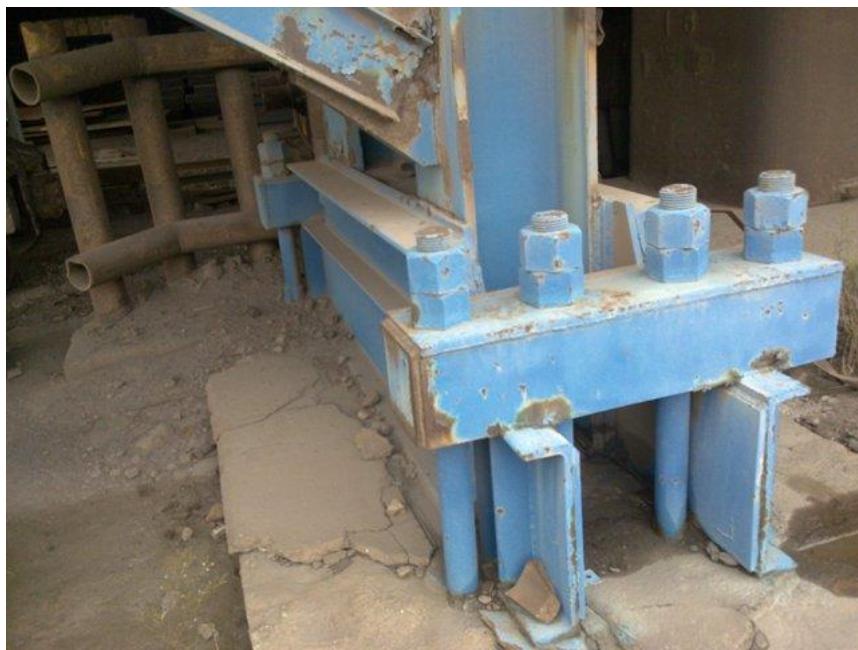
Figure 8-15: Yielded anchor bolts. (Source: Courtesy of CAP Acero)

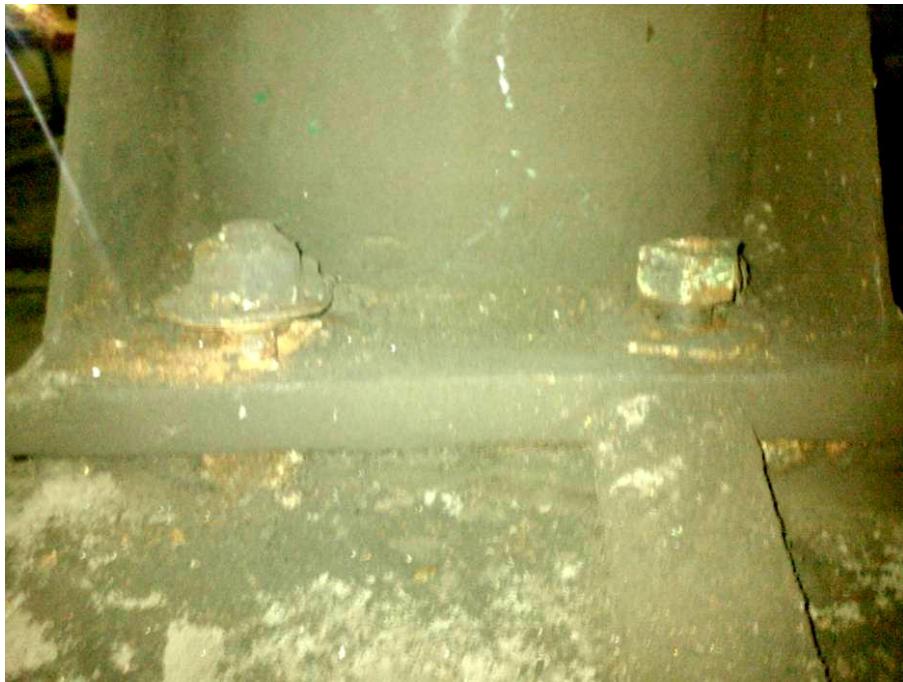
Figure 8-16: Stretch/failure of baseplate anchors (no anchor chair). (Source: Courtesy of CAP Acero)

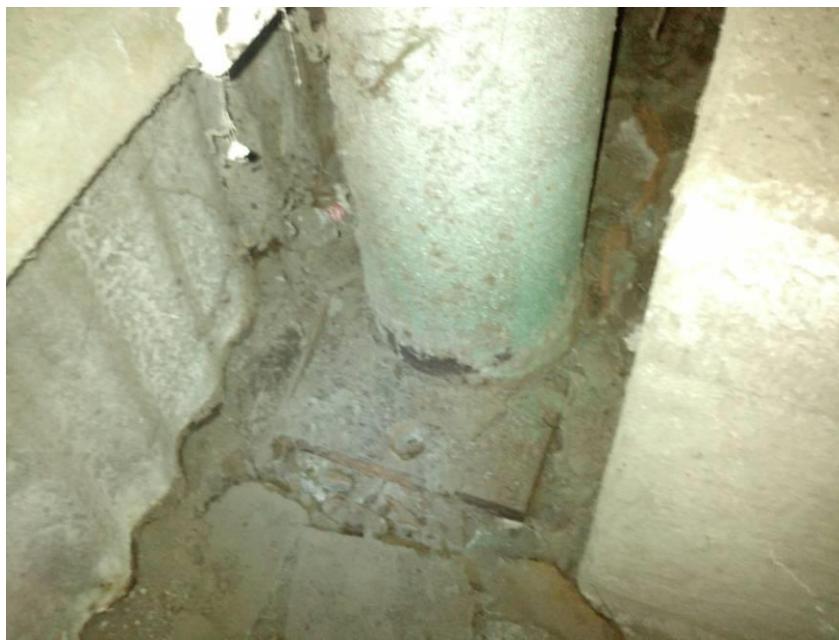
Figure 8-17: Failure of baseplate anchors (no anchor chair). (Source: Courtesy of CAP Acero)

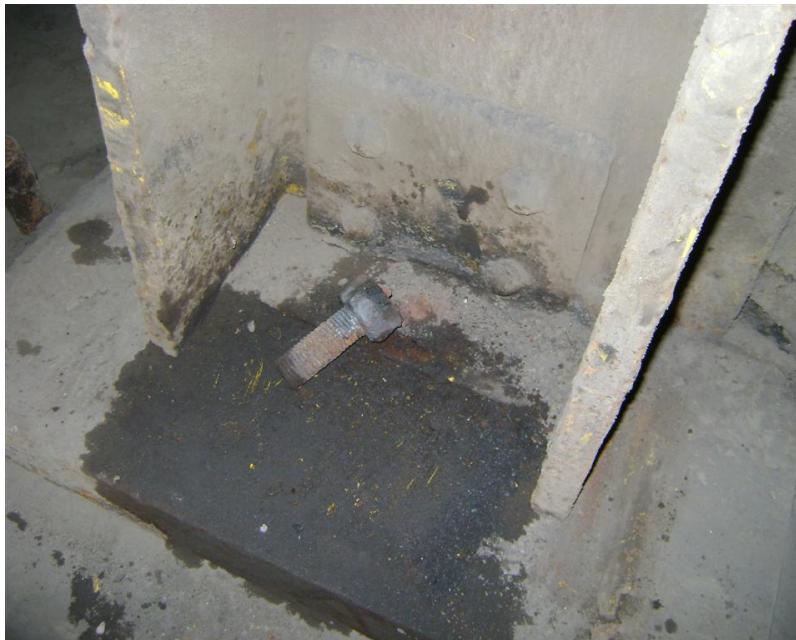
Figure 8-18: Fracture of baseplate anchors (no anchor chair). (Source: Courtesy of CAP Acero)

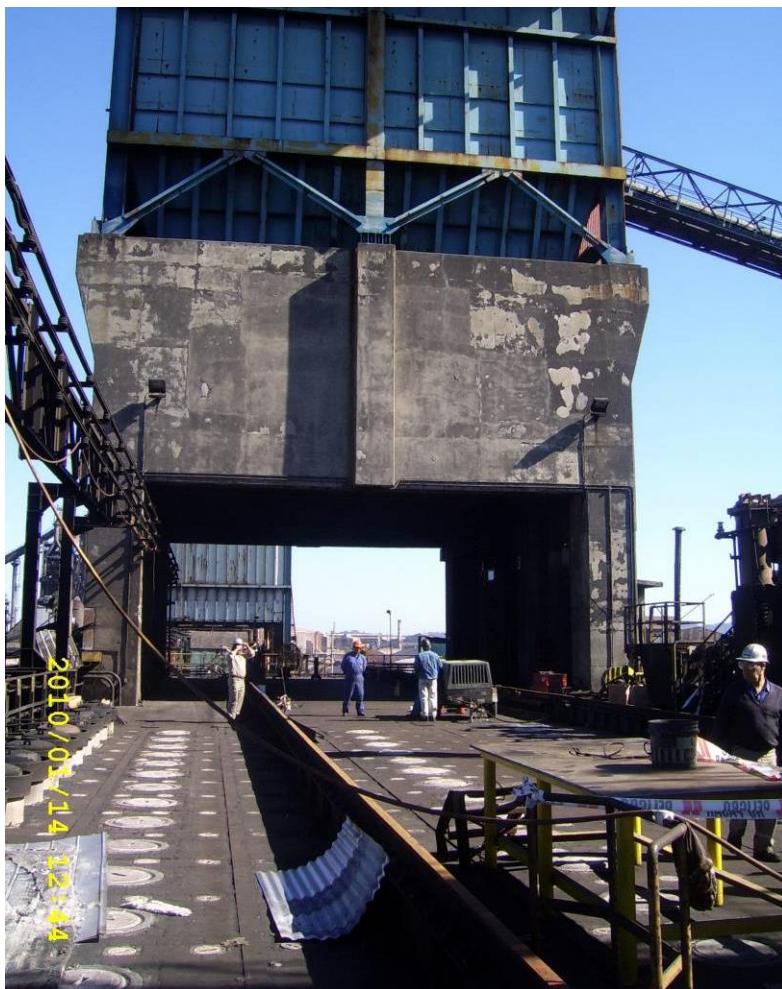
The anchorage failure of the coal bin (Figure 8-19) represents a typical weakness in older pedestal anchor bolt designs where significant shear is present and shear lugs are not used. In Figure 8-20, the edge failure likely led to the bending and rupture of the near-edge anchor. The small edge distance afforded these bolts indicates that they may not have been designed for this condition.

Figure 8-19: Coal bin. (Source: Courtesy of CAP Acero)

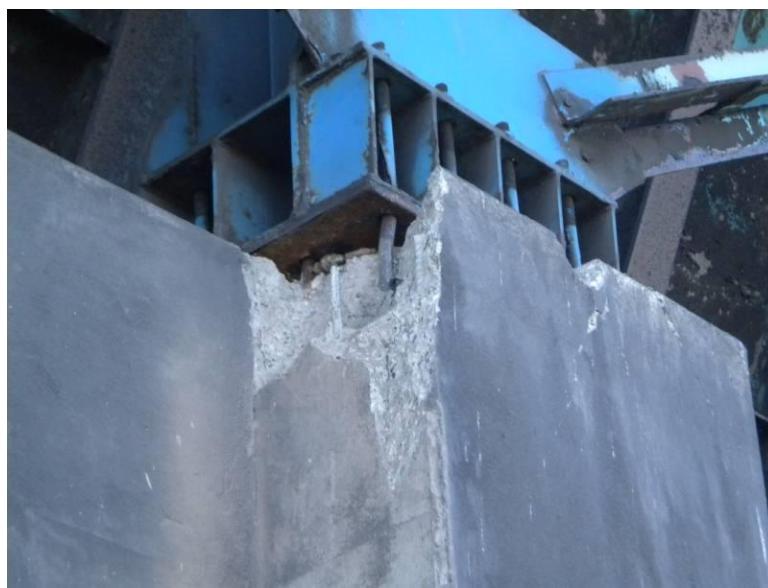
Figure 8-20: Shear failure of anchorage at coal bin.(Source: Courtesy of CAP Acero)

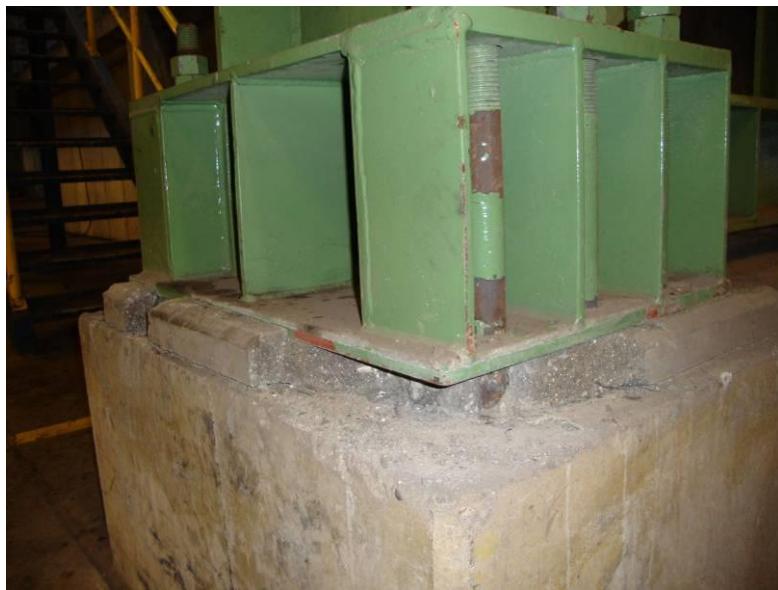
Figure 8-21: Damage to column base cap in bar mill (new).

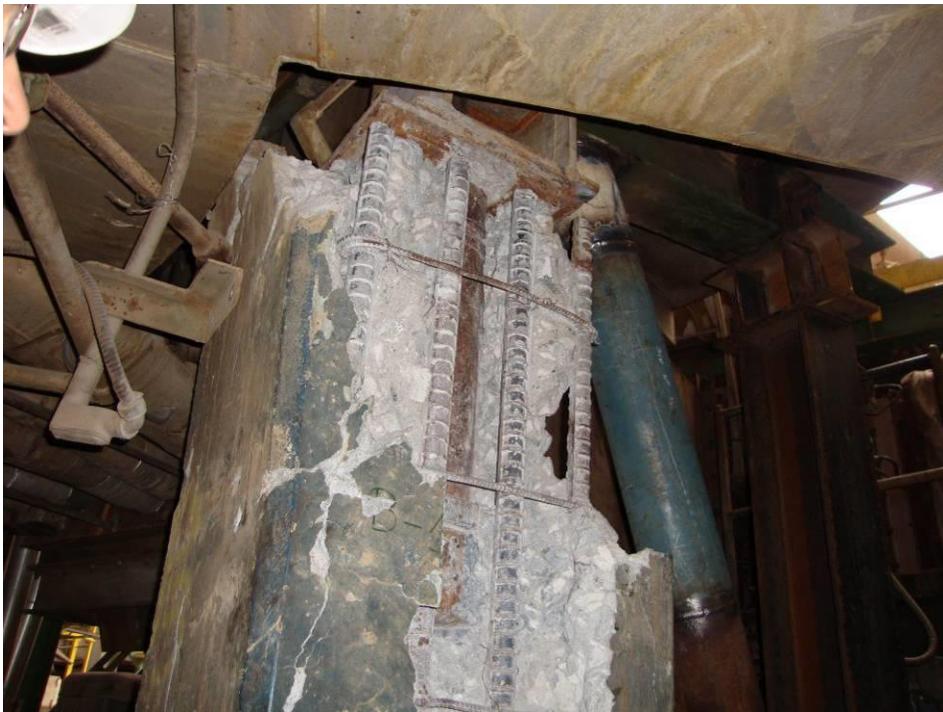
Figure 8-23: Failed pedestal anchorage.

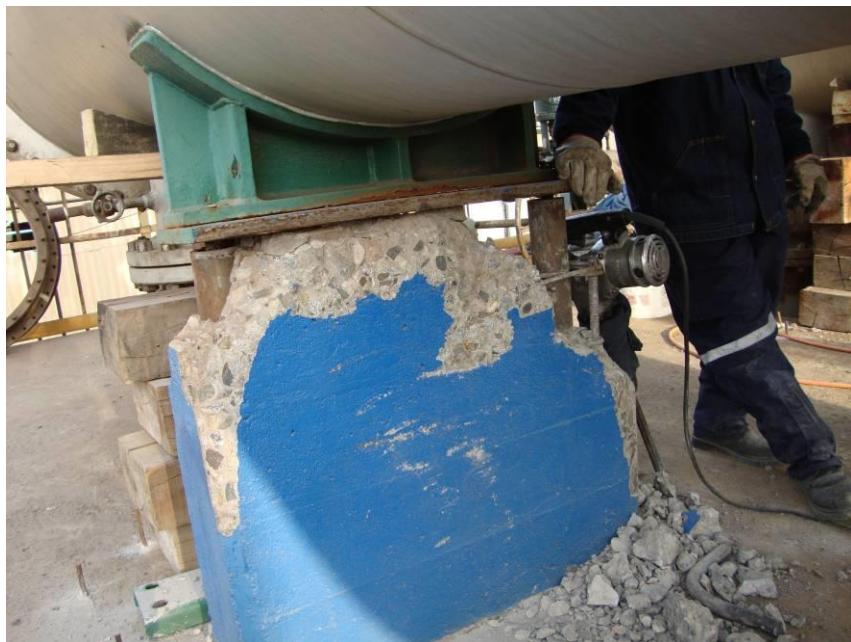
Figure 8-24: Failed saddle anchorage.
