# Chile Earthquake of 2010

## Assessment of Industrial Facilities around Concepción

J.G. (Greg) Soules, P.E., S.E.  
Robert E. Bachman, P.E., S.E.  
John F. Silva, P.E., S.E.

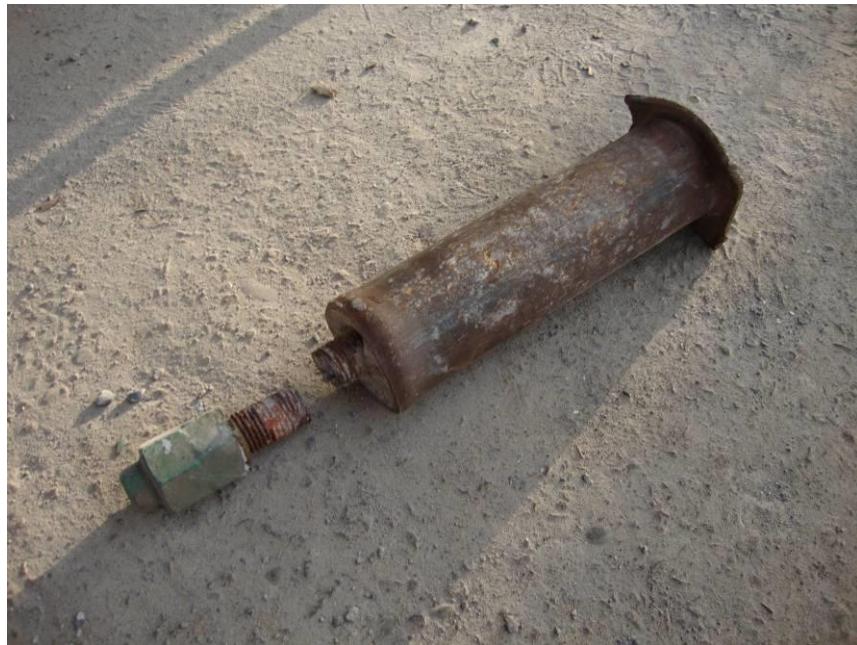
Figure 8-25: Failed anchor from saddle. Note cupping of bearing plate.
