**APPENDIX C**

## Prospection Drawings

### SEISMIC RETROFITTING PROJECT

HOTEL COMERCIO  
Lima, Perú

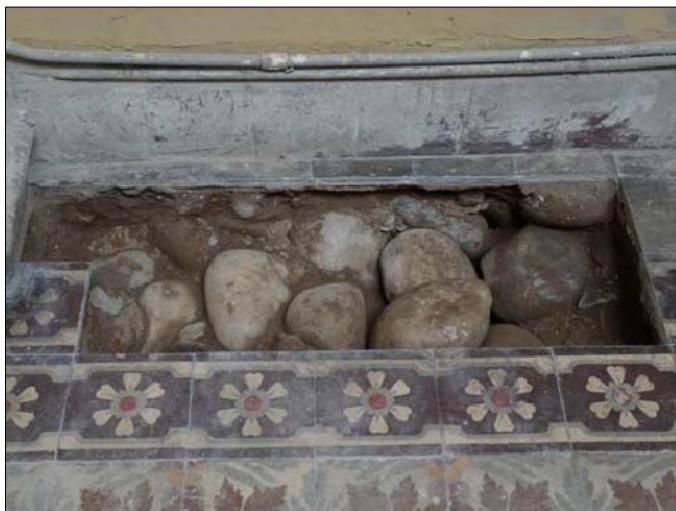
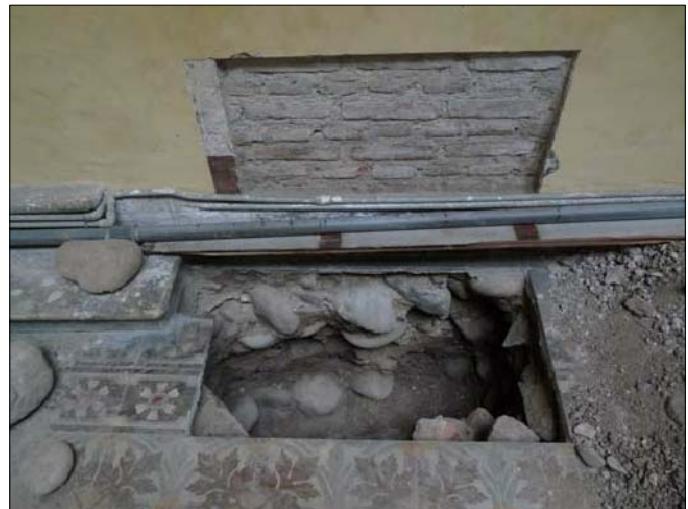
IS-1

THIS OPENING IS LOCATED AT THE FIRST PATIO AND HAS THE OBJECTIVE OF EXPLORING THE FOUNDATIONS.

THE FLOOR IS COVERED WITH CONCRETE TILE SET IN A CEMENT AND SAND MORTAR BED. BELOW THE TILES THERE IS DAMP SOIL WITH A LARGE QUANTITY OF COBBLESTONES HAVING A DIAMETER BETWEEN 0.20 m AND 0.30 m. THIS IS TYPICAL OF SOIL IN LIMA.

THE FOUNDATION OF THE WALL ADJACENT TO THE NORTHEAST SIDE OF PATIO IS ALSO CONSTRUCTED WITH COBBLESTONES SET IN A LIME AND SAND MORTAR AND IS APPROXIMATELY 0.46 m DEEP. BELOW THE FOUNDATION COBBLESTONES THERE IS A NATURAL COMPACTED CLAY SOIL CONTAINING LOTS OF COBBLESTONES.

IT IS IMPORTANT TO NOTE THAT BELOW THE FLOOR TILE, BRICK WALLS WERE FOUND. THE CONFIGURATION OF THESE WALLS IS DIFFERENT FROM THE WALLS OF THE CURRENT BUILDING, SUGGESTING THAT THEY ARE THE REMAINS OF AN EARLIER STRUCTURE ON THE SITE.

AT THE WALL ABOVE, FIRED BRICK SET IN A LIME AND SAND MORTAR WAS OBSERVED IN AN AREA CORRESPONDING TO THE WINDOW SILL. HOWEVER, IN A SMALL OPENING BETWEEN THE WINDOWS, MUD BRICKS WERE OBSERVED AT THE SAME LEVEL AS THE FIRED BRICKS IN THE FIRST OPENING. THIS WOULD INDICATE THAT THE WINDOW OPENINGS ARE REINFORCED WITH FIRED BRICKS. A SIMILAR SITUATION WAS ALSO OBSERVED AT THE WINDOW OPENINGS IN THE SECOND PATIO (NO OPENINGS WERE MADE, AS THE BRICK WAS VISIBLE AS A RESULT OF THE POOR CONDITION OF THE SECOND PATIO).

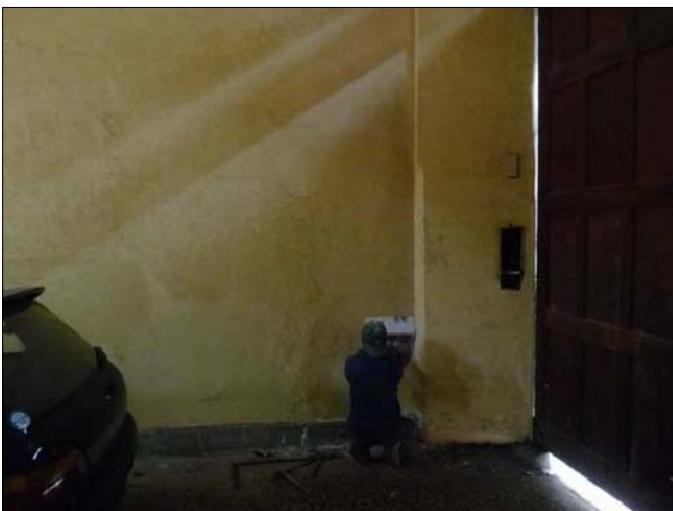
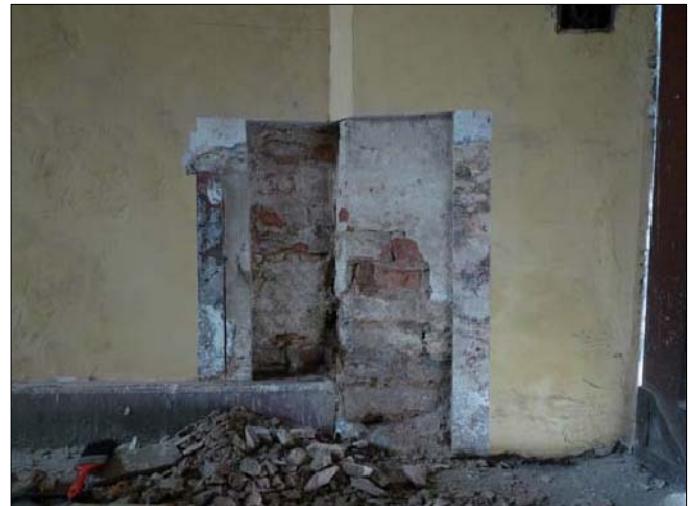
IW- 1

THESE OPENINGS ARE LOCATED IN THE WEST CORNER OF THE ENTRY HALL, NEAR THE ENTRANCE PORTAL. THEY SHOW A FIRED BRICK BASE WITH A MUD BRICK AND MORTAR WALL ABOVE. THE ENTRANCE PORTAL IS CONSTRUCTED WITH FIRED BRICKS SET IN A LIME AND SAND MORTAR, AND THE BRICKS CONTINUE INTO THE WALL THAT IS PERPENDICULAR TO THE PORTAL AND ARE THEN INTERWOVEN WITH THE ADJACENT MUD BRICKS.

IN THE CENTER OF THE SOUTHWEST WALL THERE IS WINDOW OPENING THAT HAS BEEN INFILLED WITH FIRED BRICKS. THE INFILLED OPENING HAS A FIRED BRICK SURROUND ABOVE THE BASE COURSE AND A WOOD LINTEL.

ALL OF THESE MATERIALS ARE COVERED WITH A THICK PLASTER OF LIME, SAND, AND CEMENT.

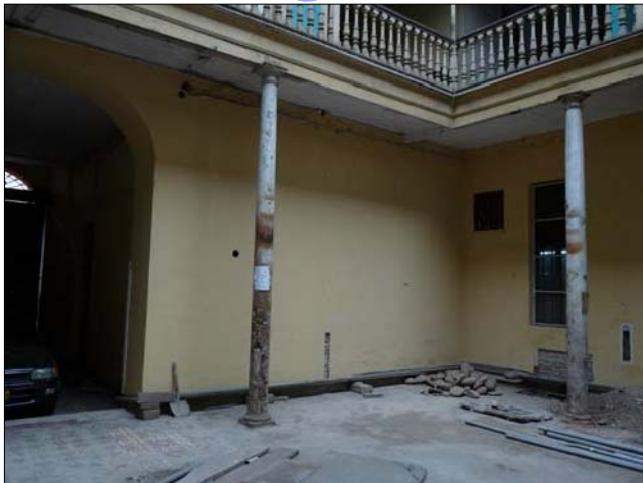
IW-1G

THIS DETAIL IS LOCATED IN THE FIRST PATIO, ON A WALL OPPOSITE THE STAIRCASE. IT SHOWS A BRICK BASE COURSE, SET IN A LIME AND SAND MORTAR, RISING TO A HEIGHT OF 1.06 m ABOVE THE FLOOR LEVEL IN THE PATIO. ABOVE THIS ARE MUD BRICKS SET IN A MUD MORTAR. IT WAS ALSO POSSIBLE TO OBSERVE THE OPPOSITE SIDE OF THIS WALL FROM THE SMALL AREA BELOW THE STAIR LANDING. HERE, ONE COULD OBSERVE THE TOP OF THE FOUNDATION WHICH CONSISTS OF COBBLESTONES SET IN A LIME AND SAND MORTAR, OVER WHICH ARE THREE COURSES OF BRICK (WHICH ARE ALSO SEEN FROM THE OPPOSITE SIDE), AND OVER THIS ARE ADOBE BRICKS SET IN A MUD MORTAR.

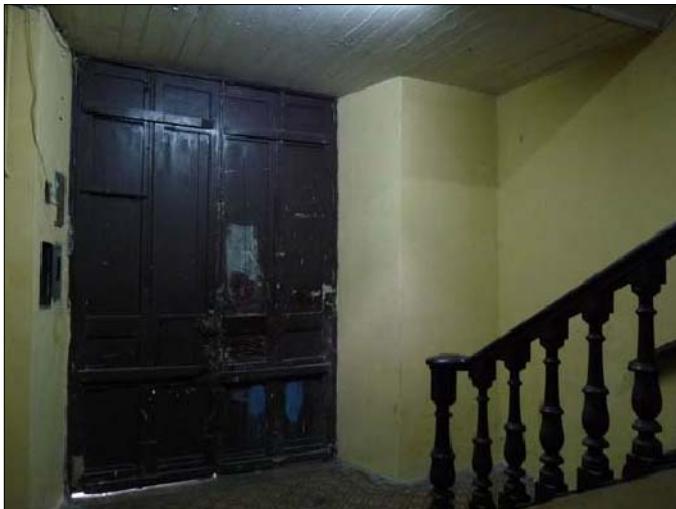
IW- 2

THIS DETAIL IS LOCATED IN THE ENTRY HALL (STAIR HALL 131) THAT PROVIDES ACCESS TO THE RESIDENCES, BETWEEN THE FAÇADE WALL AND THE PERPENDICULAR WALL THAT SEPARATES THE HALL FROM THE ADJACENT SHOP.

ONE CAN OBSERVE THAT THE CHAMFERED DOOR JAMB IS CONSTRUCTED WITH FIRED BRICK FOR THE FULL THICKNESS OF THE WALL. THIS BRICK MASONRY IS FOUND AROUND ALL OF THE OPENINGS ON THE FRONT FAÇADE, AND BETWEEN THE OPENINGS AND BRICK SURROUNDS THERE ARE MUD BRICK WALLS. THE FIRED BRICK IS INTERWOVEN WITH THE MUD BRICKS, WITH INDENTATIONS EVERY THREE TO FOUR COURSES. THE FAÇADE WALL ALSO HAS A BRICK BASE COURSE RISING TO A HEIGHT OF 0.70 - 0.80 m, AS MEASURED FROM THE FLOOR LEVEL IN THE HALL. THE MUD BRICK FAÇADE AND LATERAL WALLS ARE CONNECTED BY INTERWOVEN BRICKS.

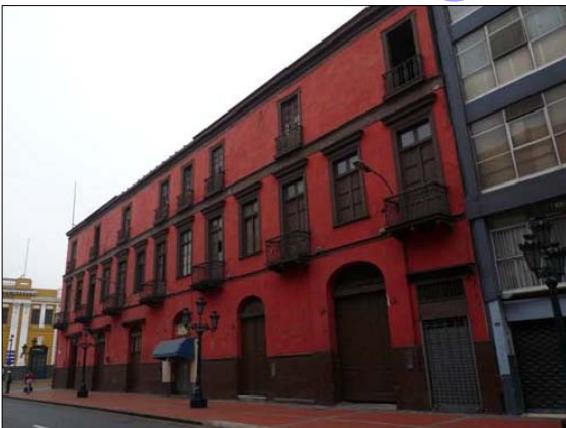
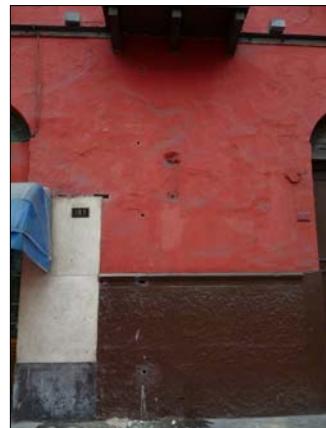
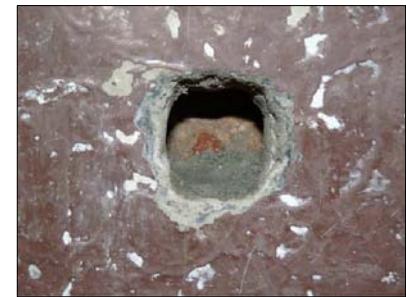
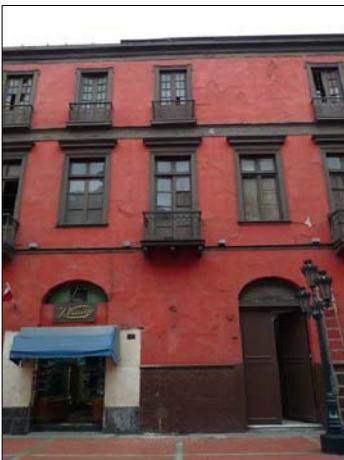
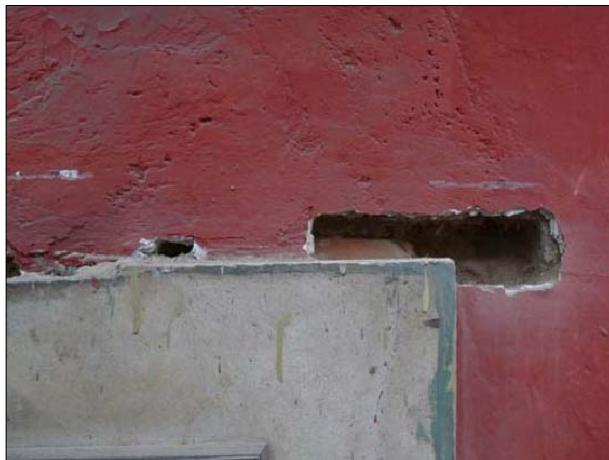
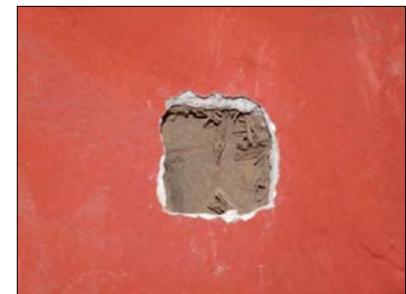
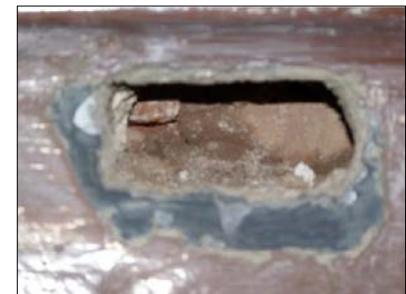
## IW-3

THESE OPENINGS ARE LOCATED ON THE FAÇADE WALL, NEXT TO THE ENTRANCE TO SHOE STORE. THE OPENINGS SHOW THAT THE BRICK BASE COURSE RISES TO A HEIGHT OF 1.00 m ABOVE THE SIDEWALK. BRICK MASONRY IS ALSO USED FOR THE SHOP ENTRY SURROUND. THE WIDTH OF THE FIRED BRICK JAMB IS 0.96 m, AND THE MASONRY CONSTRUCTION EXTENDS ACROSS THE FULL THICKNESS OF THE WALL. ABOVE THE FIRED BRICK BASE COURSE IS A MUD BRICK WALL CONSTRUCTION, EXTENDING TO THE UNDERSIDE OF THE SECOND FLOOR. THE MUD BRICKS ARE INTERWOVEN WITH THE FIRED BRICK SURROUNDS AT THE OPENINGS.

A THICK LIME AND SAND PLASTER INTEGRATES THE DIFFERENT MATERIALS.

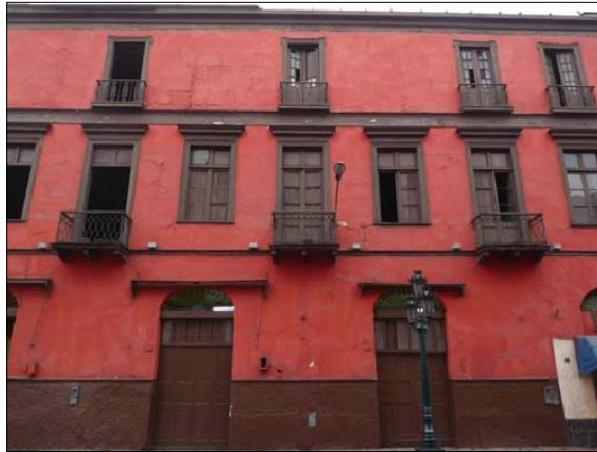
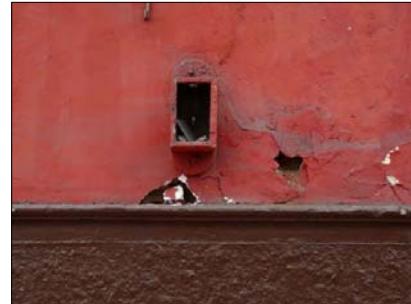
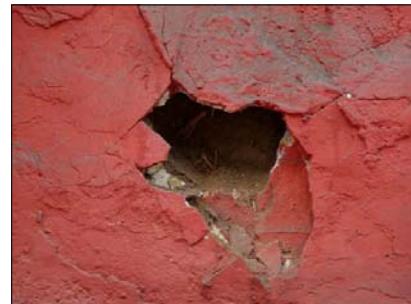
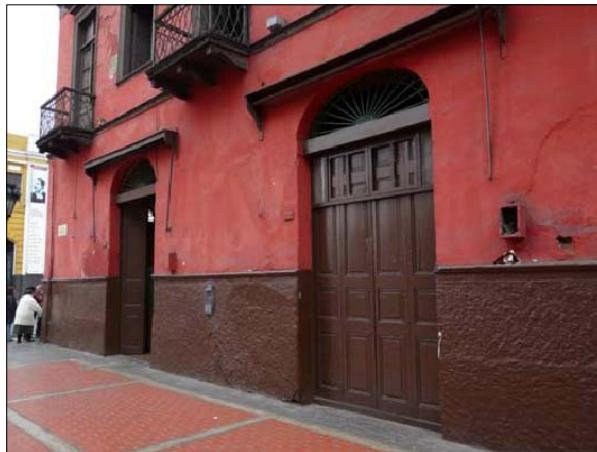
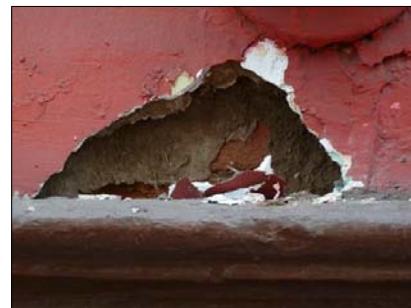
IW-4

THE CONSTRUCTION OBSERVED THROUGH THIS PROSPECTION IS THE SAME AS THAT DESCRIBED FOR PROSPECTION IW-3.

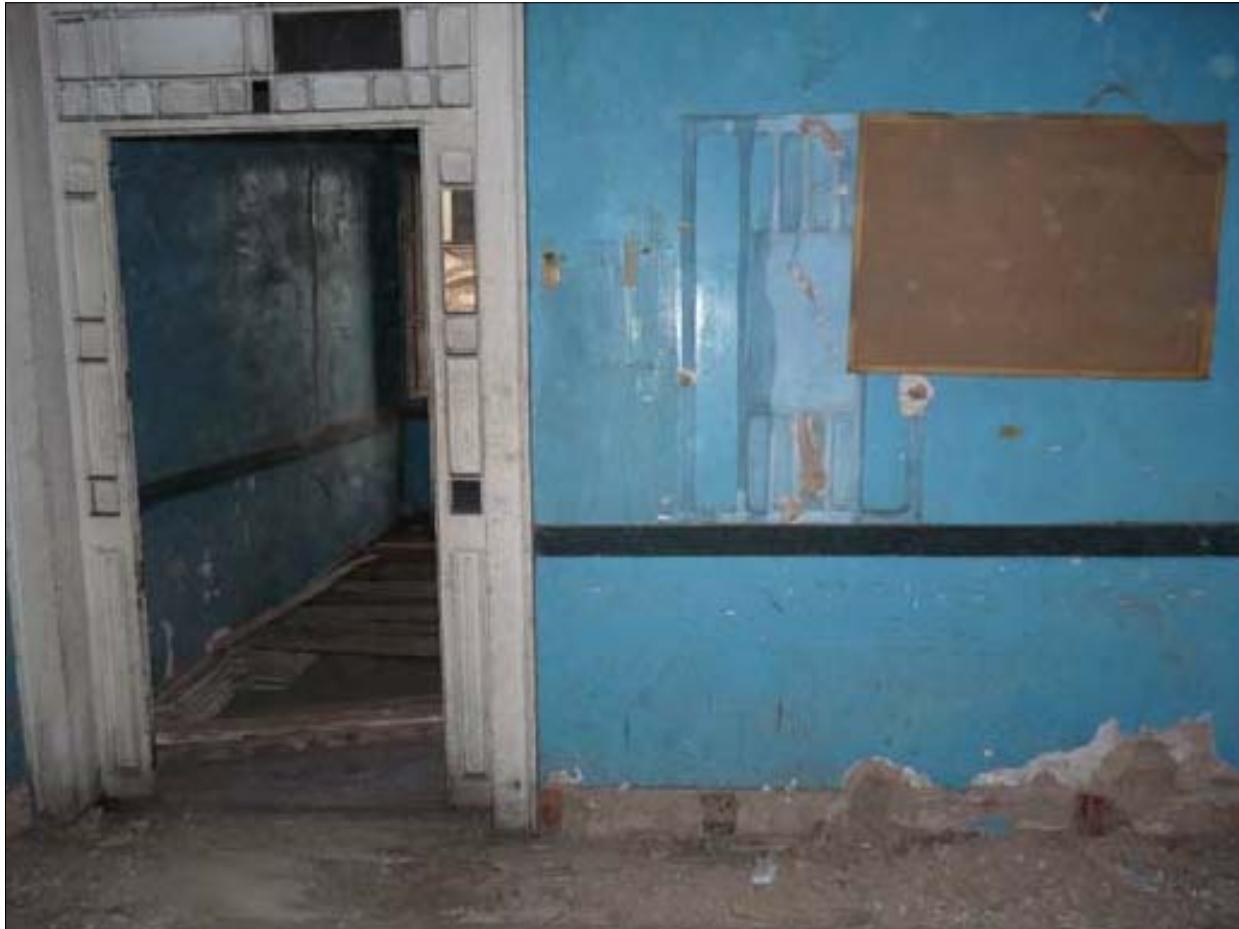
IIW-1

THIS OPENING IS LOCATED ON THE SECOND FLOOR, IN THE CORNER ROOM, ABOVE BAR CORDANO.

THE SECOND FLOOR CONSTRUCTION (FROM BOTTOM TO TOP) IS AS FOLLOWS:

A FALSE CEILING, CONSTRUCTED OF WOOD BOARDS, WHICH IS A FEATURE OF BAR CORDANO. THIS CEILING IS NAILED TO TWO LARGE WOOD BEAMS THAT SPAN THE DEPTH OF THE BAR. THE WOOD BEAMS MEASURE APPROXIMATELY  $0.26 \times 0.30$  m, AND ONE END OF THE BEAMS RESTS ON THE MUD BRICKS AT THE FRONT FAÇADE AND THE OTHER END IS SUPPORTED BY TRANSVERSE BEAMS. THE REMOVAL OF AN ADOBE WALL BETWEEN AREAS 127 AND 128 OF BAR CORDANO, FOR THE PURPOSES OF OPENING UP THE BAR'S FLOOR AREA, LED TO THE SOLUTION OF TRANSVERSE BEAMS SUPPORTING BEAMS. FLOOR JOISTS SIT ON TOP OF THE TWO BEAMS; AND THESE JOISTS RUN PERPENDICULARLY TO THE BEAMS. THE JOIST ENDS REST ON ADOBE WALLS: THE LATERAL FAÇADE WALL AND THE PARALLEL WALL. THE SPACE BETWEEN THE JOIST ENDS IS FILLED WITH MUD BRICKS. OVER THE JOISTS IS WOOD DECKING, AND WOOD SLEEPERS SIT ON TOP OF THE DECKING. THE SPACE BETWEEN THE SLEEPERS IS FILLED WITH A MORTAR OF EARTH AND LIME. ANOTHER LAYER OF WOOD DECKING, WHICH FORMS THE FINISH FLOOR OF THE ROOM, IS NAILED TO THE SLEEPERS.

BY EXTENDING THE OPENING TO THE QUINCHA WALL CONSTRUCTION, THE FOLLOWING STRUCTURE WAS OBSERVED:

AT THE TOP OF THE ADOBE WALL, THERE IS A  $0.12 \times 0.10$  m SILL PLATE, WHICH SERVES AS THE BASE OF THE QUINCHA FRAME. ABOVE THIS ARE WOOD POSTS, CONNECTED WITH MORTISE-AND-TENON JOINTS. THE BOTTOM PART OF THE QUINCHA FRAME IS FILLED ("CITARA") WITH DIAGONAL WOOD BRACES, WITH MUD BRICKS IN THE SPACES BETWEEN THE DIAGONALS. AT THE TOP OF THE BRICKS, THERE IS NOT A HORIZONTAL WOOD PLATE TO RECEIVE THE ENDS OF THE VERTICAL CANES ABOVE. SUCH A PLATE ONLY OCCURS AT THE WINDOW SILLS.

THE VERTICAL CANES (A TYPE OF CANE WITH A FILLED CENTER, CALLED "CAÑA BRAVA") EXTEND THE FULL HEIGHT OF THE WALL FRAME AND ARE WOVEN THROUGH THREE HORIZONTAL CANES. THESE HORIZONTAL CANES PASS THROUGH HOLES IN THE WOOD POSTS. AT THE TOP OF THE FRAME, THERE ARE FOUR HORIZONTALS OF THIS TYPE.

AT THE HIGHEST PART OF THE FRAME THERE IS A WOOD BEAM, CALLED A "CARRERA" OR TOP PLATE. THE TOP OF THE WOOD POSTS ARE CONNECTED TO THIS TOP PLATE WITH MORTISE-AND-TENON JOINTS. ABOVE THE TOP PLATE IS ANOTHER PLATE, CALLED THE "VIGA DE AMARRE" OR CAP PLATE.

AT THE CORNERS, WHERE THE FAÇADE WALL AND PERPENDICULAR WALL SEPARATING THE ROOMS CONVERGE, THE TOP PLATES OF THE TWO FRAMES ARE CONNECTED WITH HALF-LAP JOINTS.

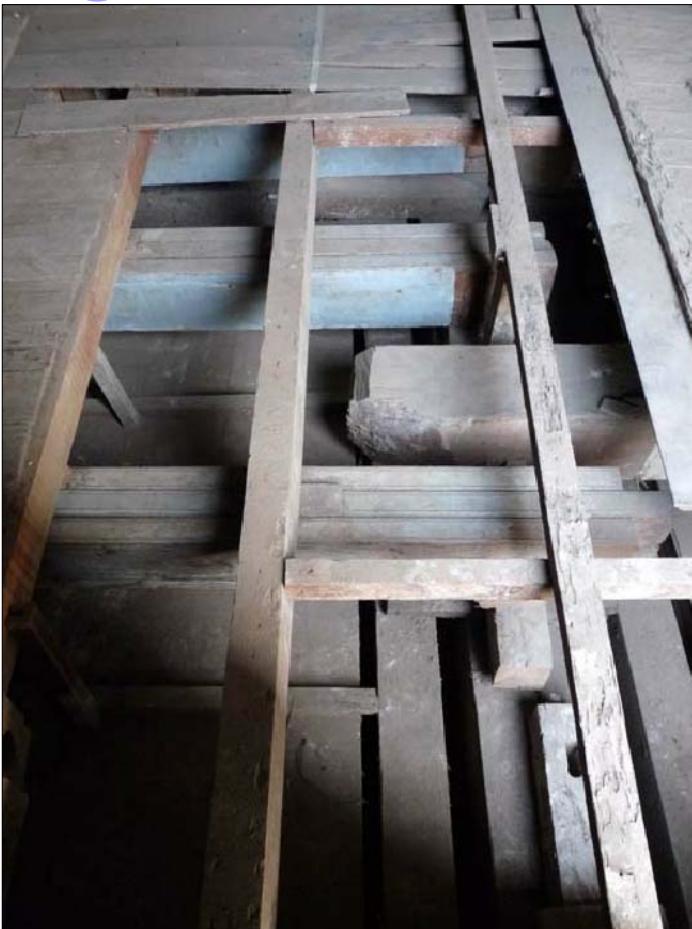
IIS-1 and IIW-2

THESE TWO PROSPECTIONS ARE LOCATED IN THE SAME ROOM. THEY ALLOW US TO OBSERVE THE IMPORTANT LOCATION WHERE THE VARIOUS FLOOR BEAMS MEET.

THE SECOND FLOOR STRUCTURE IS AS FOLLOWS:

FROM BAR CORDANO, ON THE FIRST FLOOR BELOW, ONE CAN SEE A FINISHED CEILING MADE OF WOOD BOARDS, WHICH ALSO INCLUDES A GIRDER RUNNING THROUGH THE CENTER OF THE BAR AREA. THIS "GIRDER" IS ACTUALLY CONSTRUCTED OF FOUR BEAMS THAT HAVE BEEN CLAD WITH WOOD BOARDS TO GIVE THE APPEARANCE OF BEING ONE. THE ENDS OF THIS GIRDER ARE EMBEDDED IN THE LATERAL FAÇADE WALL AT ONE SIDE AND, AT THE OTHER SIDE, THE INTERIOR ADOBE WALL SEPARATING THE MAIN BAR AREA FROM THE PRIVATE DINING ROOMS. THIS GIRDER TOOK THE PLACE OF AN EARLIER MUD BRICK WALL THAT WAS REMOVED, WITH THE POSSIBLE PURPOSE OF JOINING TWO SMALL SHOPS / ROOMS TO CREATE ONE LARGER ROOM.

ONE CAN SEE THAT THIS GIRDER SUPPORTS OTHER MAJOR BEAMS THAT RUN LONGITUDINAL TO THE ROOM. SOME OF THESE BEAMS ARE MADE OF REUSED MATERIAL FROM THE BUILDING - THREE WOOD JOISTS GROUPED TOGETHER TO FORM ONE BEAM, WITH WOOD BLOCKING TO LEVEL THEM. IT APPEARS THAT THESE CHANGES WERE MADE NOT THAT LONG AGO. OVER THESE JOISTS / BEAMS IS WOOD DECKING.

AS THE SECOND FLOOR ROOMS ARE SMALLER THAN THOSE ON THE FIRST FLOOR, THE WOOD-FRAMED QUINCHA WALL AT THE SECOND FLOOR DOES NOT ALIGN WITH A WALL BELOW. AS A RESULT, ONLY THE WOOD DECKING SUPPORTS THE SILL PLATE AT THE BOTTOM OF THE WALL FRAME. THIS SILL PLATE IS CONNECTED TO THE FRAME POSTS THROUGH MORTISE-AND-TENON JOINTS. ONE CAN OBSERVE A DEPRESSION IN THE DECKING, AND THUS AN UNEVENNESS IN THE FLOOR LEVEL OF THIS ROOM. OVER THE DECKING, THERE ARE WOOD SLEEPERS SPACED AT 0.40 m, AND THE SPACE BETWEEN THESE SLEEPERS IS FILLED WITH A MORTAR OF EARTH AND LIME. ANOTHER LAYER OF WOOD DECKING, WHICH FORMS THE FINISH FLOOR OF THE ROOM, IS NAILED TO THE SLEEPERS. THE UNEVEN FLOOR LEVEL, CAUSED BY THE INABILITY OF THE DECKING TO SUPPORT THE WEIGHT OF THE QUINCHA WALL, HAS BEEN PARTIALLY CORRECTED THROUGH WOOD BLOCKING, WHICH RETURNED THE SLEEPERS TO LEVEL AND ALLOWED THE DECKING TO BE LEVEL AGAIN.

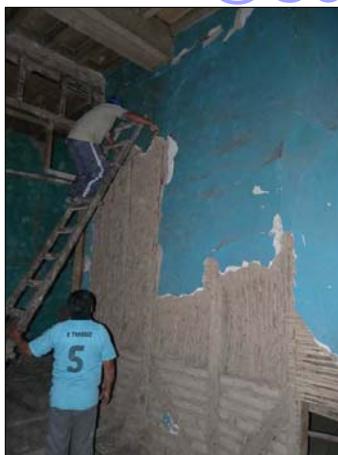
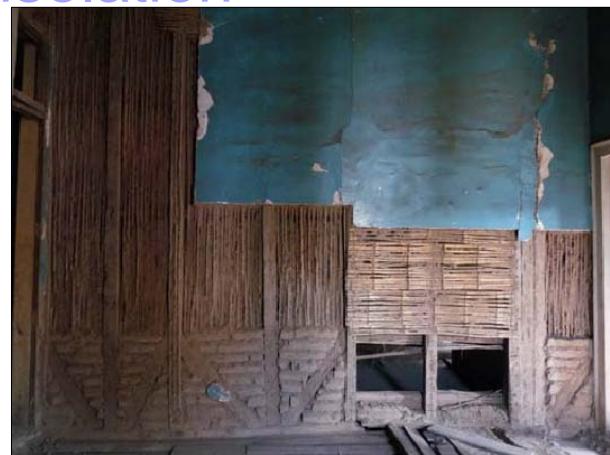
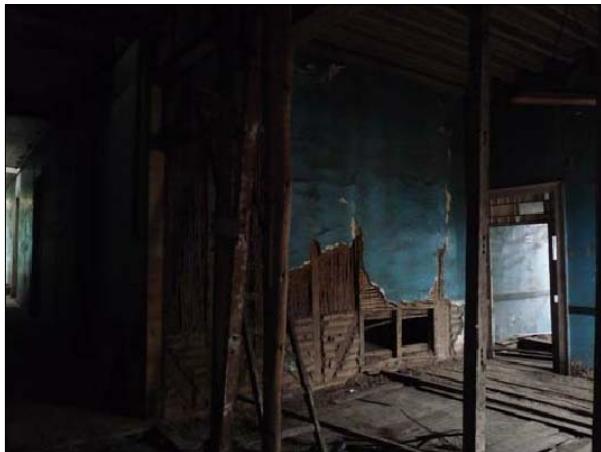
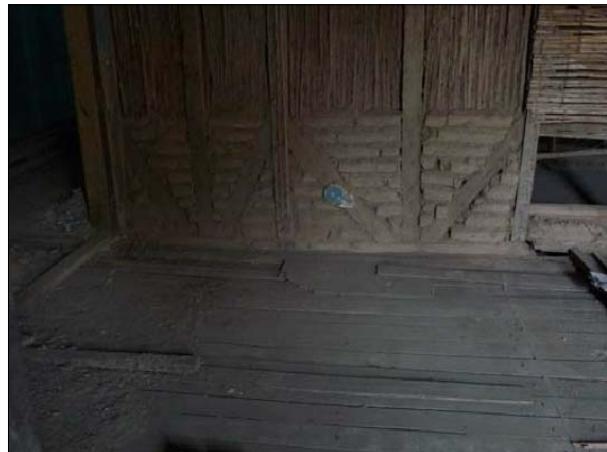
## IIS-2

THIS OPENING IS LOCATED IN A ROOM ABOVE BAR CORDANO.

ONE CAN OBSERVE THE INTERIOR QUINCHA WALL THAT SEPARATES TWO ROOMS. THE STRUCTURE IS ALMOST IDENTICAL TO THAT OBSERVED THROUGH PROSPECTION IIW-1. THE ONLY DIFFERENCE IS THAT THIS QUINCHA WALL IS SUPPORTED BY A CORRESPONDING WALL ON THE FIRST FLOOR, THE WALL FRAME SITS ON JOISTS THAT ARE SUPPORTED BY BEAMS. THESE BEAMS ARE SUPPORTED BY OTHER BEAMS THAT WERE INSTALLED TO TAKE THE PLACE OF A WALL THAT WAS REMOVED IN THE BAR CORDANO SPACE AT THE FIRST FLOOR.

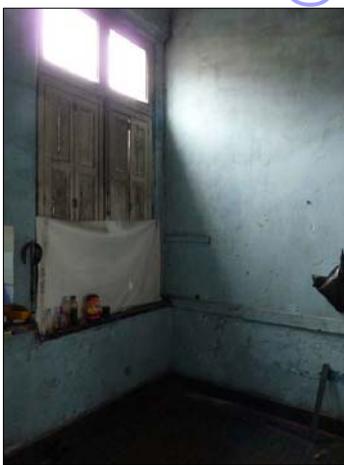
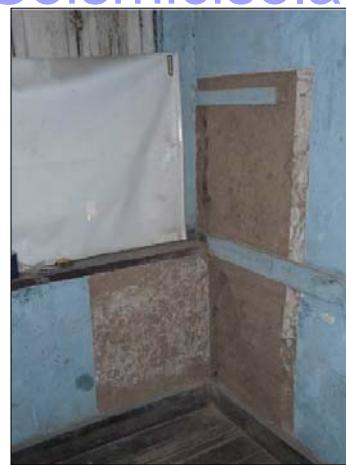
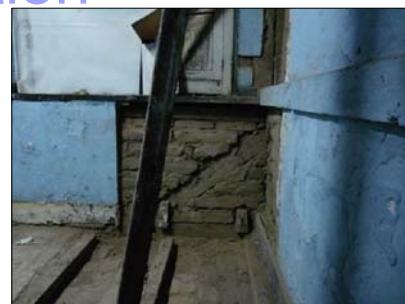
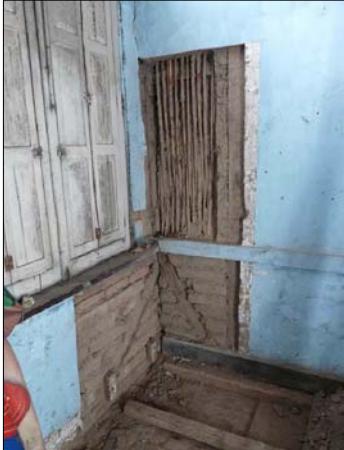
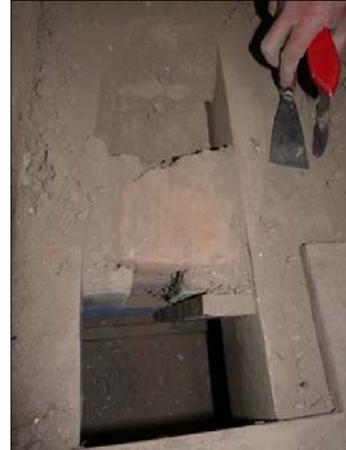
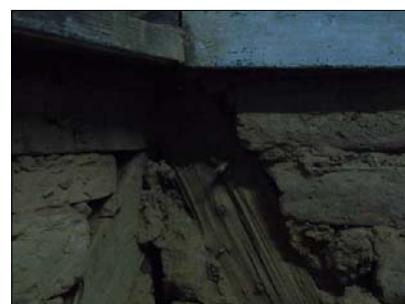
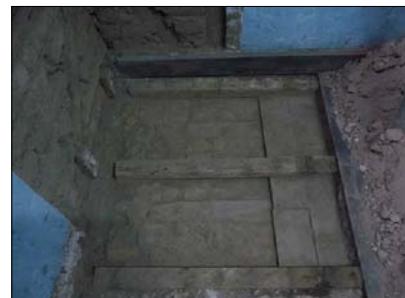
IIW-3

BY EXTENDING THE OPENING TO THE QUINCHA WALL CONSTRUCTION, THE FOLLOWING STRUCTURE WAS OBSERVED:

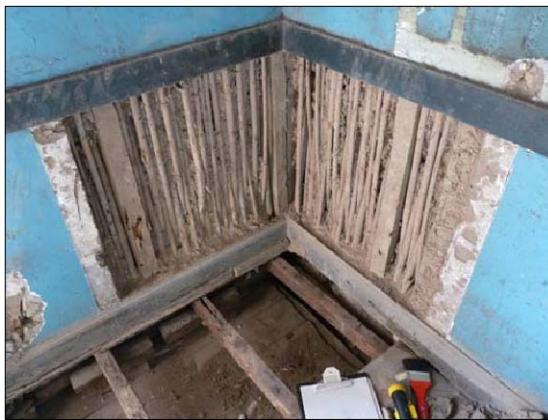
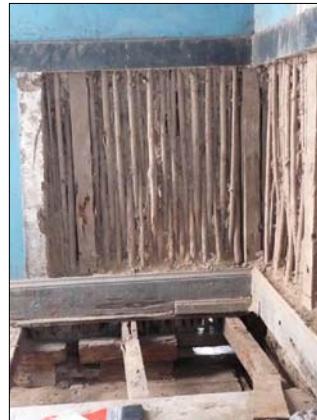
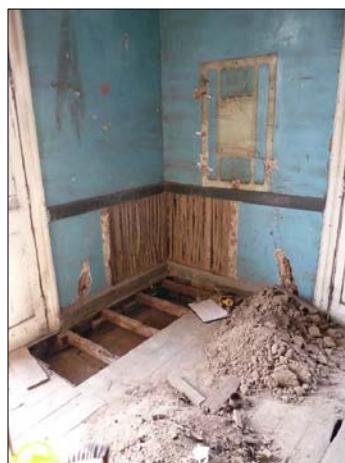
IIIS-1

THIS OPENING IS LOCATED IN A THIRD FLOOR ROOM THAT FORMS THE CORNER OF THE BUILDING.

OVER THE CAP PLATE AT THE SECOND FLOOR QUINCHA WALL, THERE IS A  $0.14 \times 0.10$  m JOIST. PARALLEL TO THIS ARE ALL THE OTHER JOISTS THAT CAN BE OBSERVED AT THE CEILING OF THE SECOND FLOOR BELOW. THE SPACING BETWEEN THE JOISTS IS  $0.40$  m.

OVER THE TOP PLATE AT THE WALL FRAMES, THERE ARE JOISTS SPACED AT  $0.40$  m. OVER THE JOISTS THERE IS WOOD DECKING. OVER THE DECKING IS A LAYER OF MUD, THEN A SECOND LAYER OF MUD AND STRAW, FOLLOWED BY A THIRD LAYER OF MUD, AND FINALLY A LAYER OF LOOSE SOIL (APPARENTLY CARRIED BY THE WIND OVER A LONG PERIOD OF TIME).

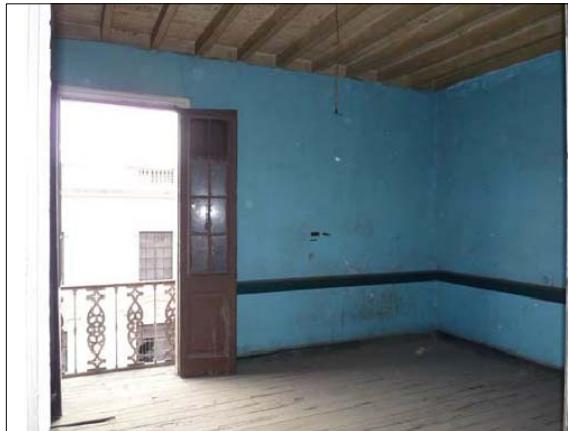
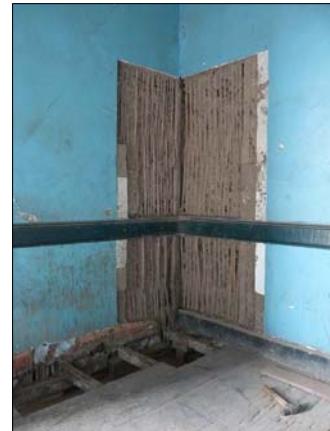
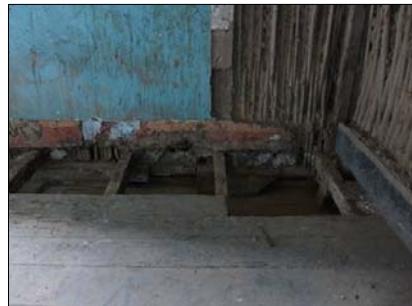
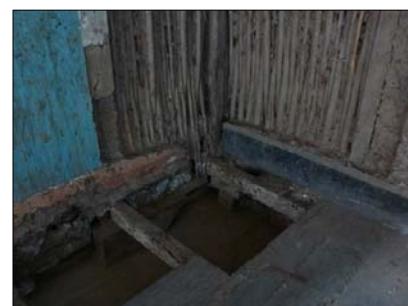
IIIS-2

THIS OPENING IS LOCATED IN A THIRD FLOOR ROOM ABOVE THE ENTRY HALL.

OVER THE CAP PLATE AT THE SECOND FLOOR QUINCHA WALL, THERE IS A  $0.14 \times 0.10$  m JOIST. PARALLEL TO THIS ARE ALL THE OTHER JOISTS THAT CAN BE OBSERVED AT THE CEILING OF THE SECOND FLOOR BELOW. THE SPACING BETWEEN THE JOISTS IS  $0.40$  m.

OVER THE TOP PLATE AT THE WALL FRAMES, THERE ARE JOISTS SPACED AT  $0.40$  m. OVER THE JOISTS THERE IS WOOD DECKING, OVER THE DECKING IS A LAYER OF MUD, THEN A SECOND LAYER OF MUD AND STRAW, FOLLOWED BY A THIRD LAYER OF MUD, AND FINALLY A LAYER OF LOOSE SOIL (APPARENTLY CARRIED BY THE WIND OVER A LONG PERIOD OF TIME).

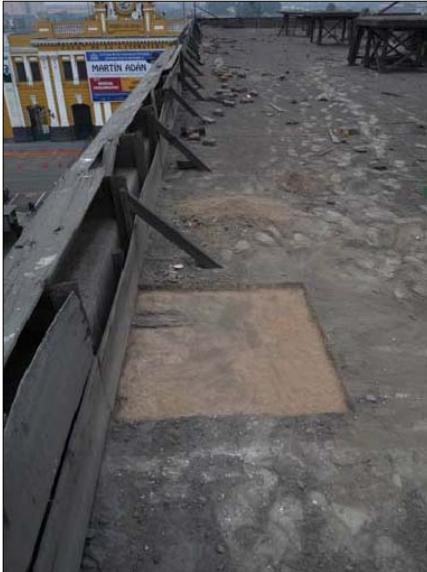
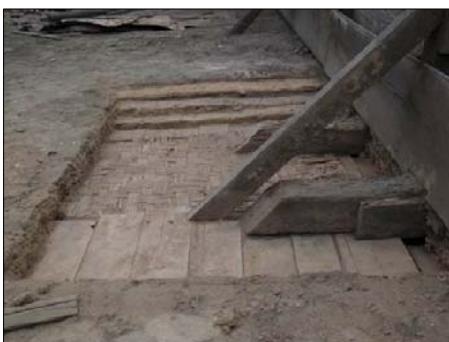
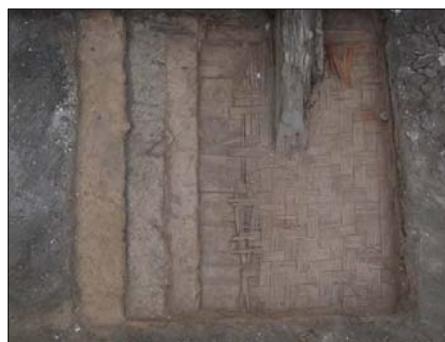
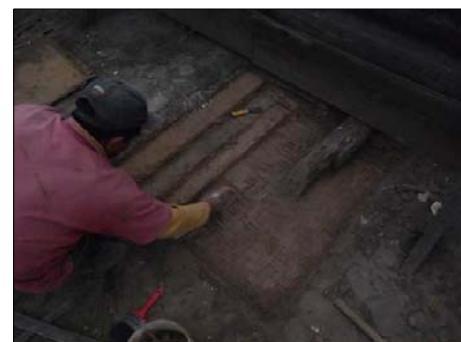
IVR-1

OVER THE TOP PLATE AT THE WALL FRAMES AT THE THIRD LEVEL BELOW, THERE ARE JOISTS SPACED AT 0.40 m. OVER THE JOISTS THERE IS WOOD DECKING. OVER THE DECKING IS A LAYER OF MUD, THEN A SECOND LAYER OF MUD AND STRAW, FOLLOWED BY A THIRD LAYER OF MUD, AND FINALLY A LAYER OF LOOSE SOIL (APPARENTLY CARRIED BY THE WIND OVER A LONG PERIOD OF TIME).

THE ENDS OF THE JOISTS PROJECT DEEP INTO THE FAÇADE WALL AND ARE COVERED WITH A WOOD TRIM THAT SERVES AS THE BUILDING CORNICE. THE TOP OF THE CORNICE IS HIGHER THAN THE ROOF LEVEL, THUS FORMING A PARAPET WALL. THIS PARAPET IS SUPPORTED BY VERTICAL WOOD BATTENS, DIAGONAL WOOD BATTENS ACTING AS STRUTS, AND LARGE WOOD BLOCKS, ALL OF WHICH ARE NAILED TO THE ROOF DECK.
