# Rise to the Occasion

LESSONS FROM THE  
Bingham Canyon  
Manefay Slide

Brad Ross

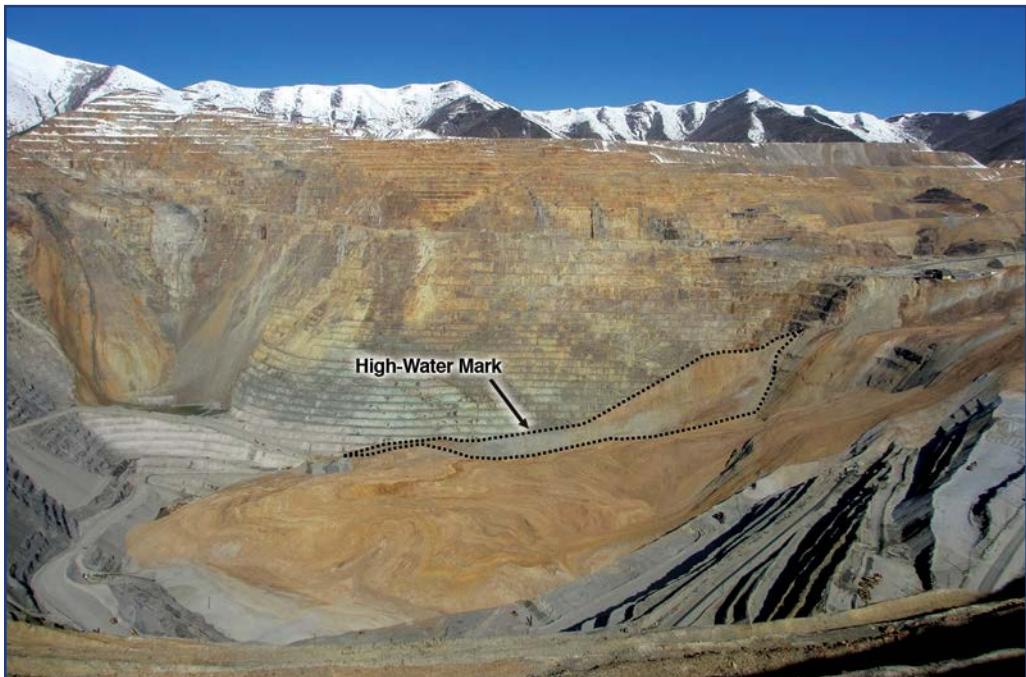
Figure 1.10 • High-Water Mark

Instead of falling straight down the highwall to the bottom of the pit as gravity would dictate, the first failed mass began to slide with such great velocity along the Manefay bed that it became airborne as it hit the adjoining highwall. The mass slammed into the west wall, ricocheted off the wall, then swirled around the pit, flooding the bottom of the pit, and pushed over the top of the Moly Dome toward the south wall of the pit. Debris left a “high water mark” (Figure 1.10) over a half mile long and deposited material at least 300 feet higher than the top of the Moly Dome. The debris from the first failure was primarily in-place rock, which is the white or light-colored material seen on the outer edge of the debris field. The second failed mass followed the same path and direction as the first failed mass. Much of the second slide event was old waste material that had been mined decades earlier. This material had oxidized and turned orange or reddish in color. Thus the top layer of the slide debris is orange. The various geologic layers were spread along the length of the debris flow instead of being jumbled into a single homogeneous mass. The result was a layering and swirling of the colors and textures that stretched from the top of the head scarp to the bottom of the pit. It was almost as if the Manefay had become nature’s three-dimensional canvass that stretched 1½ miles in distance and nearly 3,000 feet in elevation.

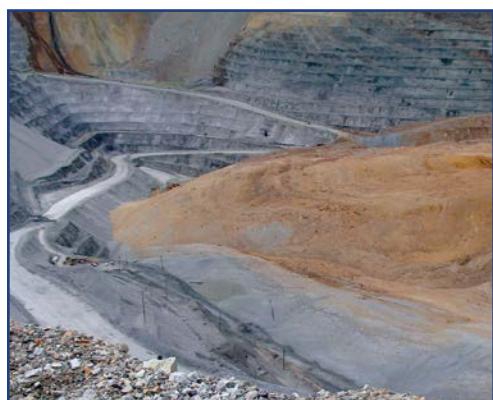
Figure 1.12 • Pit Bottom After the Manefay

The sight of the aftermath was overwhelming. Most of the preparations to return to production quickly and efficiently were now covered by more than 300 feet of Manefay debris. Figure 1.11 shows the pit the day before the slide, and Figure 1.12 exhibits the aftermath. The pictures were taken from approximately the same location on the east side of the pit looking west. The white building and equipment on the lower left side of the photo are the facilities used by the Underground Team to build the drainage galleries to dewater the mine. The Moly Dome is the raised flat area in the middle of Figure 1.11 with the pit bottom located on the lower right side. The Manefay failure came from the right side in Figure 1.12.

The debris covered almost everything in the pit bottom. Most equipment, parts, and supplies in the bottom of the pit were either completely buried and destroyed or severely damaged by the debris. Figure 1.13 shows the first piece of equipment that was pulled from the Manefay debris. This rubber tire dozer was caught on the edge of the slide. Although the cab was not totally engulfed by the debris, the rest of dozer was extensively mangled.

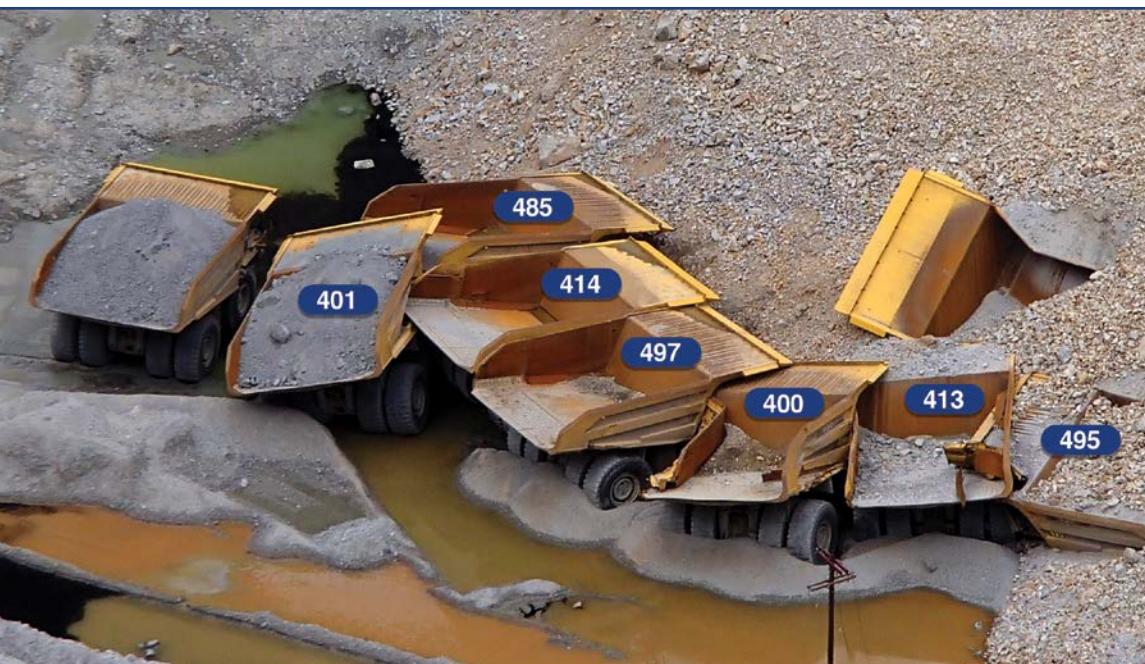
Figure 1.14 • Haul Trucks in Manefay Debris

The only remaining mobile equipment that had been stationed on the Moly Dome was now a pile of eight 320-ton Komatsu haul trucks shoved to the far end of the debris flow (Figure 1.14). Figure 1.15 shows truck 495 after it had been removed from the debris. Parts of the truck that were engulfed in the debris were mangled almost beyond recognition.

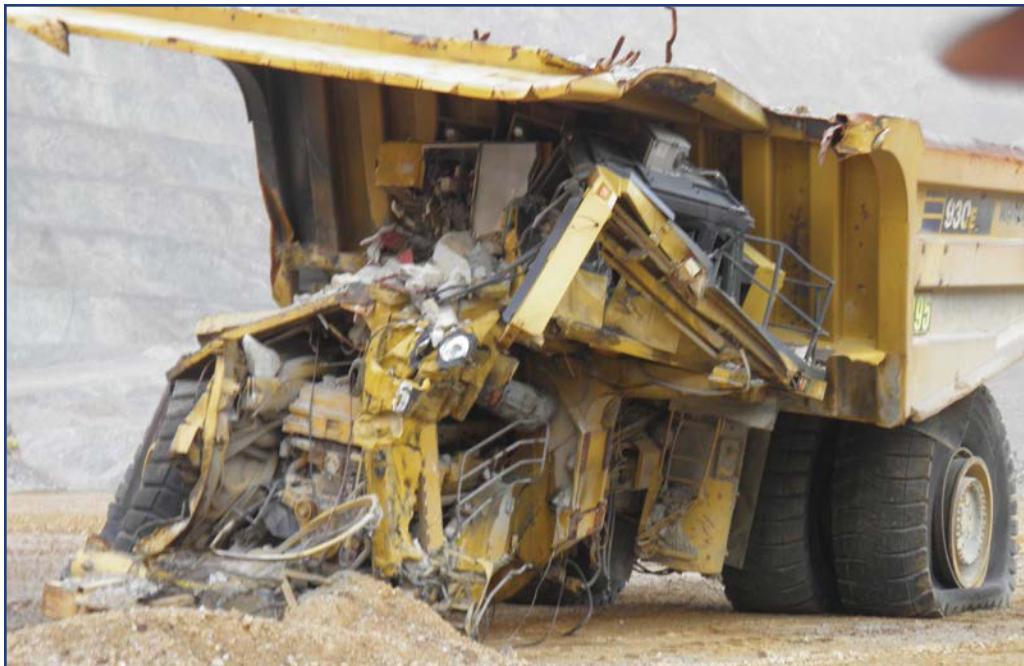
Figure 1.15 • Haul Truck Damage

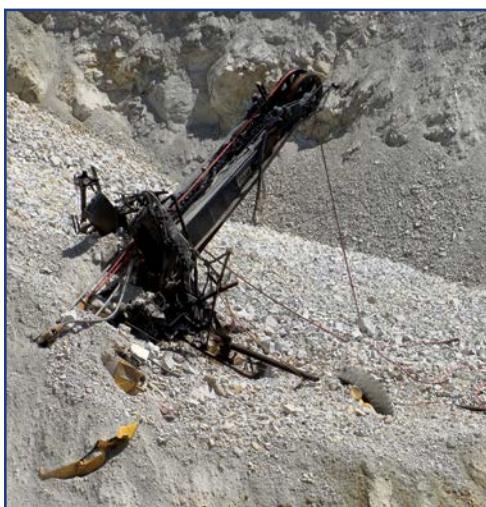
Figure 1.16 • Boom of P&H 4100C Shovel from Two Perspectives

Higher up in the pit, the boom of a P&H 4100C shovel (that the superintendent considered moving) could be seen sticking out of the edge of the debris, as shown in Figure 1.16. The right photo shows a different perspective, with the back of the Bingham Shop at the top. Although the boom looks intact in the photos, some of the metal on the boom is actually remnants of a drill that was also caught up in the debris flow and embedded into the body of the shovel. The debris flow also shoved the shovel, which weighs more than 1,500 tons, much closer to the edge of the highwall.

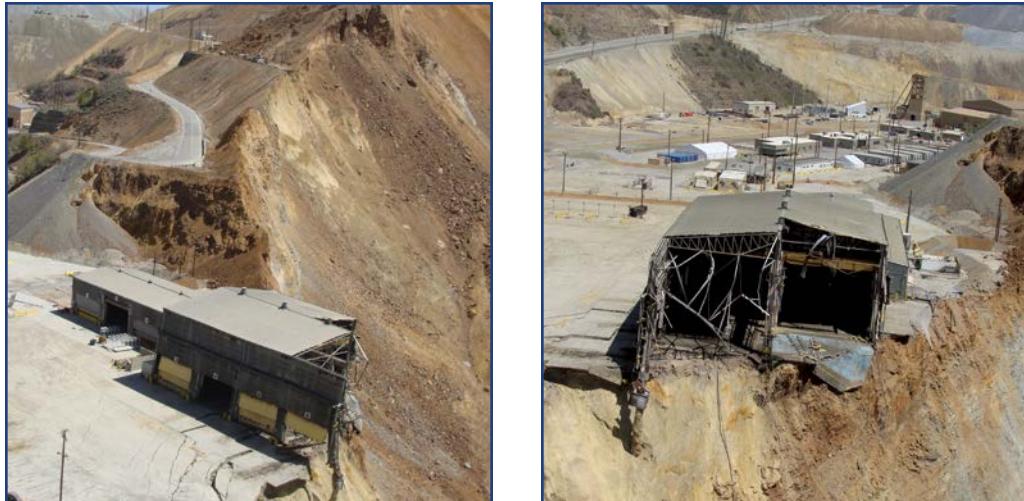
The slide damaged more than the equipment, parts, and supplies at the bottom of the pit. The back portion of the Bingham Shop was destroyed and what was left was sitting precariously on the edge of a scarp, as shown in Figures 1.19 and 1.20. The Bingham shop was not salvageable and would have to be demolished.

Figure 1.19 • Bingham Shop Front (left) and Back (right)

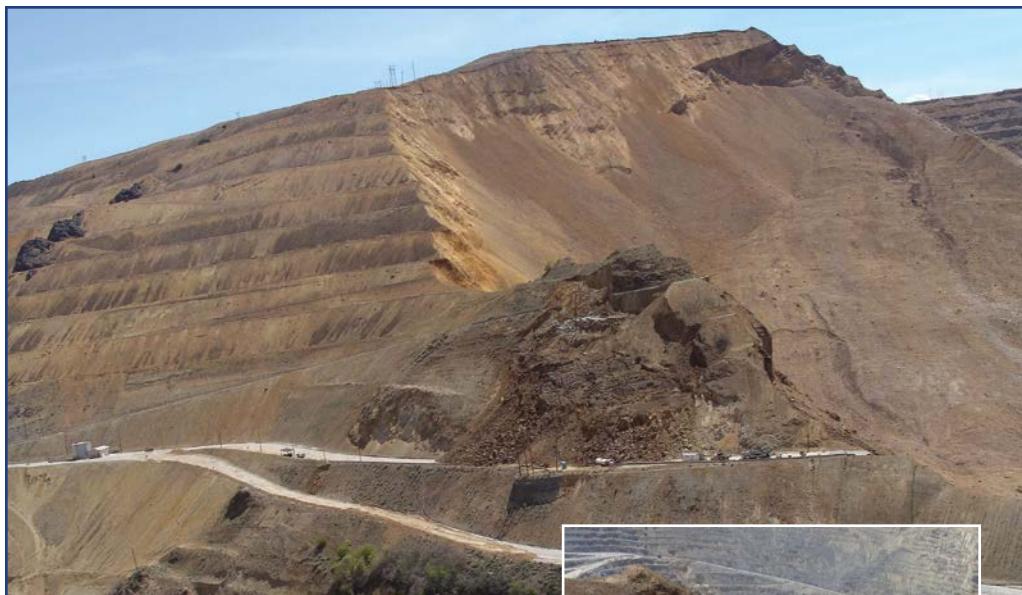
Another remnant of the Manefay was an overly steep piece of rock left in place just above the 6190 Complex that became known as the 6190 knob. Not only was the 6190 knob a steep scarp over the failure zone, it also had a relatively large failure zone on the back side that threatened the contractor's drill and parts of the 6190 Complex. Figure 1.22 shows the proximity of the 6190 knob to the 6190 Complex.

Figure 1.22 • 6190 Knob Overview (left) and Close-up (right)

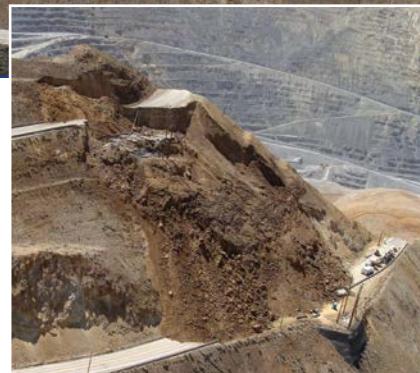
It is not known why or when the secondary failure on the 6190 knob occurred. It could have been in conjunction with the initial Manefay landslide or the second. One theory is that it was a result of the second landslide running into the wall and basically creating the failure on the other side of the 6190 knob. It is also possible that it was a consequence of the rebound effect that created the earthquakes after the second failure. Regardless, it was probably the rubble from this slide area that the IC Team heard after the second slide which created concern that additional slides were possible and the 6190 Complex should be evacuated as soon as possible.

Besides the immediate concern of the IC Team, the slide on the back side of the 6190 knob created questions about the stability of the knob itself and the safety of the 6190 Complex. The 6190 knob would have to be remediated to get the mine back to normal operation.

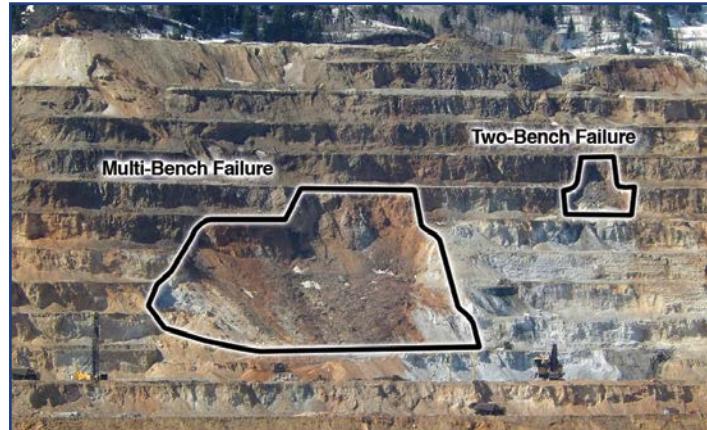
Figure 2.2 • Multi-Bench Highwall Failure

Given the massive size and complexity of the Bingham Canyon Mine, there is a wide variety of geologic conditions and rock types. Some of these conditions include faults, intrusions, and bedding planes that have made the rock or structures weak and unstable in areas. Over the decades, the mine has experienced hundreds of highwall failures, estimated to be anywhere from a few thousand tons up to a few hundred thousand tons. Figure 2.2 shows a multi-bench failure that involves six benches in the south wall of the mine.

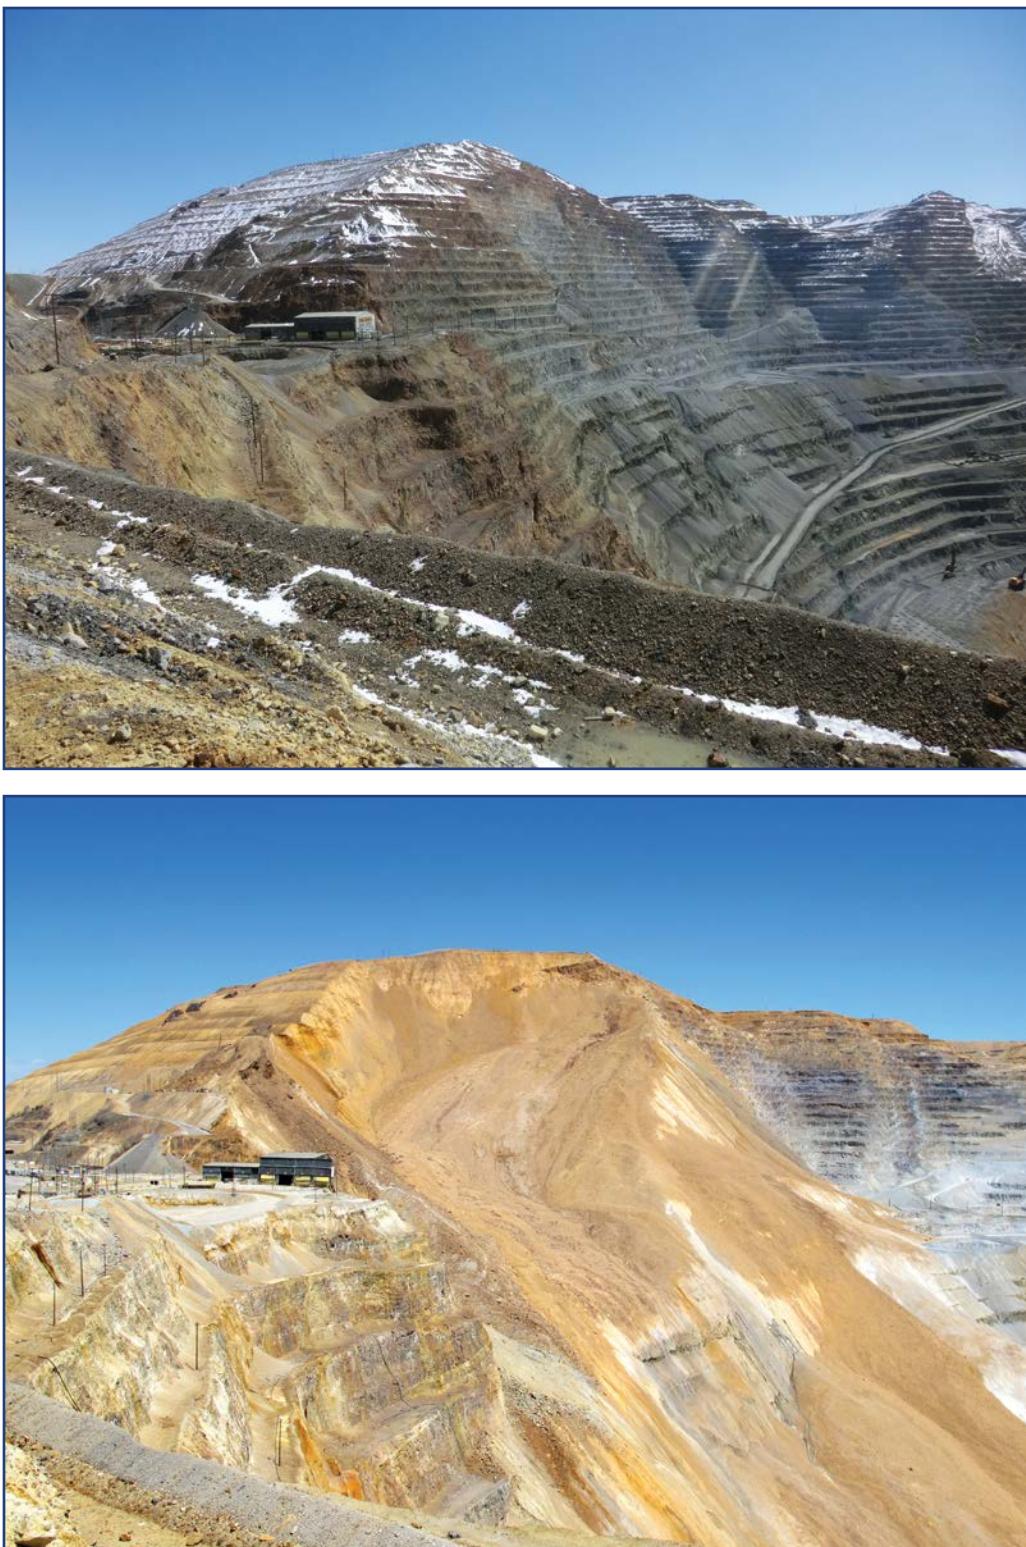
Figure 3.1 • Before and After the Manefay Failure

This chapter and the next detail the amazing recovery of the Bingham Canyon Mine after the Manefay (Figure 3.1). There were many different work streams progressing simultaneously. Each work stream was dependent on the others, and all were critical to the ultimate success of the recovery. The work streams included the Operations group that was able to quickly return to production and achieve rates that exceeded expectations. Another was the remediation work—a task larger than anything that had been done like it before, and one that required new methods, equipment, and processes. Development of new mine plans and budgets were needed because even though the mine was more than 100 years old, the pit had changed overnight and thus the planning had to start anew. Also included was the purchase and commissioning of a large amount of equipment that was required for the remediation work and to replace equipment that had been destroyed. These and many other work streams were critical to the Bingham Canyon Mine being able to quickly and efficiently return to its former production.

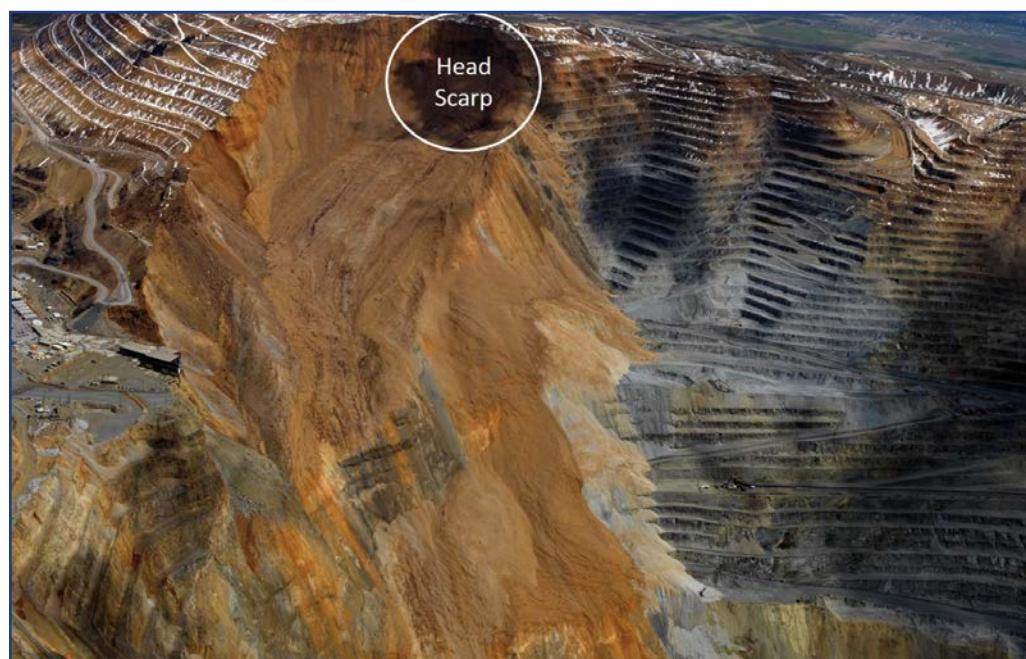
Figure 3.2 • Head Scarp

Although a lot of equipment had been damaged or destroyed, there was adequate loading, hauling, and drilling capacity to at least start production. The crusher, conveyor, and tunnel leading to the mill were intact and operational. Therefore, the basic requirements were available to begin ore production, even though it was not enough to reach and maintain the maximum production capabilities of the downstream facilities. However, to start ore production, several hurdles had to be crossed before production could commence. The first hurdle was that a large mass of material called the head scarp still rested on the Manefay bed far above the ore, and it was unknown how stable the material was or if it would affect the ore operations should it fail. Considering the two slides on the night of the Manefay, no one was willing to take a chance of putting people in an area that could be covered up if the head scarp were to fail unexpectedly. Significant geotechnical studies on the stability of the head scarp and potential run-out areas if it were to fail were required to understand the risks before mining could commence. Figure 3.2 shows the location of the head scarp at the top of the Manefay failure. Coincidentally, the photo shows the head scarp being covered by the shadow of a passing cloud, which is fairly symbolic of the shadow that the head scarp cast on the remediation work for several months until it could be stabilized.

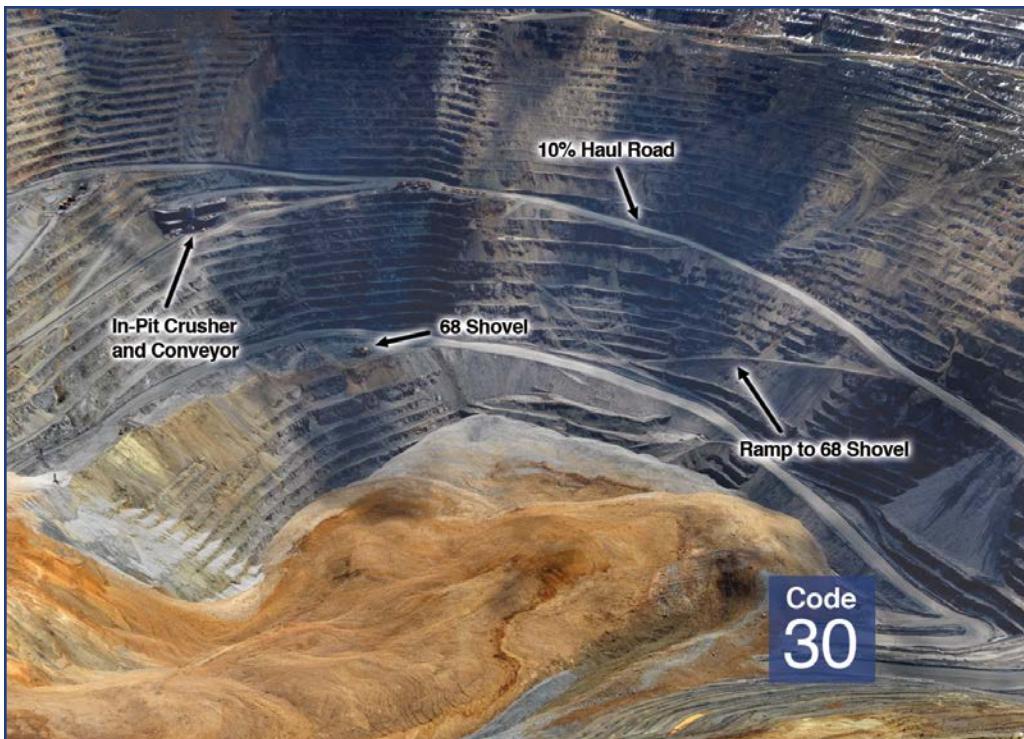
Figure 3.3 • Code 30 Location

The final issue was getting access to the bottom of the pit. Most of the Keystone access road was intact, except for a few hundred feet at the bottom of the ramp that had been covered by the Manefay debris. In addition, there was a section of the haul road at the bottom of the pit, called Code 30, that had been covered by the debris. It would have to be cleared to access the areas of the ore that had not been concealed with rubble. Figure 3.3 shows the location of Code 30 in the bottom of the pit in relationship to the 68 shovel (P&H 2800 shovel, assigned no. 68 by the company).

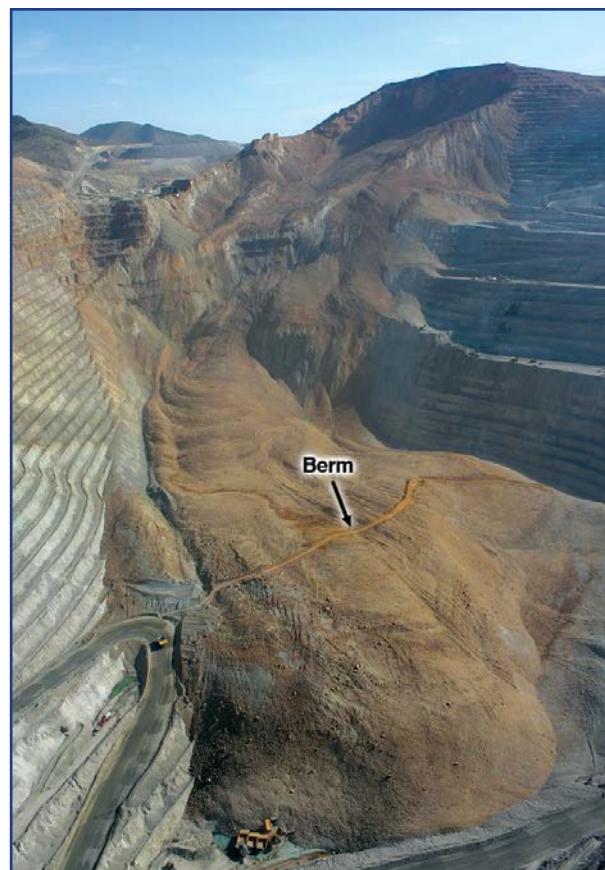
Figure 3.6 • No-Go-Zone Berm

After the manned equipment started working on the Code 30 area, they were able to complete their tasks quickly. By April 26, a plan was submitted to MSHA for a permanent change to the 103(k) Order so that ore mining in the E4 South sector (the portion of the ore that had not been covered up) could commence. As part of the plan, a berm was constructed outside the runout area of the head scarp to ensure that no one could inadvertently enter that area. Above the berm, people were allowed to work as they normally would. Below the berm was the No Go Zone where people were not allowed to enter without approval from MSHA and Kennecott management. Figure 3.6 shows the location of the berm where it crosses the Manefay debris field.

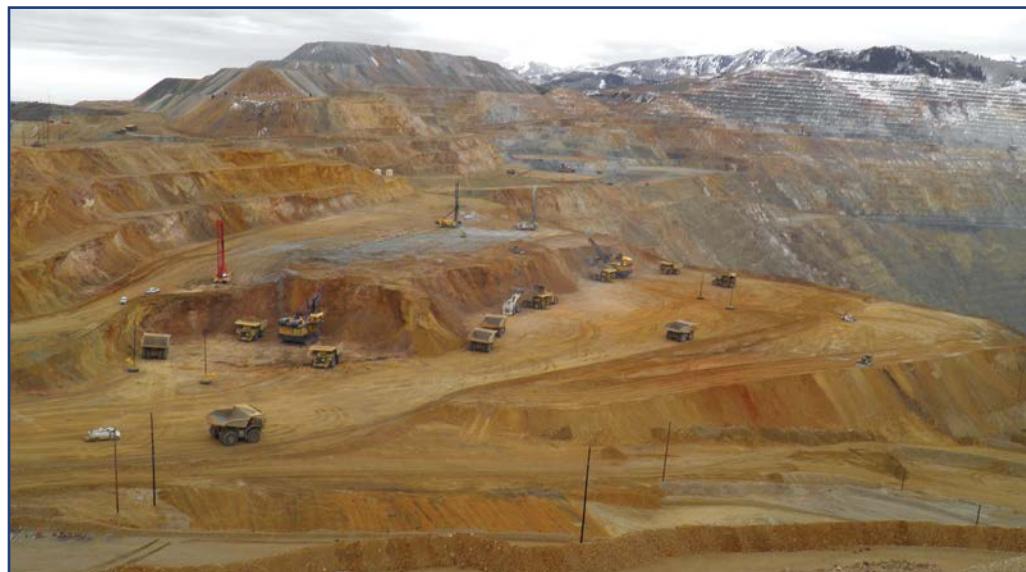
Figure 5.3 • Fortuna Unweighting

At the end of October, the Next Ore Team work was starting to wind down. The 10% haul road had been reestablished, the head scarp and intermediate scarps were completed, and the safety benches above the 10% were cleaned. Work was progressing smoothly and ahead of schedule on cleaning the debris off the E4 ore that was covered up on the north side of the pit and that work would be finished by bottom-of-pit operations before the Thanksgiving goal. At the beginning of November, Matt Lengerich made the decision to move Cody Sutherlin and Don Mallet from the Next Ore Team to manage the Cornerstone overburden mining and Fortuna unweighting. Cody, Don, and the entire Fortuna production team understood the importance of staying ahead of the E5 Mandate Team's schedule—they did not want to be the bottleneck that slowed down production. The challenge with the Fortuna was that it involved a small area with short faces. Operationally it was difficult because the team would have to start a new bench at least once a month. Starting a new bench was much slower than normal operations, so it negatively impacted production rates. Figure 5.3 shows the close proximity of the shovels when mining the Fortuna.

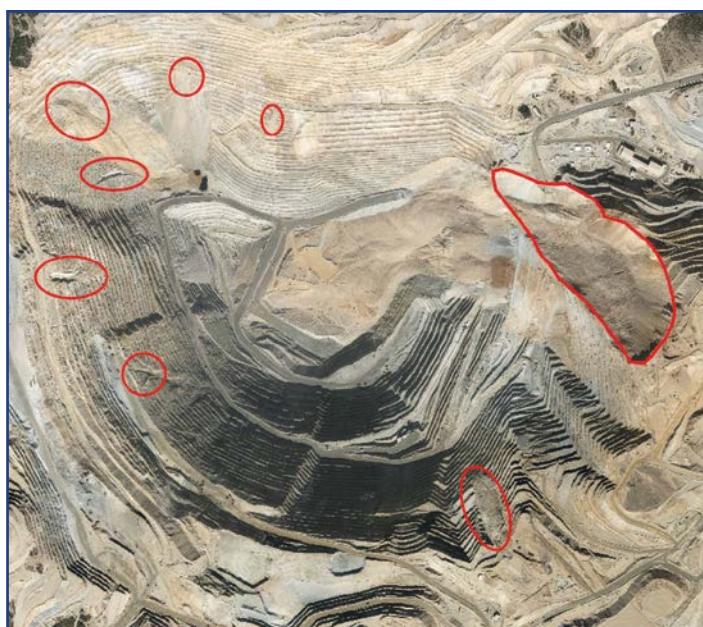
Figure 6.4 • Highwall Failures at Bingham Canyon Mine

With a pit the size of Bingham Canyon, the odds were there would be a few failures that had to be remediated each year. Figure 6.4 shows an overhead plan view of the mine with several highwall failures circled in red. The Manefay failure on the right side of the photo was more than 100 times the size (in tons) than any of the other slides in the photo.

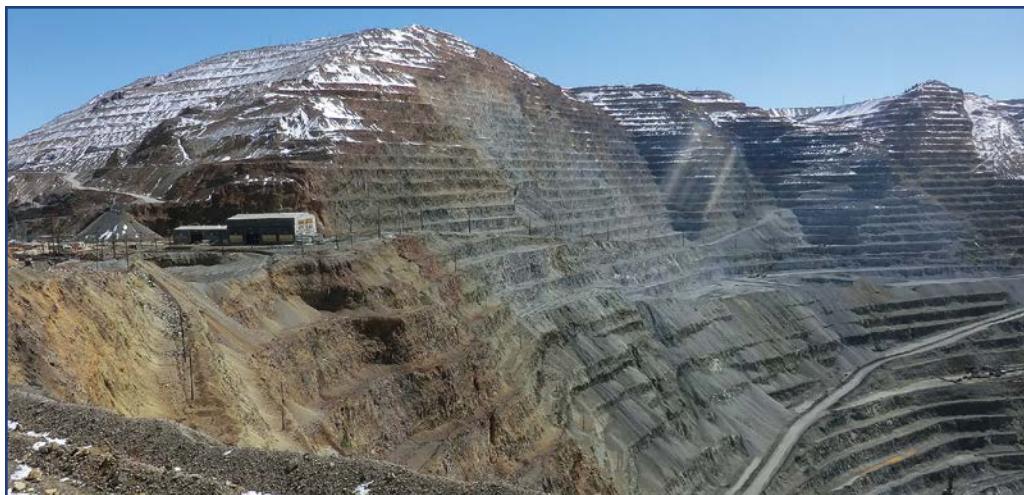
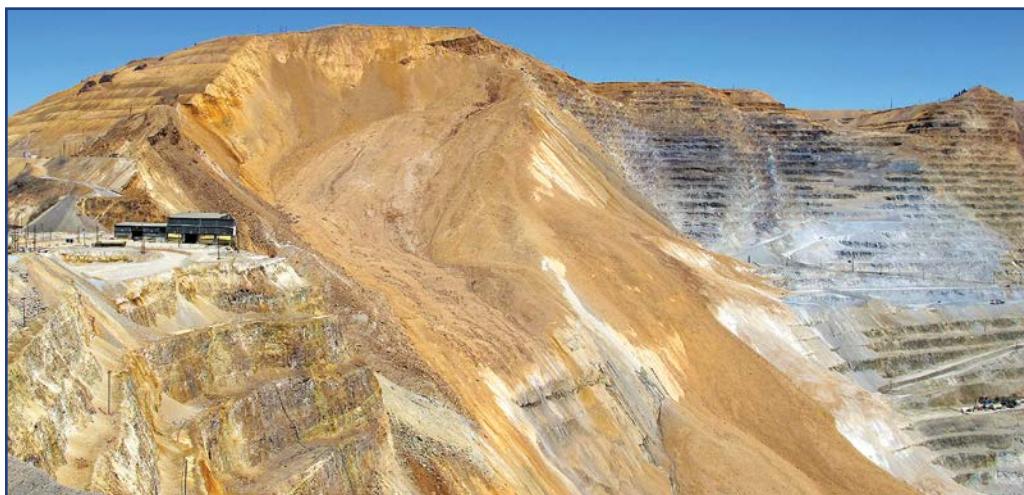
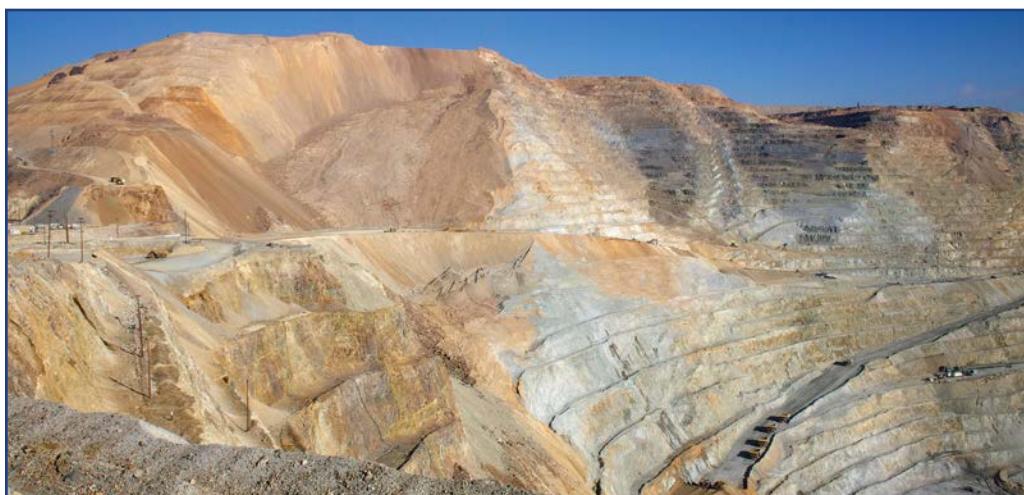
Figure 7.13 • Manefay Progression

In the nine months from February 2013 when it was determined that the Manefay would fail, to November 13 when the Next Ore was delivered, the Bingham Canyon Mine went through a tremendous transformation—both physically and culturally. The physical changes were evident and can be seen in Figure 7.13, which shows the wall of the Manefay before April 10, just after the failure on April 11, and finally after the next ore was delivered on November 13. The impact to the mine was remarkable.

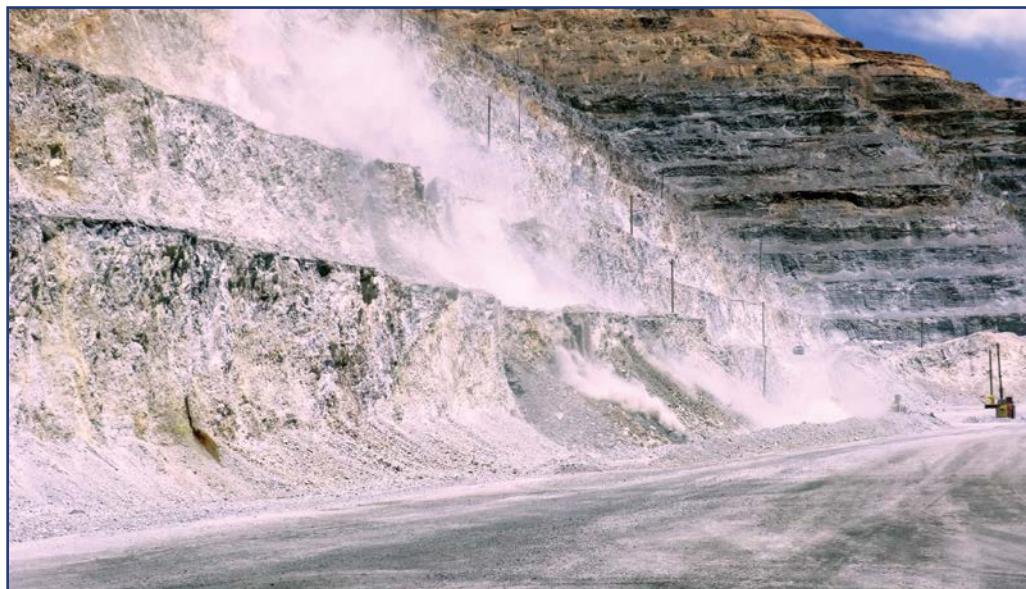
Figure A.1 • Dust Cloud

- Falling rocks,
- Cracking in highwalls and benches,
- Dust clouds from rolling rock (Figure A.1), and
- Newly fallen rock on benches (Figure A.2).

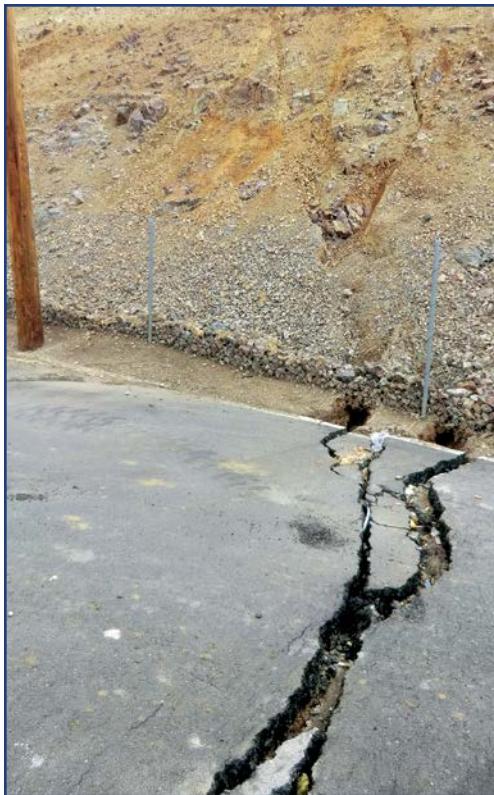
Figure A.5 Surface Crack

Before the Manefay failed, several large cracks were observed behind the highwall in the area of the Visitors Center that overlooked the Bingham pit. These cracks were mapped with their location, orientation, and size. The maps and radar data were critical to confirm the movement of the Manefay mass. Some of the mapped cracks were

monitored with extensometers that continuously monitor the width of the cracks and detect whether they were moving or growing, an indication that a slope is shifting. Figure A.5 shows an example of a crack on the edge of a highwall of the Bingham Canyon Mine.
