FORENSIC ENGINEERING

ENVIRONMENTAL CASE HISTORIES FOR CIVIL ENGINEERS AND GEOLOGISTS

Gerard Shuirman

James E. Slosson

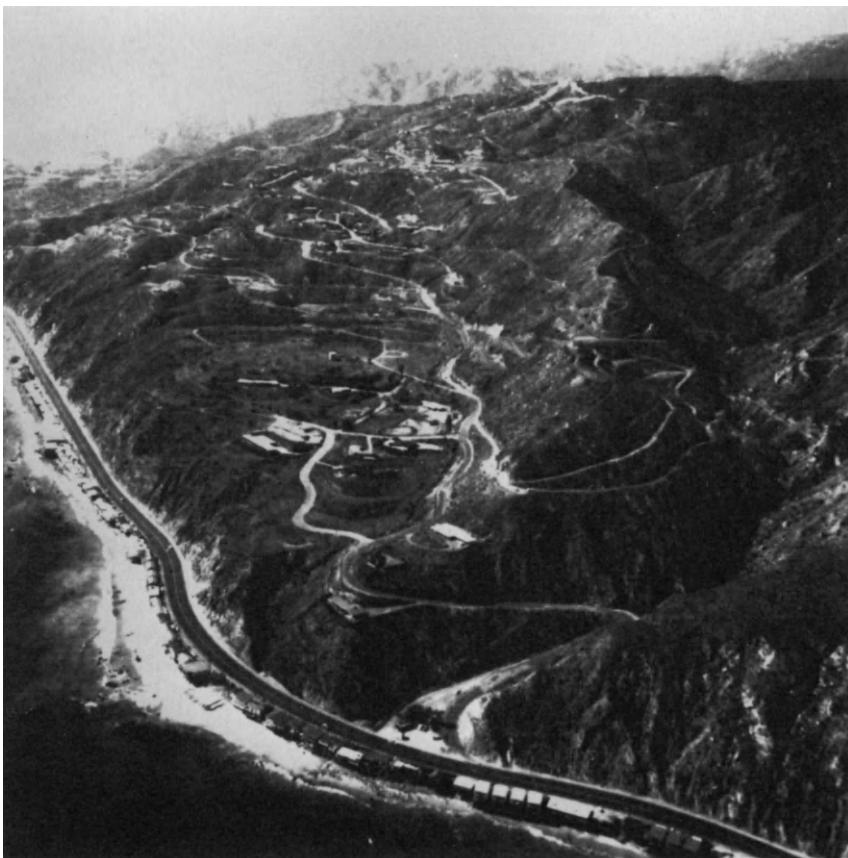
A 1962 oblique aerial photograph of Big Rock Mesa before development. At that time it was the opinion of one of the authors that the large amphitheater-shaped mesa in the center of the photo displayed the morphology of a subdued or ancient landslide.

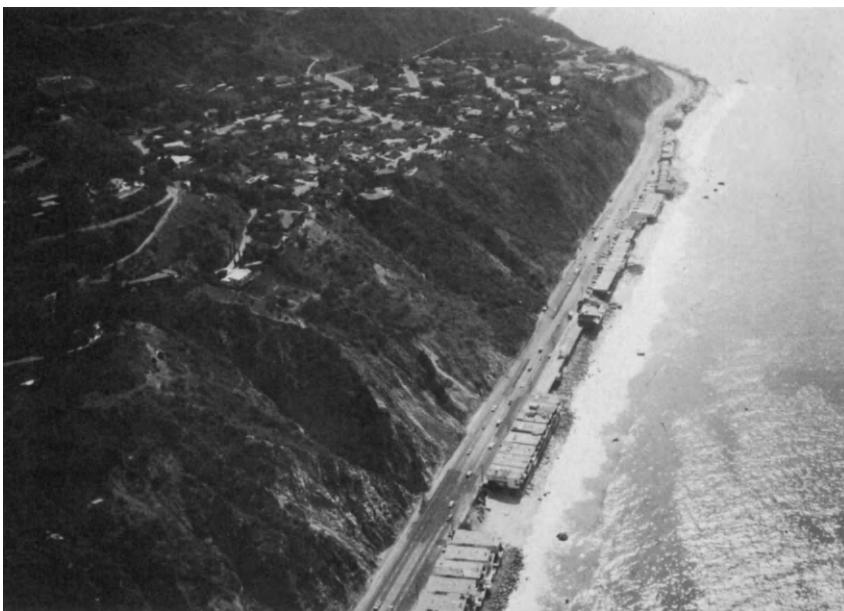
Oblique aerial view from the west showing the Pacific Coast Highway, the height and steepness of the bluff (caused by wave erosion), and the narrow beach area.

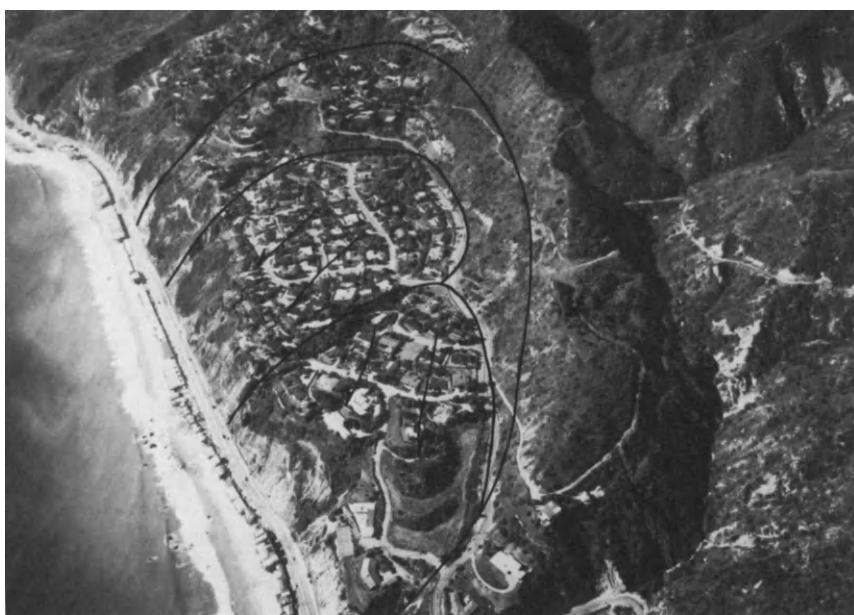
A 1983 oblique aerial view of Big Rock Mesa with the Pacific Ocean to the left (south). Note the bluff has a scalloped appearance from numerous small landslides and slumps. The back scarp of the main landslide is located upslope of the road in the center of the photograph. The three parts of the Big Rock Mesa landslide can be recognized by the slight lows in elevation and the shadow pattern. Photo courtesy of Geo-Tech Imagery, Oceanside, California.

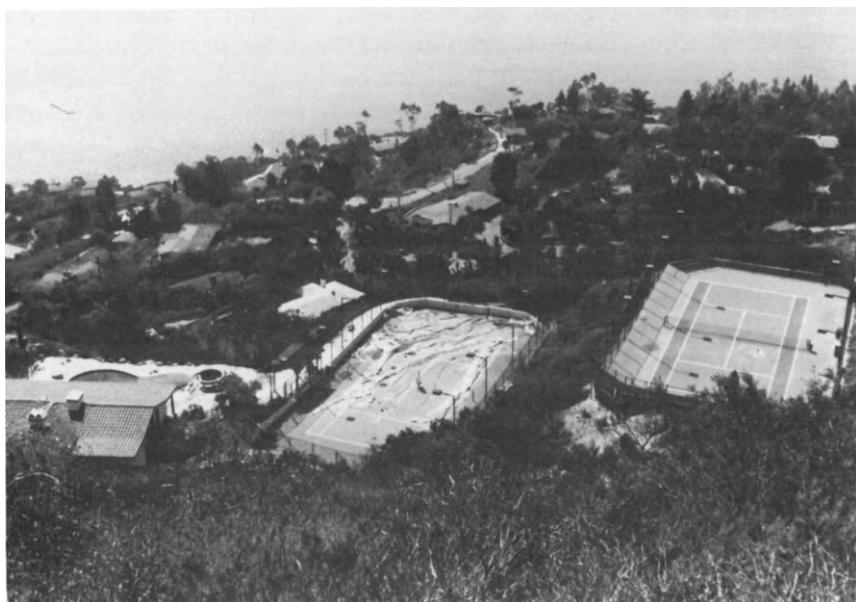
1. The house and improvements had been completely destroyed. Salvage value was minimal.
2. The lot had been rendered unbuildable except at an indeterminate cost of mitigation.

Tennis court of initial plaintiff. Within weeks the house was destroyed as well. Construction had been completed only 3 yr earlier. See Figure 3–3 for location of property of initial plaintiff.

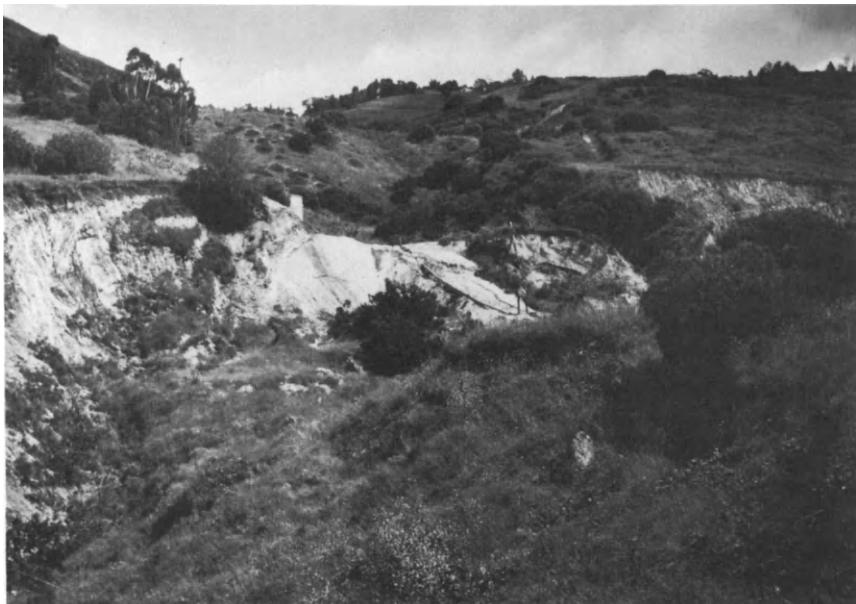
Graben at head of Portuguese Bend landslide. Whether storm-runoff accumulation in graben affected Abalone Cove landslide was a major item of controversy.

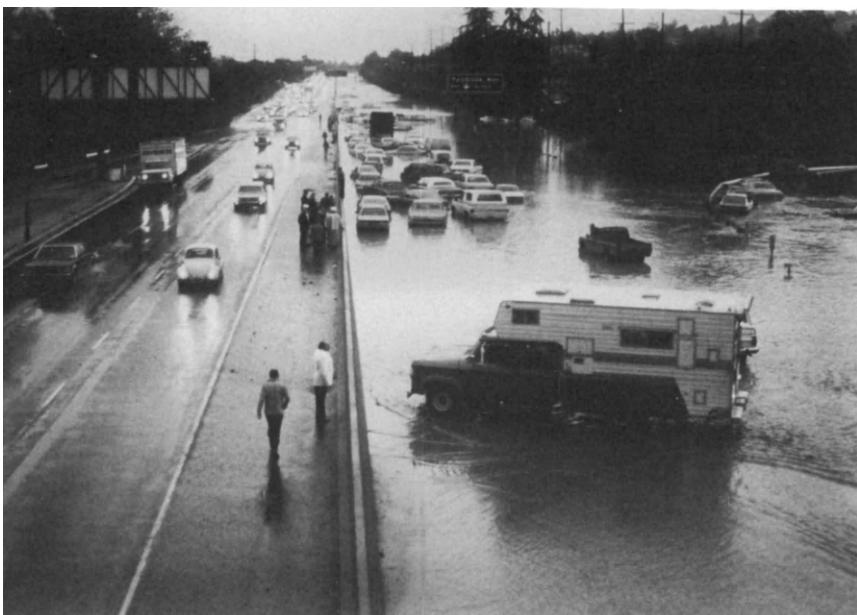
Low-angle oblique photograph taken from helicopter at peak of flooding. Viewer is looking east along Ventura Freeway with the Dry Canyon twin box culvert approximately 650 ft (200 m) past the freeway sign. Photo shows the freeway median divider acting as a weir, causing the water to rise 2.5–3 ft (0.8–0.9 m) and to flow over the divider.

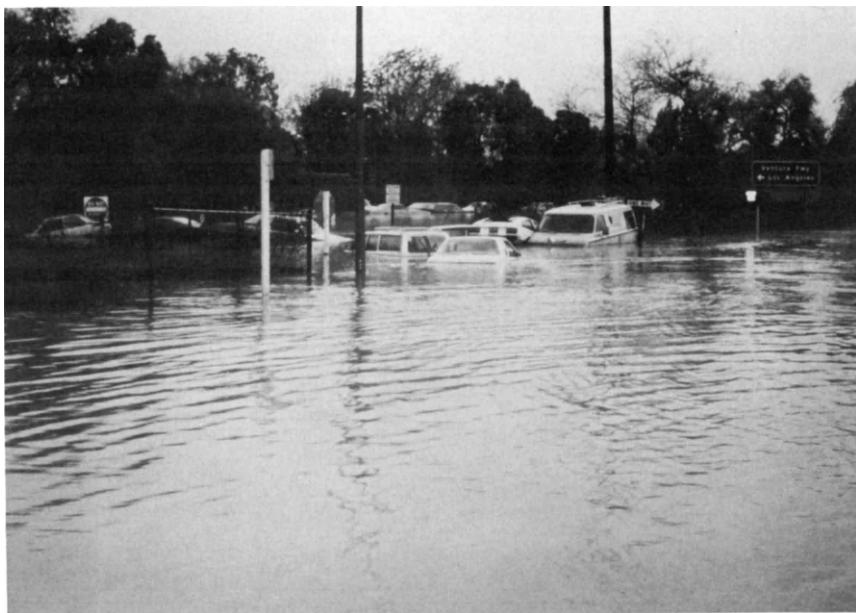
View of the Ventura Freeway on-ramp at Valley Circle Drive. The deepest floodwater and box culvert is approximately 650 ft (200 m) to the right of the on-ramp sign.

open channel, outletting to twin concrete box culverts under the freeway. It was readily apparent without measurement survey or calculations that these facilities were grossly undersized in relation to drainage structures both upstream and immediately downstream.

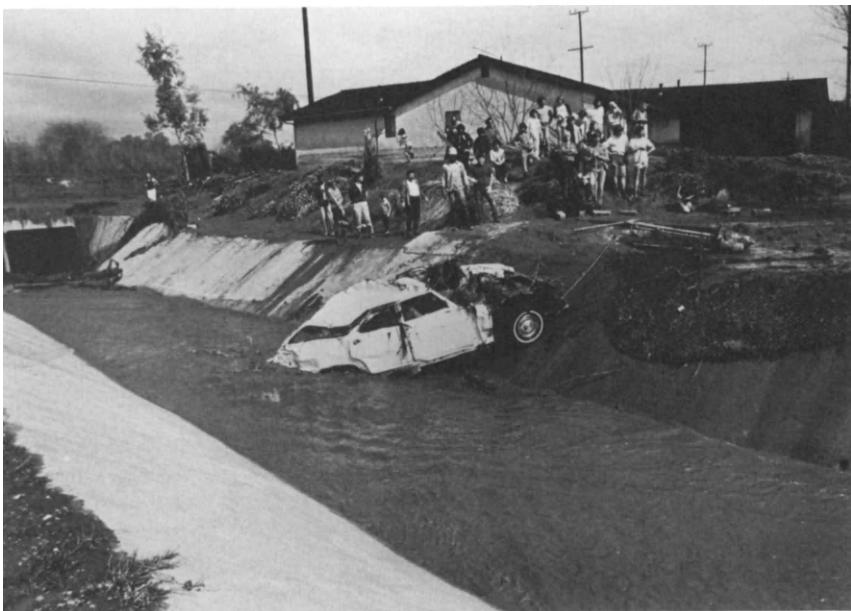
Station wagon that became impaled on the entrance to the freeway culverts being removed the day after the inundation occurred.

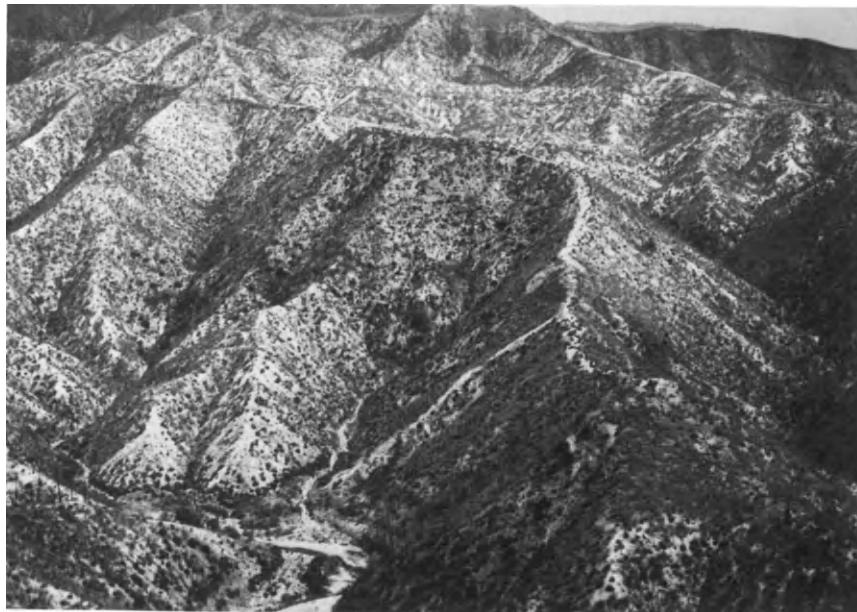
Typical condition of watershed contributing to Hidden Springs. Note denuded terrain and extreme steepness of slopes.

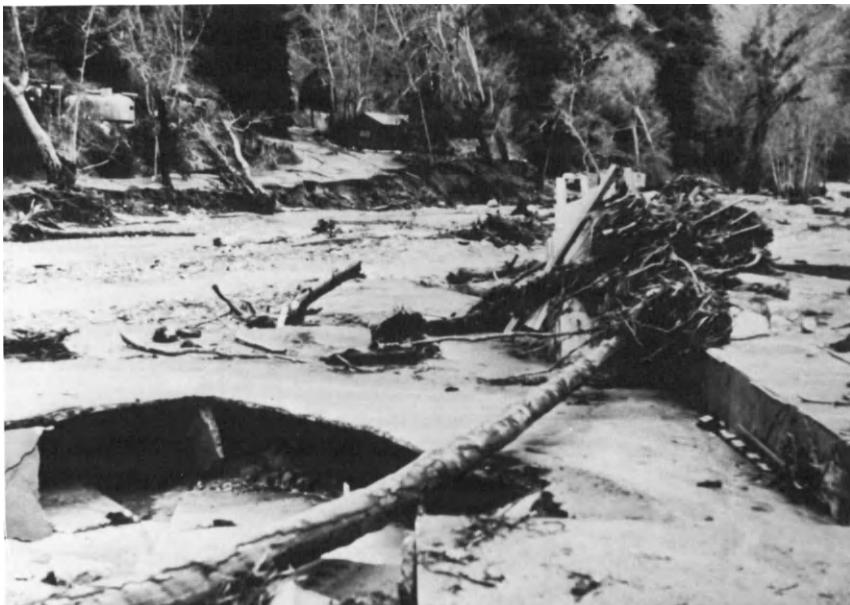
Path of destruction of the Hidden Springs floods and debris flow. The crest height of water in the channel area was estimated to be over 15 ft (4.5 m). The bulking factor was estimated at 400%.

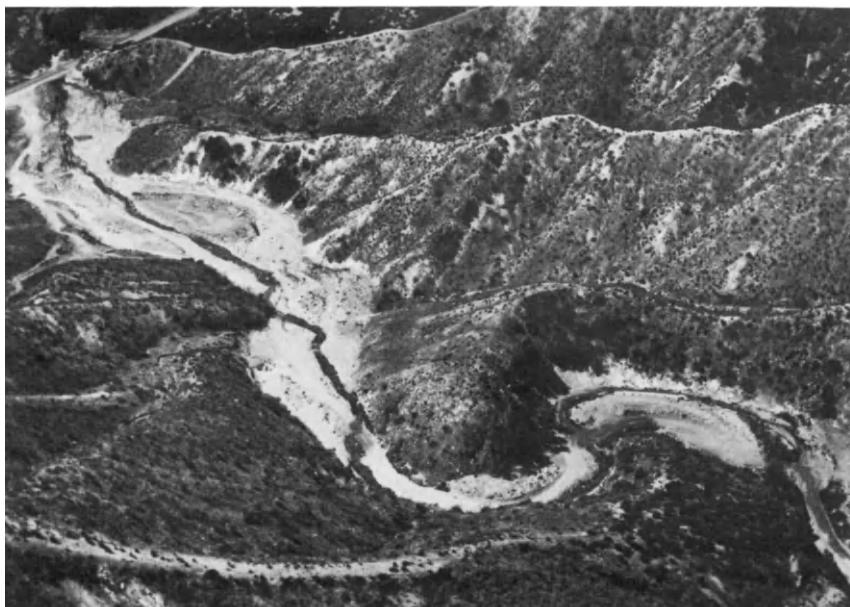
We investigated what effect a temporary damming of the Gooseneck might have had on the peak flow. Using the high-water marks that were plainly visible, we calculated the maximum volume of water and debris that could have been stored and then suddenly released. Because of the steepness and narrowness of the canyon at this point, the storage volume, even if suddenly released, would not have been enough to have a meaningful effect on the surge.

"Gooseneck" curve where possibility of temporary blockage was investigated. Highway can be seen in upper left corner of photograph.

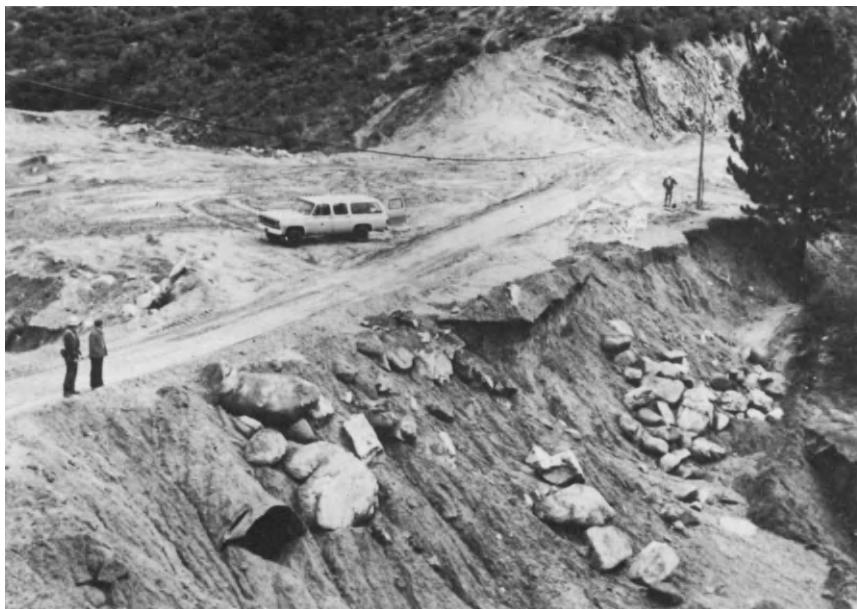
Debris covering the Angeles Forest Highway after Hidden Springs flood-debris flow. Note the size of the boulders visible in the lower right. The level area where vehicle is parked and upstream to the left represent the filling of a canyon with sand and boulder-sized debris. The roadway was not breached, but the debris-laden flow across the roadway was estimated at 380,000 yd^3 (304,000 m^3).

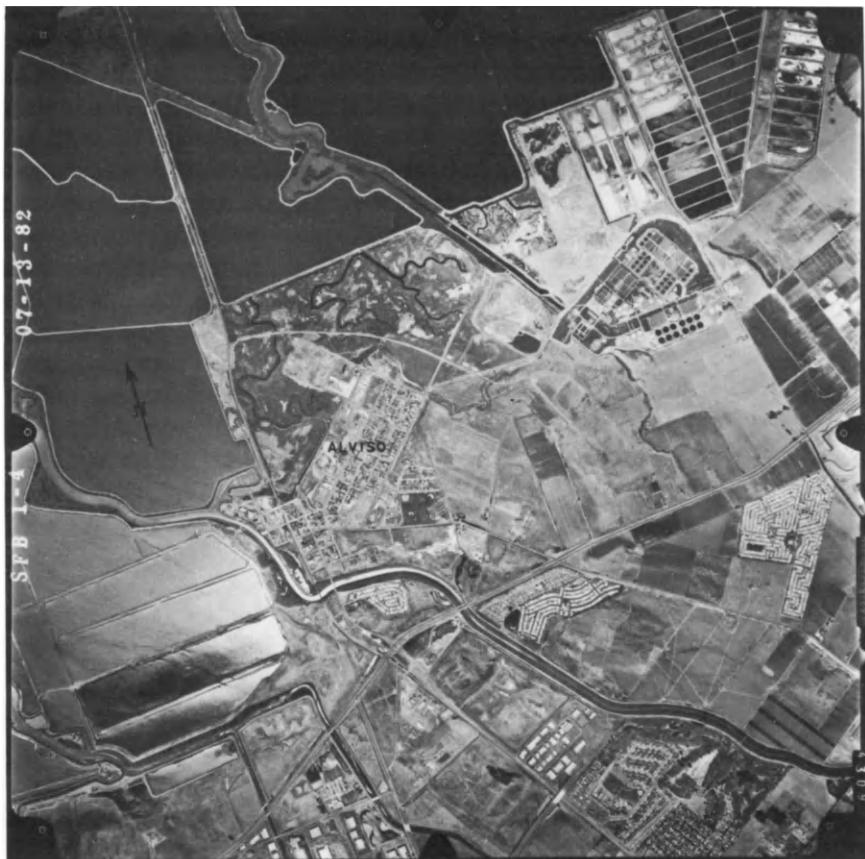
Aerial photograph showing community of Alviso (left center), salt evaporators (left side and top), sewage ponds and plant (upper right), and Guadalupe River (from left center to lower right). Coyote Creek is off photo to the right (east). At peak of flood, water ranged from 3 to 5 ft (1 to 1.5m) deep. Floodwater entered Alviso from the south-southeast (lower right) at the same time the tide was rising in the bay. See Figure 9-2 for location of features.

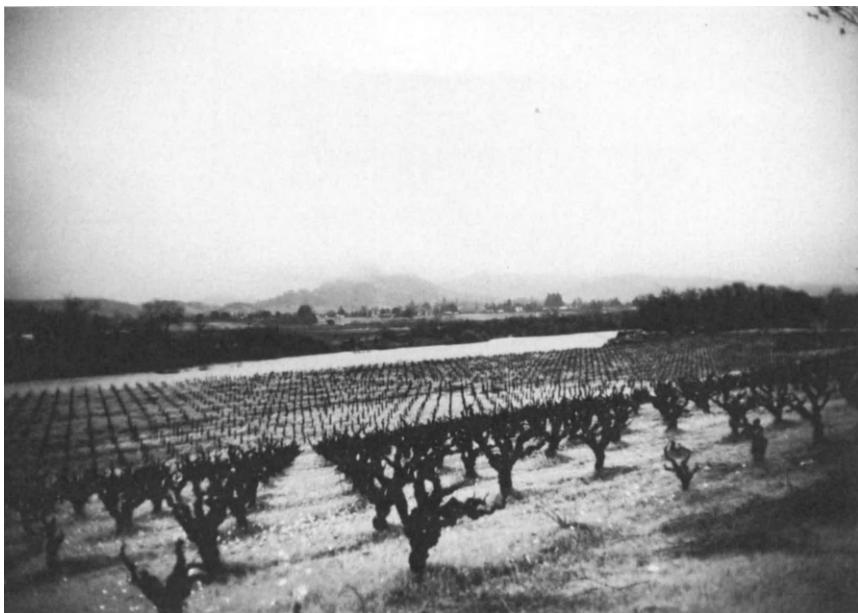
Typical orchard along Dry Creek. Note evidence of instability on opposite riverbank.

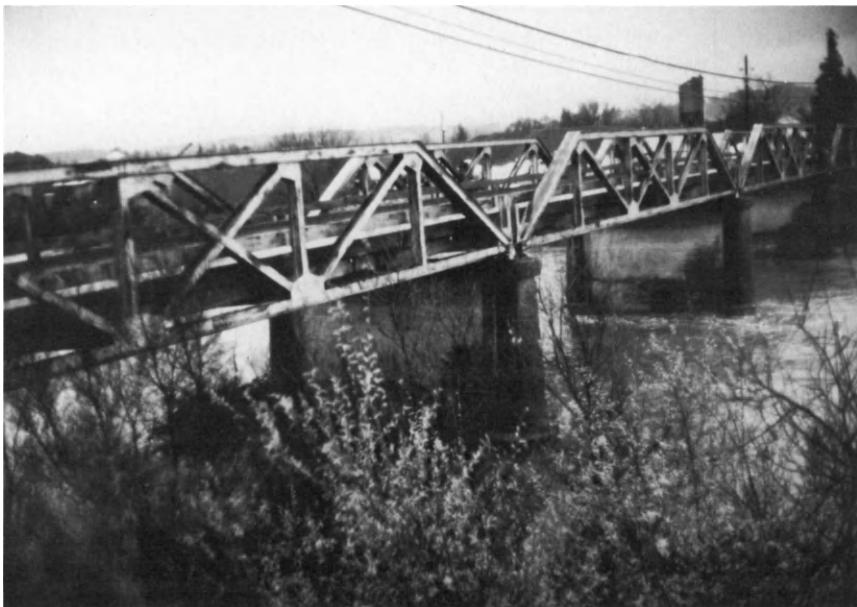
Westside Bridge over Dry Creek at Healdsburg. Extreme streambed degradation that was due, in the authors' opinion, to excessive in-stream extraction of sand and gravel downstream from bridge caused exposure of bridge pier footings.
