Hurricane Ike Field Investigation

*A Report of Field Observations
on October 3–6, 2008*

HURRICANE IKE FIELD INVESTIGATIONS

A REPORT OF FIELD OPERATIONS FROM OCTOBER 3–6, 2008

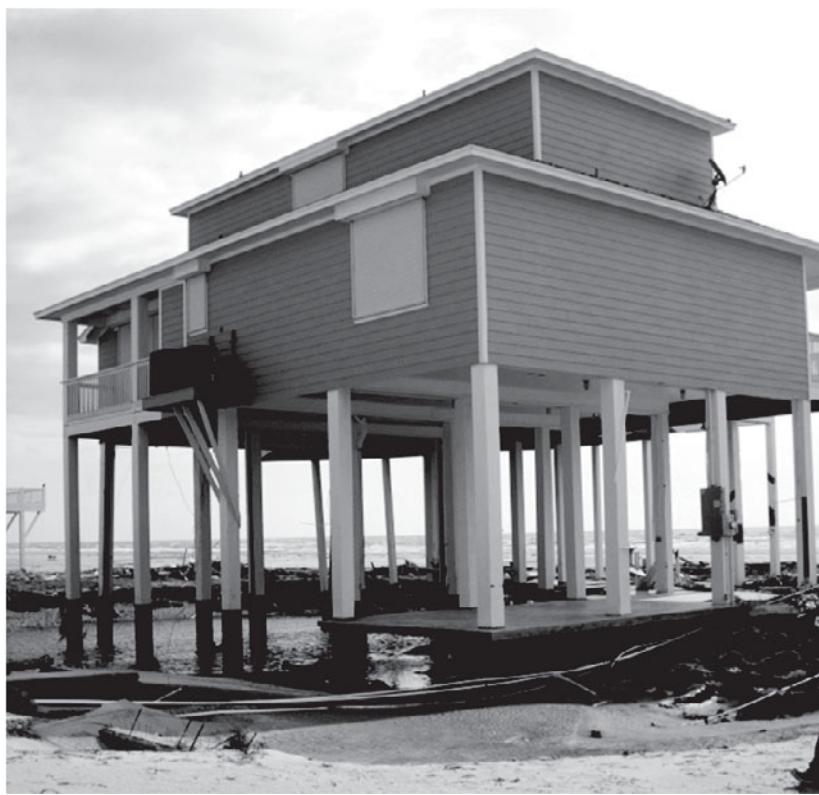
Figure 3-11. The home of John Russell on Bolivar Peninsula

An anemometer on resident John Russell's roof in The Biscayne development on the Bolivar Peninsula (N30 38.361 W94 04.174) worked through most of the storm. Russell recorded a maximum wind speed of 46 m/s from the northeast before his anemometer broke. The bottom clearance of his house was about 4.3 m, placing the roof at about +10 m above original ground level (Figure 3-11).

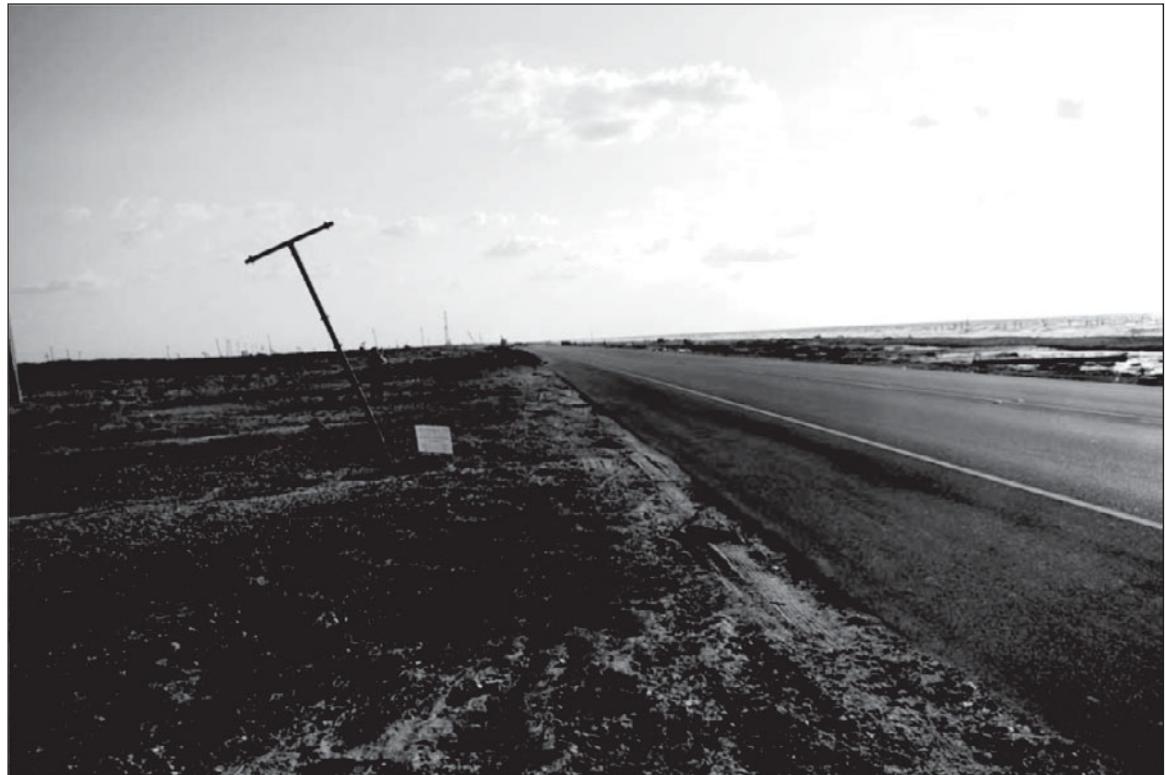
From Sabine Pass westward to just before Rollover Pass, the shoreline is composed of deltaic plane and marsh deposits as shown schematically in Figure 2-2 and photographically in Figure 4-2. The shoreline and coastal evolution have been controlled by sediments deposited at the mouth of the Sabine River as the sea level rose and from transport onshore from the nearshore. The shoreline is characterized with a flat slope with little or no beach and dune development, which progresses landward into an extensive coastal marsh (Figure 4-2). This mainland coast encompasses all of the Jefferson and Chambers counties and extends just into the Galveston County shoreline. Texas Highway 87 ran along the shoreline for the entire length of Jefferson County, but erosion and landward movement of the shore has eroded the roadway. The road has been abandoned through the McFadden National Wildlife Refuge as even small storms have washed out each attempt to repair it.

Figure 4-2. Low relief of the Sabine River deltaic headland. Texas Highway 87 and extensive coastal marsh are landward of the narrow beach

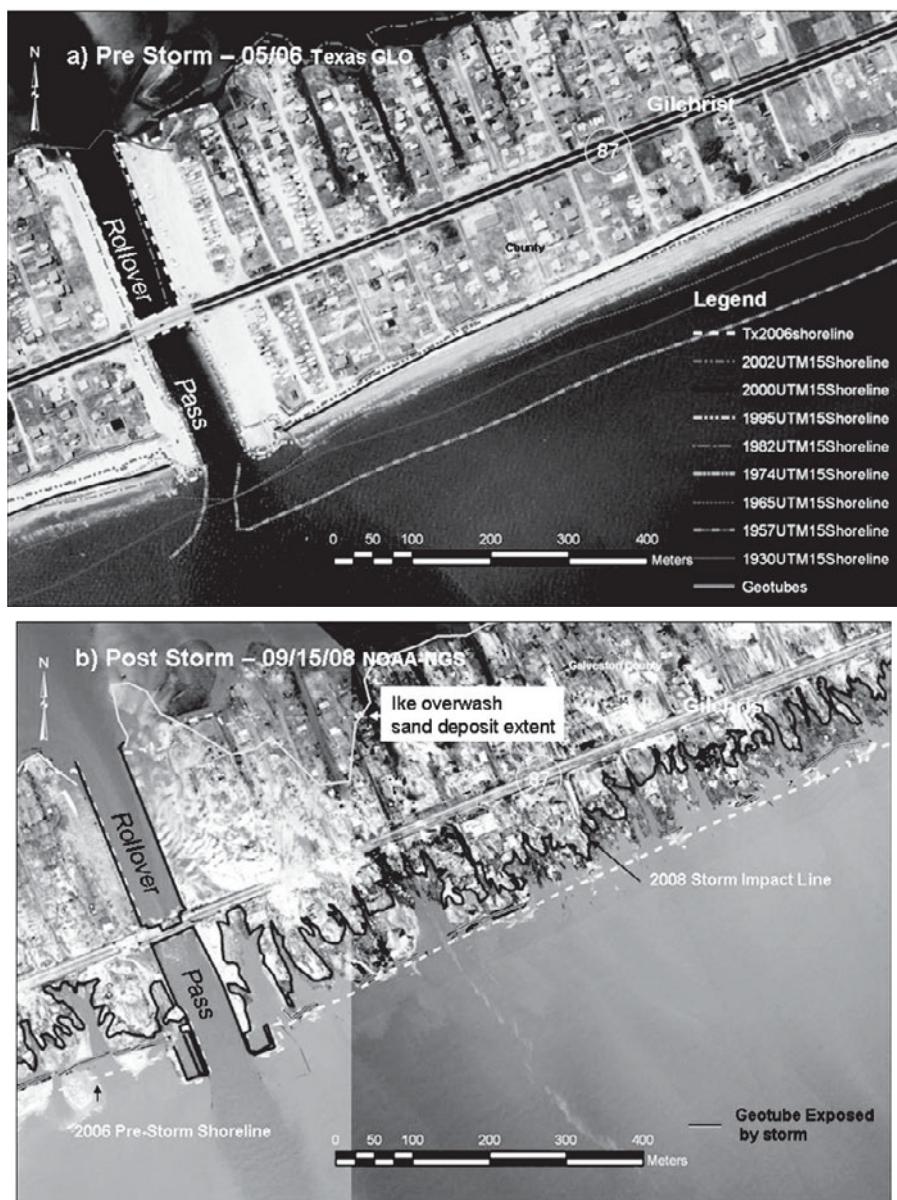
Figure 4-6. (a) Pre-storm aerial photography of Rollover Pass and Gilchrist with historic shorelines and location of buried geotextile tubes and (b) post-storm impacts of overwash extent

Photos taken three days after landfall of Hurricane Ike showed severe erosion of the beach and near total destruction of upland structures in the Rollover Pass area of Gilchrist. The post-storm photo shows that sand had overwashed the entire narrow width of this part of Bolivar Peninsula (Figure 4-6b). Despite the geotextile protection, the beachfront experienced major erosion with the formation of localized erosion channels. Because the beach sands are a veneer over marsh deposits, the storm gouged the island where erosion channels have cut back almost to Texas 87 in many places through the softer marsh deposits. The geotextiles appeared to somewhat reduce, but not prevent, the extent of erosion farther landward compared to unprotected sections and areas where the tubes were damaged. This part of the spit was completely under water during the height of the storm, allowing the sediment to transport into East Bay. The sands remaining on the beach were composed of coarse shell hash material.

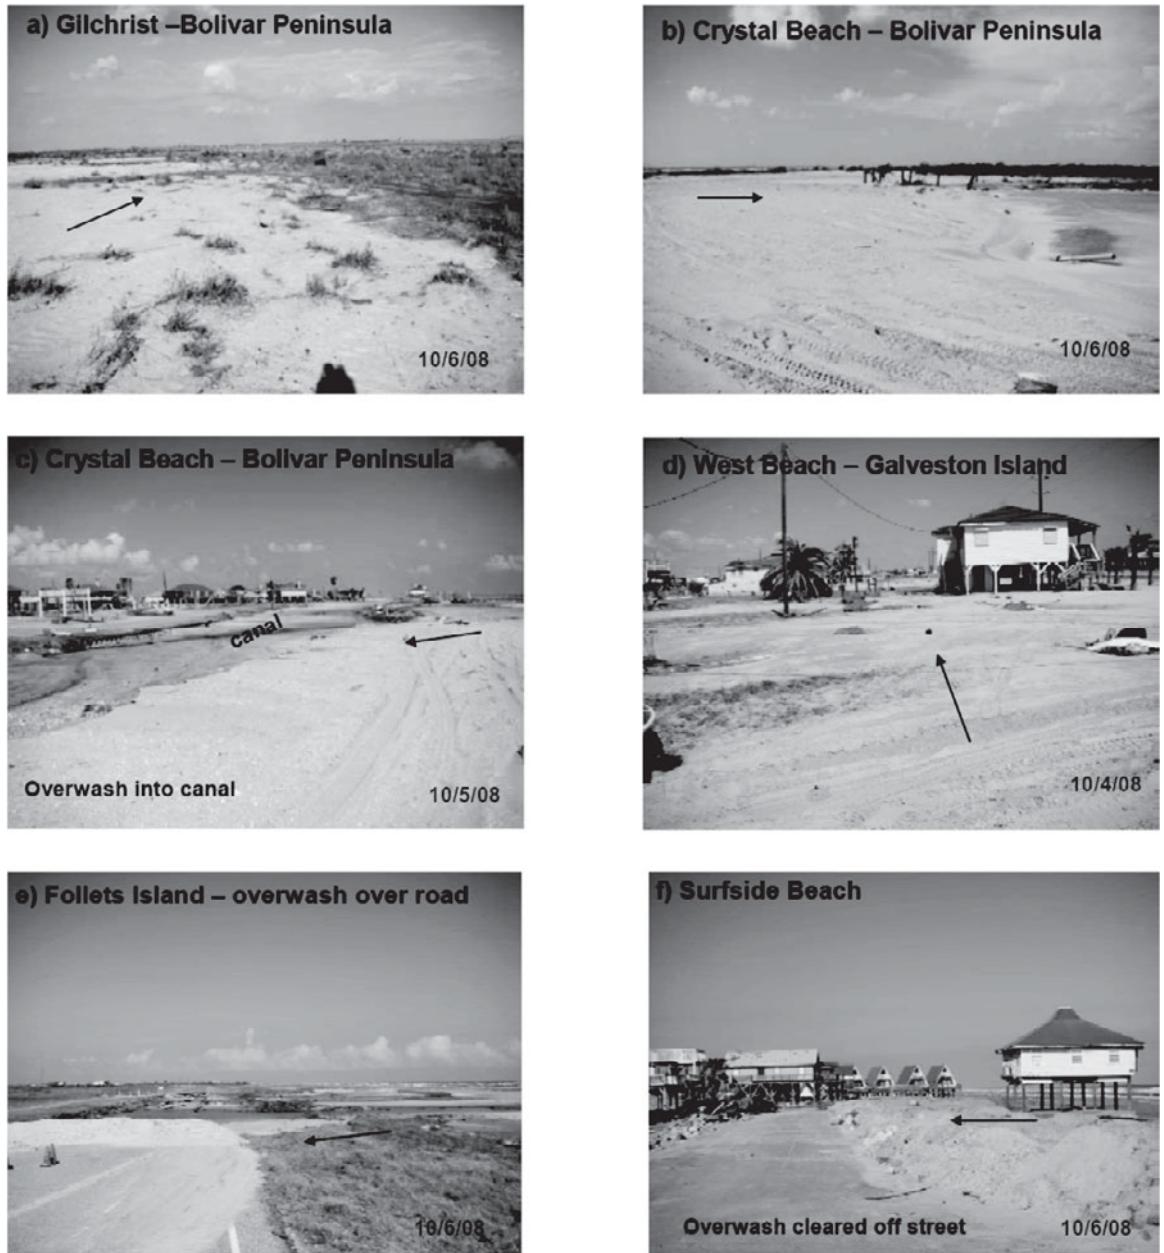
The visible limit of inland sand transport was mapped from the post-storm aerial photography to determine the linear extent and transport distance. The surge went further inland, but the sand overwash deposits provide a good picture of the transport of sand-size sediment inland. The overwash deposits were not uniform and varied within each geomorphic zone. This variation was a result of the quantity of sand available to be transported inland, pre-storm dune development, surge force, and track of the storm. The linear extent and distance inland along the Sabine River deltaic headland was limited to 150 to 200 m inland but was consistent along the zone (Figures 4-3 and 4-4). The limited available sand probably minimized the inland distance of sand transport while the surge was substantial.

Bolivar Peninsula exhibited the most landward extent of overwash sand deposits, which was located near Crystal Beach. Substantial landward penetration of the sand was seen all along this spit. Bolivar Peninsula and the Sabine River deltaic headland were on the right front quadrant of the storm and, thus, received the most intense winds, waves, and surge from Ike. They also received the largest overwash extent of sand in the study area. Figure 4-15a shows the landward extent of the overwash fan deposits over the marsh and back beach surface around Gilchrist. The depth of the deposit was roughly estimated at 0.3 to 0.6 m at Crystal Beach (Figure 4-15b). Sand transport filled beach parallel canals at Crystal Beach (Figure 4-15c). The sand was transported about 0.5 km inland at the narrow Gilchrist area and from 1 to 2 km inland at Crystal Beach.

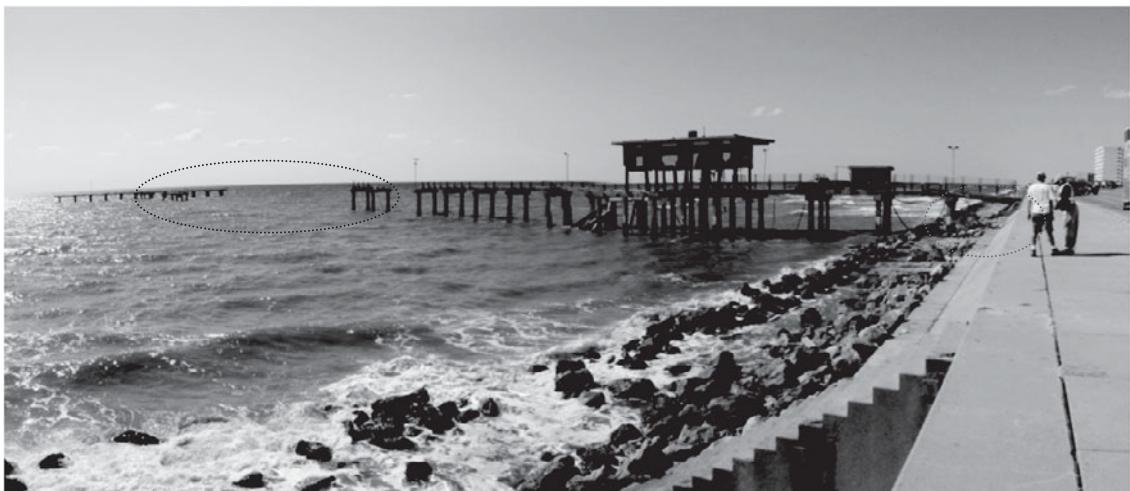
Figure 5-1. 89th Street fishing pier

The fishing pier is located near 89th Street in Galveston. The total length was about 340 m. The segment between 125 and 310 m from the seawall was lost as shown in Figure 5-1. The two-story building on the pier located near the seawall was heavily damaged, and the first floor was completely lost. These damages were mainly caused by the uplift and horizontal wave forces inside the surf zone.

It seems that the end of the pier remained because it was located outside the surf zone. The first girder attached to the seawall was also damaged as shown in Figure 5-2. The uplift force of the wave in front of the seawall is assumed to have hit the girder. The concrete decking panels were lifted upward by the waves and fell through the girders onto the beach or seafloor.

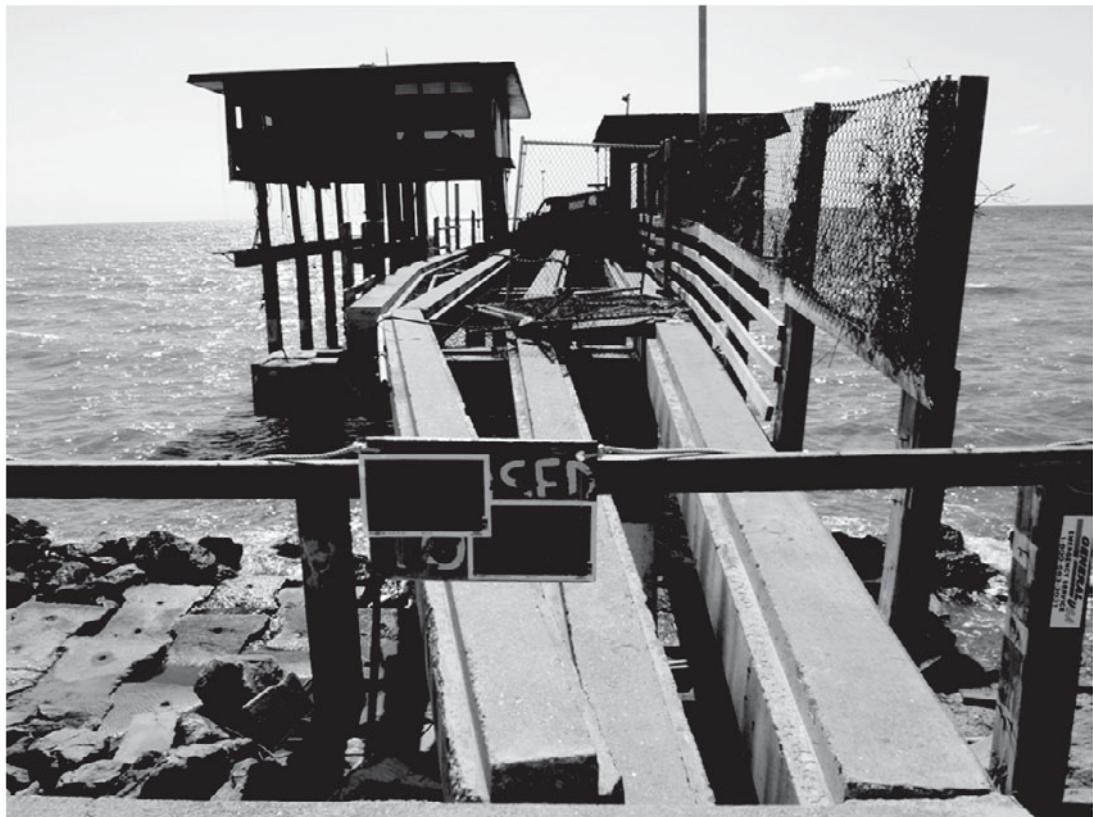
Figure 5-2. The girders attached to the seawall were damaged by the deflected waves on the seawall

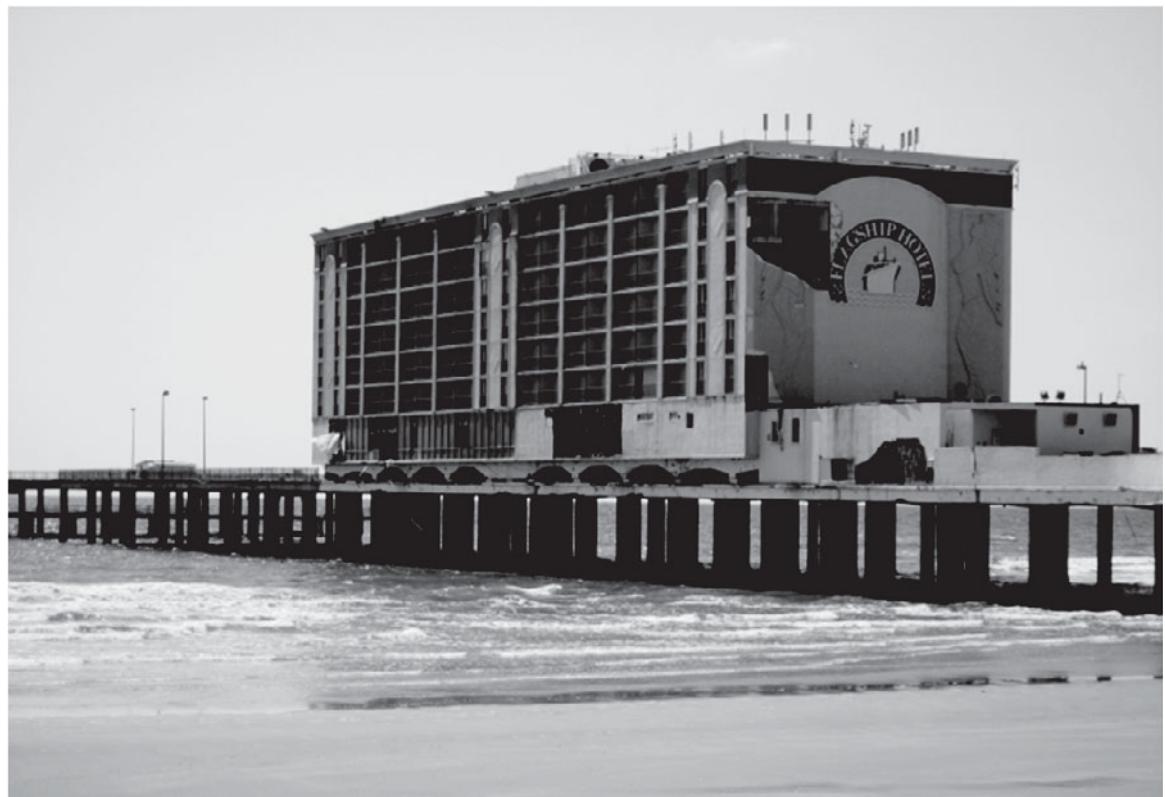
Figure 5-3. Flagship Hotel Pier

The 25th Street pier (also called the Pleasure Pier or Flagship Hotel Pier) with a total length of about 350 m was the only pier that remained somewhat intact despite heavy damage after Hurricane Ike (Figure 5-3). However, almost all piles of the 25th Street Pier remained in contrast with those of the 89th Street fishing pier. There are several reasons for the differing damage between the 25th Street (hotel) Pier and fishing pier. The clearance between the sea surface and the horizontal beams of the hotel pier was higher than for the fishing pier. Also there was likely deeper embedment of the piles to support the load of the hotel structure and resist the wave forces. Additionally, the water depth seems much shallower than that at the fishing pier, which would have made the wave height smaller than that under the fishing pier.

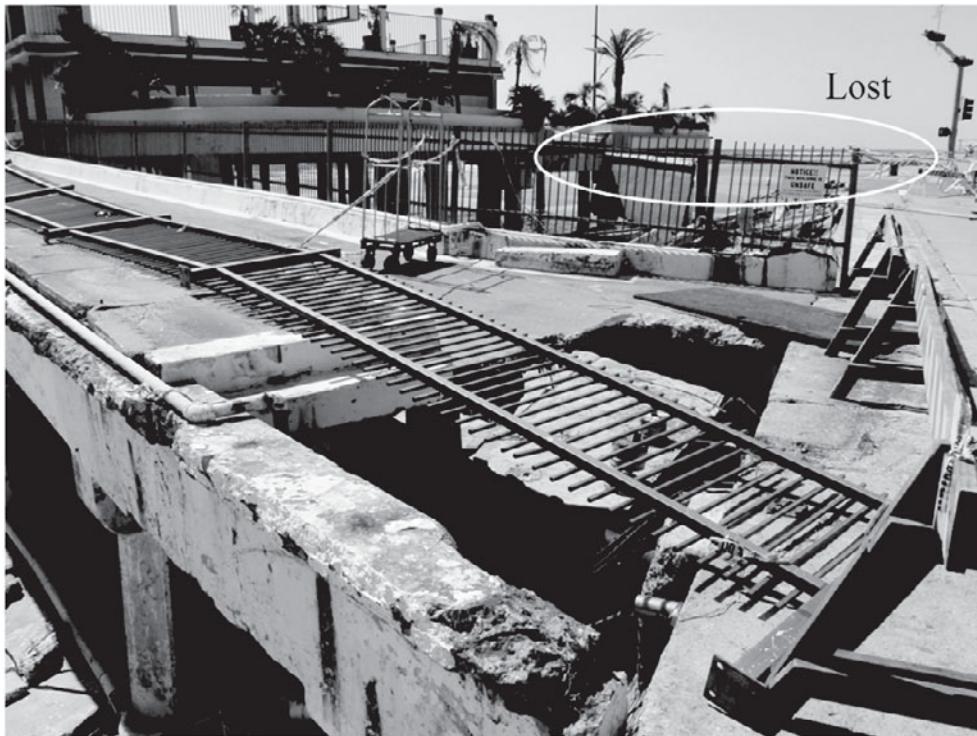
As at the fishing pier, the first girder attached to the seawall (Figure 5-4) and the sidewalk behind the seawall near the hotel pier (Figure 5-5) were damaged. It seems that the waves overtopped the seawall, and some material was piped through or underneath it. Additionally, there was damage to the hotel ramp. The uplift forces were greater than the old corroded steel drift pins could resist as shown in Figure 5-6.

Figure 5-4. The loss of the first girder of the hotel pier caused by the uplift force of the waves

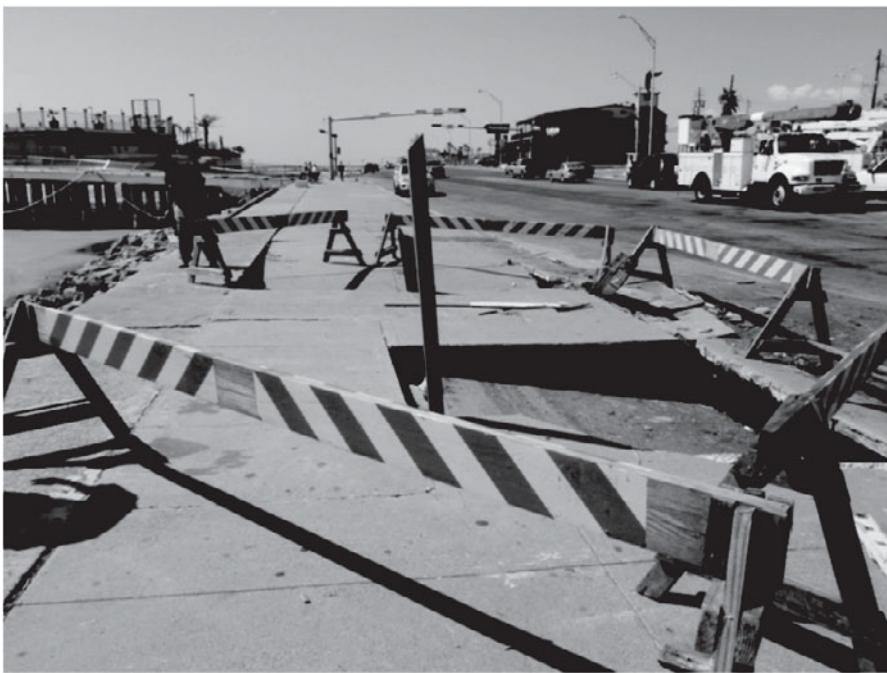
Figure 5-5. Overtopping wave seems to have caused the leakage of backfill

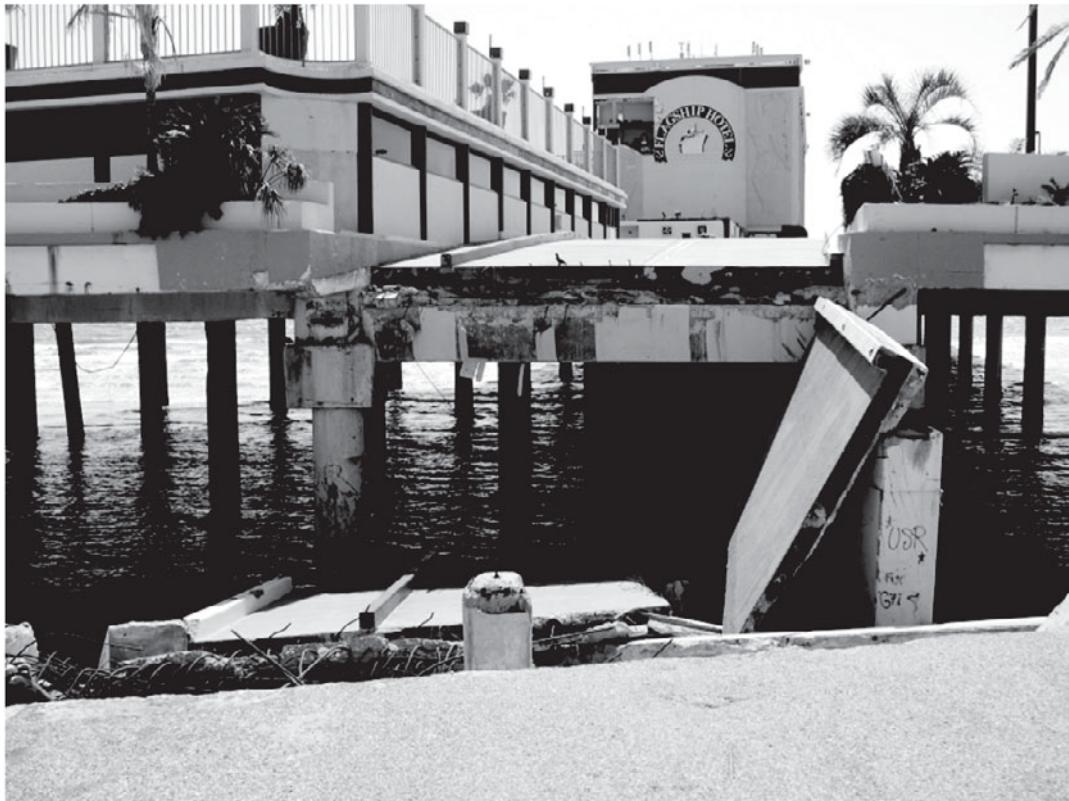
Figure 5-6. Collapse of ramp onto Flagship Hotel Pier

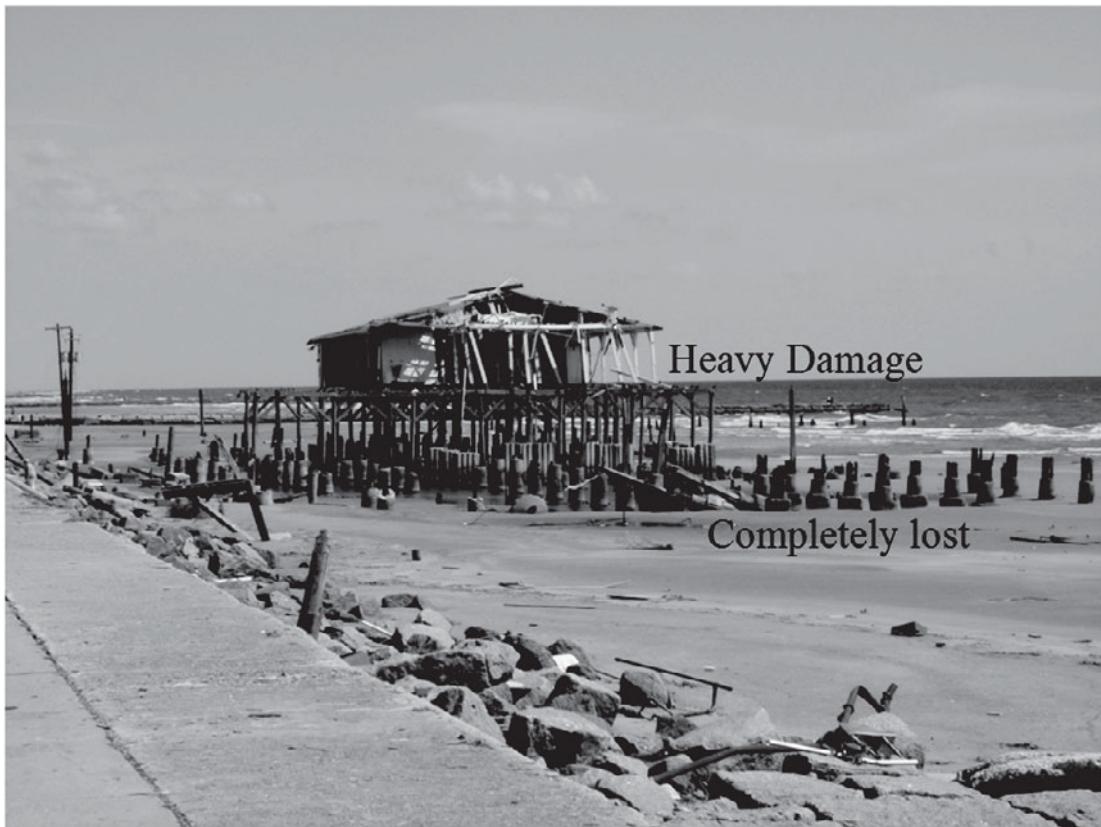
Figure 5-7. Wooden piles supporting the pier for the historic Balinese Room

There were two wooden pile piers 250 m northeast of the Flagship Hotel. The smaller clearance between the sea surface and the beams placed high lateral and uplift wave forces on the structure. As a result, the weak wooden structures were destroyed as shown in Figure 5-7. The piles were quite old, and marine borer damage had required several previous repairs.

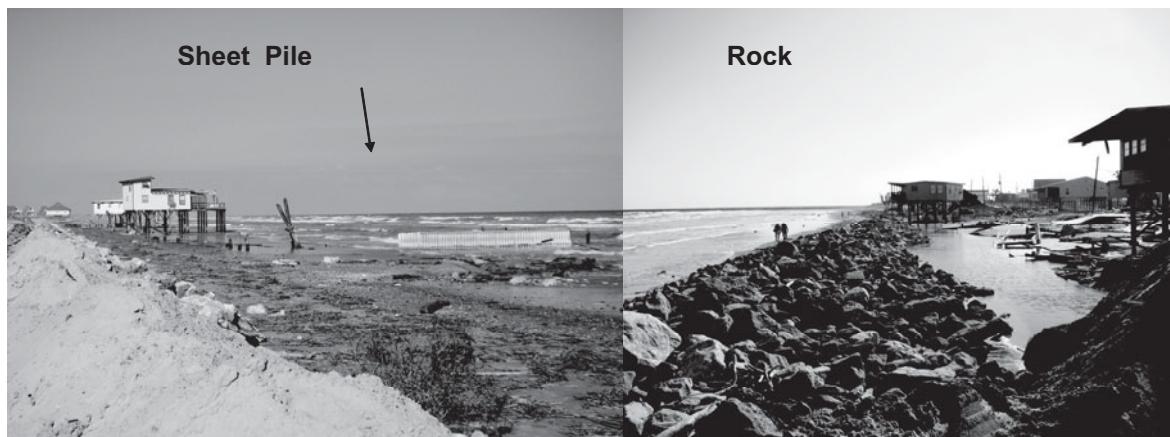
*Figure 5-8. Damages to coastal structures at Surfside*

In the Town of Surfside, a rock revetment was constructed along the gulfward side of Beach Drive and covered with a dune. There were several houses on the beach, gulfward of the revetment/dune. The owners of five of the homes located between Sundial and Crab Streets constructed a vertical metal sheet pile seawall in front of their properties, with a flanking wall on each end. The sheet pile structure was destroyed by the hurricane except for the west flanking wall (Figure 5-8a). The rock revetment along Beach Street was uncovered as the storm washed the dune into the interior as overwash (Figure 5-8a). The sand from this overwash was bulldozed back over the revetment in some places. In others the displaced rock was all that was left after the storm. Most of the houses gulfward of the revetment were destroyed, and several landward of the structure suffered heavy damages (Figure 5-8b).

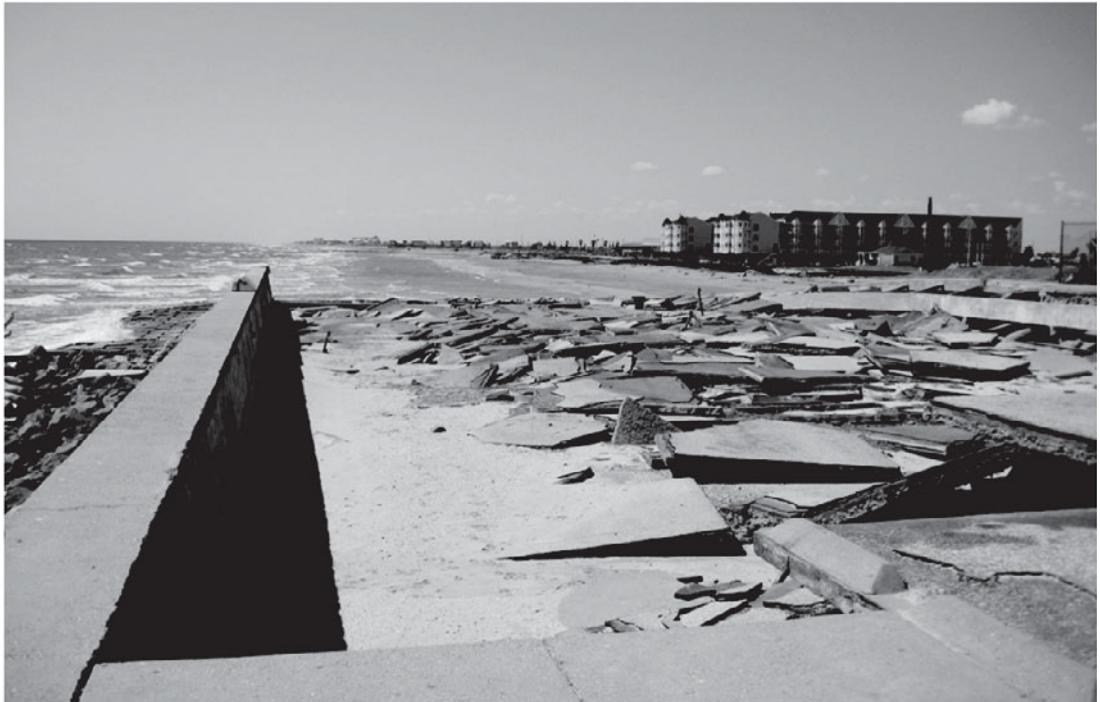
Figure 5-9. Damage at southwest end of seawall

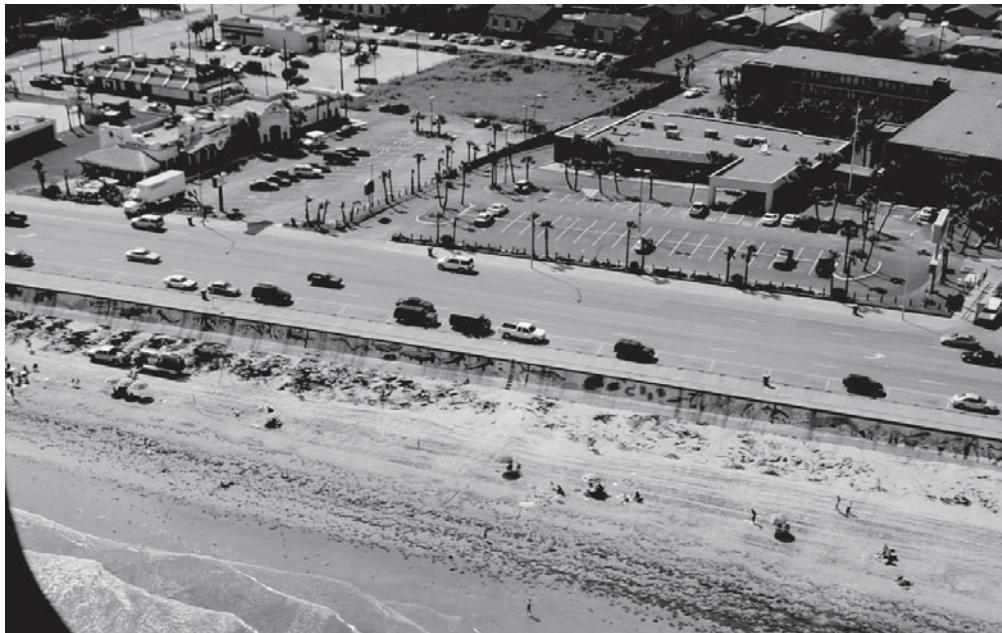
Figure 5-11. Condition of Galveston Seawall before Hurricane Ike

Figure 5-11 shows the condition of the Galveston Seawall before Hurricane Ike. It can be seen that behind the wall is Seawall Boulevard which has a sidewalk on either side. The paved area is in general sloped seaward to allow overtopping water to escape without running through the city.

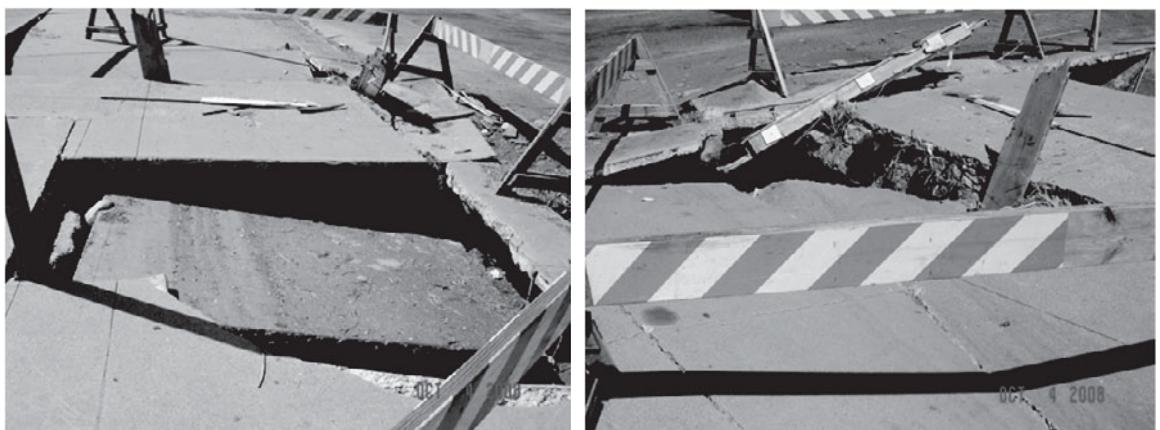
Figure 5-12. Settlement of slabs behind the seawall, potentially caused by piping failures

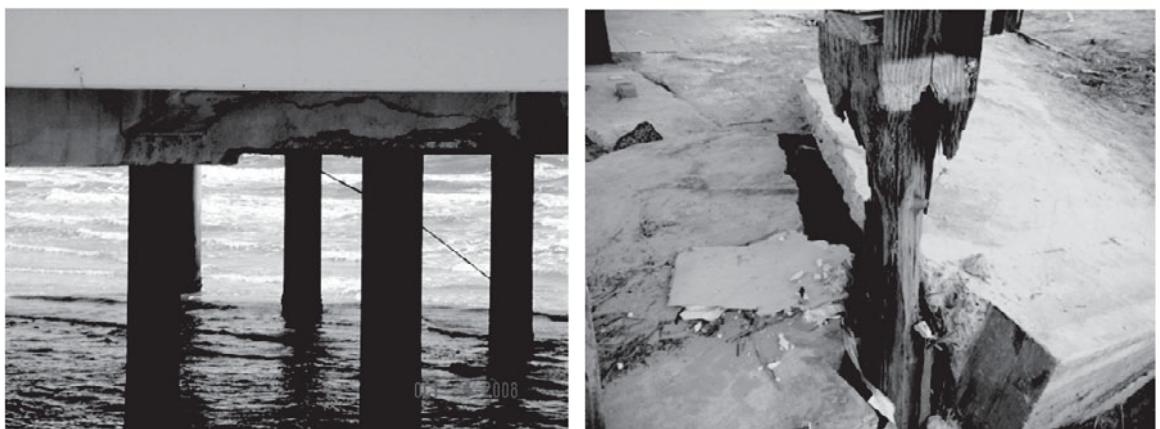
Figure 5-13. Examples of Seismic isolation

Although the Galveston Seawall apparently performed well during Hurricane Ike, several observations indicate that the seawall might only be marginally stable during a future major hurricane. Observations during the field investigation suggest that the water level in the backfill behind the wall may have been at a high level, perhaps near the surface, while the water level seaward of the wall was much lower. Elevation of the waterlevel behind the seawall is indicated by failure of numerous locations of the sidewalks behind the seawall (Figure 5-12) where an apparent “piping” failure occurred. The piping failure would have occurred if the hydrostatic water head behind the wall caused migration (piping) of the sand backfill through joints in the wall or along utility trenches or similar pathways causing loss of backfill. It is unlikely that the original design envisioned a condition where the backfill might be saturated when a relatively low water level exists on the seaward side of the wall. The high water level in the backfill would cause a large lateral pressure on the wall when there was a significant differential water level across the wall. If the differential water-level condition develops during another major storm event, two other elements may become critical to the wall’s global stability. The water pressure would exert an additional force on the rip rap along the toe of the wall and on the pilings underneath the wall. The pilings were likely designed as axially loaded rather than laterally loaded piles and would, therefore, provide only nominal lateral capacity without detrimental deflection. The stability of the wall could potentially become unstable if a future storm event produces high water behind the wall and also displaces a substantial portion of the rip rap. The stability would be further reduced if the tops of some of the pilings deteriorated near the connection between the pilings and the base of the seawall. Numerous cases of severe deterioration of both wood and concrete structural members were observed during the field investigation, but no exposed pilings under the wall were found (Figure 5-13).

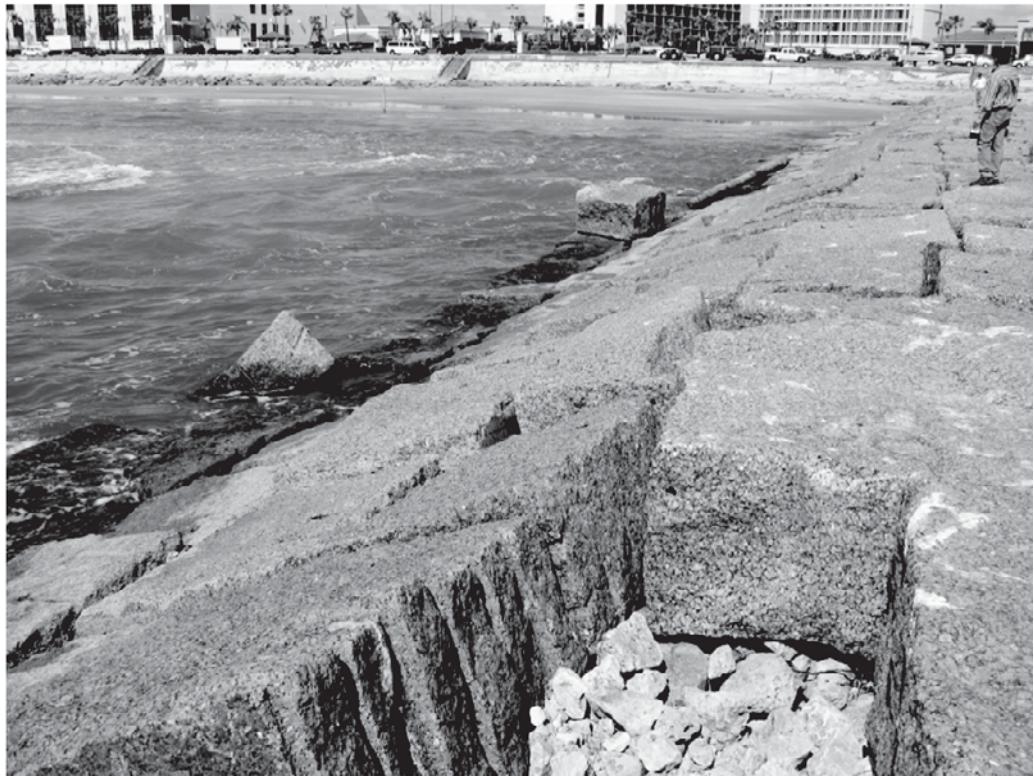
Figure 5-20. Loss of armor stone from 53rd Street groin fronting the Galveston Seawall

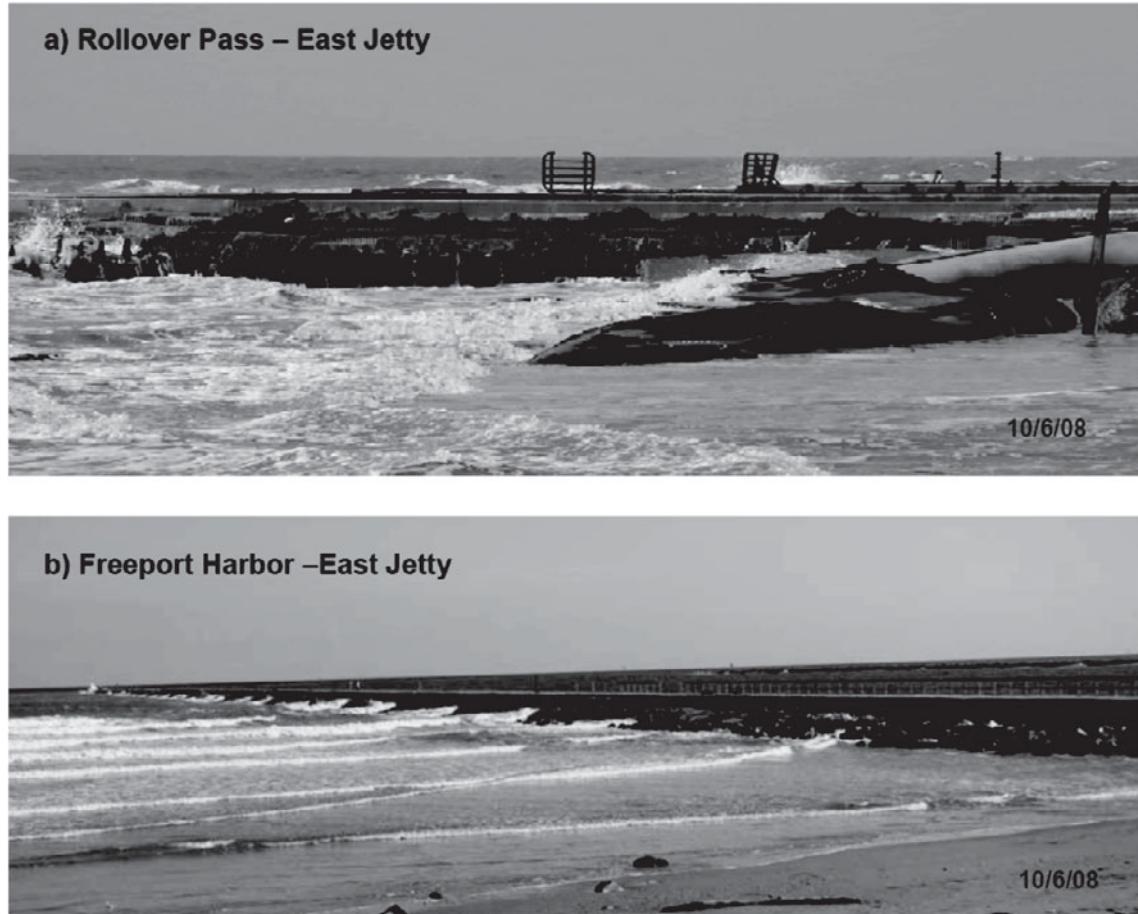
Figure 5-21. Inlet jetty response to Hurricane Ike (a) at Rollover Pass showing deterioration to sheet pile wall and erosion of sand and (b) at Freeport Channel where only railing damage was observed

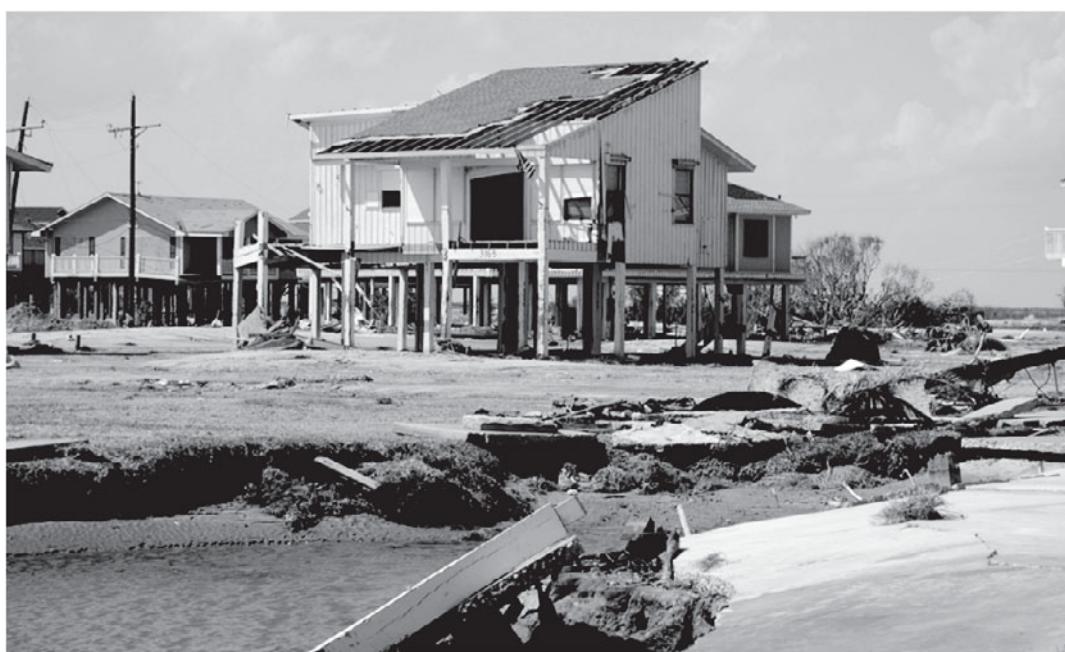
Figure 6-1. Partial roof deck failure due to wind uplift

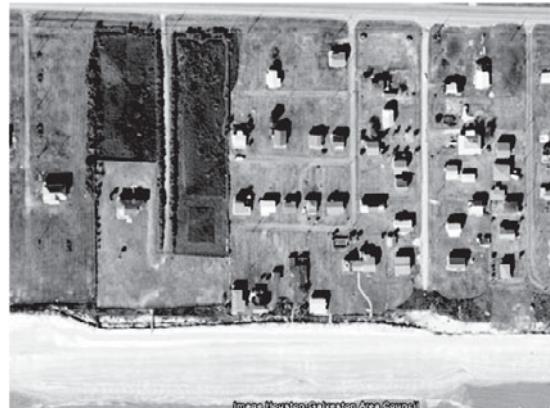
Figure 6-2. Building survivors and failures on the Bolivar Peninsula. The first two rows experienced erosion landward of geotextile tube. More landward buildings were destroyed by waves. Surviving buildings, circled on left side of (b), had higher floor elevations.

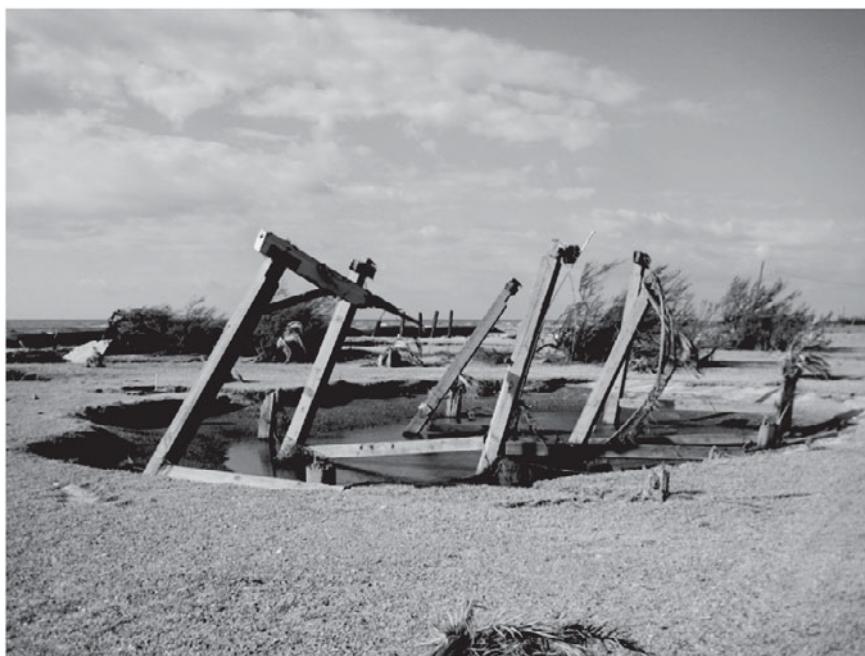
Figure 6-3. Localized scour eroding the full footprint of the short pile foundation

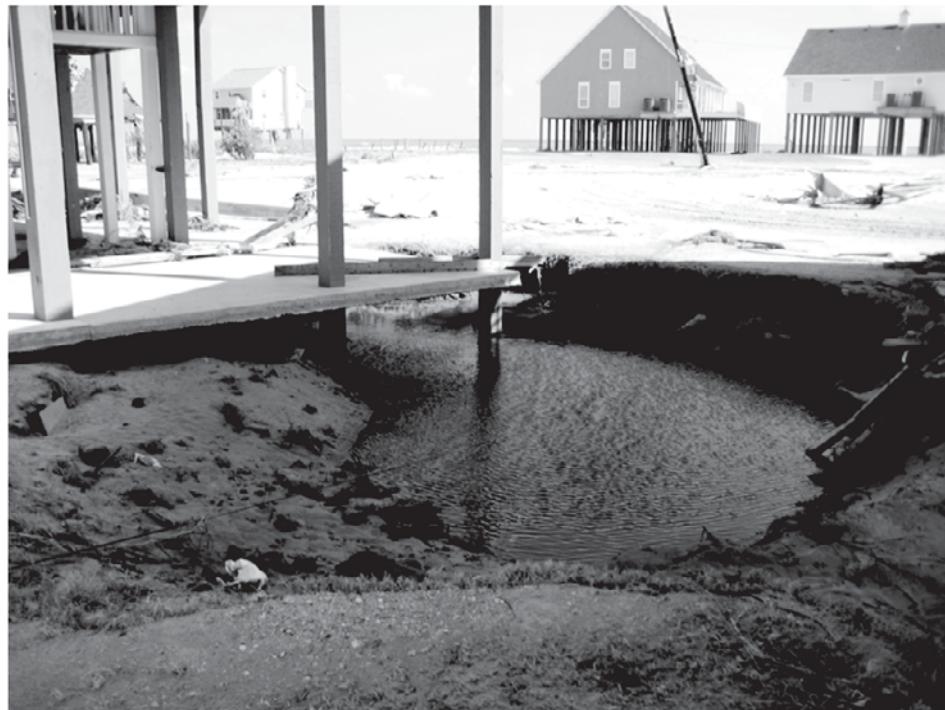
Figure 6-4. Local scour at the corner of the ground slab

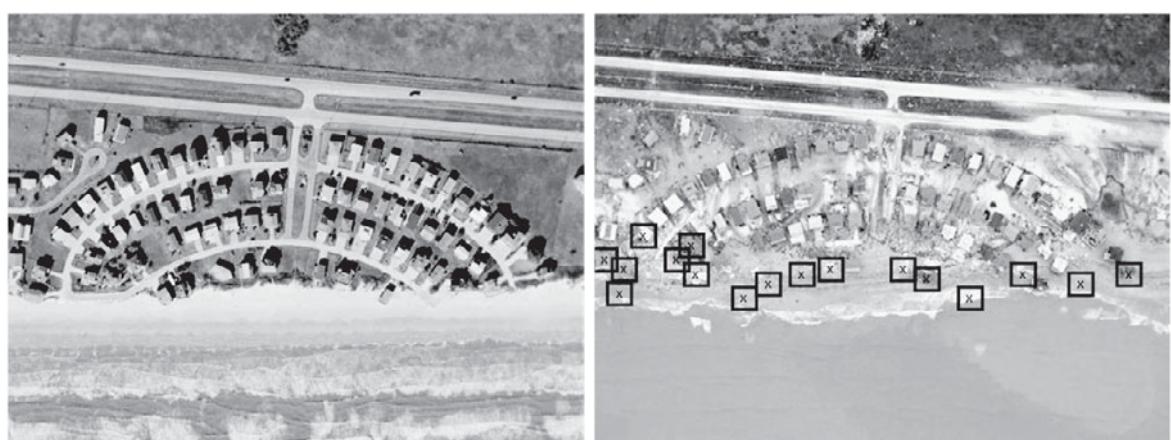
Figure 6-7. West Beach building failures primarily due to wave induced erosion of shoreline; minimal damage to elevated buildings farther landward. Source: Houston Area Council and NOAA images

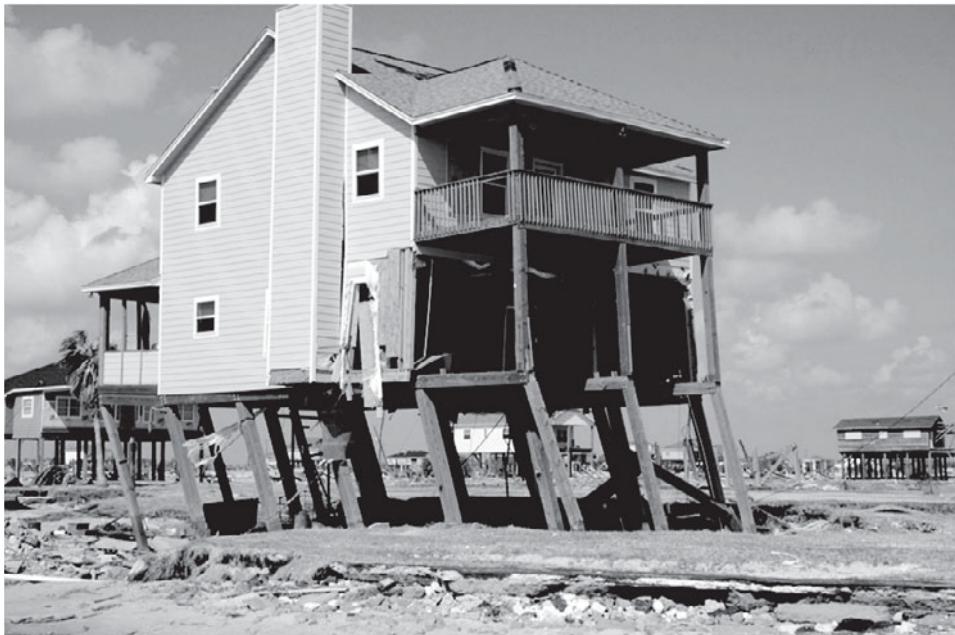
Figure 6-8. Foundation rotation due to inadequate piling embedment

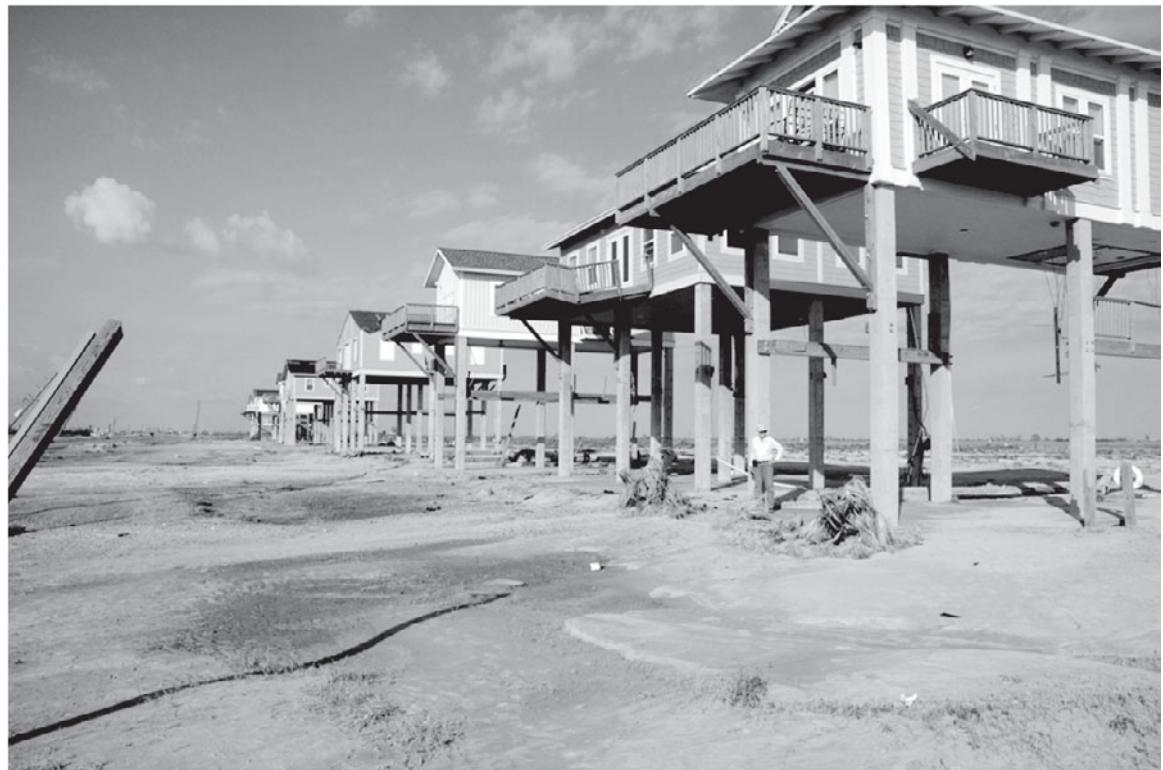
A new subdivision near the east end of the Bolivar Peninsula had recently installed 13 houses on composite foundations (Figure 6-9). Augured concrete pilings were cast with an integral slab-on-grade cap with cast-in-place, reinforced concrete columns to support the elevated buildings. The dimensions and workmanship of the piles, columns, and reinforcing appeared to be much better than those built pre-Alicia. The buildings were located on the north side of the beach road and likely received higher storm surge, wave, and wind conditions than any other buildings in the path of Ike's U.S. landfall. Local scour around the slabs was 0.3 m or less, barely exposing a few of the auger piles, thus, ruling out erosion as a significant stress on the foundation. The lowest, wood-frame floors were well elevated, approximately 6 m above grade, which was sufficient to avoid wave impacts. A wooden deck was bolted to the columns approximately 3.7 m above grade. Three buildings collapsed with column failures at or above the slab level (Figure 6-10). Deck failures in each of the remaining 10 houses suggested that wave heights reached at least a 0.3 m above the deck level but below the elevated floor components. Most of the collapsed and standing columns exhibited tension cracks as closely spaced as 0.15 m in sections up to the deck level. Partial compression fractures at the slab/column connection were also present in two of the remaining foundations (Figure 6-11). The steel reinforcement rods from the auger pile/slab forming the connection to the columns remained in place in the failed buildings. Vertical separation of the steel from the concrete column was apparent where remnants of the columns remained.

Figure 6-9. Surviving composite-concrete foundations on Bolivar Peninsula
