Hurricane Ike Field Investigation

*A Report of Field Observations
on October 3–6, 2008*

HURRICANE IKE FIELD INVESTIGATIONS

A REPORT OF FIELD OPERATIONS FROM OCTOBER 3–6, 2008

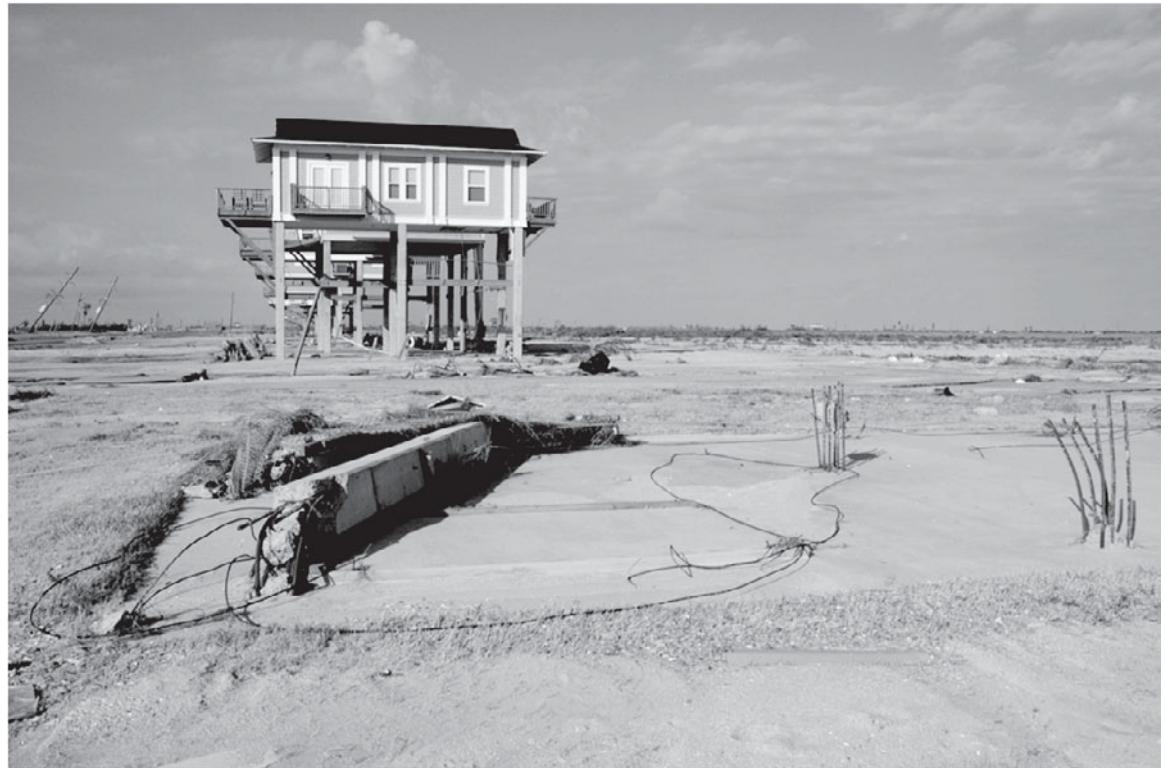
Figure 6-10. Composite-concrete foundation column failure at column to slab/pile cap connection

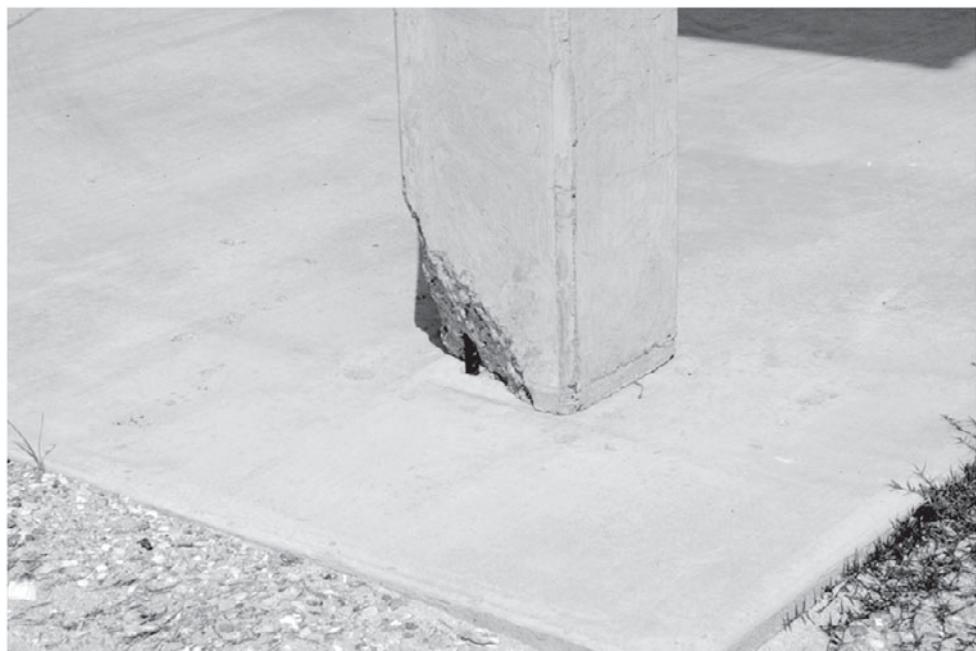
Figure 6-11. Compression fracture at column to slab joint in composite-concrete foundation

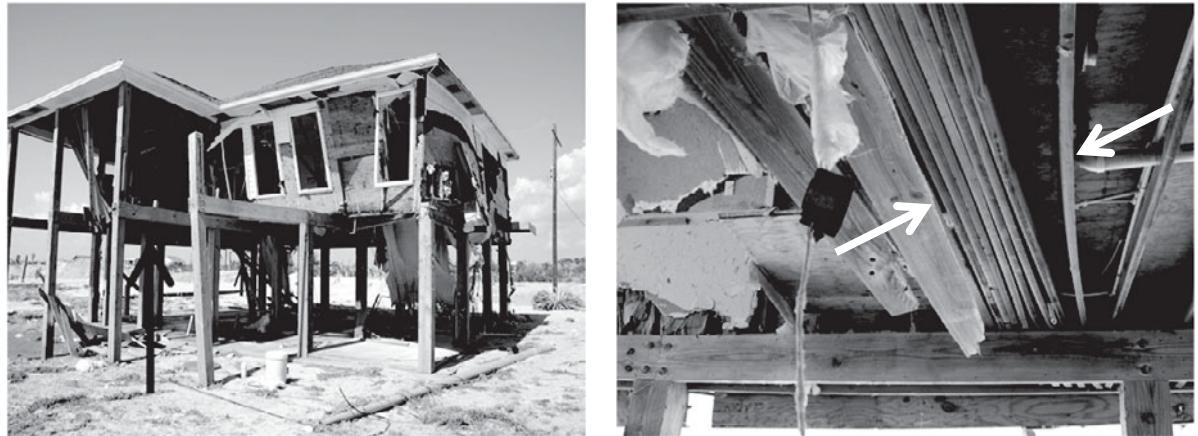
Figure 6-12. (a) Damage to house floor joists; (b) close-up of floor joists compressed by wave impact

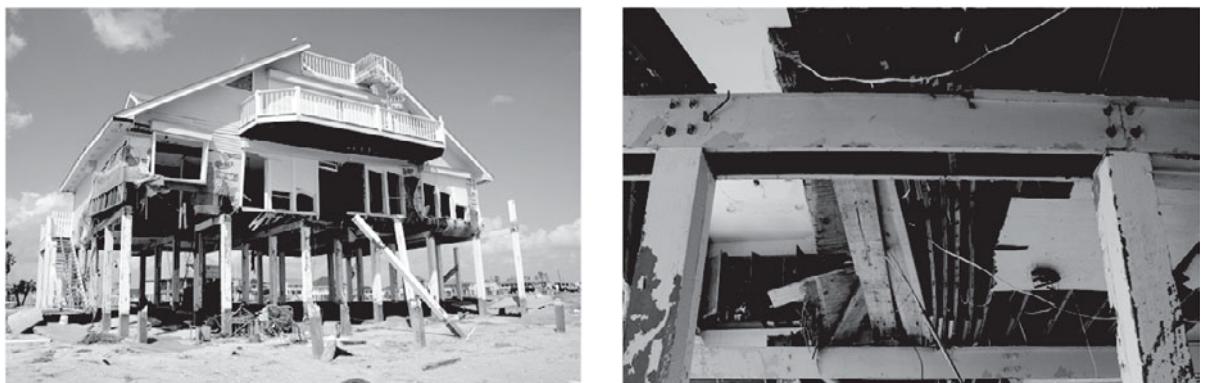
Figure 6-13. (a) Damaged house; (b) left to right, missing floor joists, displaced joists, compressed joists, and original joist spacing

Where shore-parallel floor joist compaction is observed and floor uplift failure initiated without obvious wave damage to the higher walls, it is reasonable to assume that the peak wave elevation was somewhere between the top and bottom of the floor joist. By measuring the distance from the post-storm ground elevation to the joists, various wave theories can be used to calculate the storm surge elevation without waves. Given the high uncertainties in the process, it is reasonable to use depth-limited, linear wave theory to predict the water level. The same methods presently are currently used by FEMA (2000) to predict wave elevations from the predicted storm surge to map for base flood elevations on Flood Insurance Rate Maps.

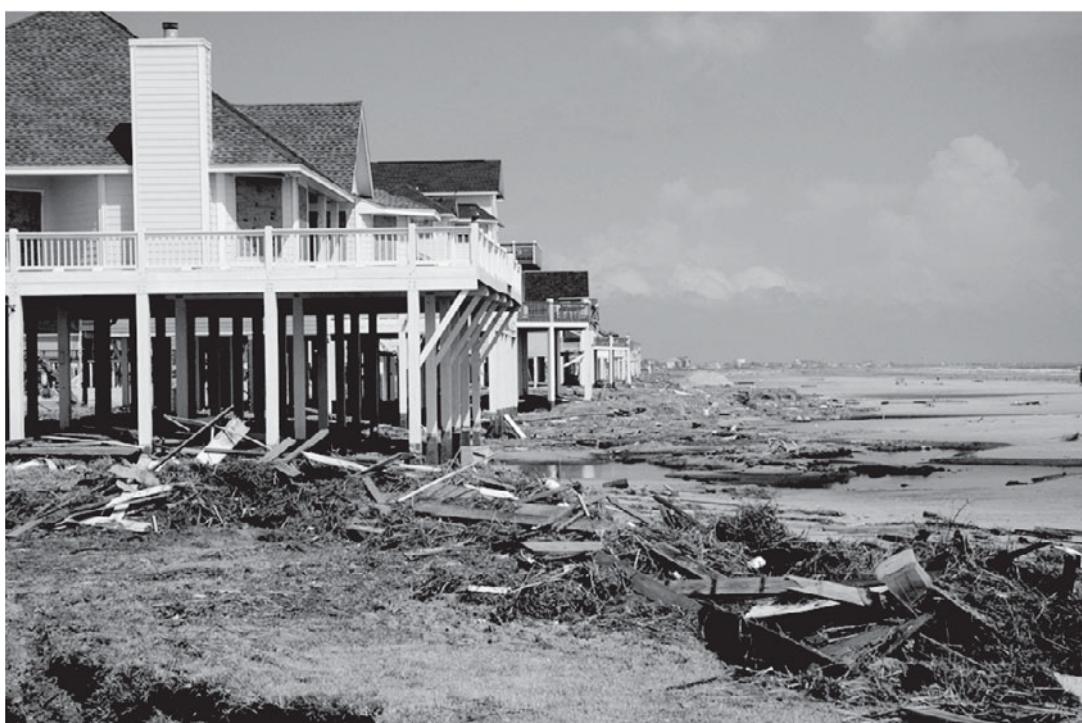
Figure 6-14. Recently constructed Bolivar Peninsula houses elevated more than 2 ft. above minimum required elevation that had minimal damage to elevated structures

Many building were destroyed by Hurricane Ike, particularly on the Bolivar Peninsula. The observed features that separated the survivors from the failures mirrored other recent storms. Piling foundations must be adequately imbedded to tolerate local erosion conditions, and the horizontal building components must be sufficiently elevated to avoid all breaking wave height elevations (Figure 6-14). The primary safety factors are deeper piling embedment and added floor elevation beyond the minimum requirements.

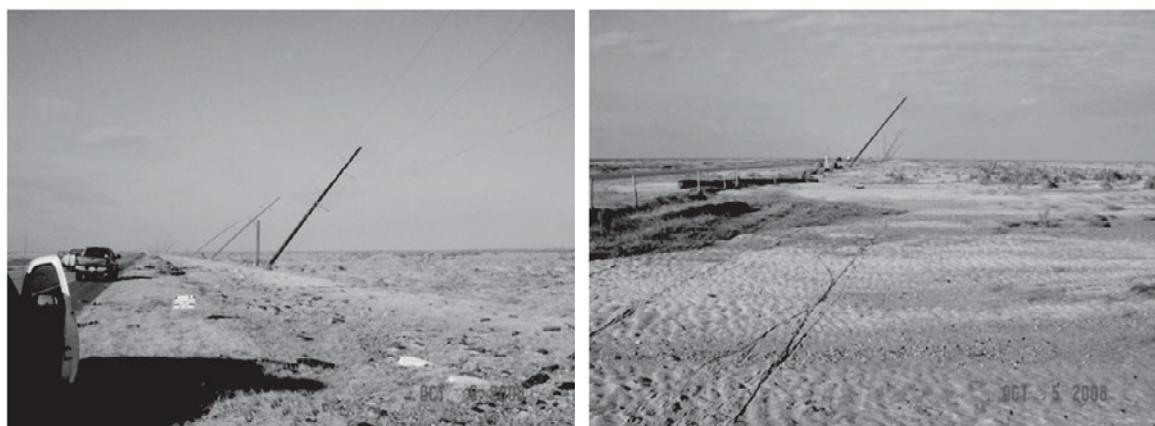
Widespread power loss occurred during the storm. One of the most significant factors was the lateral failure of power poles supporting the overhead power lines. The combination of saturated soils, wind, and the storm surge resulted in the loss of lateral support, and many overhead power lines failed as a result (Figure 7-1). Erosion uncovered and damaged underground power lines in a few locations, but buried power lines apparently survived the hurricane with little damage for the most part. Deeper pole embedment may have saved some of the overhead power lines.

Figure 7-1. Overhead power line damage on Highway 87, Bolivar Peninsula

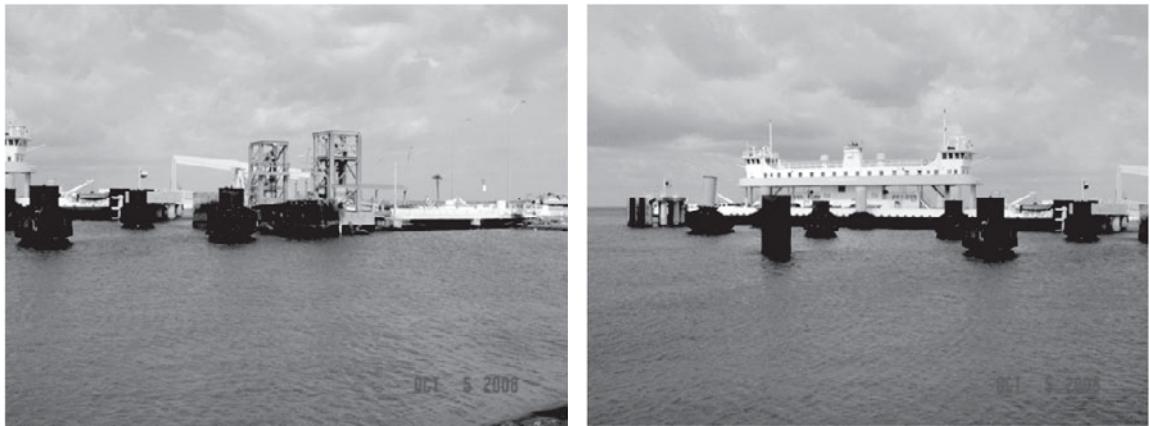
Although a large amount of debris was deposited around the Bolivar Ferry Terminal, the loading structures and harbor apparently experienced only minor damage, and reportedly, the terminal was partially operational shortly after the hurricane (Figures 7-2 and 7-3). However, extensive damage occurred to some of the ancillary facilities, such as the pavilions and adjacent restroom building (Figures 7-4 and 7-5).

Figure 7-2. Minor damage to main facilities at the Bolivar Ferry Terminal

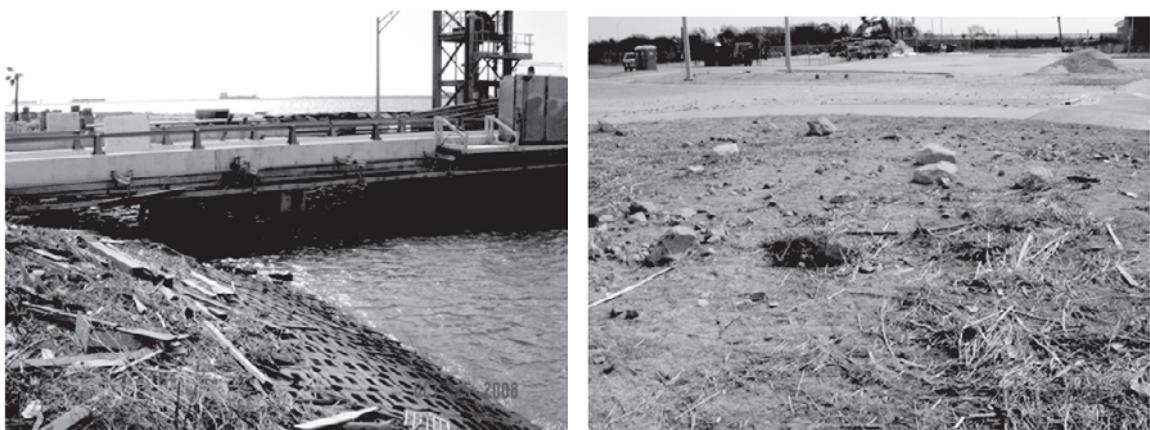
Figure 7-4. Storm debris and displaced rip rap stone at Bolivar Ferry Terminal

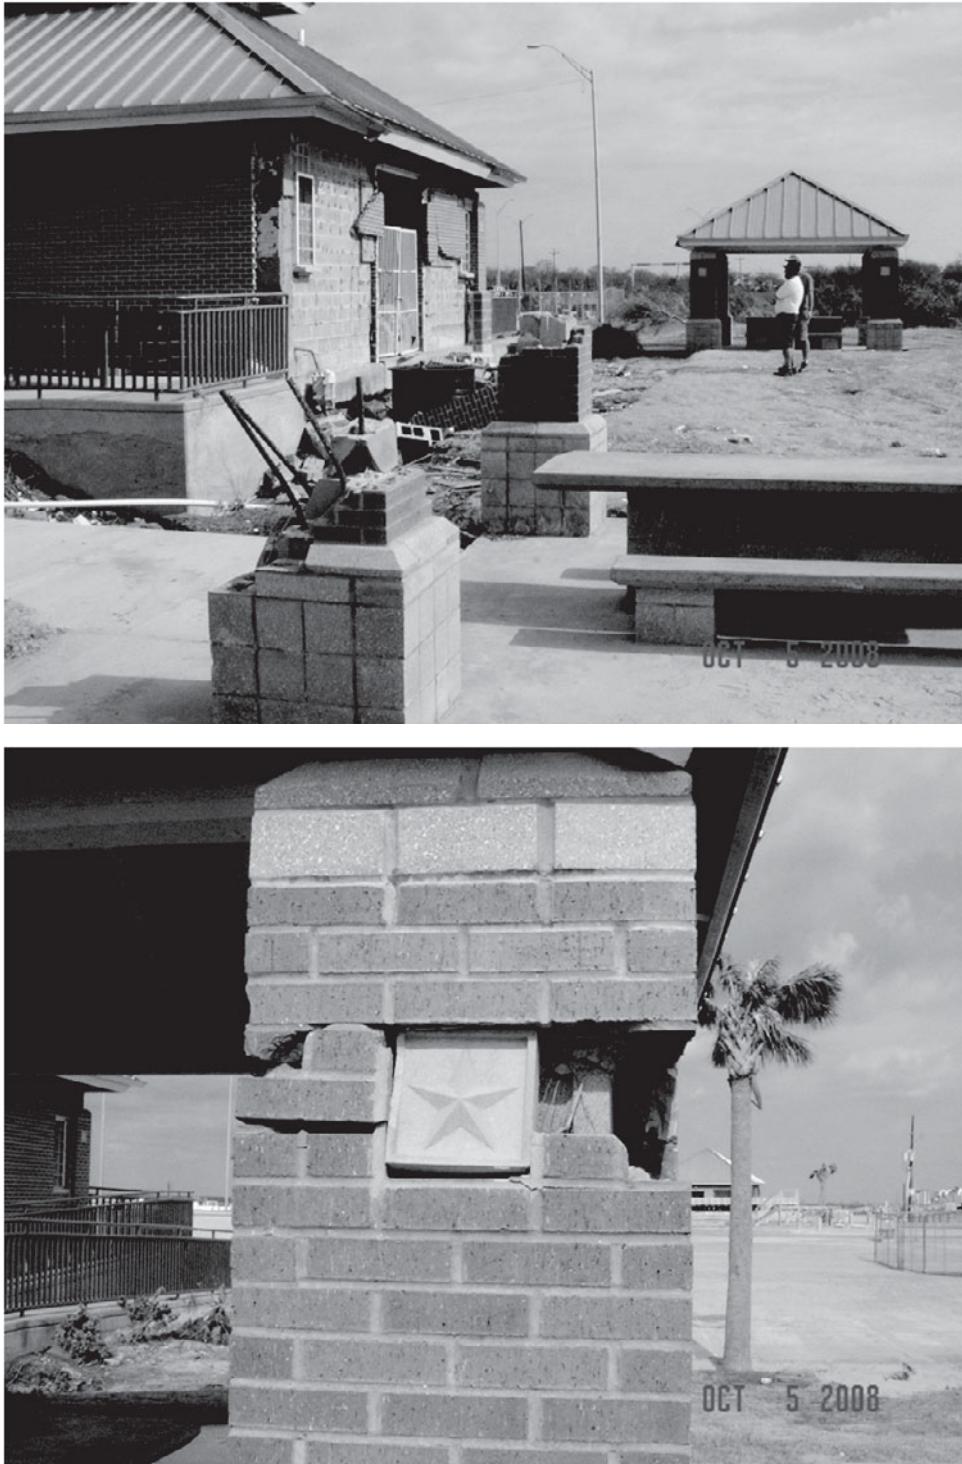
Figure 7-5. Extensive damage to pavilions and restroom facilities at Bolivar Ferry Terminal. Billy Edge, Ph.D., and Paul Work, Ph.D., are shown in top photo.

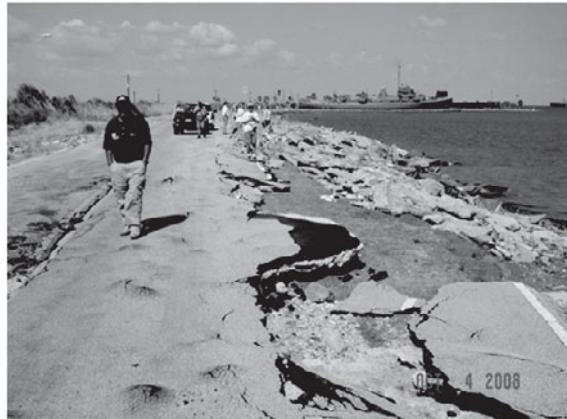
The investigation team observed extensive roadway pavement failures in numerous beachfront locations (Figures 7-6 to 7-9). Most of the pavement failures were caused by erosion of the base materials and uplift of the pavement surfacing during the surge. Some wearing surface was stripped from some of the roadways. This was specifically observed along the Galveston Seawall where waves overtopped the seawall with a very high velocity.

Figure 7-6. Pavement damage on Seawolf Parkway—Pelican Island Seawolf Park. Jeff Waters, Ph.D., is shown in foreground of left photo.

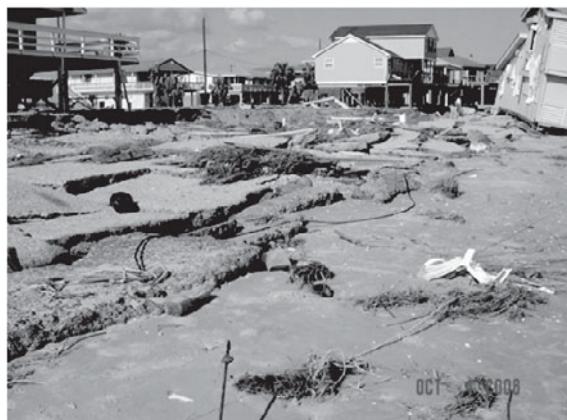
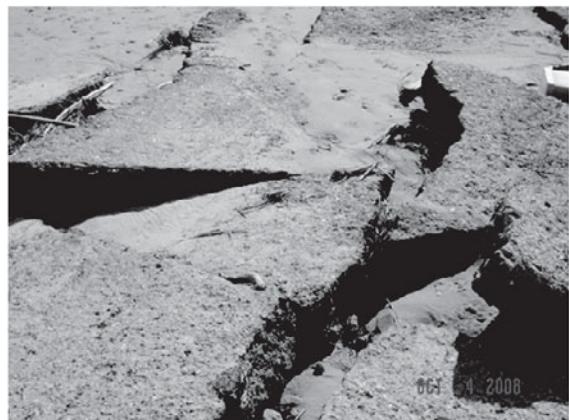
Figure 7-7. Destruction of Residential Roadway—Bermuda Beach near San Luis Pass

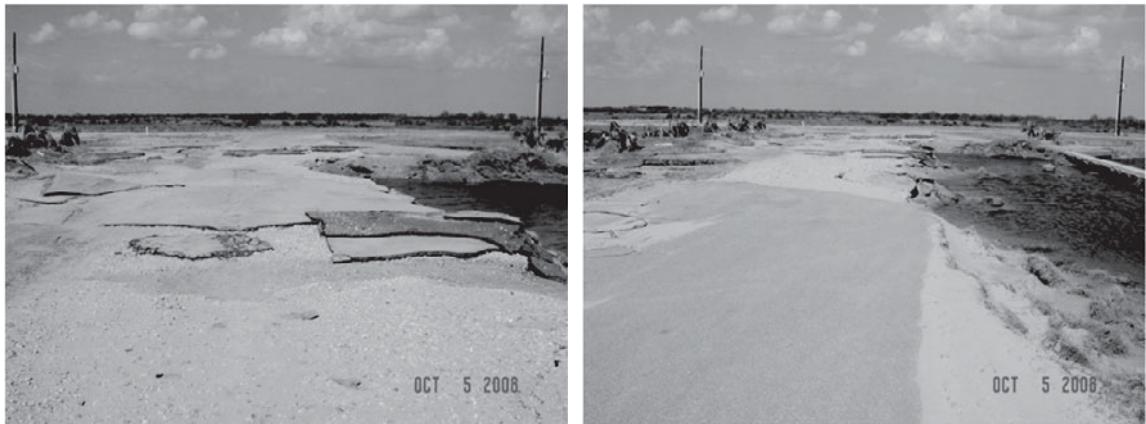
Figure 7-8. Entrance Road Damage—The Biscayne off Highway 87

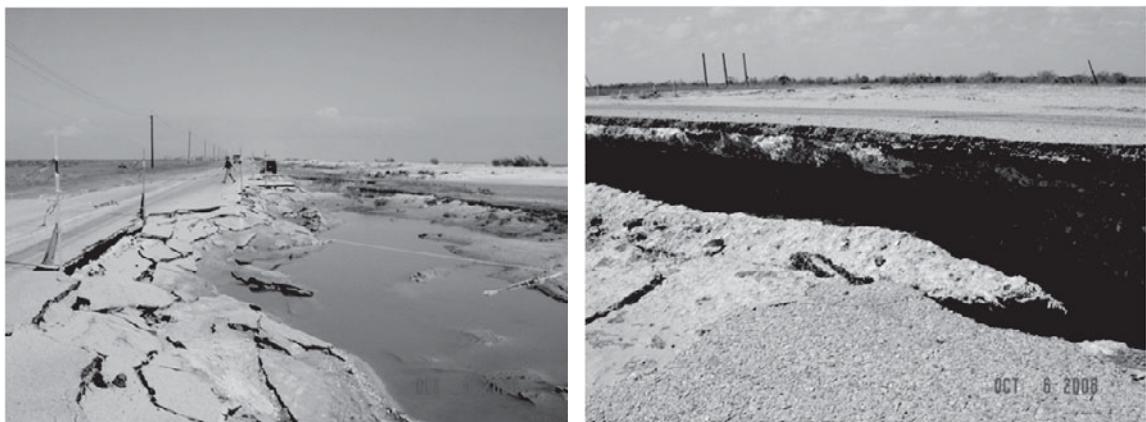
Figure 7-9. Roadway Damage—Coastal Highway between San Luis Pass and Surfside Beach

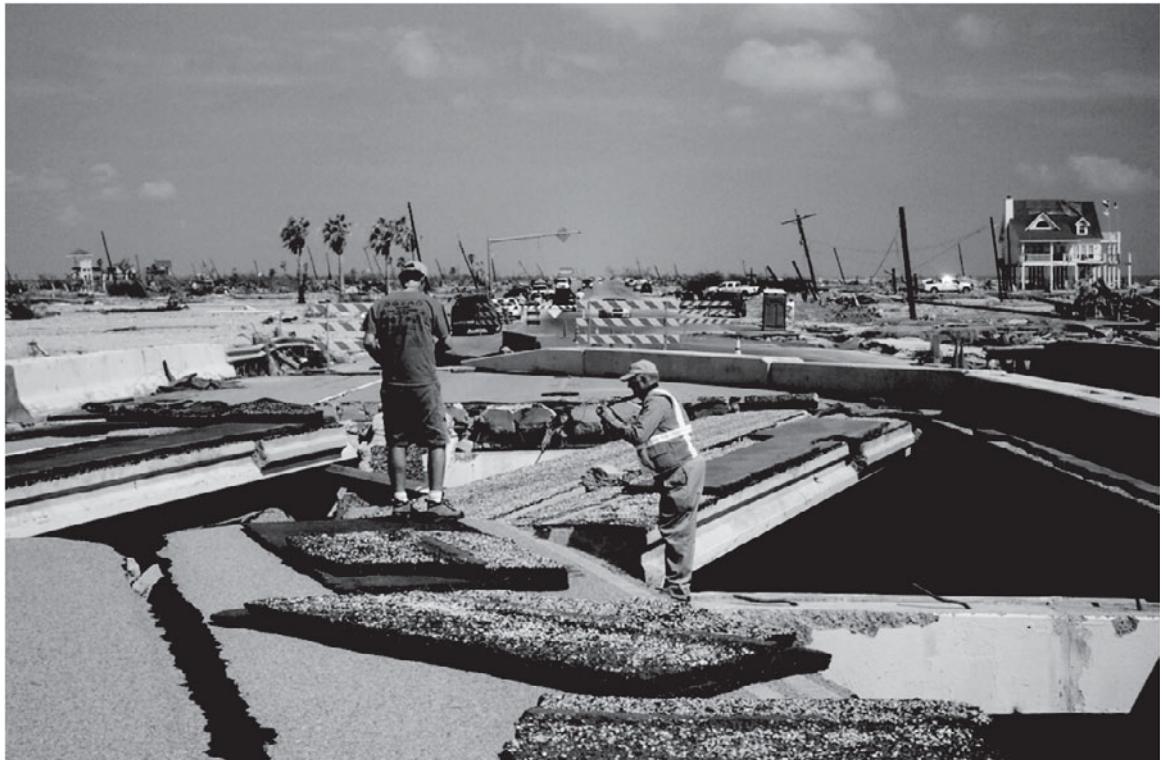
Figure 7-10. Bridge deck damage at Rollover Pass Bridge—Highway 87. Paul Work, Ph.D. and Garry Gregory, Ph.D. (l to r) are shown on the bridge during the investigation.

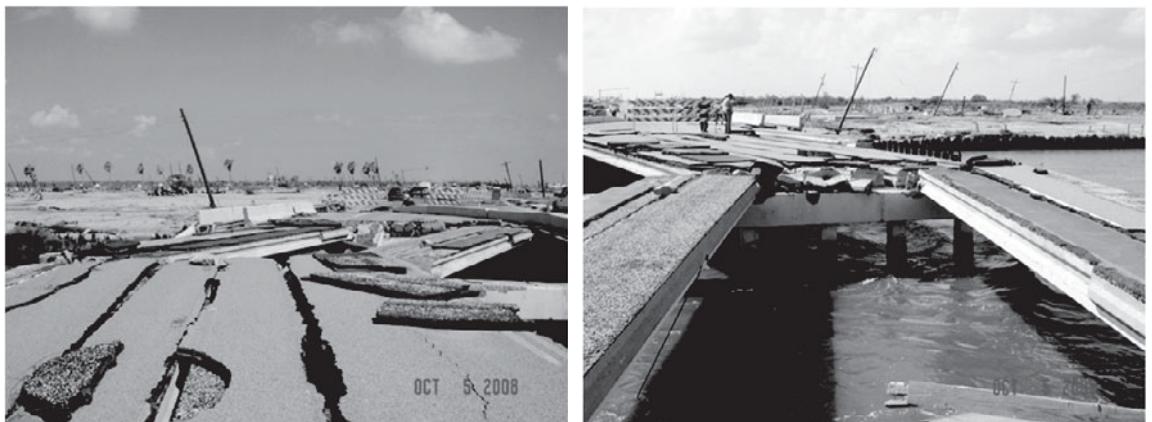
The Highway 87 bridge at Rollover Pass incurred extensive damage and displacement of the bridge deck (Figures 7-10 to 7-14). Amazingly, one outside lane remained sufficiently intact to allow limited traffic flow. The bridge abutments and piers appeared to have suffered little damage. The bridge deck failure was apparently caused by lateral and uplift forces from the storm surge and waves. A sheet pile weir just downstream of the bridge may have contributed to the failure. The deck failure occurred over the bridge piers at the connection between adjacent deck spans. The deck consisted of prestressed concrete panels, which were connected with a cast-in-place reinforced concrete filler beam that connected the adjacent panels and was anchored to the bridge piers with vertical reinforcing steel dowels. The failure mode appears to have been bond failure and stripping of the concrete filler beam from the dowels embedded in the bridge piers.

Figure 7-11. Rollover Pass bridge deck damage

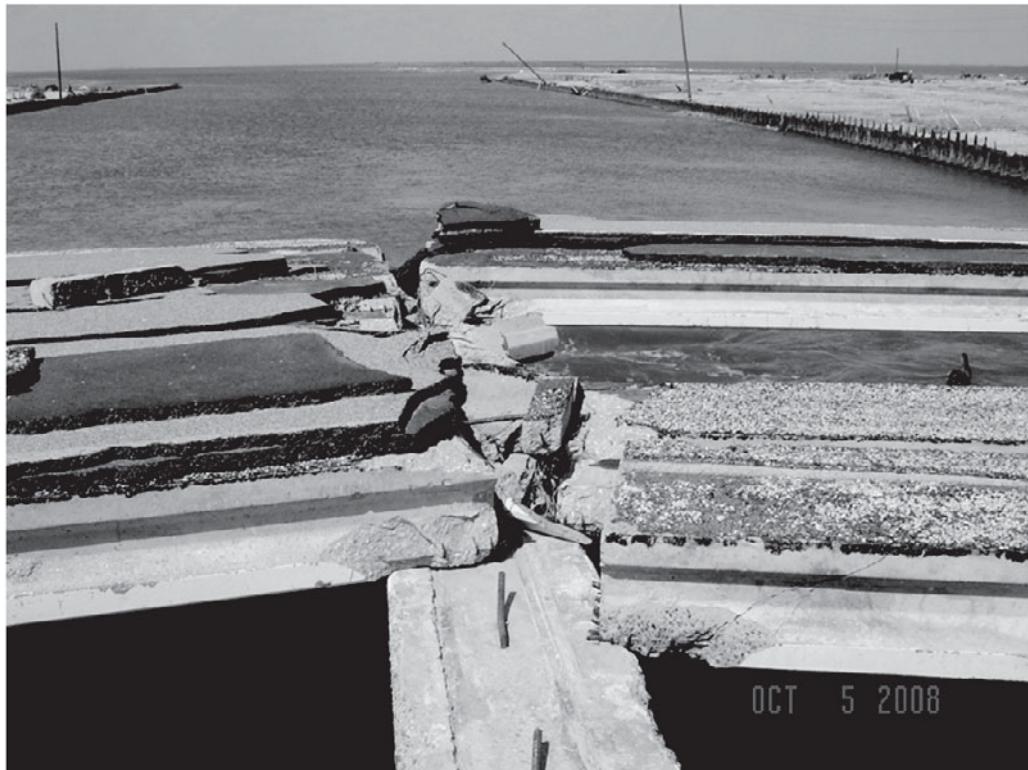
Figure 7-12. Bridge deck connection filler beam stripped from bridge pier dowels

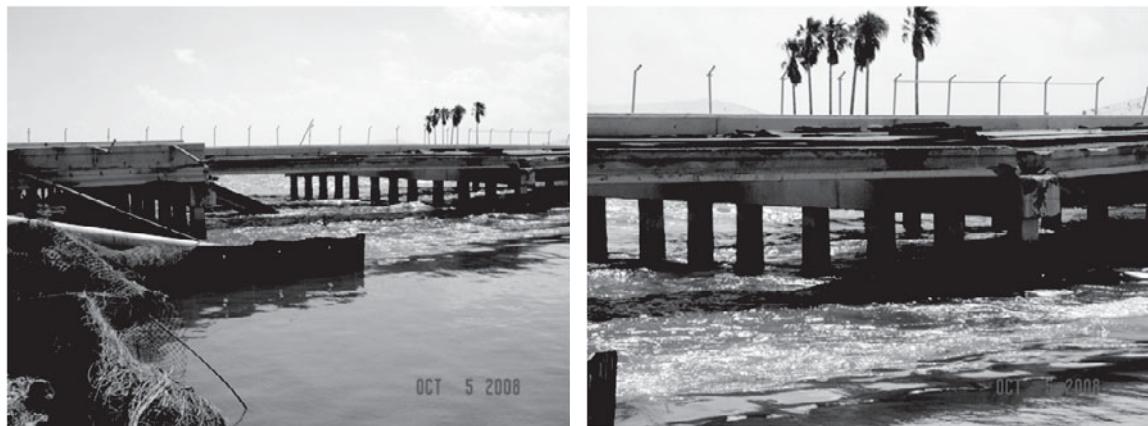
Figure 7-14. Bridge piers intact beneath displaced deck panels. Sheet pile weir in left photo.

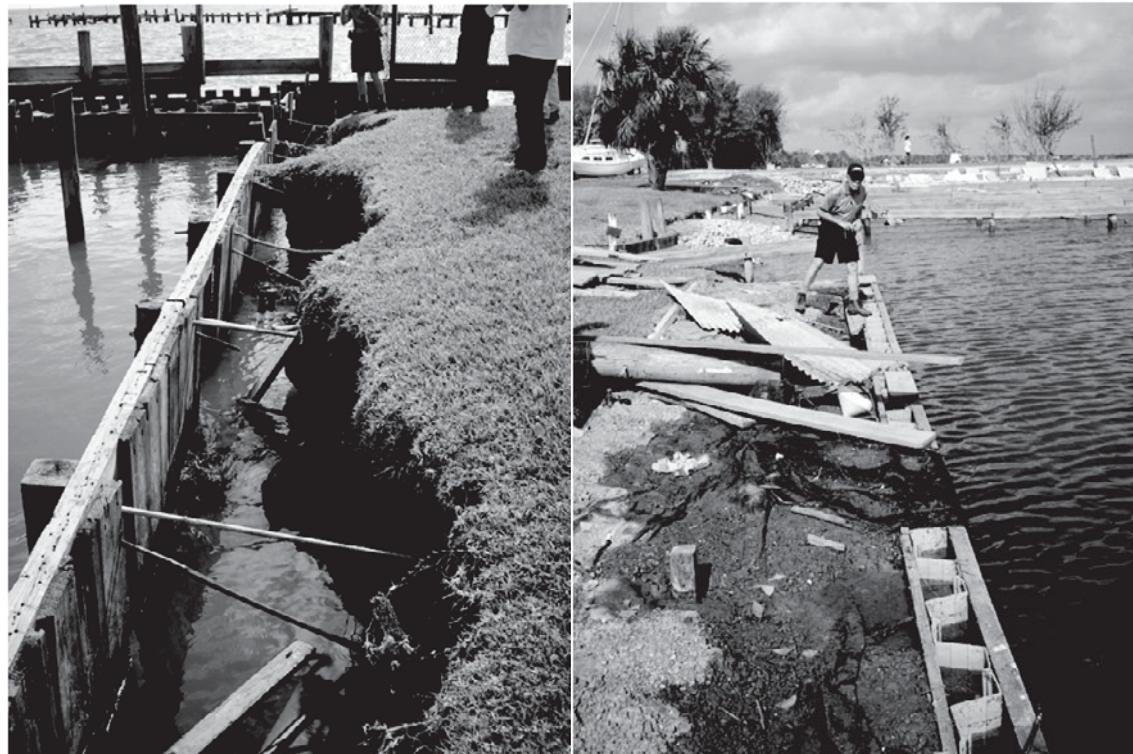
Figure 7-16. Scour damage to wooden and aluminum bulkheads at Houston Yacht Club with Billy Edge, Ph.D., shown in right photo.

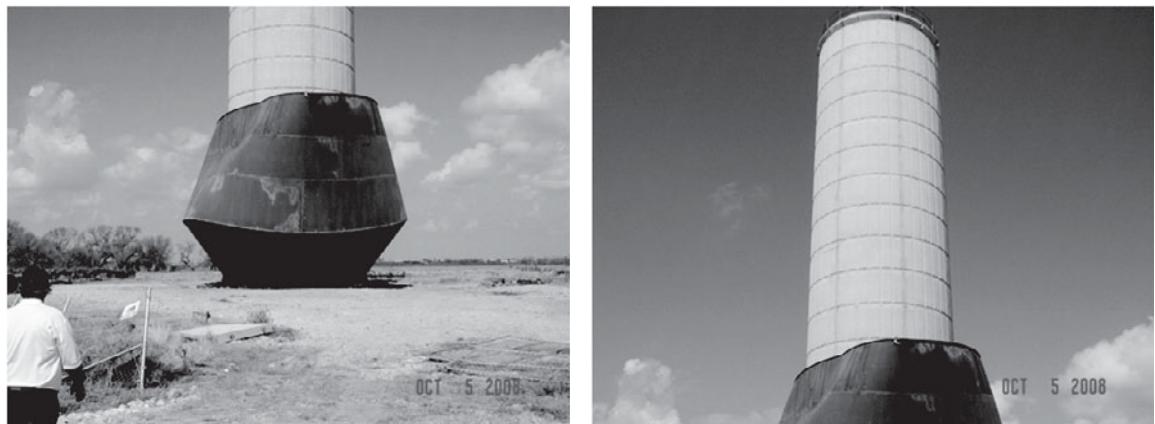
Several water storage tanks, including ground storage tanks and water towers, were observed during the field investigation (Figures 7-17 to 7-21). None of the water storage tanks appeared to have any significant damage except for the steel tank that was apparently being fabricated at ground level when the hurricane struck (Figure 7-17). The damage to the partially fabricated tank occurred prior to the tank being raised to the top of the pedestal. The pedestal did not appear to be damaged. Apparently, the existing ground storage tank on the adjacent property did not experience any significant damage.

Figure 7-17. Damaged steel water tank on Highway 87 Bolivar Peninsula, which was evidently being fabricated when Hurricane Ike occurred. No apparent damage to pedestal.

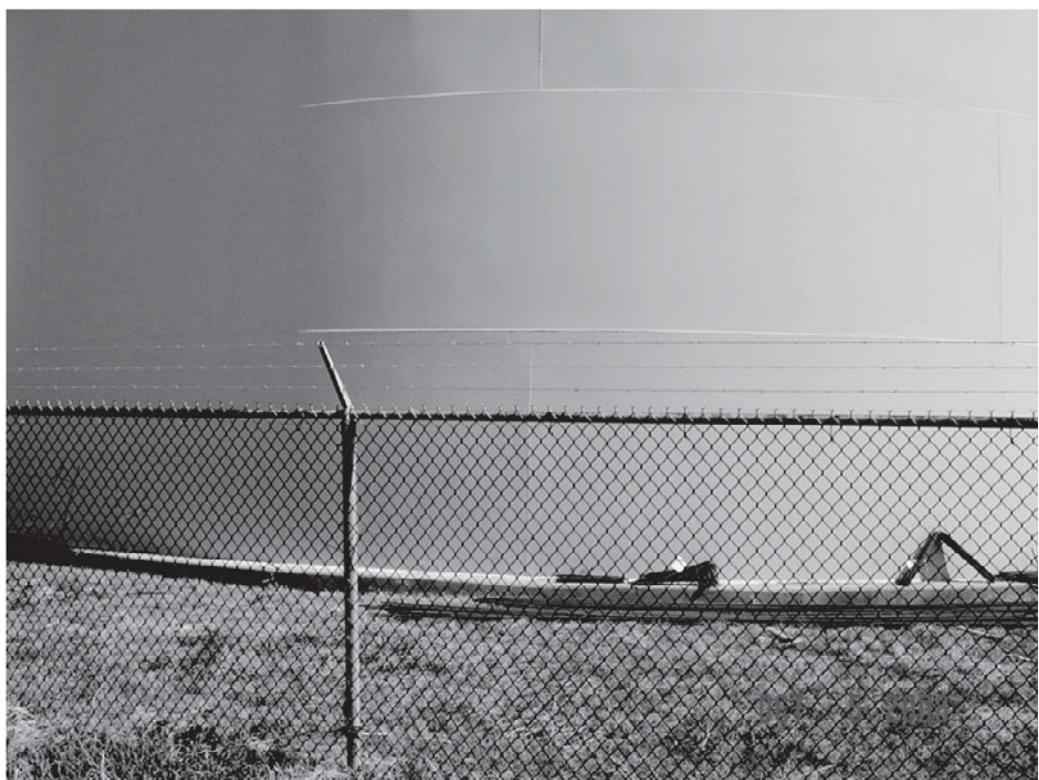
Figure 7-18. No apparent damage to ground storage tank adjacent to water tower shown in Figure 7-17

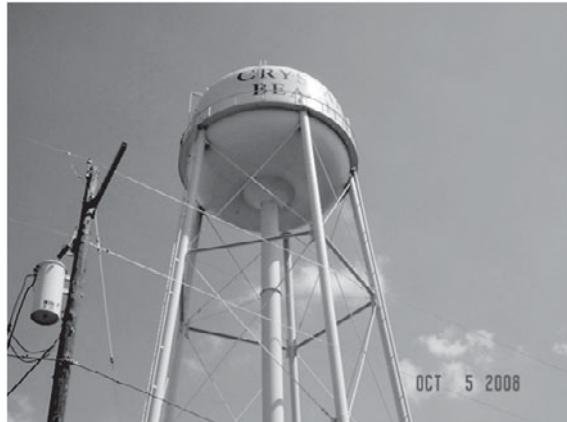
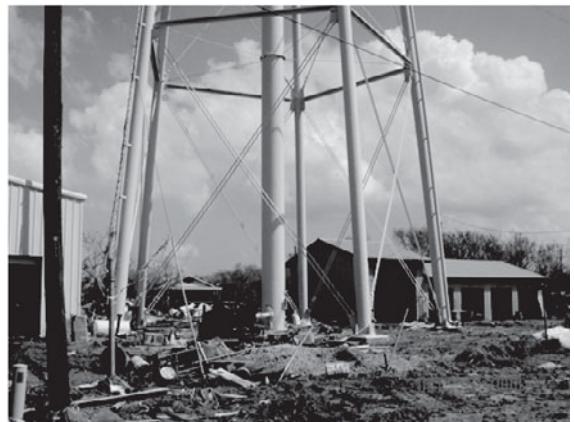
Figure 7-19. Water tower on Tuna Drive at Crystal Beach. No apparent damage to actual tower.

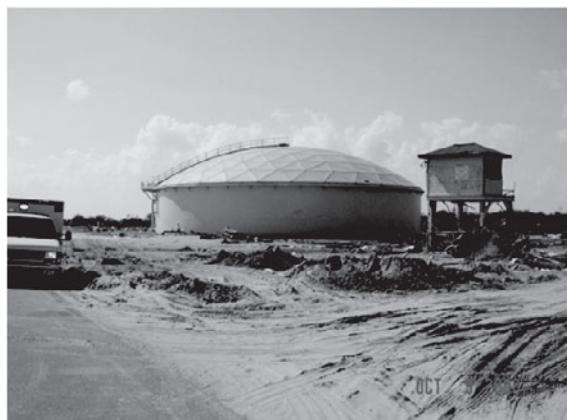
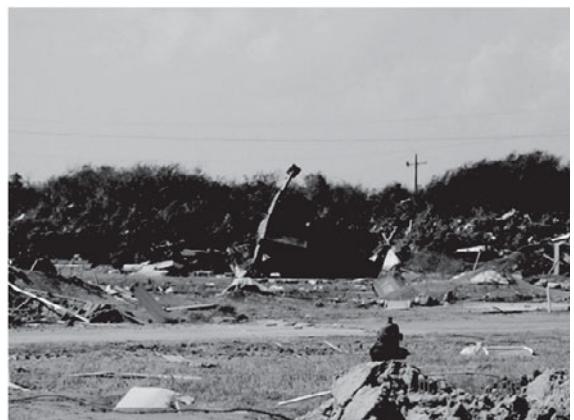
Figure 7-20. Ground storage tank (left) apparently not damaged. Adjacent debris (right) indicates extensive debris trail of storm—Highway 87 Bolivar Peninsula

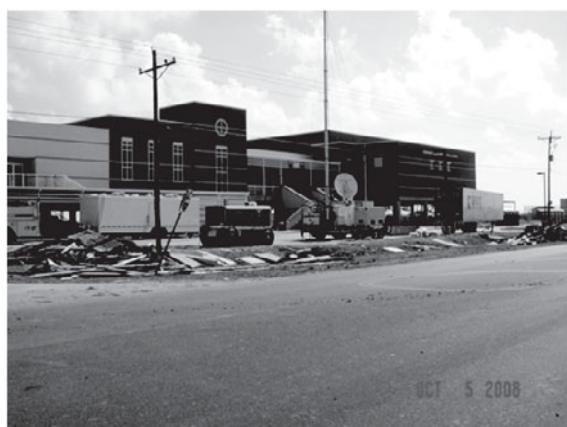
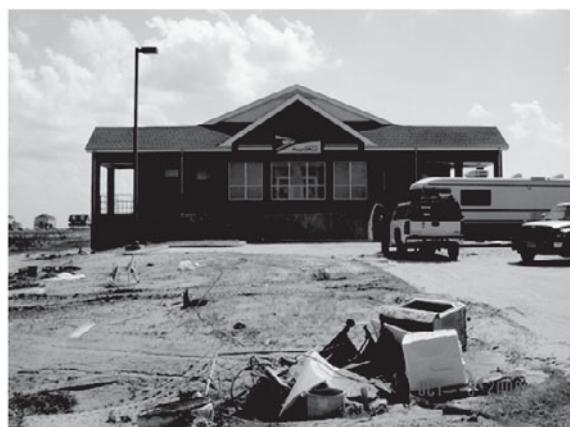
An elementary school building, which was nearing completion, and an existing small post office building were observed along Highway 87 on Bolivar Peninsula (Figure 7-22). Based on visual exterior observations, these structures did not appear to have incurred any noticeable damage. It was observed that both were located on top of fill, nearly 2 m above the road surface of Highway 87.

Figure 7-21. Elementary school (left) nearing completion of construction and existing post office (right) near Highway 87, Bolivar Peninsula. No apparent structural damage.

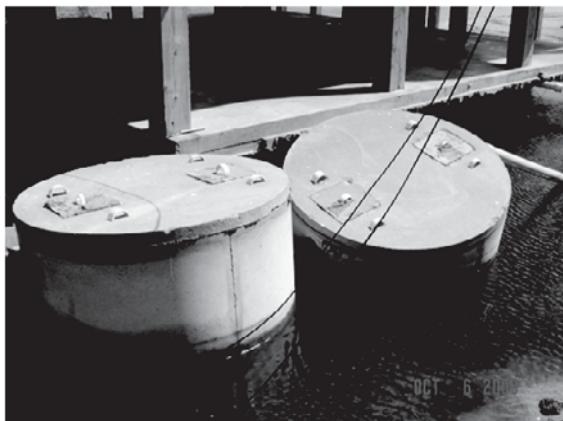
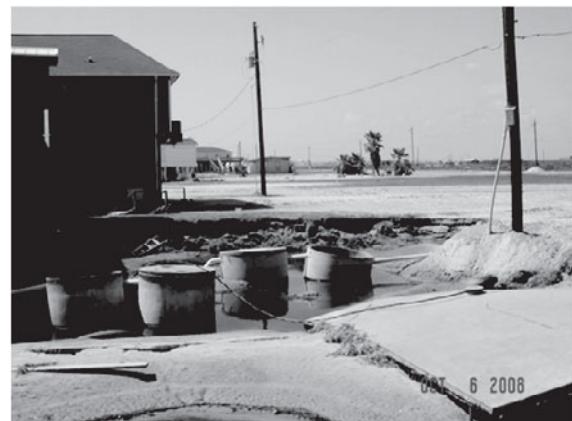
Utility lines appeared to have been damaged mostly in beachfront areas. Many locations experienced damage to septic tanks when a combination of scour and buoyancy lifted and exposed the tanks causing damage to connecting pipes and power cables (Figure 7-23).

Figure 7-22. Septic systems damaged by scour and buoyancy

In many cases damage to utilities could have been lessened if appropriate scour and erosion protection had been provided. In other cases, such as the water line on Rollover Pass Bridge, the damage could only have been prevented if the bridge deck had been protected from failure.

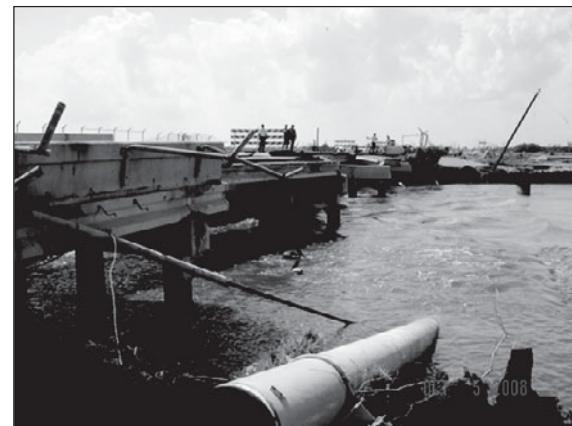
Based on local reports, many sanitary sewer lines and manholes were compromised when they were silted in by the storm surge and overwash deposits. Water supply pipelines were damaged in numerous locations where they were exposed by erosion or were connected to other facilities that were damaged (Figure 7-24).

Figure 7-23. Damaged water line at Rollover Pass bridge crossing

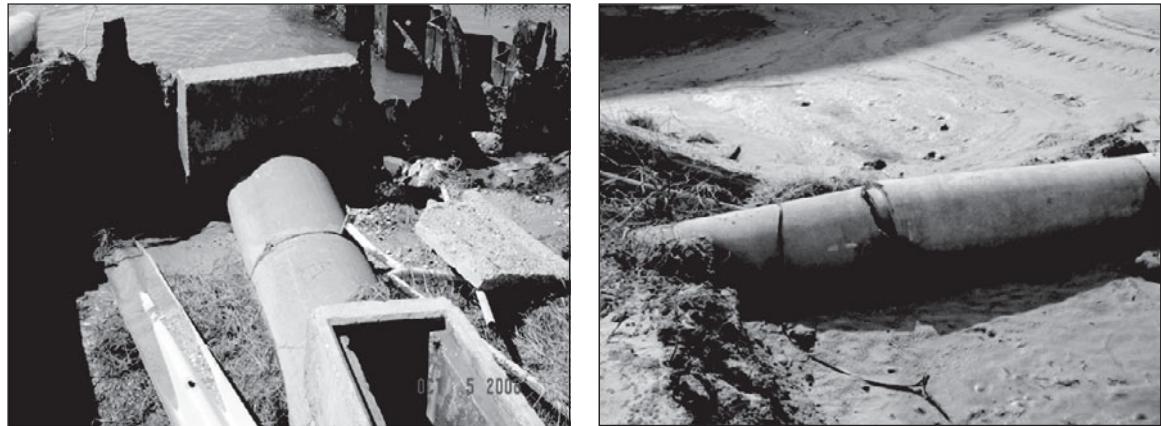
Figure 7-24. Damaged storm drains (Rollover Pass, left photo; The Biscayne, right photo)

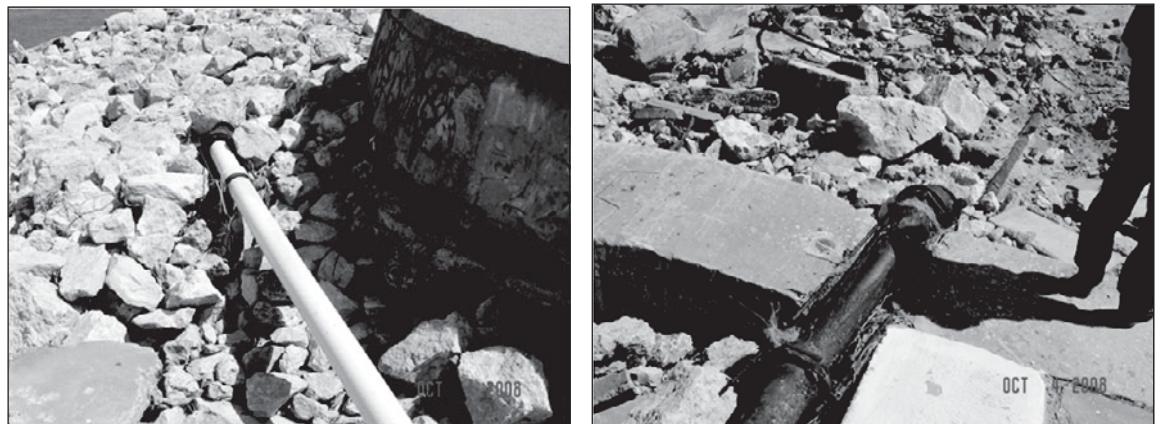
Figure 7-25. Damaged utility lines due to scour

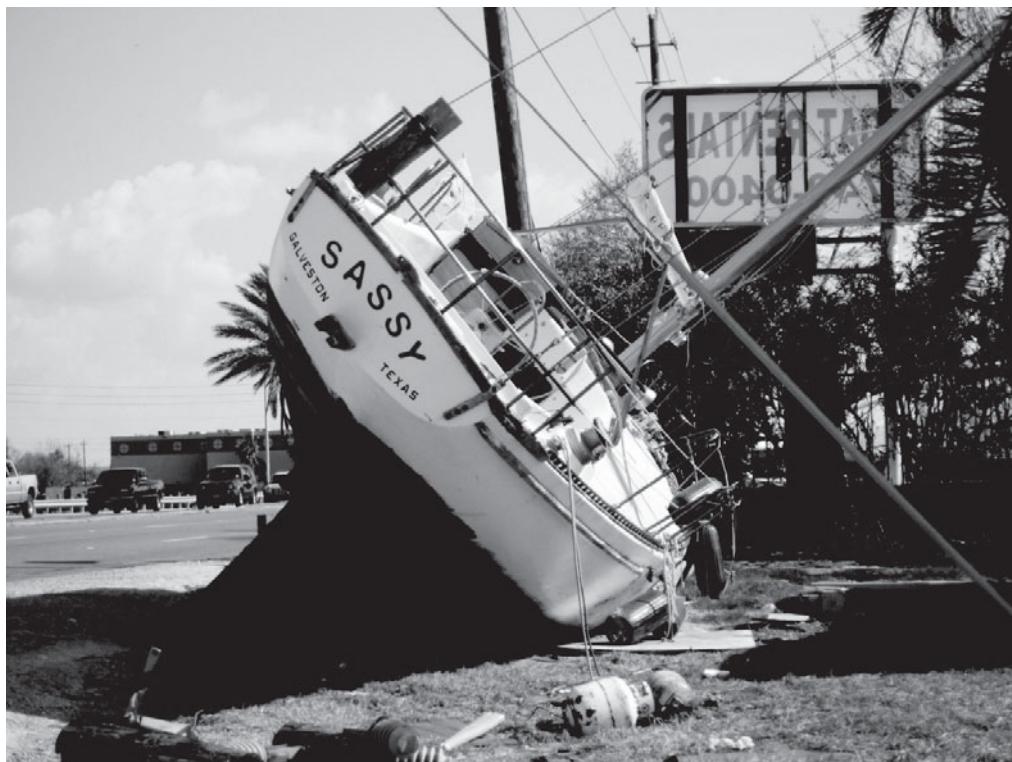
A view of some of the effects of the storm surge plus wind is indicated by the boat in Figure 8-1.

Figure 8-1. Example of boats carried inland with storm surge

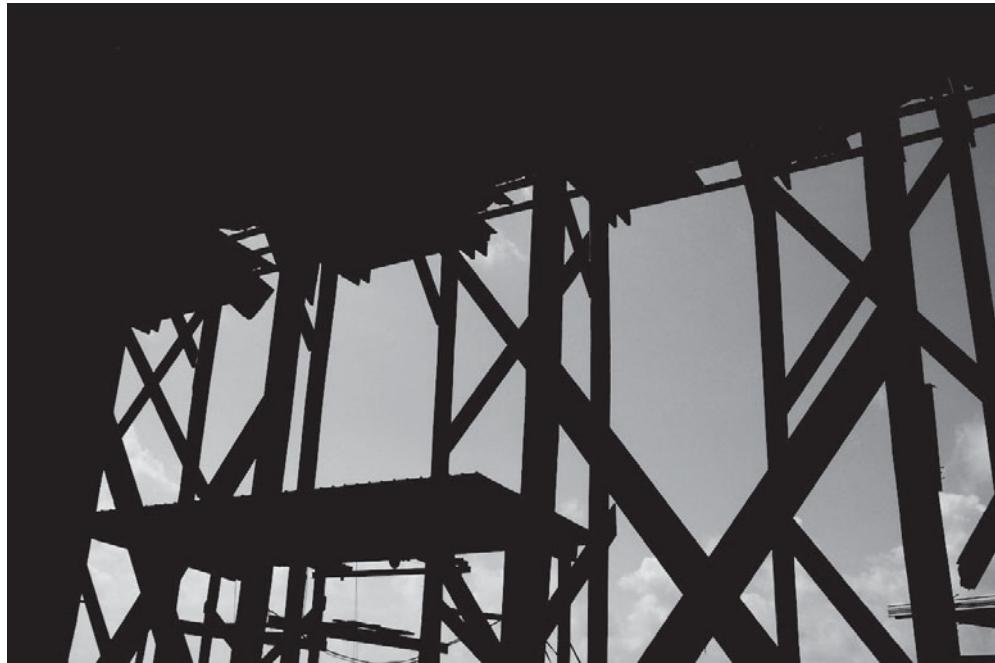
Figure 8-2. Damages to roof at Bolivar Yacht Basin

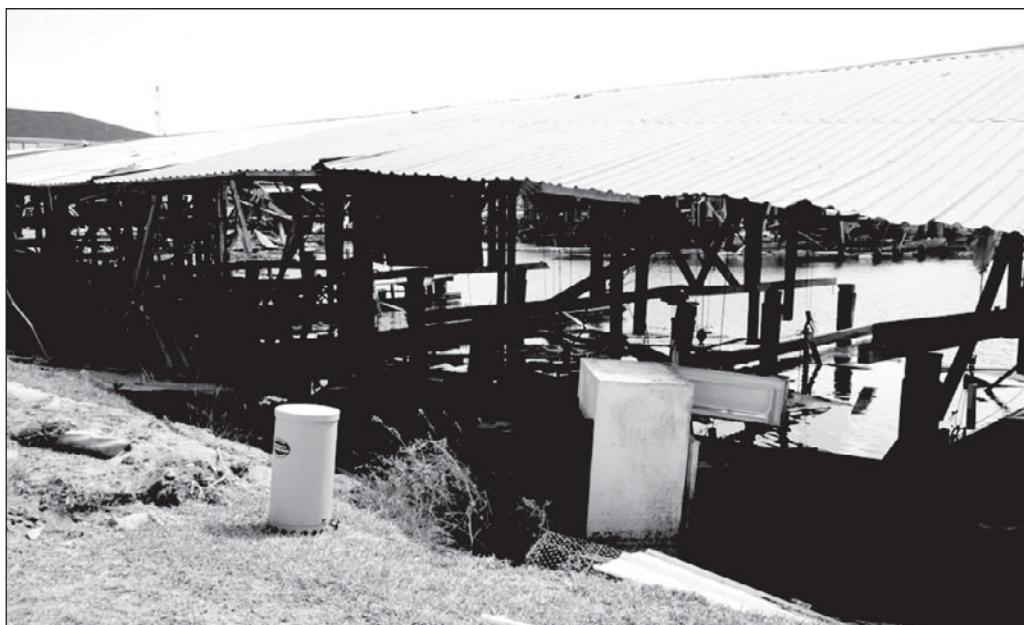
The marina received significant structural damage from the storm. There were several instances of appliances and other household materials that had been pushed into the boat slips (Figure 8-3). Some of the debris could have come from the damaged restaurant. Roof material was stripped off the covered boat slips in many instances and carried to the open area landward of the marina. Many of the taller slips still maintained their roofing material, albeit with edge damage from the wind (Figure 8-4).

Figure 8-3. Appliances in the water near boat slips

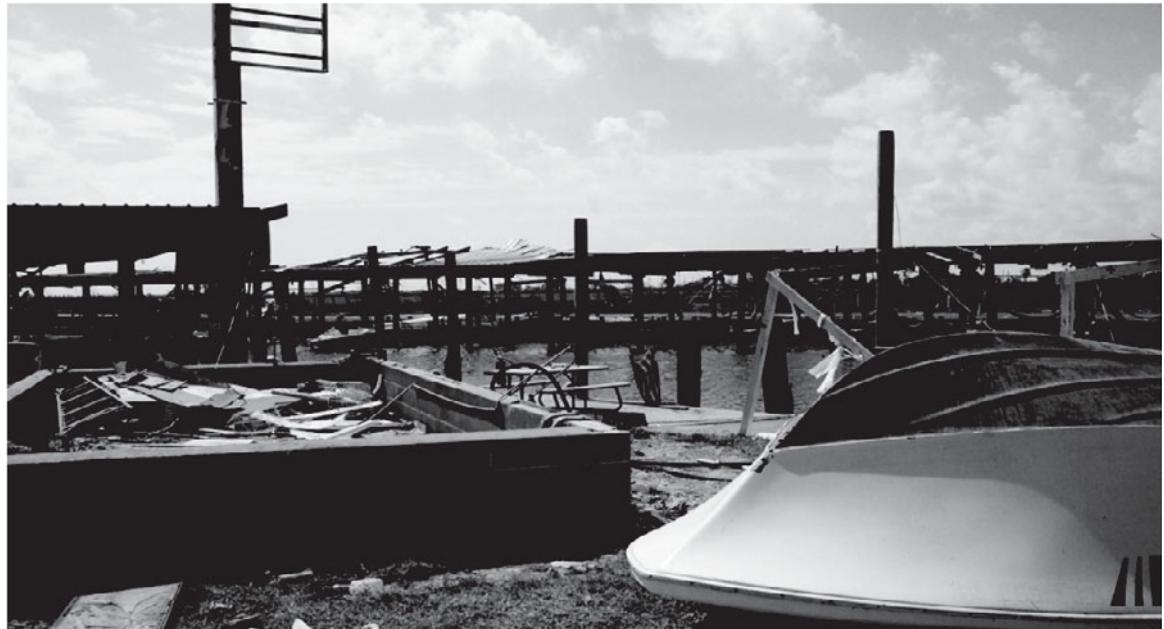
Figure 8-4. Damage to smaller slips

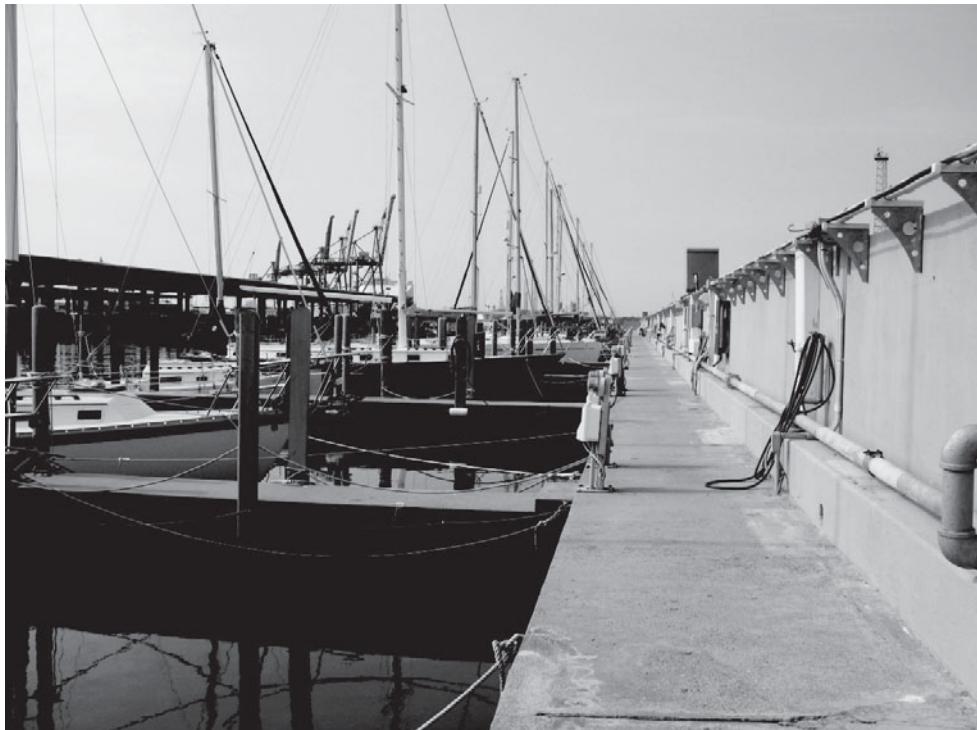
Figure 8-5. Sailboats at Galveston Yacht Club, in conditions similar to pre-storm

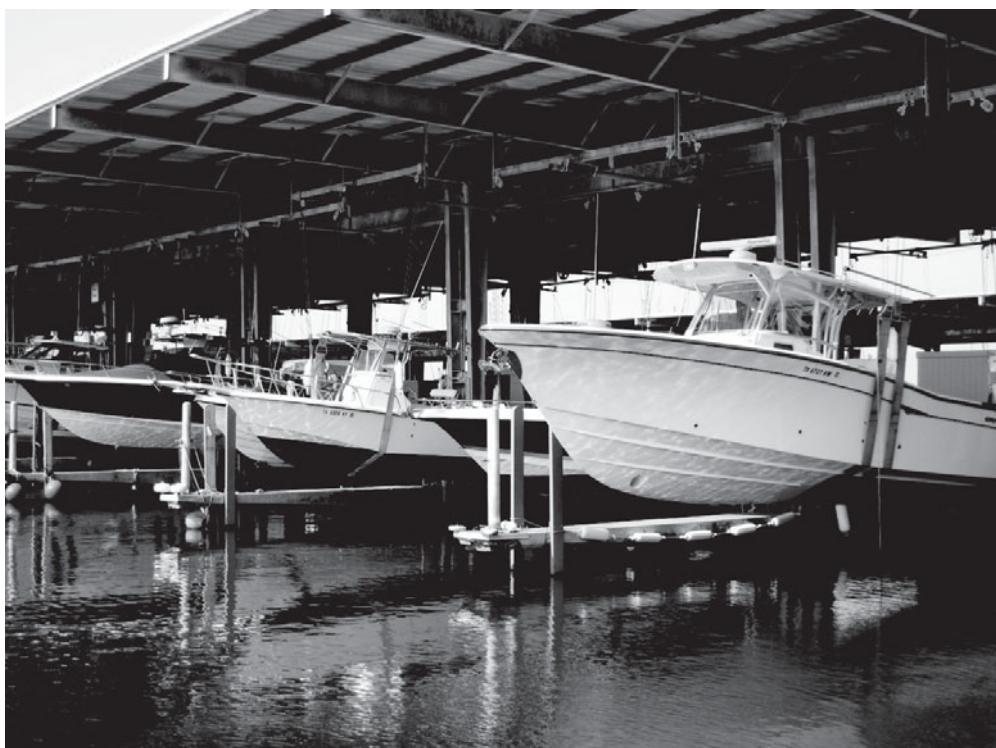
Figure 8-6. Powerboats at Galveston Yacht Club, in condition similar to pre-storm
