Hurricane Ike Field Investigation

*A Report of Field Observations
on October 3–6, 2008*

HURRICANE IKE FIELD INVESTIGATIONS

A REPORT OF FIELD OPERATIONS FROM OCTOBER 3–6, 2008

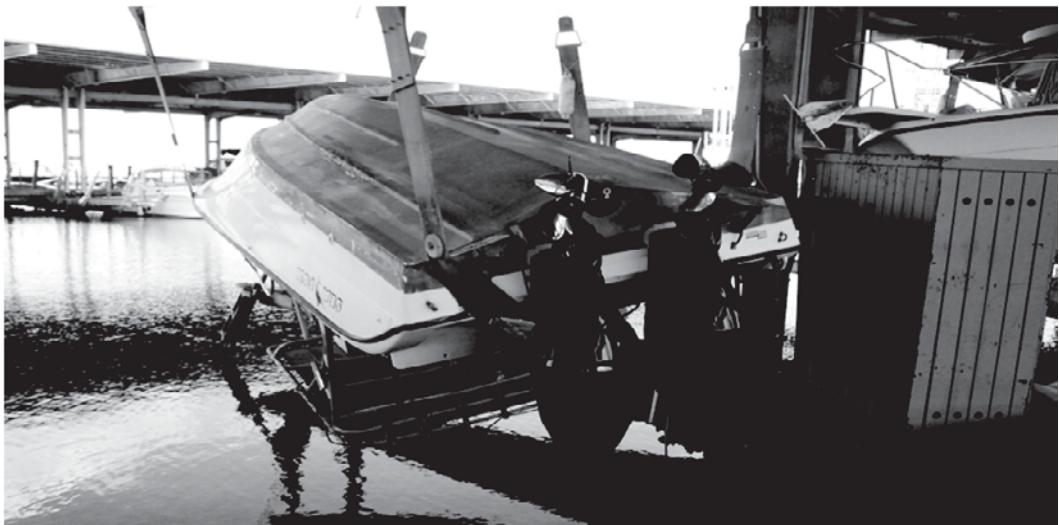
Figure 8-7. Boat twisted upside down in its sling in covered facility

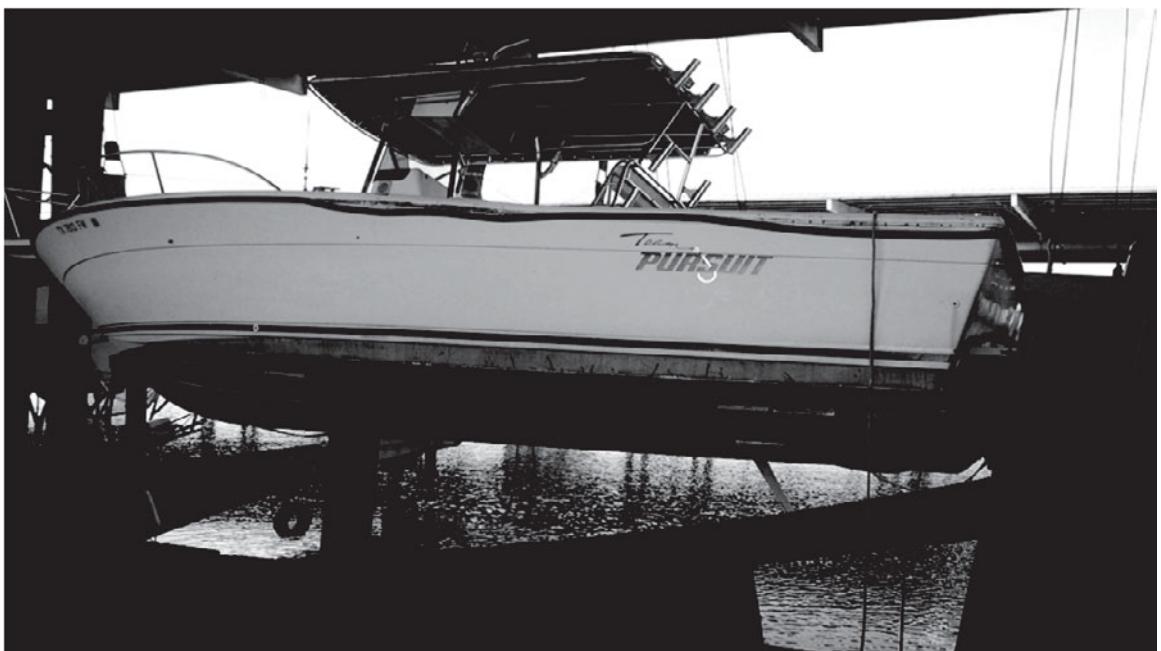
Figure 8-8. Boat resting on dockside pile in covered facility

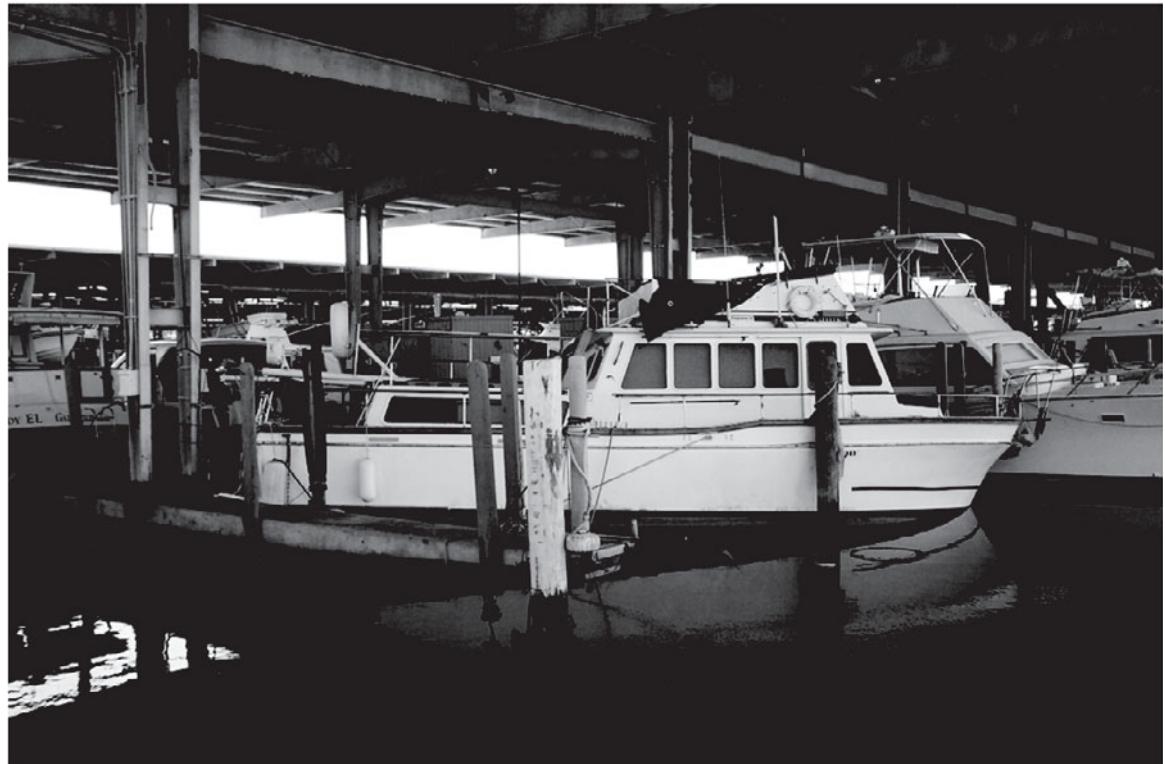
Figure 8-9. Power yacht straddling piles, Galveston Boat Basin.

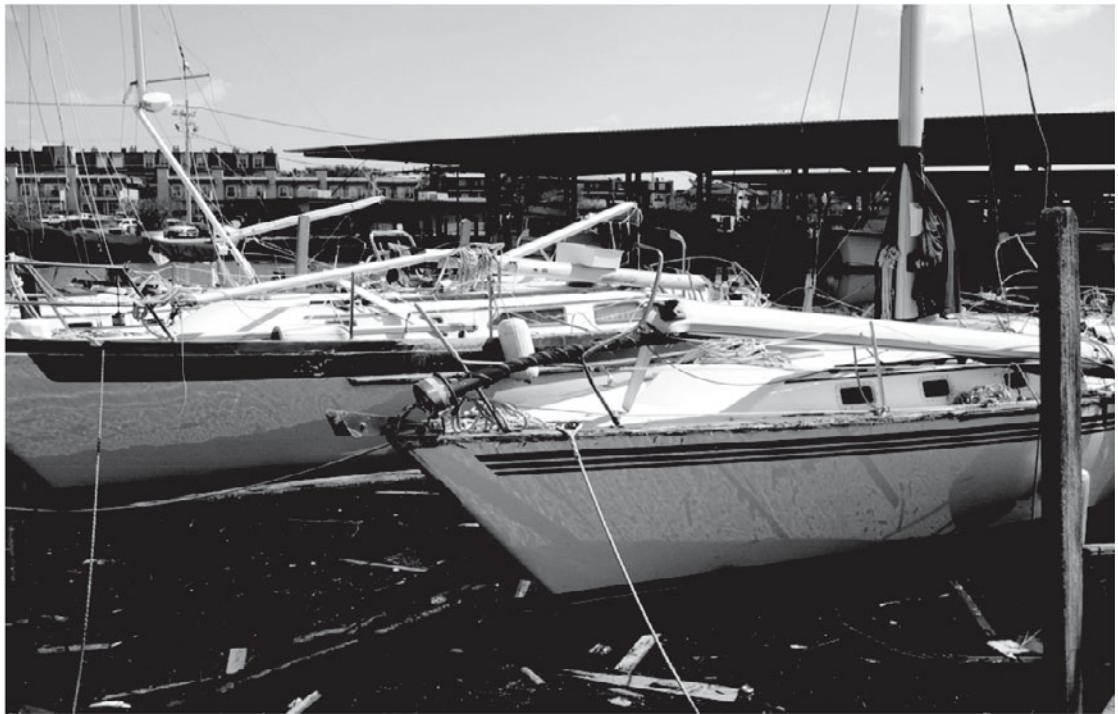
Figure 8-10. Damage to gunwales and masts, Galveston Yacht Club.

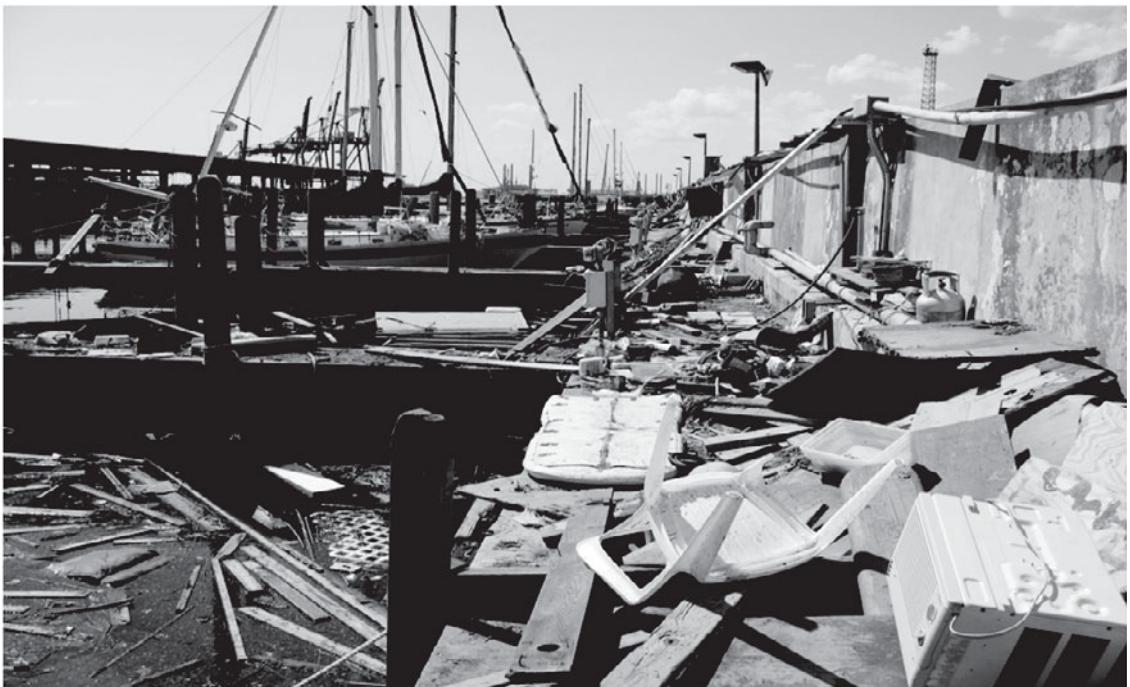
snapped in half in several slip locations. Several cleats had been pulled off the concrete deck; the connections were either undersized or connected too close to the edge of the concrete. Storm debris was present on the dockside nearest the bay. Damage to boats was widespread here; several had broken masts, and many had damage to the gunwales due to collision with or rubbing against the piles. There is some suspicion that several boats were not properly configured to survive a storm. Several boats had ripped sails and broken masts, and some slips only appeared to have one or two fenders. Figures 8-10 through 8-13 show examples of this damage.

Figure 8-11. Storm debris quayside, Galveston Yacht Club

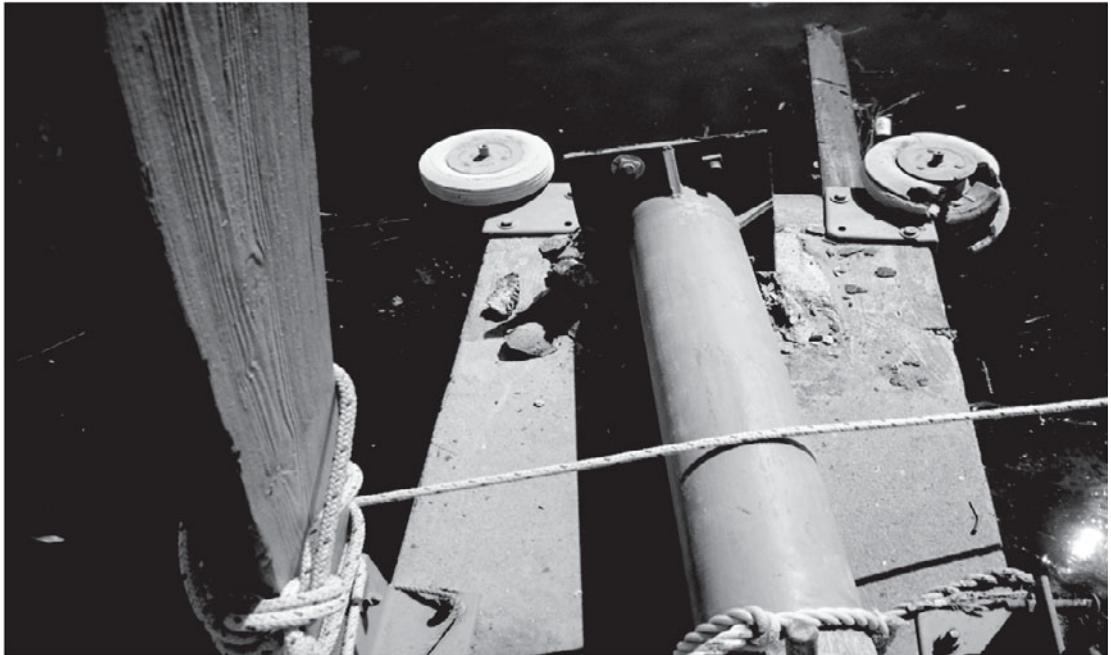
Figure 8-12. Broken column, Galveston Yacht Club

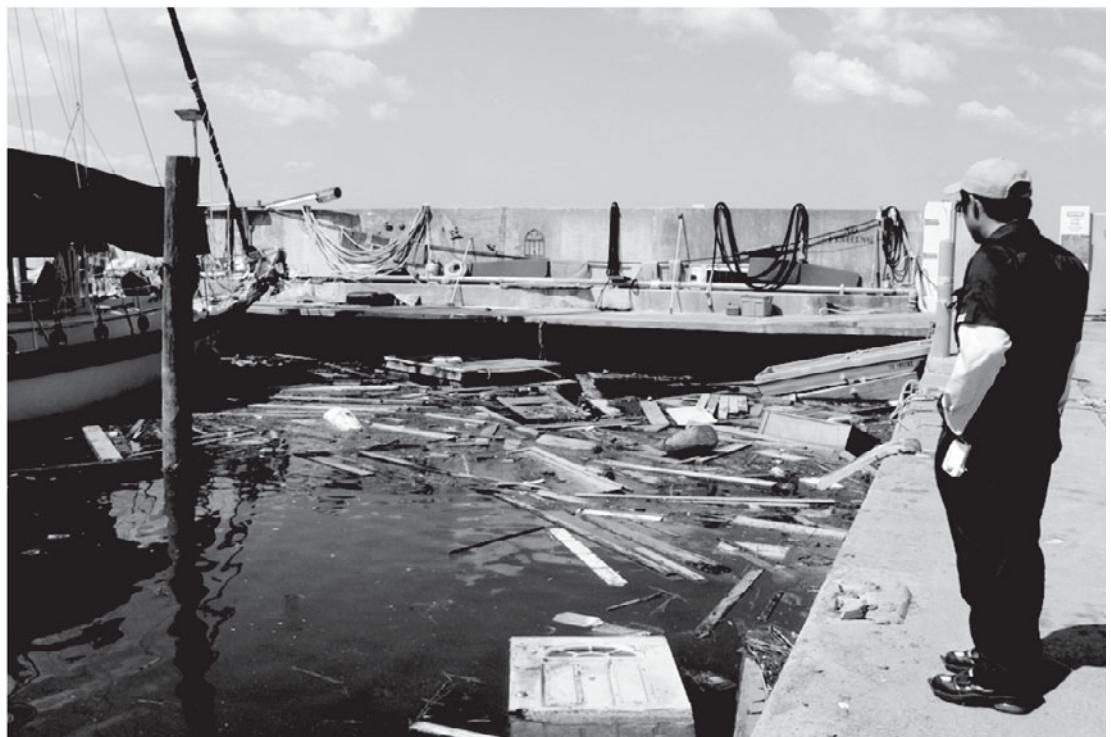
Figure 8-13. Storm debris in water, Galveston Yacht Club. Kajiro Suzuki, Ph.D., member of damage assessment team, is shown on the right.

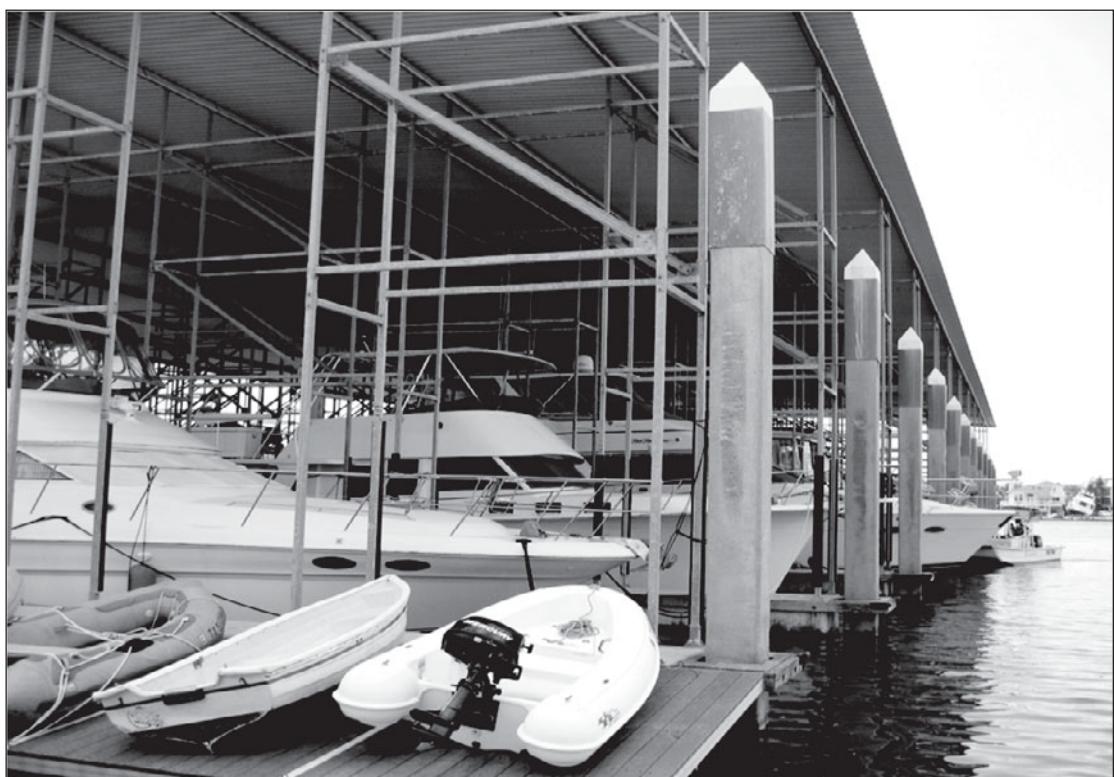
The marina boasted a large covered floating dock structure, which would allow the dock to rise with the surge. This structure appeared to perform well, although some scarring of the piles was evident as the floating dock rose and fell while buffeted by the surge. There was also some damage to part of the floating marina's siding. Figure 8-14 shows the marina; the scarring of the piles is evident as the storm surge lifted the floating finger piers.

Figure 8-14. Covered floating dock, Seabrook Shipyard

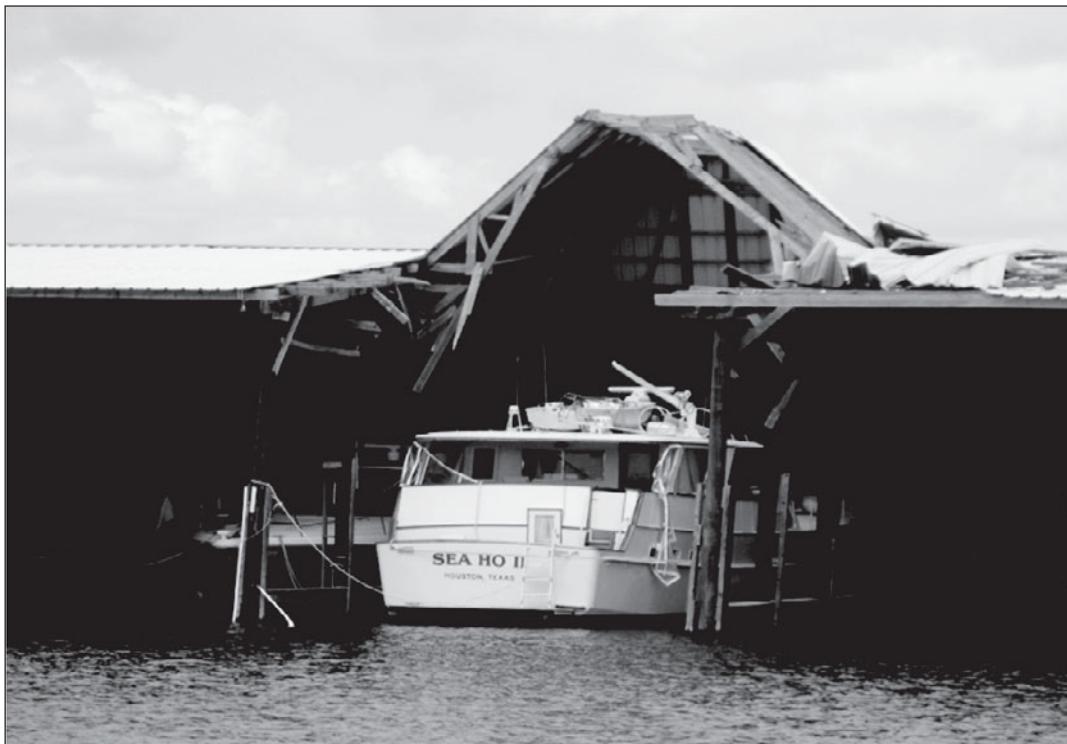
Figure 8-15. Damage to boat and roof of floating dock, Seabrook Shipyard

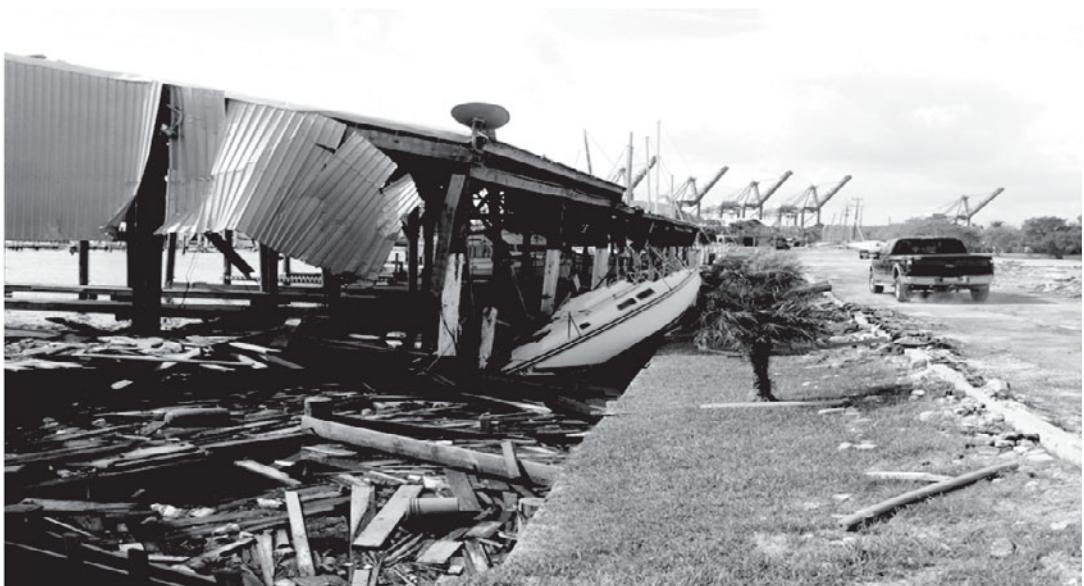
Figure 8-16. Boat driven through dock, Houston Yacht Club

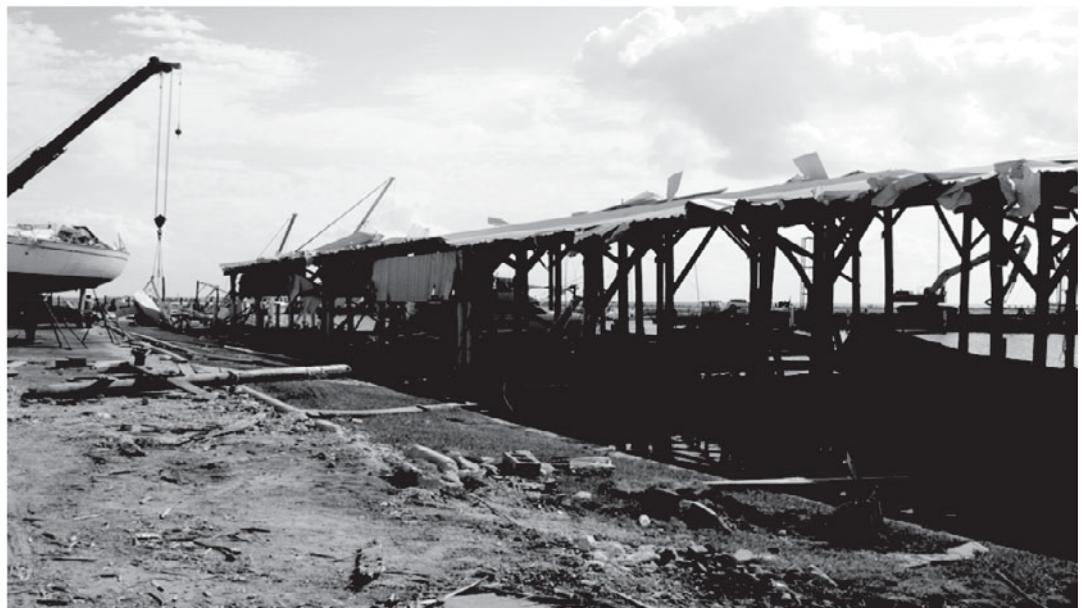
Figure 8-17. Severe dock damage, Houston Yacht Club

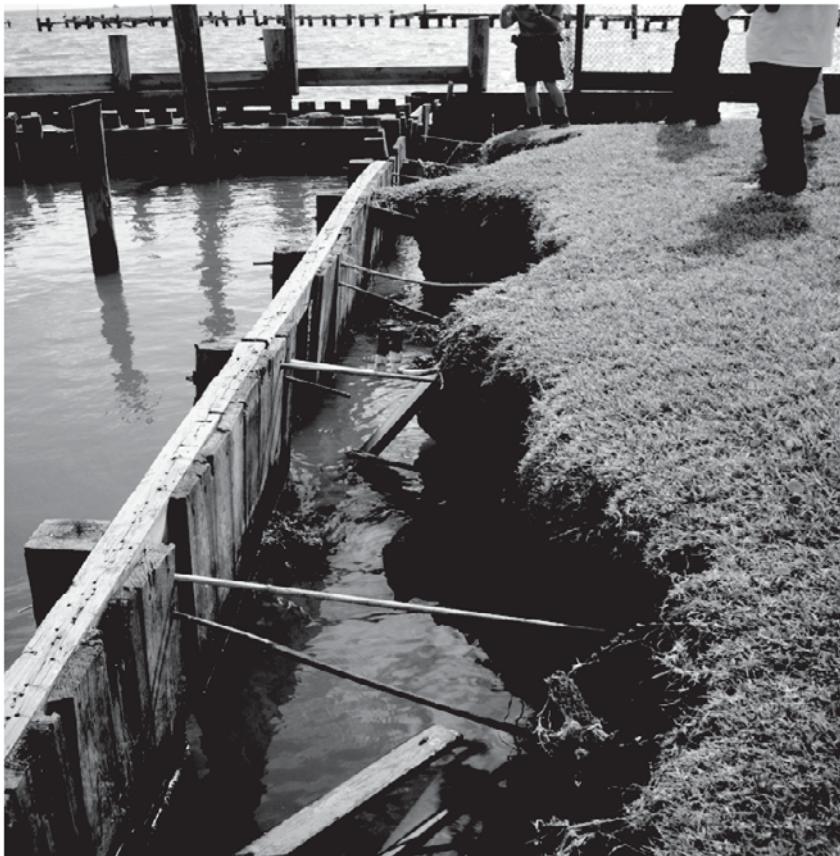
Figure 8-18. Erosion damage behind harbor bulkheads, Houston Yacht Club

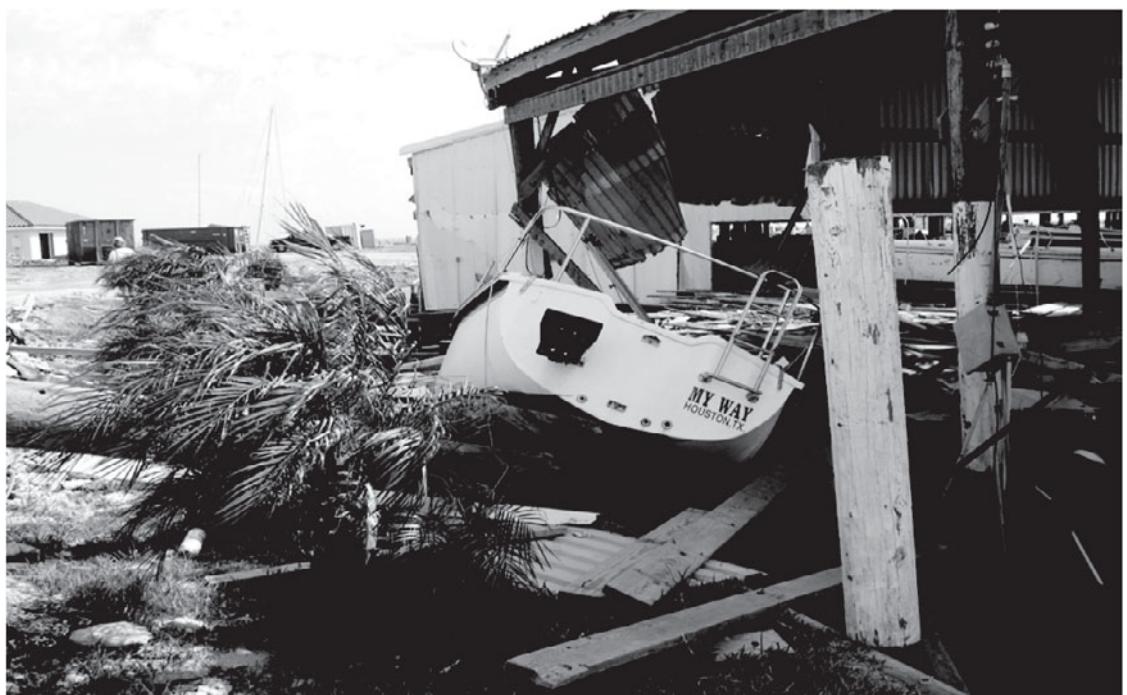
Figure 8-19. Boat and dock damage, Houston Yacht Club
@Seismicisolation

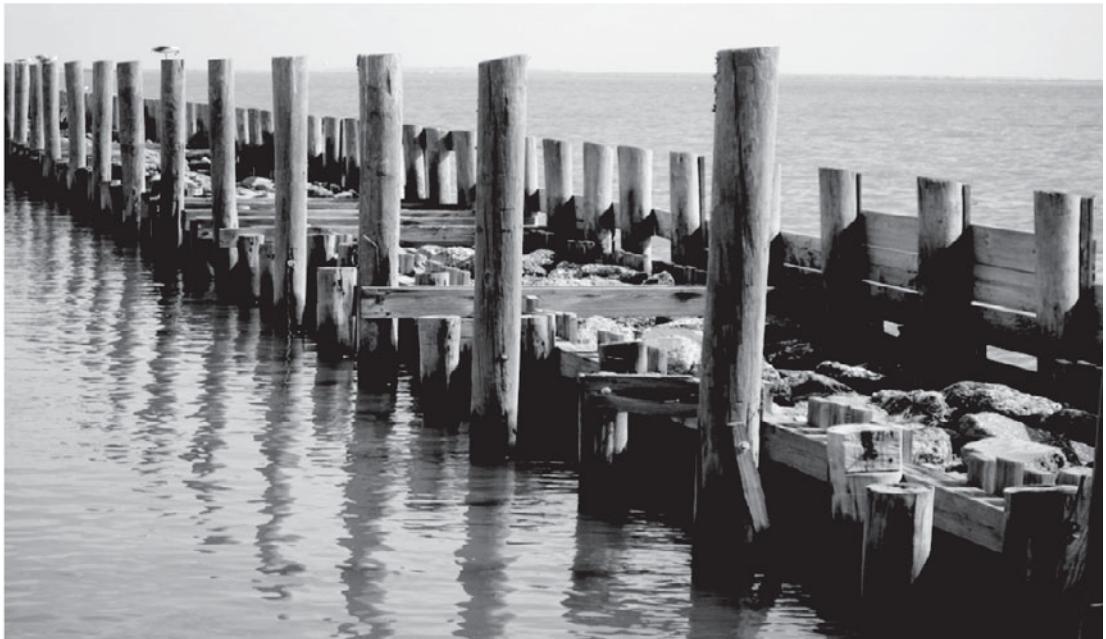
The damage to the marina and boats was significant. The yacht club's breakwater, which was made up of wooden slats, was overtapped by the waves and surge from Hurricane Ike. The bulkheads bordering the harbor were overtapped and backfill lost because there was no geotextile or filter material to prevent sediment loss between the sheathing boards. Several boats had broken loose from their moorings and were scattered around the yacht club. Some were forced further into the docks, while others ended up on the club's lawn. Others were flooded and submerged, perhaps due to shortened lines.

Figure 8-20. Wooden crib breakwater filled with stone, Houston Yacht Club

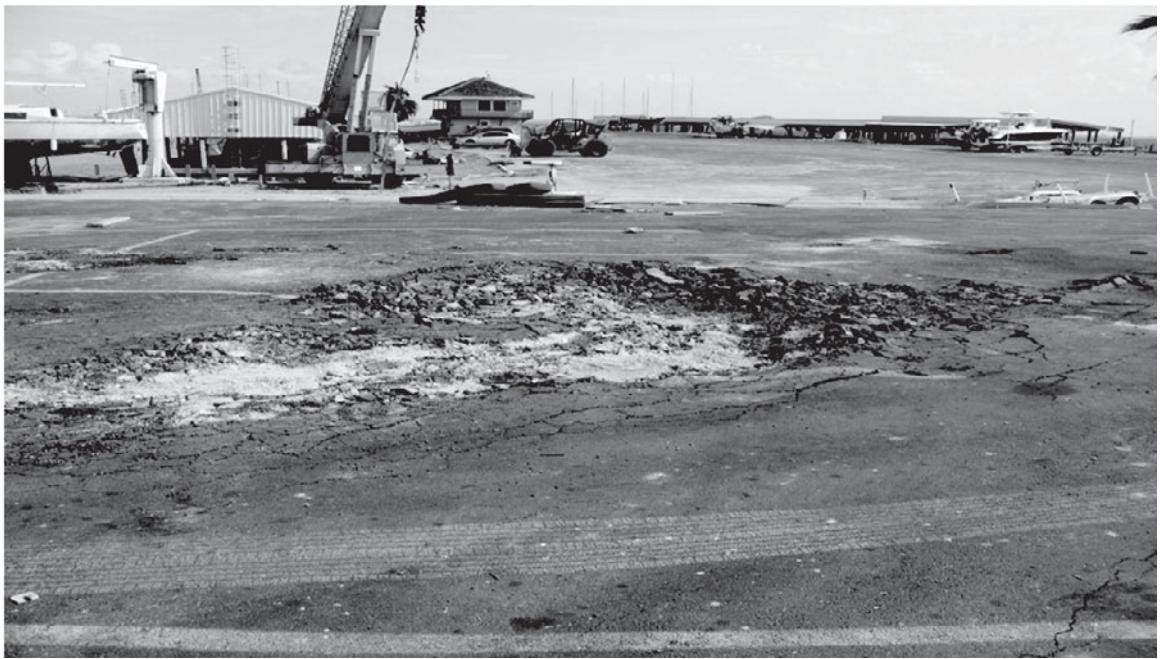
Figure 8-21. Asphalt damage in parking lot, Houston Yacht Club

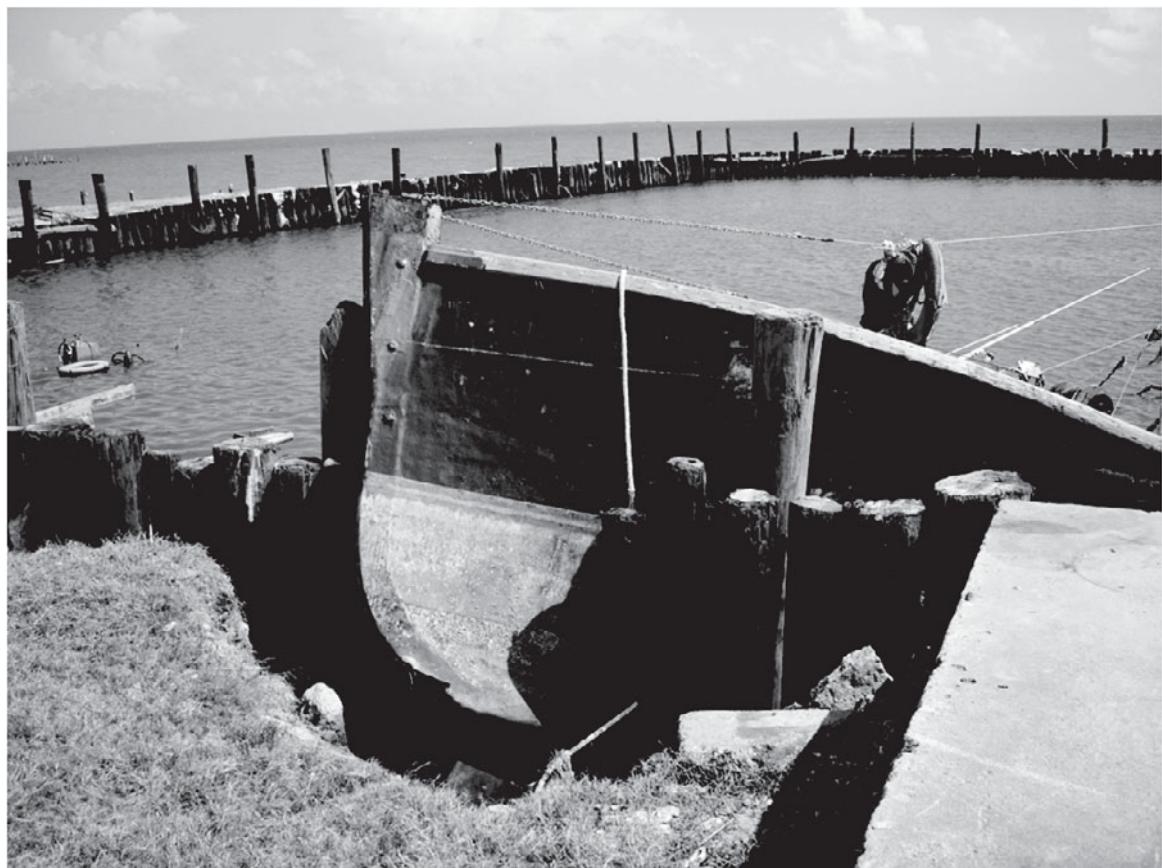
Figure 8-22. Boat and bulkhead damage, San Leon Fishing Harbor
