**Characterization of the Building Materials in the De Lesseps Statue Base  
and the Church of Saint Eugenie, Port Said, Egypt.**

**Hemdan Rabie Elmetwaly**

**Abstract:**

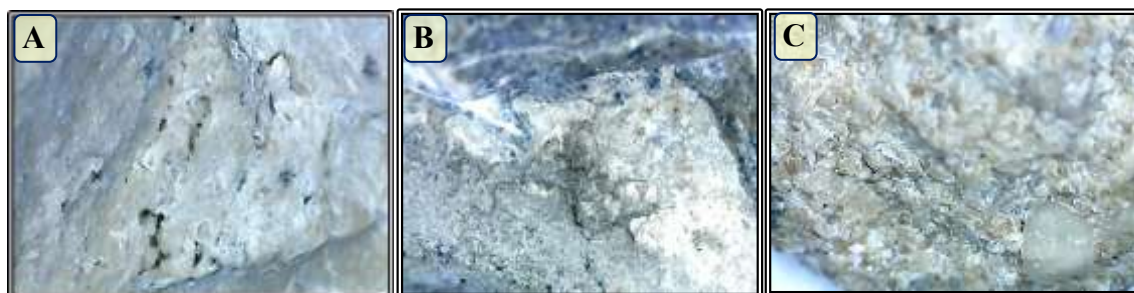
cohesion, with some veining that may be calcite, and signs of weathering and surface irregularities on the sample exposed to the atmosphere (Figure 4A).

On the other hand, the stones used in constructing the pier are composed of conglomerates of marine sediments (shells and skeletons), with sand grains bonded together in a single structure. This indicates that the stones are organic limestones. Magnified Figures with the USB Digital Microscope (USB D.M.) clearly show the sand grains and organic remains with the binding material of calcite (Figure 4B).

**Figure 4:** USB Microscope: (a) for sample A, base stone, (b) for sample C, pier stone, (c) for sample B, bonding mortar.

The bonding mortar, as observed through the digital microscope, appears to consist of a binding material that could be cement or hydraulic lime due to its dark gray color. The phases of dicalcium silicate (belite or larnite) (C<sub>2</sub>S) exhibit a yellow or beige color, while tricalcium silicate (alite) (C<sub>3</sub>S) shows a dark gray color. These are characteristic phases of hydraulic lime and cement <sup>26</sup>(Figure 4C).
