DI3RC-01

DTC	B2620	ECU Power Source Circuit Malfunction	
-----	-------	--------------------------------------	--

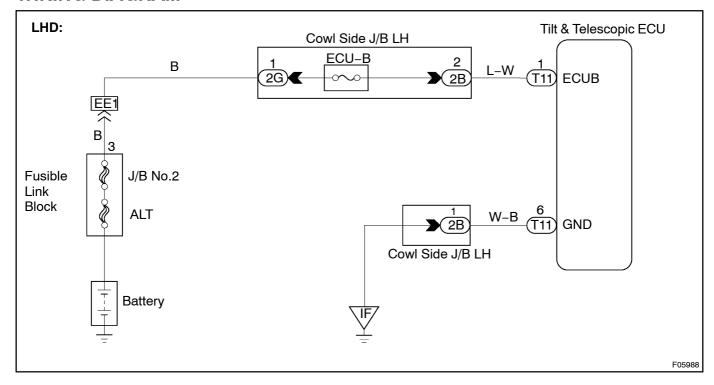
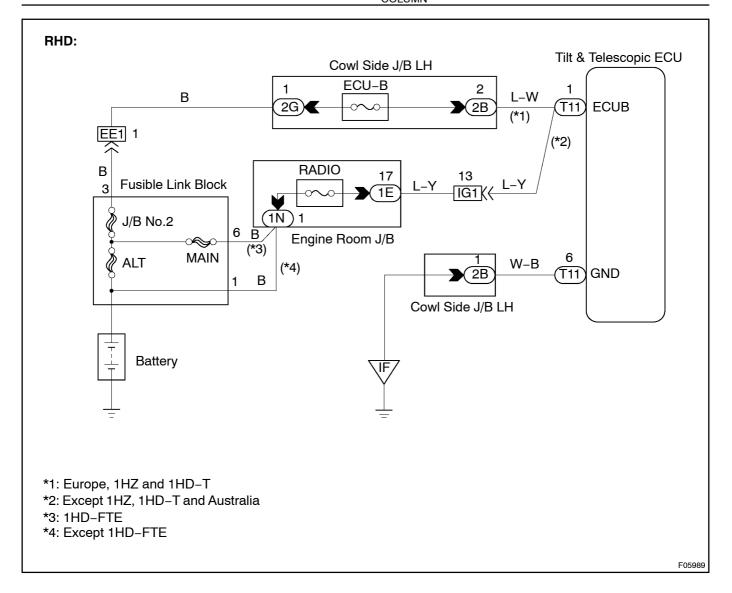
WIRING DIAGRAM

ECU power source circuit supply the battery positive voltage to tilt and telescopic ECU.

DTC No.	DTC Detecting Condition	Trouble Area
B2620	The condition that the voltage of the ECU power source circuit drop to be 8V or less continues for 10 seconds or more.	Battery ECU power source circuit Tilt and telescopic ECU
