DI23G-04

DTC B2610 Tilt Position Sensor or Tilt Motor circuit Malfunction

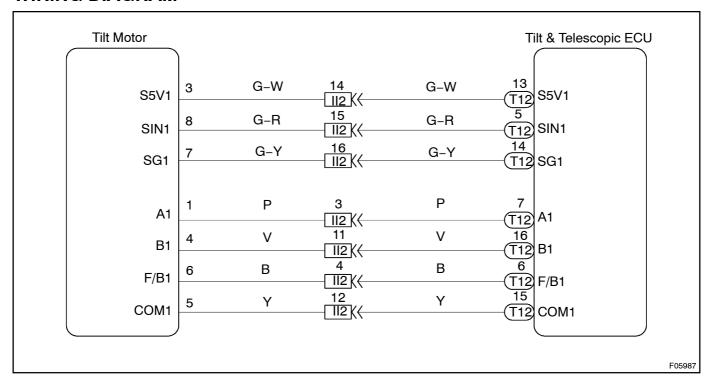
WIRING DIAGRAM

Tilt motor is operated by the power voltage supplied from tilt and telescopic ECU and makes the steering column tilt upward and downward. Tilt position sensor (Hole IC) in the tilt motor detects the tilt of the steering column and outputs the signal to the CPU in response to that tilt.

DTC No.	DTC Detecting Condition	Trouble Area
B2610	During tilt function operation, tilt operation stops within the operation range.	Sensor power source circuit Actuator power source circuit Tilt motor circuit Tilt and telescopic ECU

INSPECTION PROCEDURE Check[sensor[power[source[circuit.[See[page[DI-434] 1[] Repair or replace. NG OK 2□ Check[actuator[power[source[circuit.[See[page[DI-432] Repair or replace. NG OK Check[tilt[motor[circuit.[See[page[DI-436] 3□ NG Repair or replace. OK Check and replace the tilt and telescopic ECU.
