Installation Monitoring Report

Date: October 3, 2025

Project	NW 2050 Cypress Point	Job Number	24064	RGC Number	53216		
Address	7511, 7531, 7651 Minoru Boulevard	Inspector	Matthew	Report Number	49		
	Richmond, B.C.	Weather	Cloud / 20°C	Time	3:00pm		
Contractor	Flynn Canada Ltd.	Crew Size	0	Red Seal	0	Apprentices	0

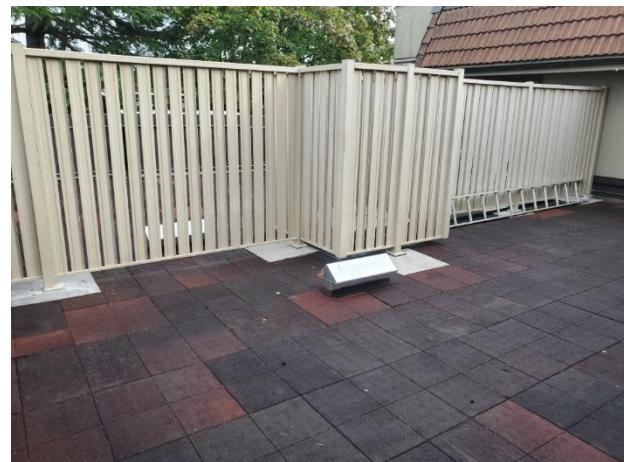
49.2 Building A

The privacy screen on the Northeast elevation has finished being reinstated in an acceptable manner.

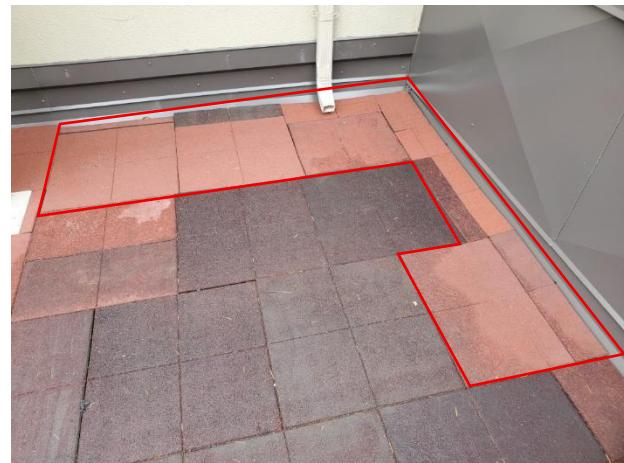
49.3 Building A

Noted paver details on the Northeast deck to be reworked with the correct size.

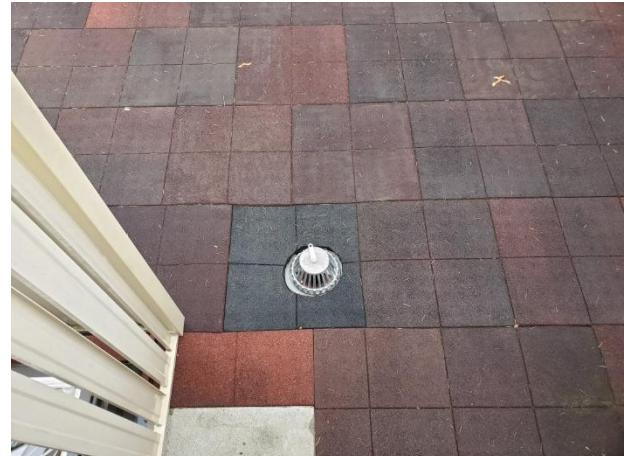
49.4 Building A

Pavers to be shimmed up around the drain on the Northeast deck area.

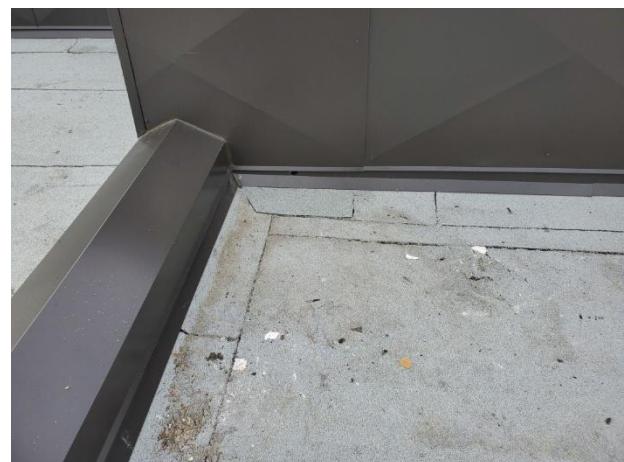
49.5 Building A

Overflow details installed that were previously missing.

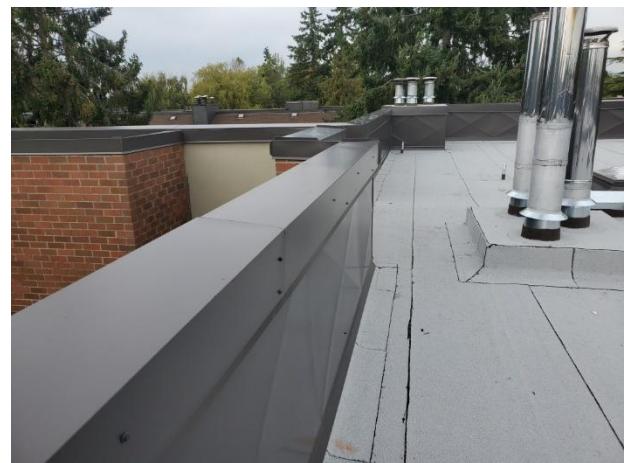
49.6 Building A

Cap flashing stand offs for the vent strip now installed.

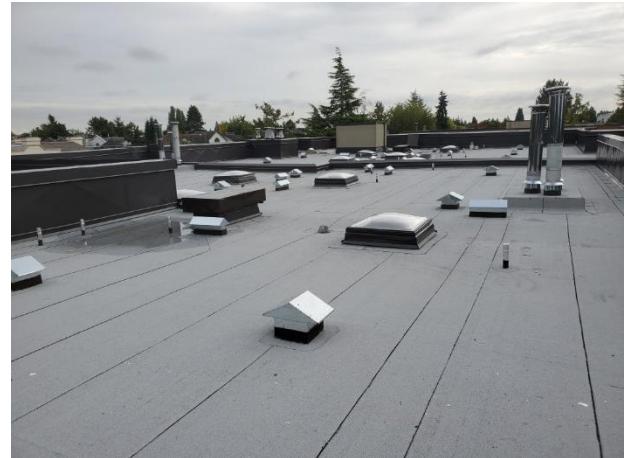
49.7 Building A

The correct opening skylights now installed to the units required.

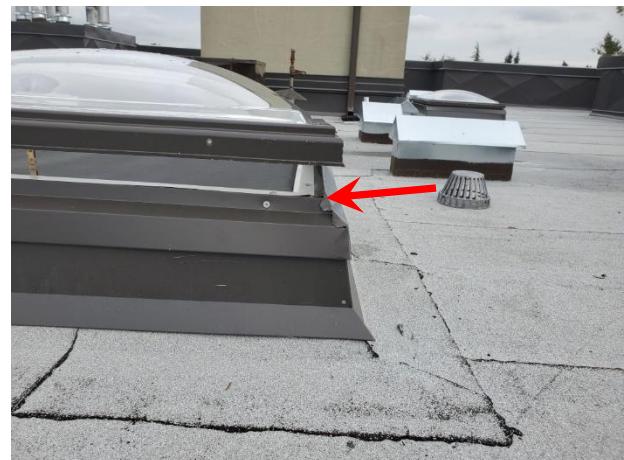
49.8 Building A

Lifting flashing edge to be adjusted to allow the skylight to close correctly.

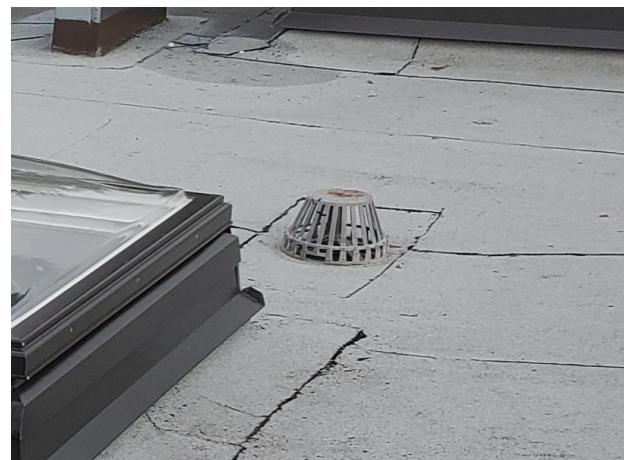
49.9 Building A

Oversized debris screens to be installed to drains.
