## Installation Monitoring Report

**Date:** October 9, 2025

<b>Project</b>	NW 2050 Cypress Point	<b>Job Number</b>	24064	<b>RGC Number</b>	53216		
<b>Address</b>	7511, 7531, 7651 Minoru Boulevard	<b>Inspector</b>	Matthew	<b>Report Number</b>	50		
	Richmond, B.C.	<b>Weather</b>	Cloud / 19°C	<b>Time</b>	11:45am		
<b>Contractor</b>	Flynn Canada Ltd.	<b>Crew Size</b>	0	<b>Red Seal</b>	0	<b>Apprentices</b>	0

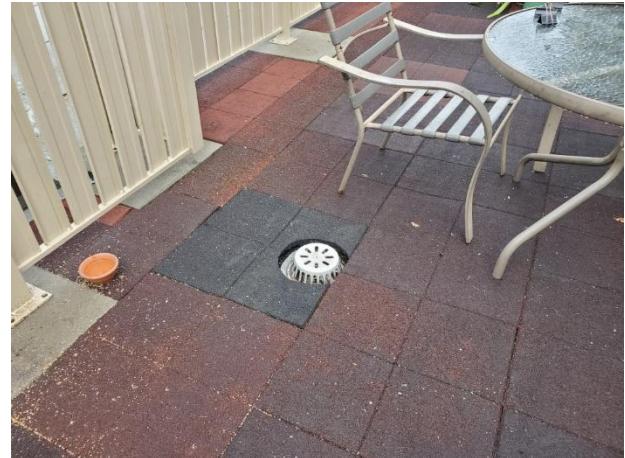
**50.1 Building A, unit 307**

Pavers still remain to be leveled around drain location.

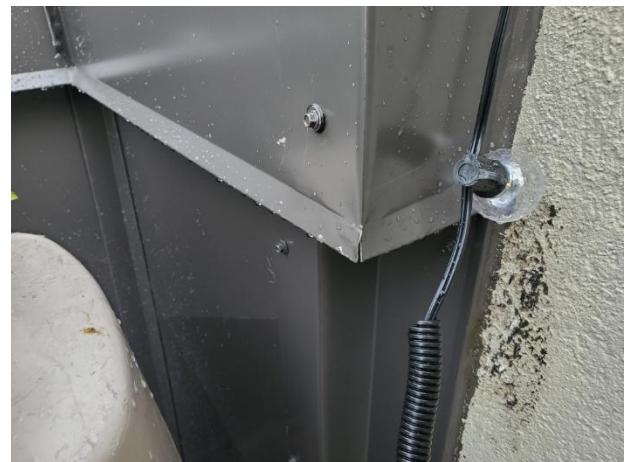
**50.2 Building A, unit 307**

Flashing corner has been corrected.

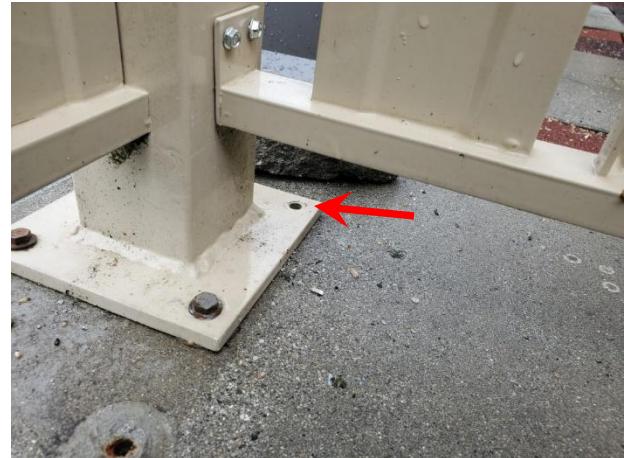
**50.4 Building A, unit 307**

Missing fasteners to be installed.

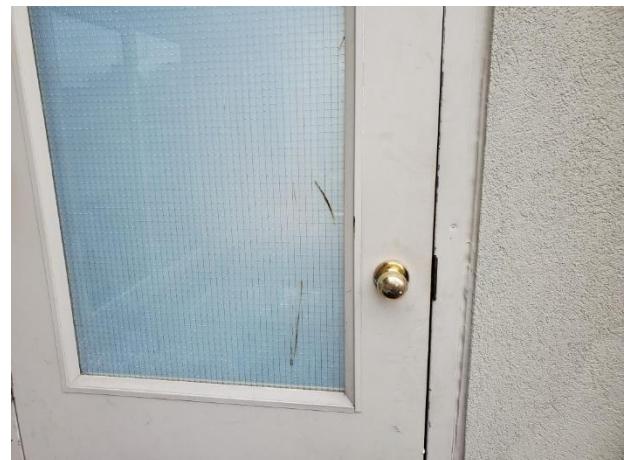
**50.5 Building A, unit 307**

Asphalt and adhesive marks on walls and doors to be cleaned off. Also, the caulking on the trim did not cure enough prior to being painted, this will need to be corrected.

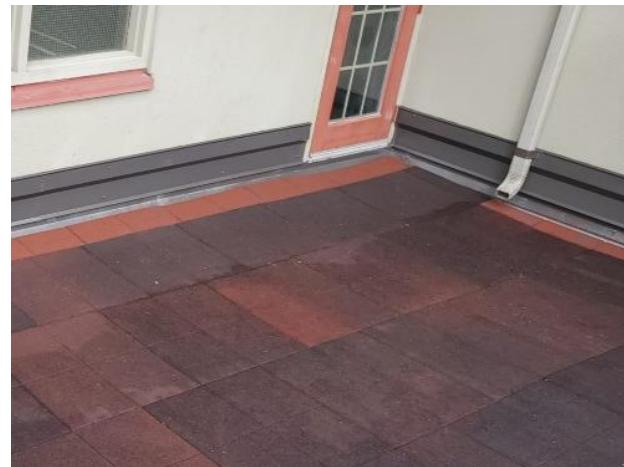
**50.6 Building A**

As previously stated, the pavers on the edge are to be no smaller than half a piece at the perimeter of the decks.

Correction remains.
