EPR Compliance Assessment Report

Report ID: 104608/0368787

This form will report compliance with your permit as determined by an Environment Agency officer							
Site	A J Spares			Permit Ref	104608		
Operator/ Permit holder	Cobb Andrew						
Date	04/03/2020			Time in	10:30	Out	11:15
What parts of the permit were assessed	Permit compliance in	nspection					
Assessment	Site Inspection	EPR Activity:	Installation	Waste Op X Water Disc		er Disch	arge
Recipient's name/position	Andrew Cobb						
Officer's name	Thomas Brabbs, Greg Deakin Date issued 08/06/2020			0

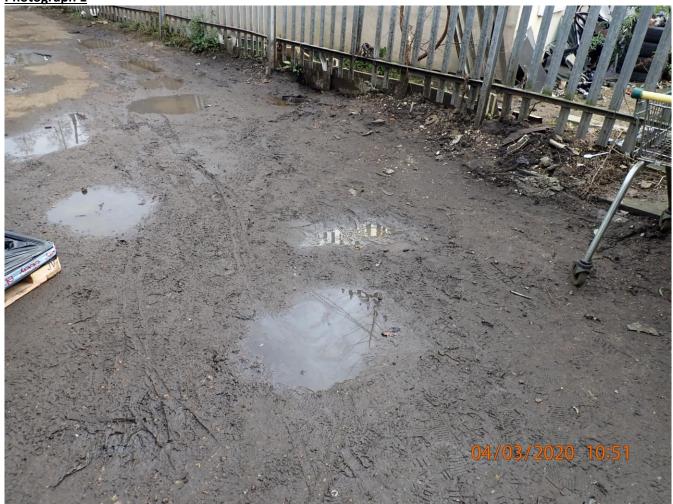
The entrance to the yard was covered in dirt and water from the recent weather, so it was difficult to ascertain the condition of the concrete in some areas. Evidence of potholes gathering water suggests this has not been maintained adequately which increases the risk of oily residue permeating into the ground.

You have been scored a Category 3 breach, 4 CCS points as a result of this. (Photograph 1, 2, 3, 4, 5 & 6).

- Repair the site surfaces to ensure that areas are impermeable throughout the site. (Photograph 1 & 2)
- Repair the damaged concrete lip at the site boundary wall so that no run-off can leave the site. (photograph 3)

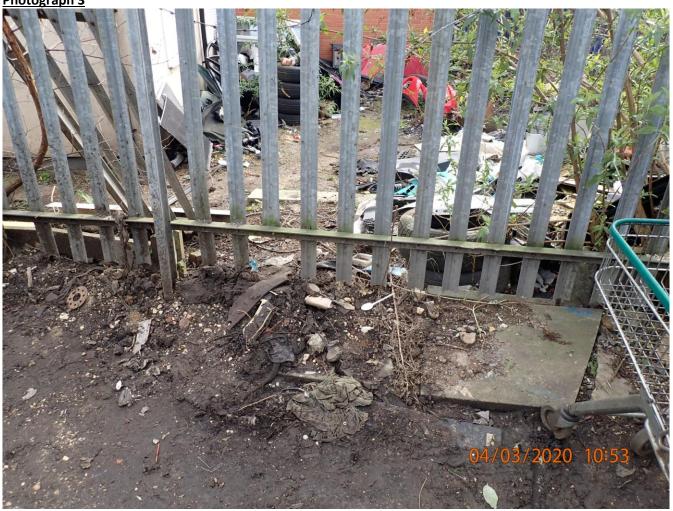
CAR 2 V2.0 Page 5 of 11 Photograph 3

The concrete lip at the site boundary entrance was damaged and in poor condition. The site supervisor was unaware of any site drainage, but knows there is a drain on the neighbouring property next to the boundary this would lead me to believe that any run off in this area of the site would escape the site and enter the surface water drain of the neighbouring property.

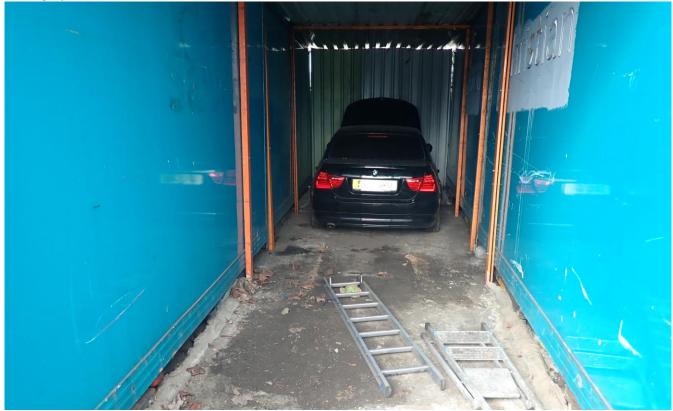
The area used to strip/de-pollute vehicles in the garage fitted with a ramp had a concrete bunded lip on the entrance. However this concrete bund was cracked in places and it was evident that pollutants namely oils had escaped this bunded area. When asked Connor explained that during heavy rainfall this area of the site can fill up with rainwater and has been known to leave site to the neighbouring site where I witnessed a surface water drain. Furthermore to the rear of the site where another bay was located I noticed that the bay was not fully bunded in order to contain any fluids or run off. The sides of this area had no concrete lip which would allow liquids to run under the containers towards unmade ground and off site to the public highway where a number of surface water road drains are located.

- Repair the concrete lip in the vehicle stripping bay area to contain any run off liquids (photograph 4 & 5)
- Ensure the depollution area is fully bunded to ensure potentially polluting liquids are appropriately collected. (photograph 6)

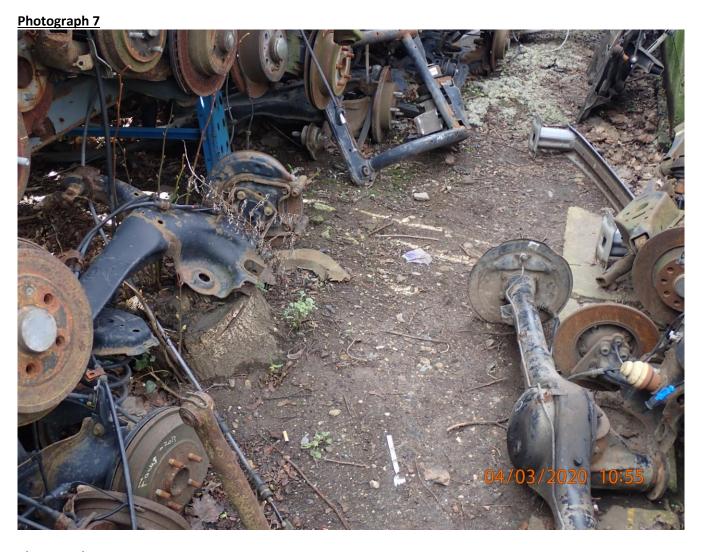
There were areas where excess parts were stored on unmade ground, which is in breach of the aforementioned operating techniques outlined in Table 2.3: 4. "All other wastes shall be stored on an impermeable surface with sealed drainage system." (Photograph 7)

These parts appeared to have been on site for some time and the manner of storage would question whether the parts were fit for reuse. Any parts containing potentially polluting liquids such as oils either waste or non-waste should be stored in a manner that ensures these liquids cannot escape into the environment. There was significant oil staining witnessed on unmade ground directly below an area of unmade ground used to store car axels, namely thick black oil. It is foreseeable that his oil could pollute surface/groundwater, therefore should be rectified as soon as possible.

Action: Ensure all wastes are stored on impermeable surface with a sealed drainage system to comply with the sites permit.

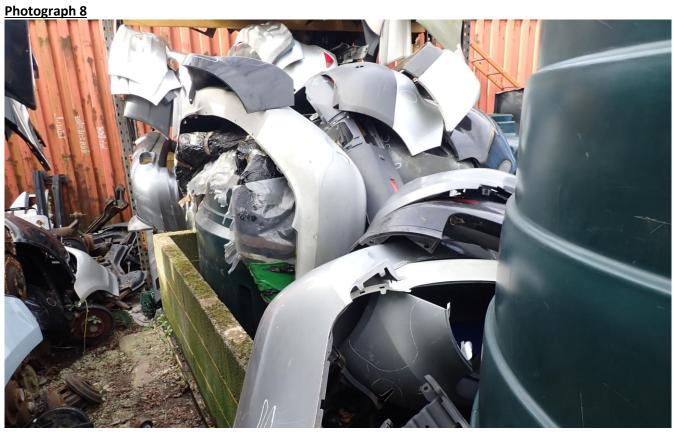
Oil storage containers were stored in a bunded area. This was also being used as an overflow for the storage of car parts. (Photograph 8)

A bunded area needs to hold at least 110% of the tank. Storing other products in this area reduces the overall capacity of the bund should a spill occur.

Section 3.1.3 of your permit states: "All liquids in containers, whose emission to water or land could cause pollution, shall be provided with secondary containment, unless the operator has used other appropriate measures to prevent or where that is not practicable, to minimise, leakage and spillage from the primary container".

There was visible oil residue in certain areas of the site which could increase the risk of pollution should this be washed in to other areas. (Photograph 8 & 9)

Action: Remove waste parts from the oil storage area and store these in an appropriate area outlined in your permit to ensure the secondary containment can sufficiently capture any spills that occur.
