GRC/AutRC 2010 earthquake shelter response

#### Presentation outline

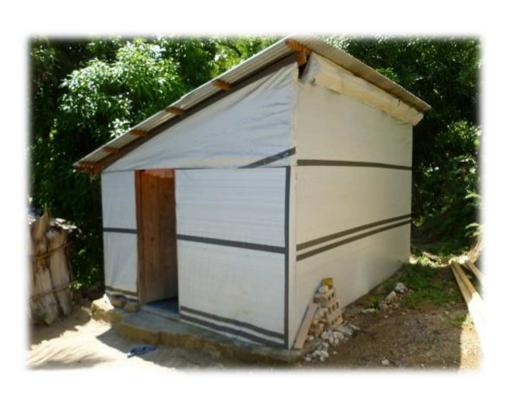
#### 1003 T-shelters

constructed between March-December 2010. Lightweight construction, tarpaulin wall covering, timber roof structure, single-pitched corrugated iron roof sheeting

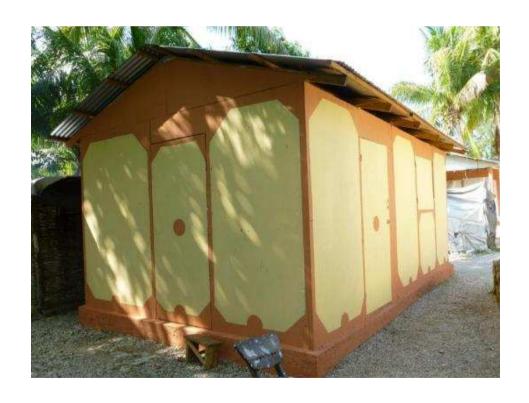
2000 P-shelters constructed between February 2011 & August 2012. Raised concrete floor, timber wall structure covered with plywood sheeting, paint, timber roof trusses, double-pitched corrugated iron roof sheeting.

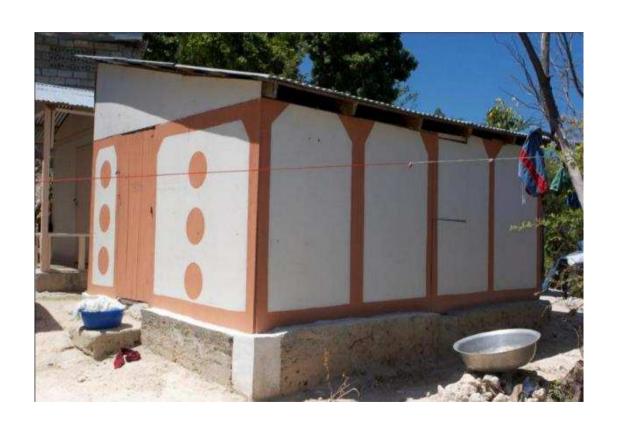
845 T-shelters
upgraded between
May 2012 – April 2013
with new concrete
footings, timber
columns, plywood
walling, window and
paint.

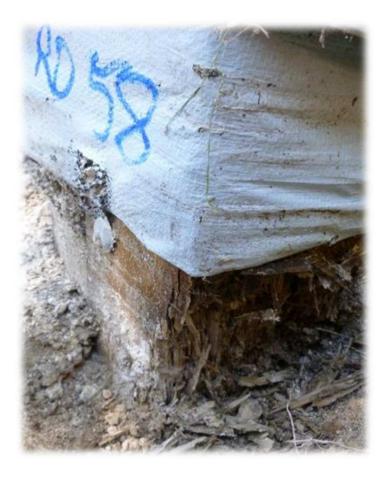
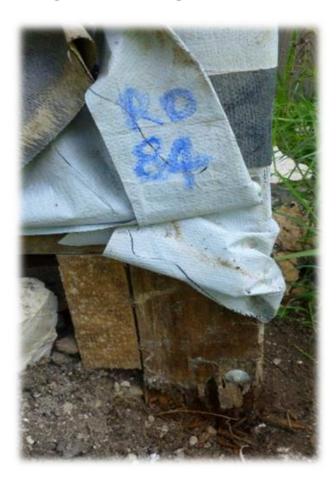
### T-shelter field survey May 2012

NUMBER OF HOUSES SURVEYED WITH:	KOLO-KOLO	SOUS DE BABA	ROSSEAU	TOTAL	%
ORIGINAL BENEFICIARIES AS OCCUPANTS		230	242	831	100%
CEMENT FLOOR CONSTRUCTED BY BENEFICIARY	314	201	189	704	85%
ORIGINAL TARPAULIN STILL IN PLACE	349	226	241	816	98%
PLYWOOD OR OTHER WALLS PRESENT	8	4	1	13	2%
CATEGORY 1:	17	7	29	53	6%
COLUMNS IN GOOD CONDITION	= /	·	_3	33	0/0
CATEGORY 2: COLUMNS WITH LIGHT WATER OR TERMITE DAMAGE	59	27	51	137	16%
CATEGORY 3: COLUMNS ROTTING, WILL NEED REPLACEMENT IN THE NEXT FEW YEARS	241	167	119	527	63%
CATEGORY 4: COLUMNS NOT STRUCTURALLY STABLE, IN NEED OF IMMEDIATE REPLACEMENT	41	28	42	111	13%
INSUFFICIENT HURRICANE STRAPPING	47	5	68	120	14%

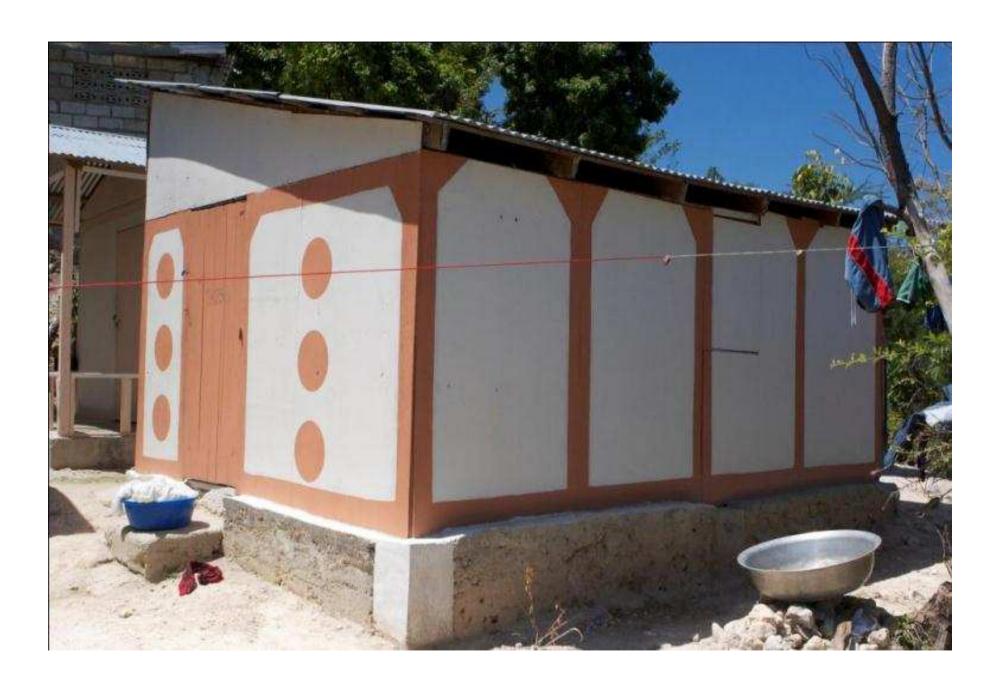
### T-shelter field survey May 2012

Improved construction detailing of T-shelter footings may have saved approx. \$USD 267,000 and 8 months.

Carefully weigh up rapid response against durability. People may live in the shelters indefinitely. An emergency shelter is not a transitional shelter

For T-shelters, build a solid, durable core structure which can be added to later.

Carefully select appropriate materials (treated timber) and protect them as much as possible from natural elements and pests

Respect local building typologies (avoid single pitched roof)
