A.4 Checking the structures of transitional shelters

B.6 Haiti (2010) - Steel Frame

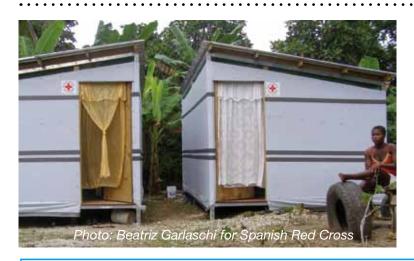
The shelter consists of a galvanised rectangular steel frame with an 8.5 degree mono-pitch roof and a suspended floor. The height to the eaves is 2.55m and 3m to the ridge and there is no bracing. The shelter is 3 x 6 m on plan and has 6 columns spaced on a 3m grid, fixed to 800x800x400mm rectangular reinforced concrete foundations using a 300x300x6mm base plate and four ordinary bolts per base. The raised floor is also supported by 13 additional stub columns on 100x100x6mm base plates bearing directly on to the soil. The main structure is three primary frames with rectangular hollow section columns.

This imported, pre-fabricated steel frame solution is relatively expensive, but quick to construct once the materials have arrived in-country. As designed, the steel frame has very limited lateral stability because there is no bracing in the walls or roof. As such, it does not perform well under seismic and wind loading*. Significant alterations are required to improve its performance include modifications to foundations, steel members and bracing in the walls and roof.

Performance of the frame under gravity loads alone is satisfactory. However there is no lateral stability system and it is essential to provide in plane bracing in the roof and walls (see Section C.3). Additional concrete foundations are required under stub column floor supports to take loads and prevent sagging.

Hazard	Performance				
Earthquake	RED: Currently the shelter does not perform well under seismic loads. Bracing is required in				
HIGH	the walls and roof to provide lateral stability. The structure is lightweight and relatively flexible				
THOIT	posing a low risk to the lives of the occupants.				
Wind	RED: The shelter does not perform well under high wind loads. The shelter should be braced,				
VERY HIGH	and the foundation improved. The column spacing should be decreased and the wall supports,				
	roof purlins and roof beams strengthened to take uplift and lateral hurricane wind pressures.				
Flood	GREEN: The shelter has a raised floor to prevent flood damage but no specific checks against				
HIGH	standing water have been made.
