Technical and Environmental Due Diligence Report

8 Allée Léon Jouhaux, 77183 Croissy Beaubourg,
France

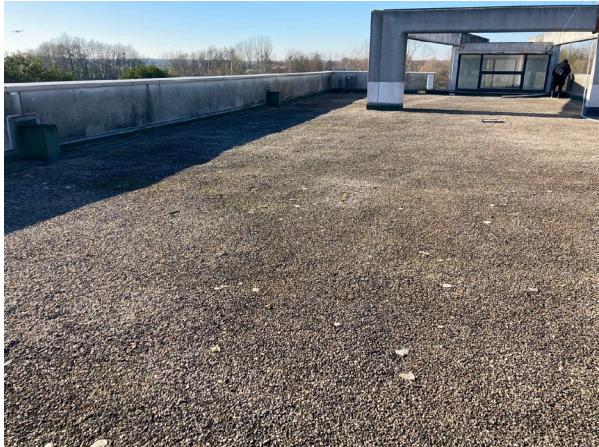
Roofs – Building A

- 3.3.2. **Assessment:** The gravel covering to the roof of building A makes assessing the condition difficult; however, repairs have been undertaken to the upstands and leaks have been reported by the occupier. We included the cost of renewing the waterproofing of the entire roof with a bituminous layer and gravel protection to building A (reusing the existing gravel). We have also included an optional cost for adding thermal insulation to office building A, this is purely an improvement, however, it can be considered to reduce energy consumption as part of the 'Decret Tertiaire'.

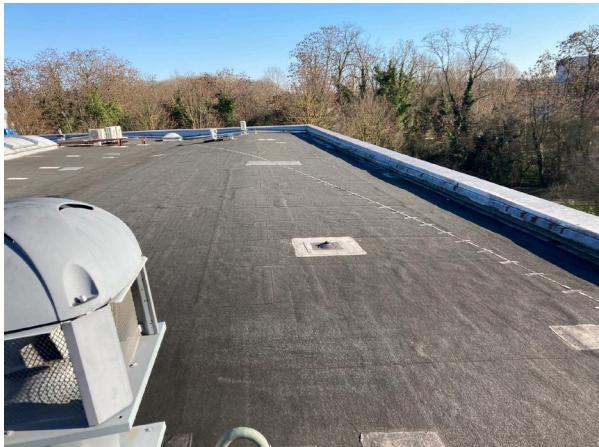
Roofs – Building B & C

- 3.3.1. **Assessment:** The waterproofing of building B's roof, installed in 1991, shows increased crazed cracking, blisters and other aging signs. Multiple rainwater leaks have been reported to us. Patch repairs have already been undertaken as part of routine maintenance. Given the age of the waterproofing (installed in 1991), renewal of the waterproofing will be required during the Capex period.

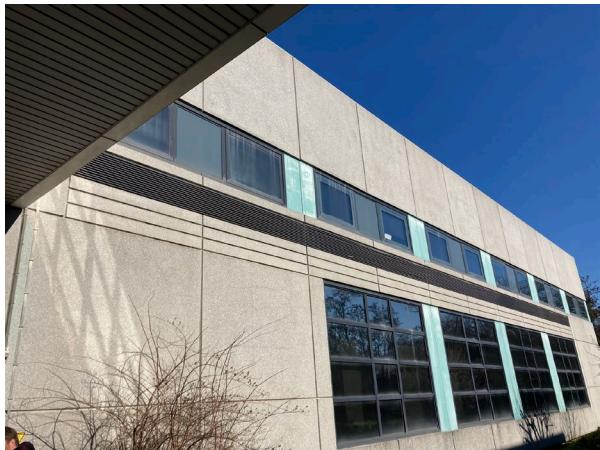
Facades – Building B

- 3.4.4. **Assessment:** Limited bloomed windows (where the seals to the double-glazed window units has failed) to building B have been observed. Costing for replacing the bloomed windows to the warehouse has been provided.

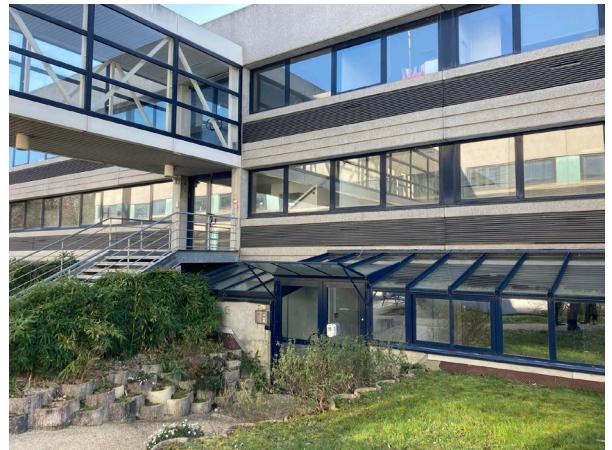
Facades – Building A

- 3.4.3. **Assessment:** The paint to the upper part of the facades (mainly the north facade) and roof concrete elements of building A is in fair condition (blistering, mould growth). As part of 'decorative' works, we have provided costing for repainting the north facade and concrete beams on the roof.

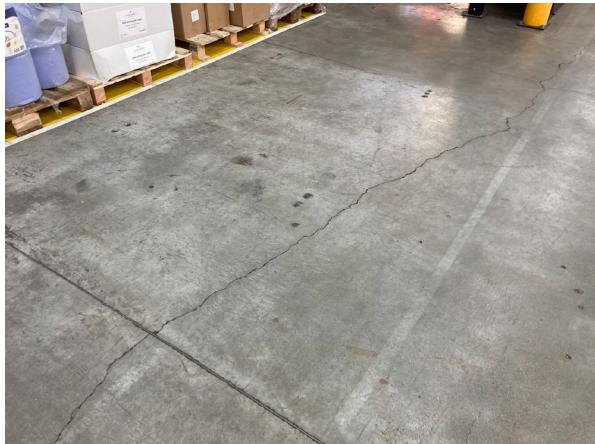
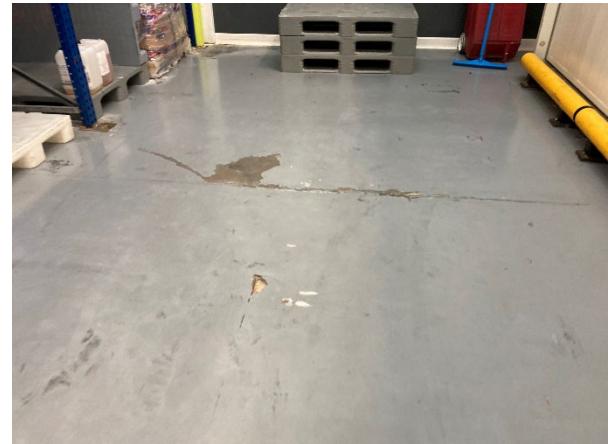
Substructure

- 3.1.1. **Assessment:** The floor slab is in a satisfactory condition. Minor cracking has been noted on the concrete slab of the warehouse (production and logistics areas), but this does not affect the structural stability of the building, however, we recommend repairing the cracking for durability and in order to prevent further damage.
- 3.1.2. **Assessment:** The design load of the floor slab in the warehouse is 5 tonnes/m² according to the DOE by EUROTECH, dated 16 January 2023. This floor loading satisfies the requirements for a traditional Class A logistics building.

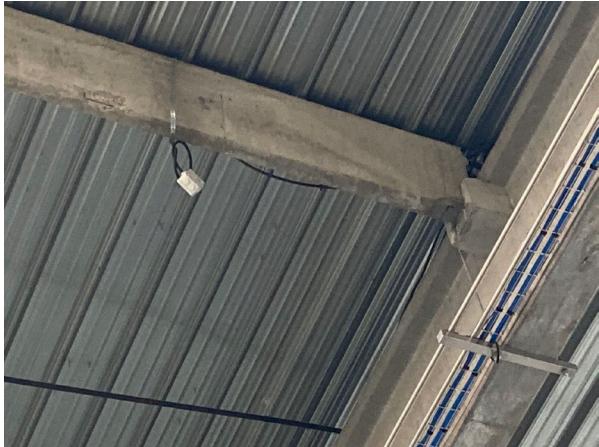
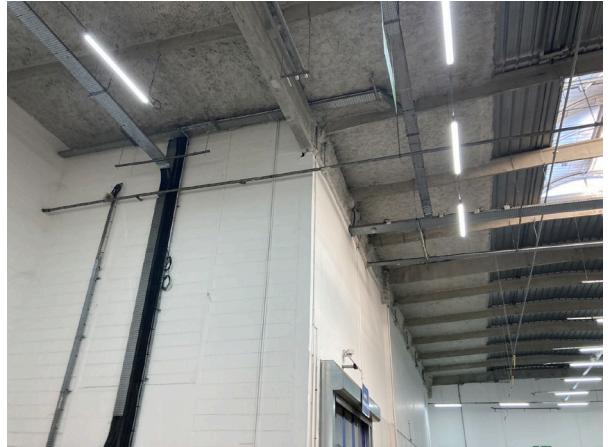
Superstructure

- 3.2.1. **Assessment:** No significant defects were identified.

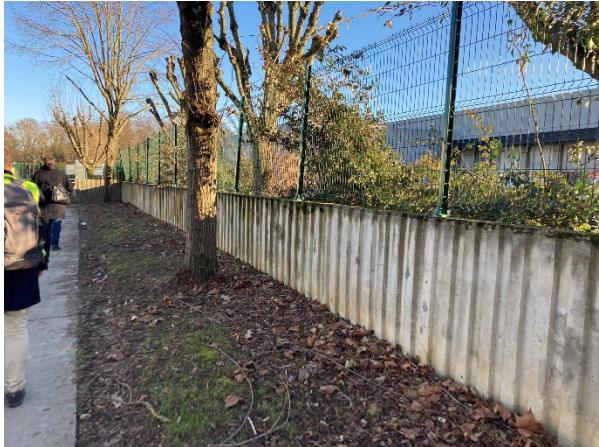
Fence

3.5.3. **Assessment:** The steel fence surrounding the property has been replaced in 2020. However, the boundary wall along Léon Jouhaux alley were found to be in a poor condition aesthetically due to mold growth. The cost of treating and repainting the boundary wall facing Léon Jouhaux alley has been included in the capex as part of improvement works.

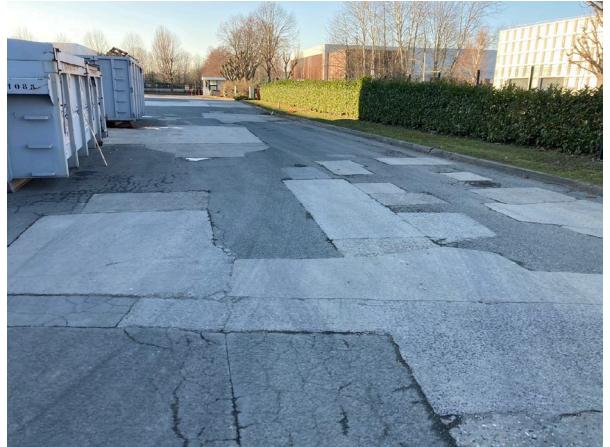
Asphalt hardstanding

3.5.1. **Assessment:** The hardstanding around both buildings are currently in a usable condition.

However, potholes and cracks have been observed in the asphalt with many small sectional repairs. We have included the cost for ongoing sectional repairs to the hardstanding and recommended replacing the entire North side hardstanding since it is the most damaged due to frequent use by heavy goods vehicles.

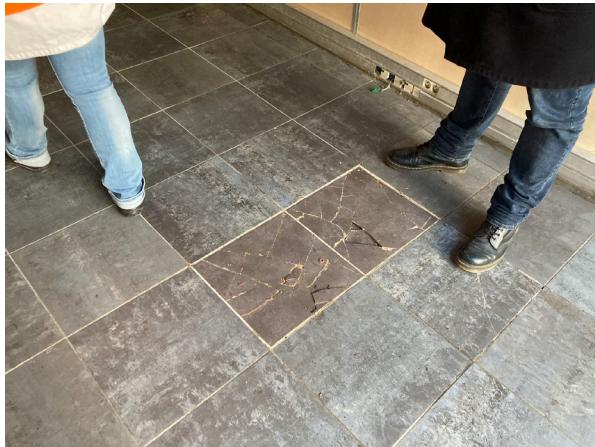
3.6.2. **Assessment:** Some parts of the PVC flooring on the first floor of building B are in poor condition. The cost for replacing the PVC flooring has been included in the capex.
