## Roof Analysis Report

**Property:** 123 example street

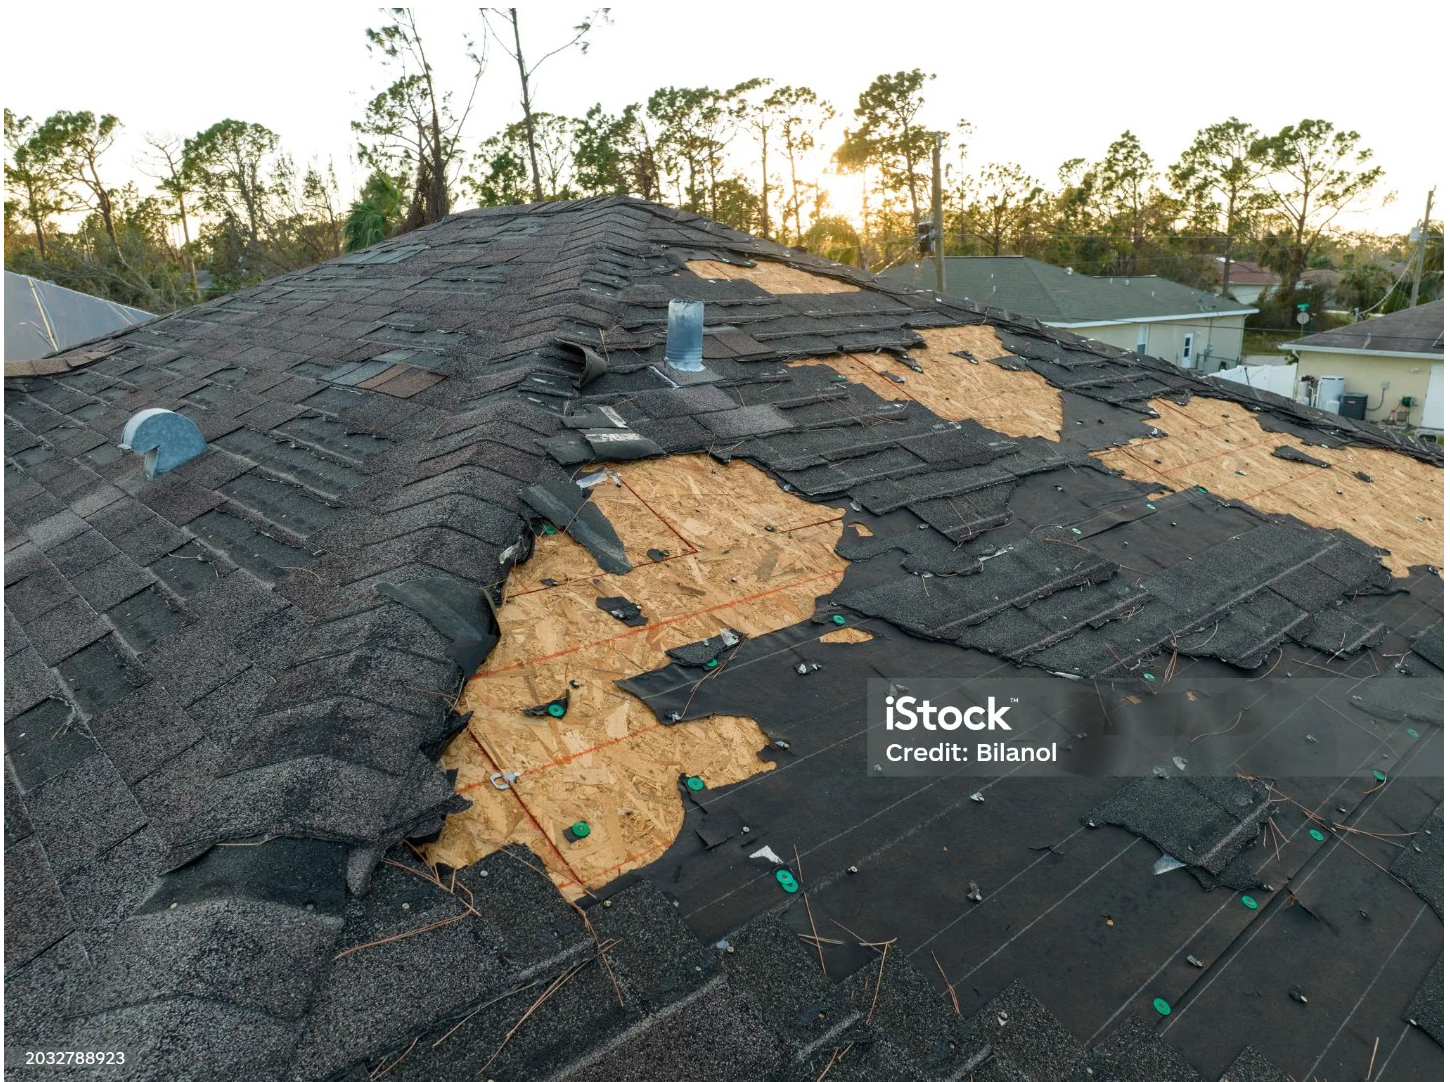
**Missing Shingles:** A large area of shingles is missing from the roof surface, exposing the underlying sheathing. This leaves the roof vulnerable to water ingress and further damage. **Severity:** High.

**Recommendation:** Replace all missing shingles with new, matching shingles to restore the roof's integrity. Ensure proper underlayment is installed or repaired before replacing shingles. **Location:** Center quadrant.

Take temporary measures to protect the exposed area, such as covering it with a tarp if safe to do so.
