| Drawing Number | HC-201 REV C | Area | Roof Plant Room — HWU-01 and HWU-02 — Roof level, Grid 6-8 |

ITP 024 — Hot Water Service · Roof Plant Room — HWU-01 and HWU-02 · Roof level, Grid 6-8

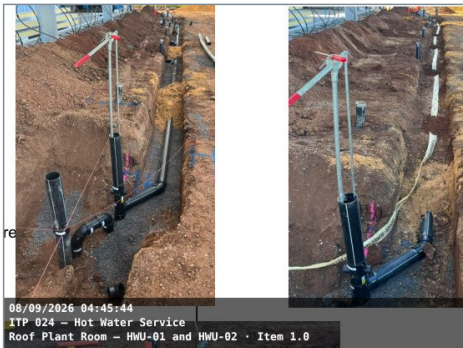
Item 1.0 · Installation  
08/09/2026 04:45:44 (recorded)

| INSPECTION & TEST PLAN | | | | |
|---|---|---|---|---|
| 1.0 | Check current revision of drawings issued for construction, including any RFI or site instruction affecting this area. | In accordance with the project Drawing Register. Superseded revisions removed from site. | X | DS<br>08/09/2026 |

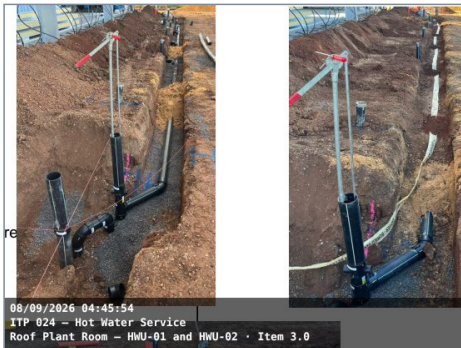
Item 3.0 · Installation  
08/09/2026 04:45:54 (recorded)

| INSPECTION & TEST PLAN | | | | |
|---|---|---|---|---|
| 3.0 | Check materials delivered to site for compliance and damage (Copper Type B / PEX / PP-R rated for the design temperature). Record batch / lot numbers and WaterMark or certification details. | In accordance with AS/NZS 3500.2:2021 Section 2.3 'Selection and Use of Materials and Products', WaterMark certification and the hydraulic specification. | X | DS<br>08/09/2026 |
