| Axis Plumbing NSW<br><br>BW-24187 | INSPECTION & TEST PLAN | ITP NUMBER:<br>025 | Revision No:<br>A | Hot Water Service |
| | Riverside Precinct — Building A | Progress 100% · Reviewed & approved | | |

| Drawing Number | HC-201 REV C | Area | Roof Plant Room — HWU-01 and HWU-02 — Roof level, Grid 6-8 |

ITP 025 — Hot Water Service · Roof Plant Room — HWU-01 and HWU-02 · Roof level, Grid 6-8

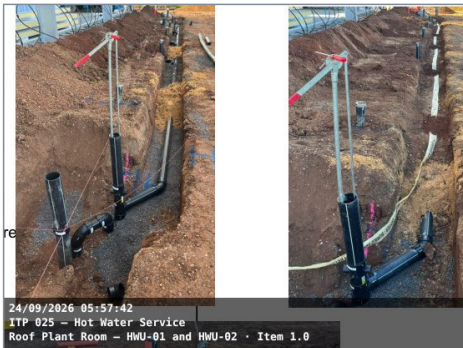
Item 1.0 · Installation  
24/09/2026 05:57:42 (recorded)

| INSPECTION & TEST PLAN | | | | |
|---|---|---|---|---|
| 1.0 | Check current revision of drawings issued for construction, including any RFI or site instruction affecting this area. | In accordance with the project Drawing Register. Superseded revisions removed from site. | X | DS<br>24/09/2026 |

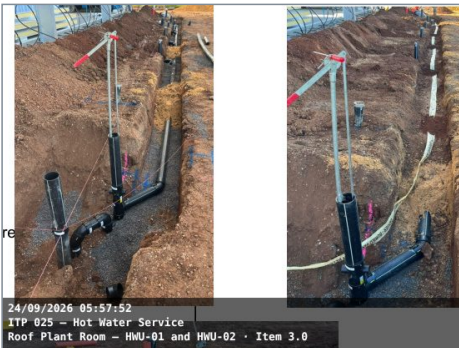
Item 3.0 · Installation  
24/09/2026 05:57:52 (recorded)

| INSPECTION & TEST PLAN | | | | |
|---|---|---|---|---|
| 3.0 | Check materials delivered to site for compliance and damage (Copper Type B / PEX / PP-R rated for the design temperature). Record batch / lot numbers and WaterMark or certification details. | In accordance with AS/NZS 3500.2:2021 Section 2.3 'Selection and Use of Materials and Products', WaterMark certification and the hydraulic specification. | X | DS<br>24/09/2026 |
