| Axis Plumbing NSW<br><br><br><br><br>BW-24187 | INSPECTION & TEST PLAN | ITP NUMBER:<br>025 | Revision No:<br>A | Hot Water Service |
| | Riverside Precinct — Building A | Progress 100% · Reviewed & approved | | |

| Drawing Number | HC-201 REV C | Area | Roof Plant Room — HWU-01 and HWU-02 — Roof level, Grid 6-8 |

ITP 025 — Hot Water Service · Roof Plant Room — HWU-01 and HWU-02 · Roof level, Grid 6-8

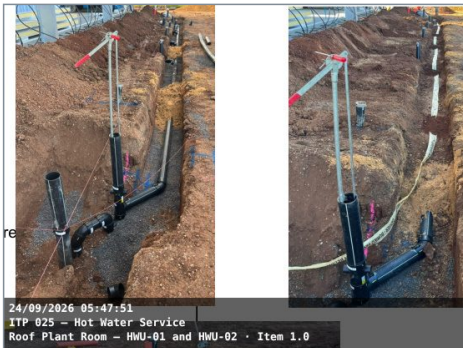
Item 1.0 · Installation  
24/09/2026 05:47:51 (recorded)

| No. | Installation: | Acceptance Criteria | Point | Initial & Date |
|---|---|---|---|---|
| 1.0 | Check current revision of drawings issued for construction, including any RFI or site instruction affecting this area. | In accordance with the project Drawing Register. Superseded revisions removed from site. | X | DS<br>24/09/2026 |

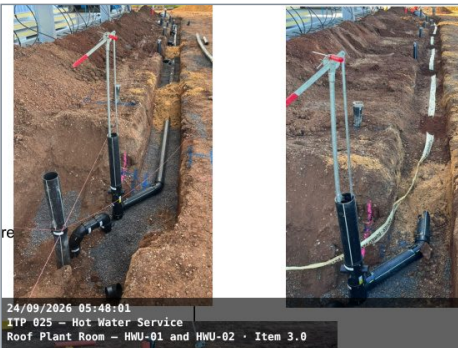
Item 3.0 · Installation  
24/09/2026 05:48:01 (recorded)

| No. | Installation: | Acceptance Criteria | Point | Initial & Date |
|---|---|---|---|---|
| 3.0 | Check materials delivered to site for compliance and damage (Copper Type B / PEX / PP-R rated for the design temperature). Record batch / lot numbers and WaterMark or certification details. | In accordance with AS/NZS 3500.2:2021 Section 2.3 'Selection and Use of Materials and Products', WaterMark certification and the hydraulic specification. | X | DS<br>24/09/2026 |
