# Barkley Heights Retaining Wall Site Inspection Report

Project: Barkley Heights Development, Bellingham, Washington

Inspection date: 2026-07-23

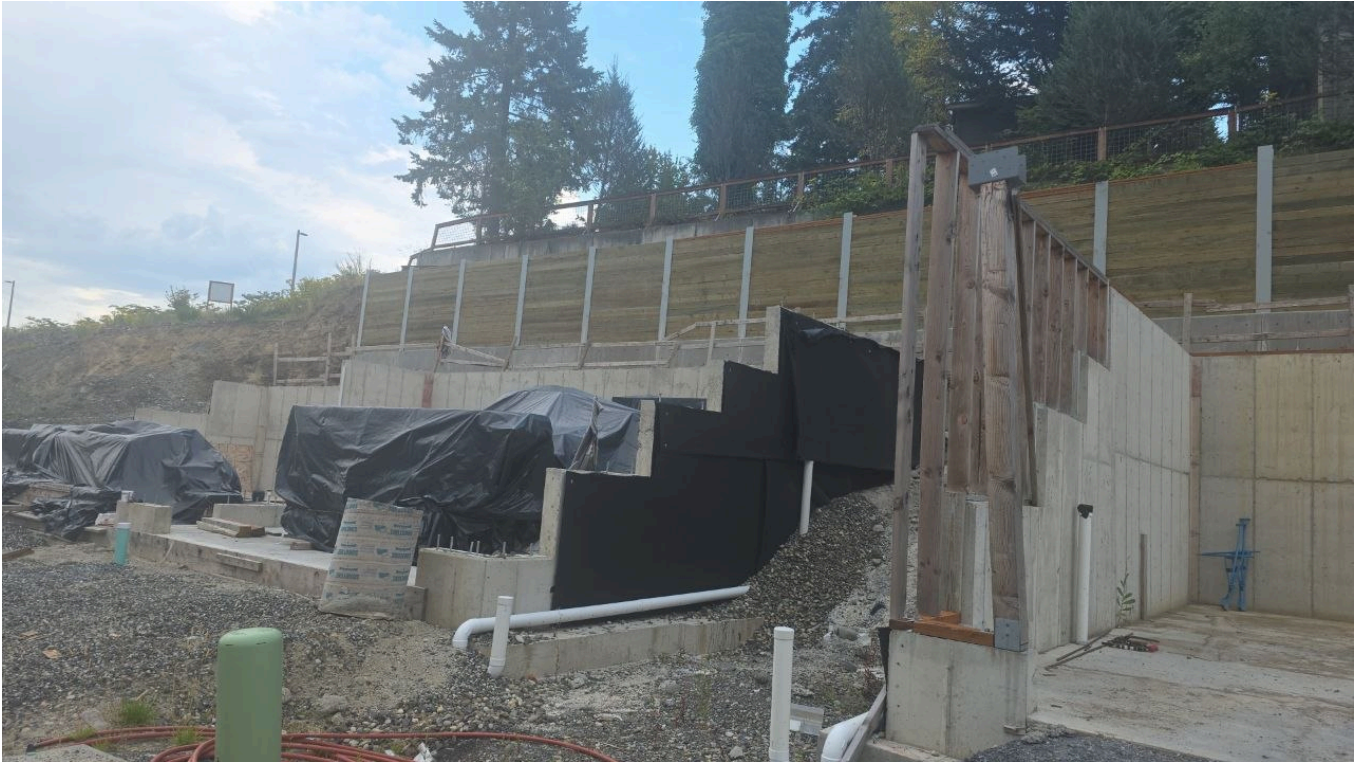
**P001** - General arrival overview of retaining/shoring wall area and adjacent partially constructed foundation.

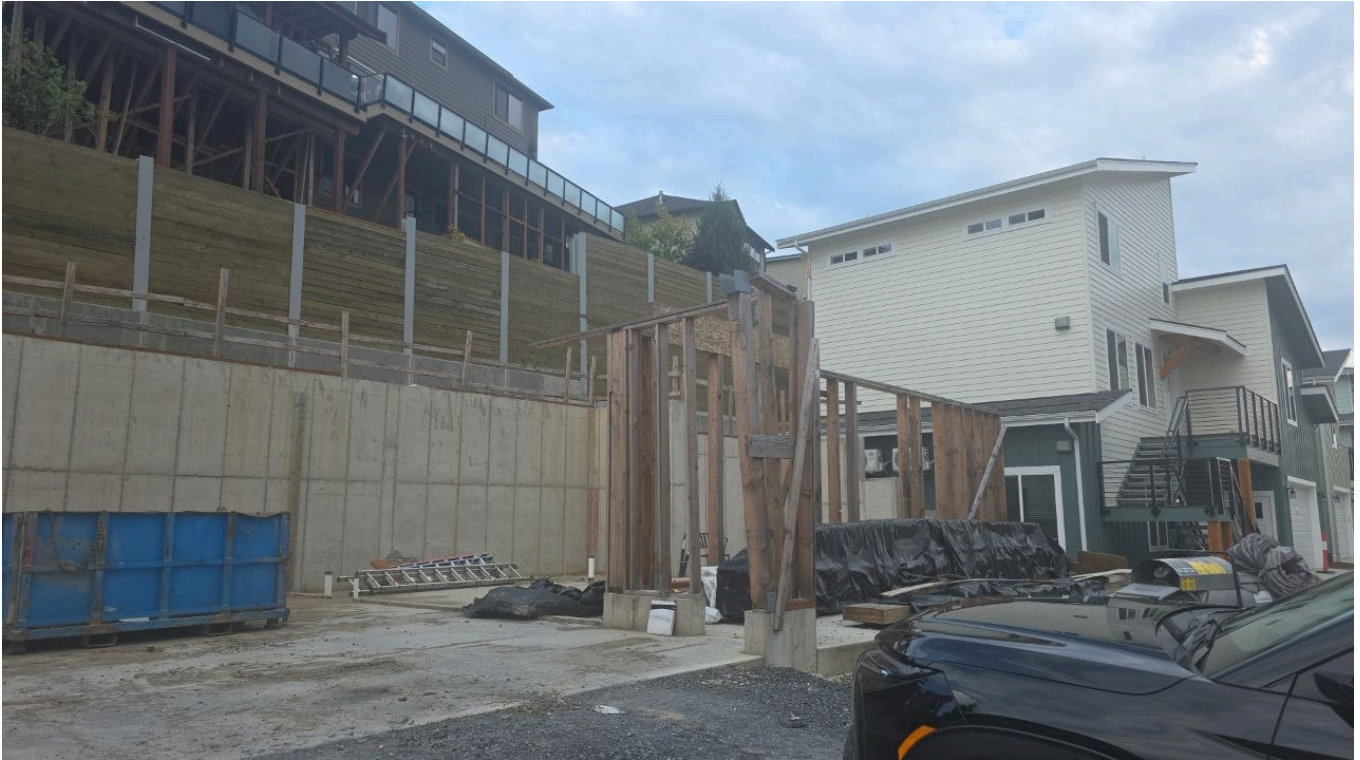
**P002** - Overview from lower grade showing retaining/shoring wall, uphill residence/deck, foreground framing/foundation work, construction materials, vehicles, and adjacent residences.

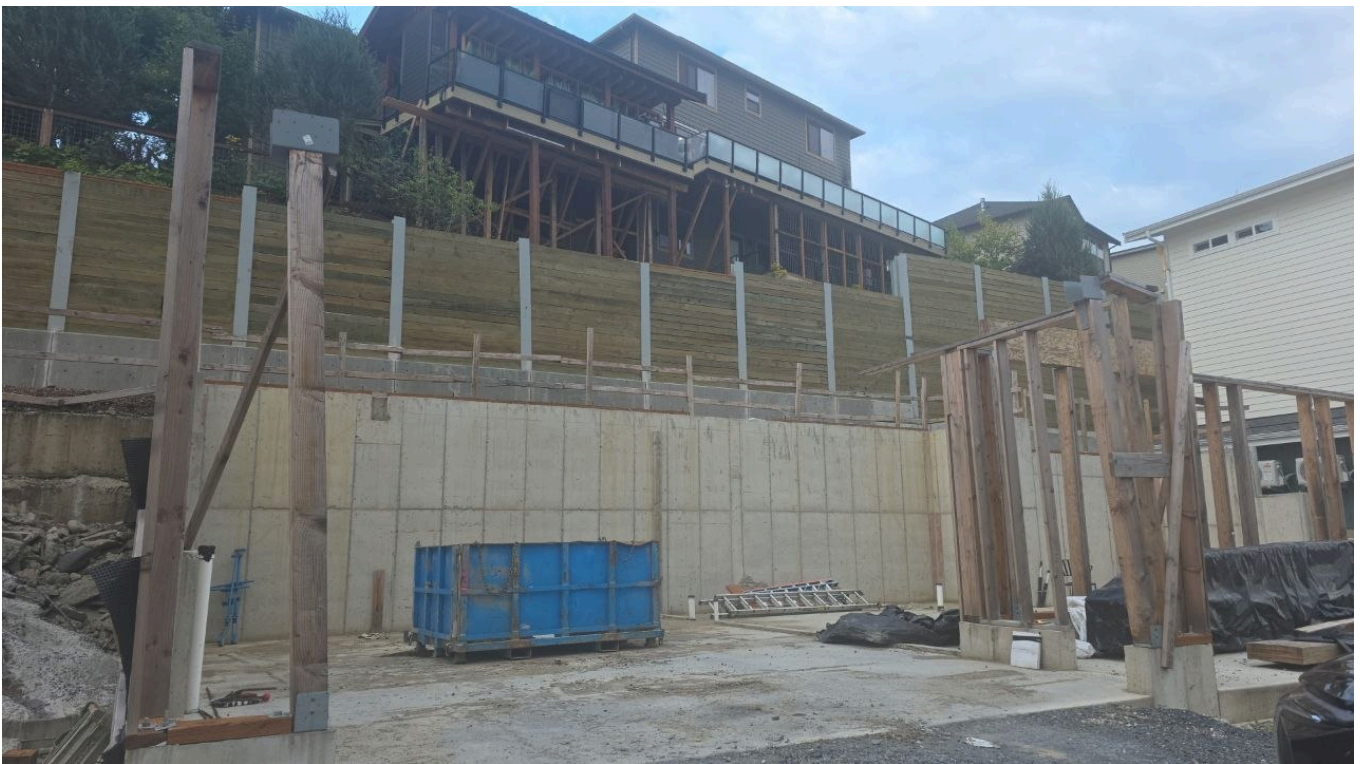
**P003** - Centered overview of wall below uphill residence/deck, including foreground construction, blue dumpster, ladder, covered materials, and exposed soil/rock.

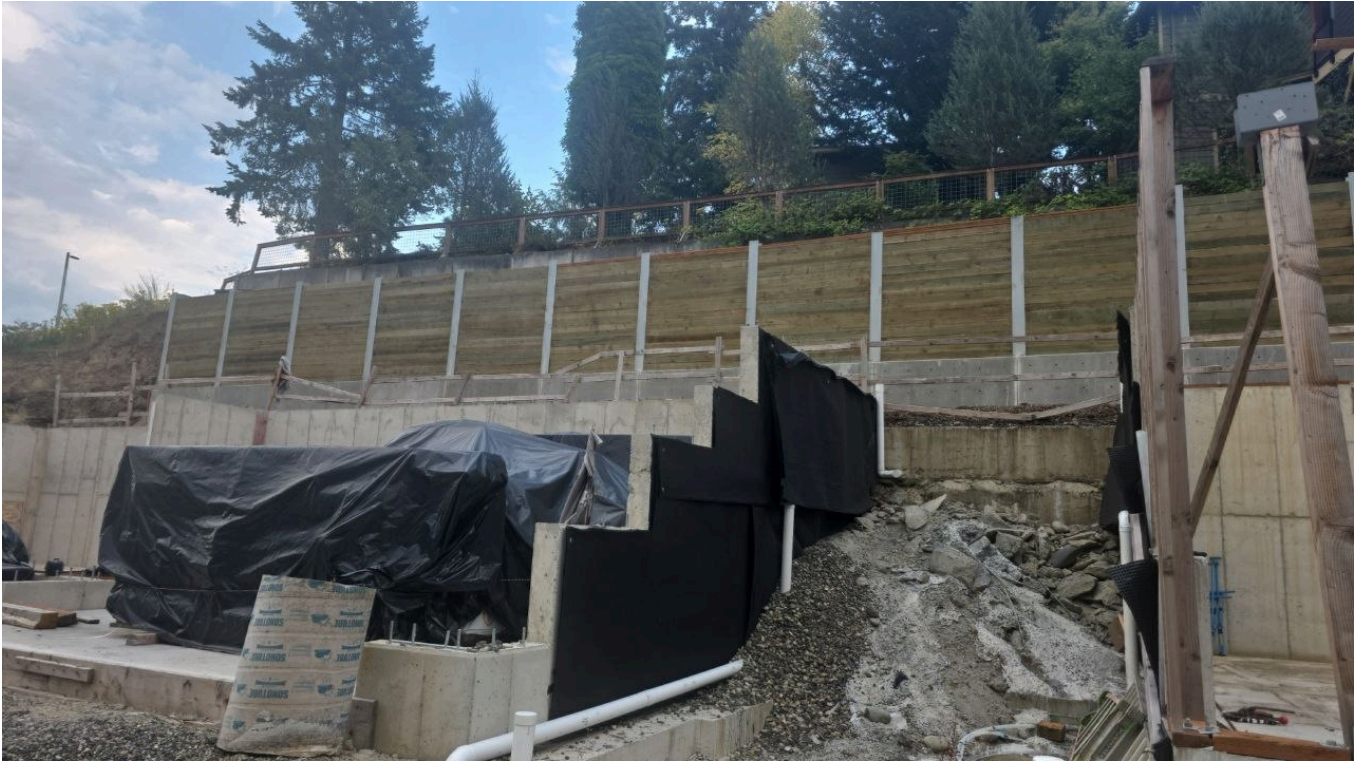
**P004** - Overview/detail of wall and stepped foundation/backfill area, including black waterproofing/drainage membrane or sheeting, gravel backfill, white pipes, and exposed soil/rock.

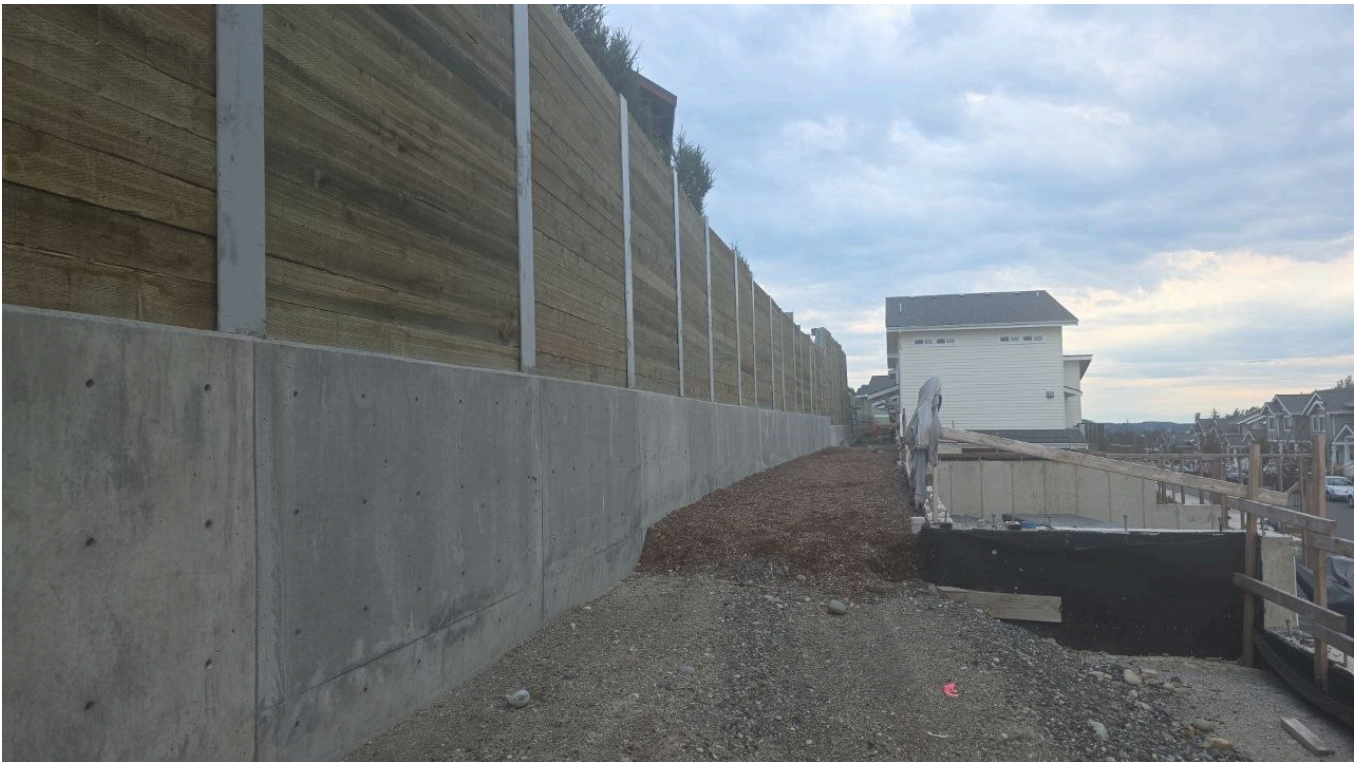
**P005** - Close along-wall view showing wood lagging, lower concrete wall, backfill/gravel path, adjacent foundation/building area, and temporary guardrail.

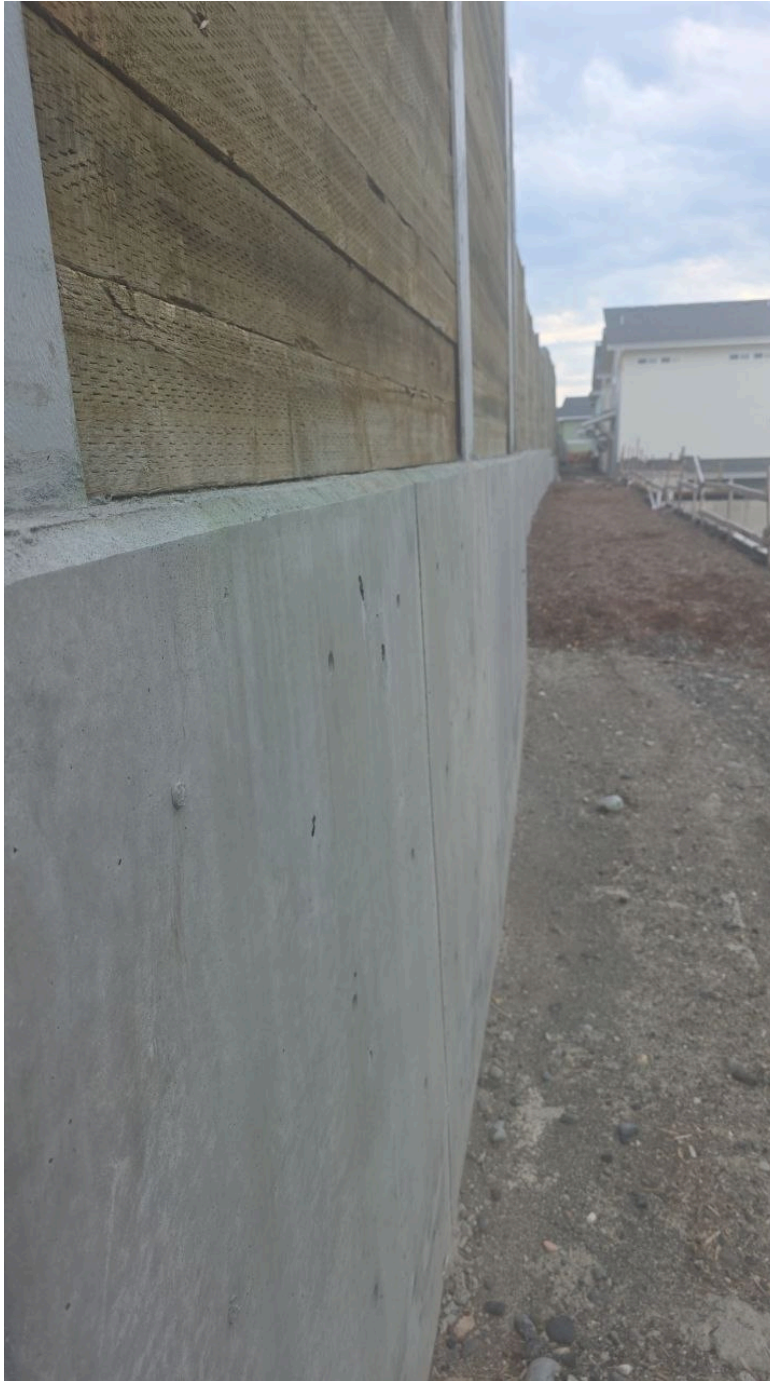
Dave identified photograph P006 as showing the apparent "wigglyness" of the wall. Photograph P007 provides additional close along-wall context, with the wall line receding into the distance. Photograph P013 was identified by Dave as showing misalignment of piles at the south end.

**P007** - Close along-wall view documenting wall alignment context.

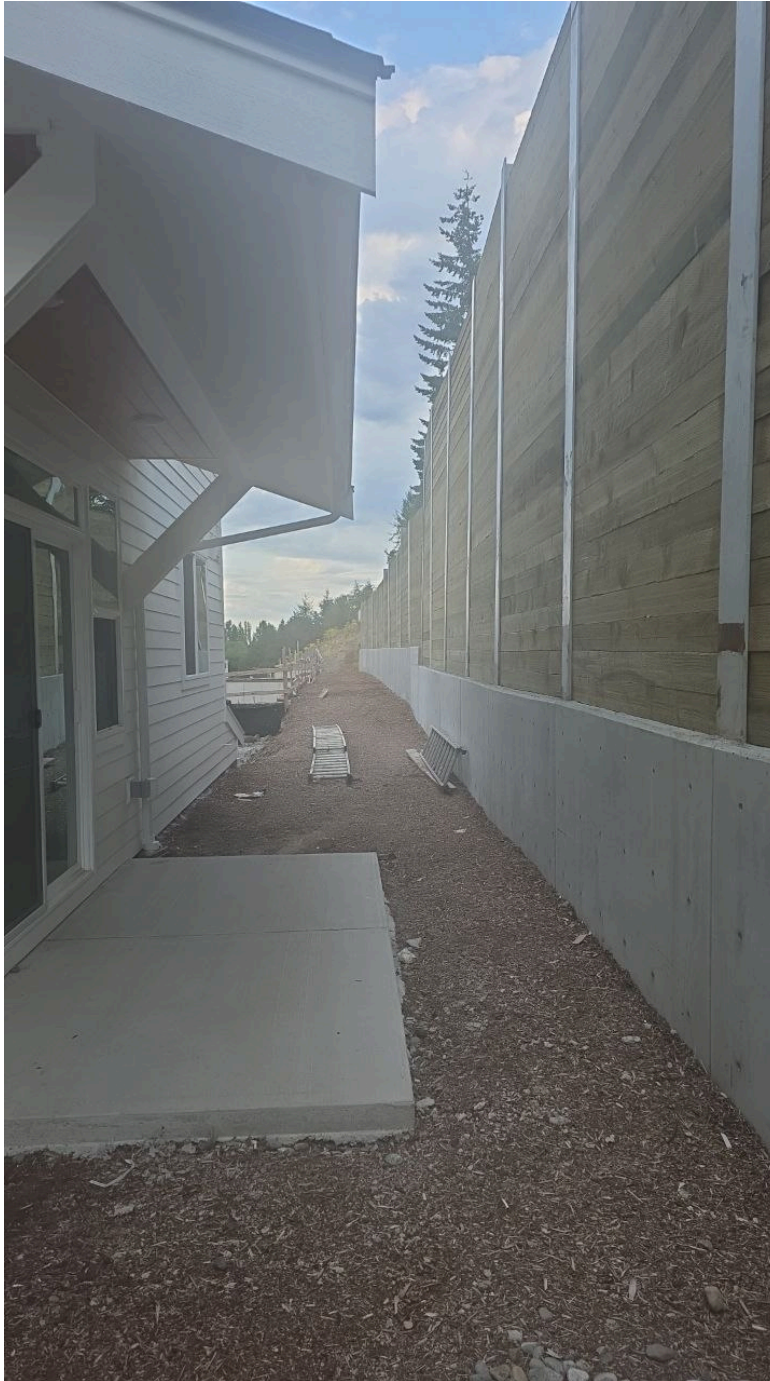
Photograph P008 was identified by Dave as showing the proximity of the retaining/shoring wall to the house at the north end. The photo description indicates a narrow space between the residence and the wall, with the residence exterior/eaves and patio slab on one side, and the retaining/shoring wall on the other.

**P008** - North-end proximity of the retaining/shoring wall to the house.

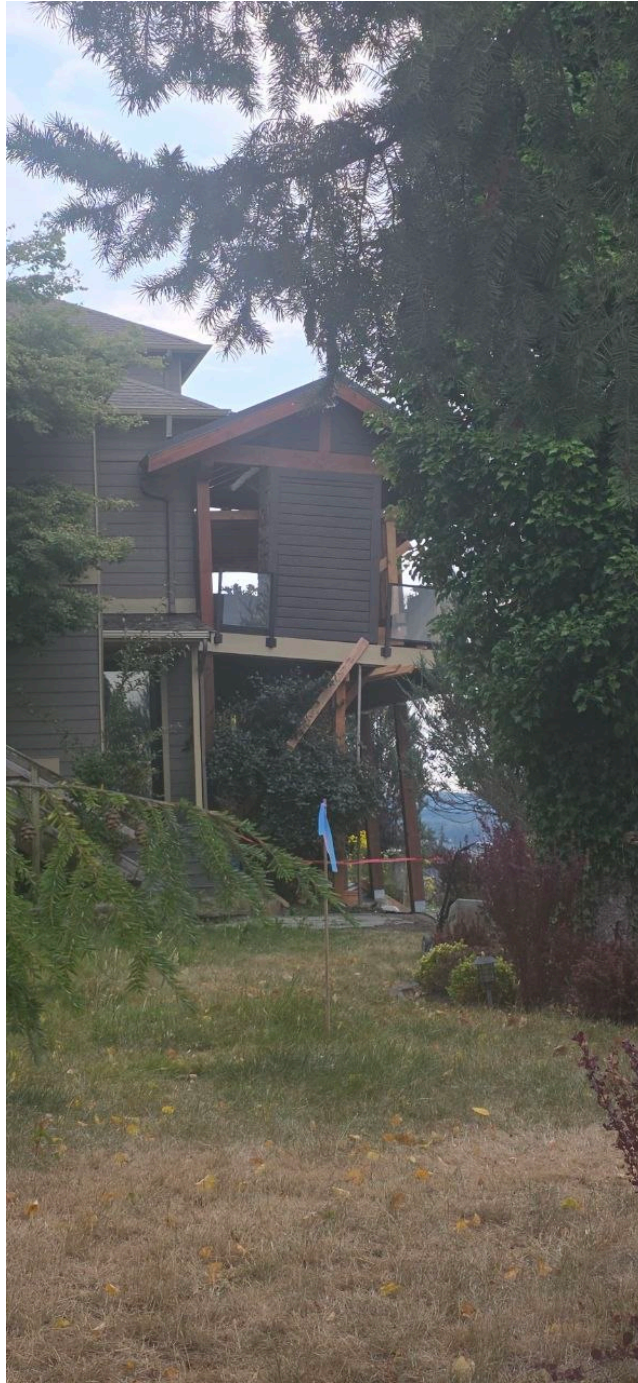
Those observations indicate that the uphill property and top-of-slope area had visible support, slope, and foundation-related conditions warranting further review. In particular, the reported porch settlement, propping, possible head scarp, missing Eco blocks, and undermined porch column foundation should be correlated with prior photographs, construction records, repair history, city or neighbor reports, and survey data before any final opinion is offered regarding timing, causation, or structural significance.

**P009** - Settlement of the porch in the property above the wall at the south end.

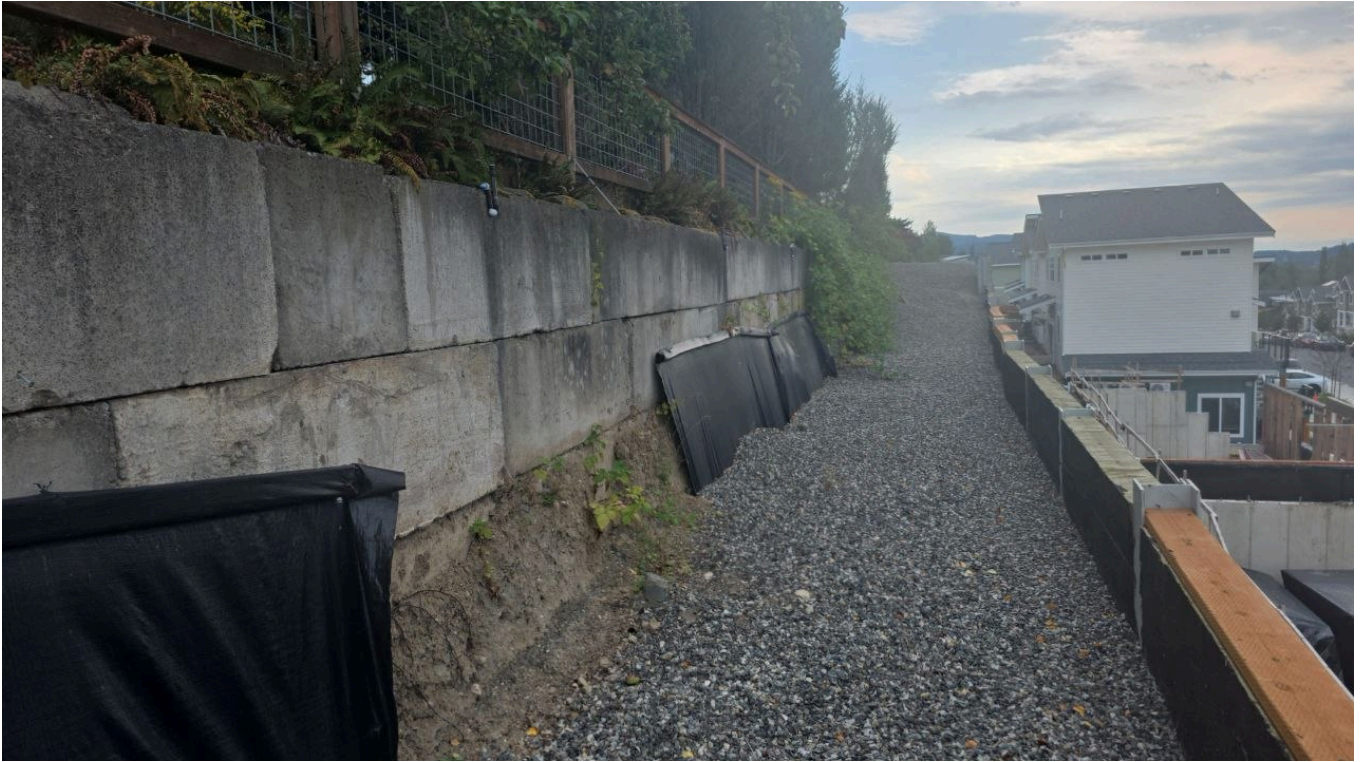
**P010** - Existing uphill concrete retaining/site wall, gravel path, black fabric/sheeting, and downhill construction.

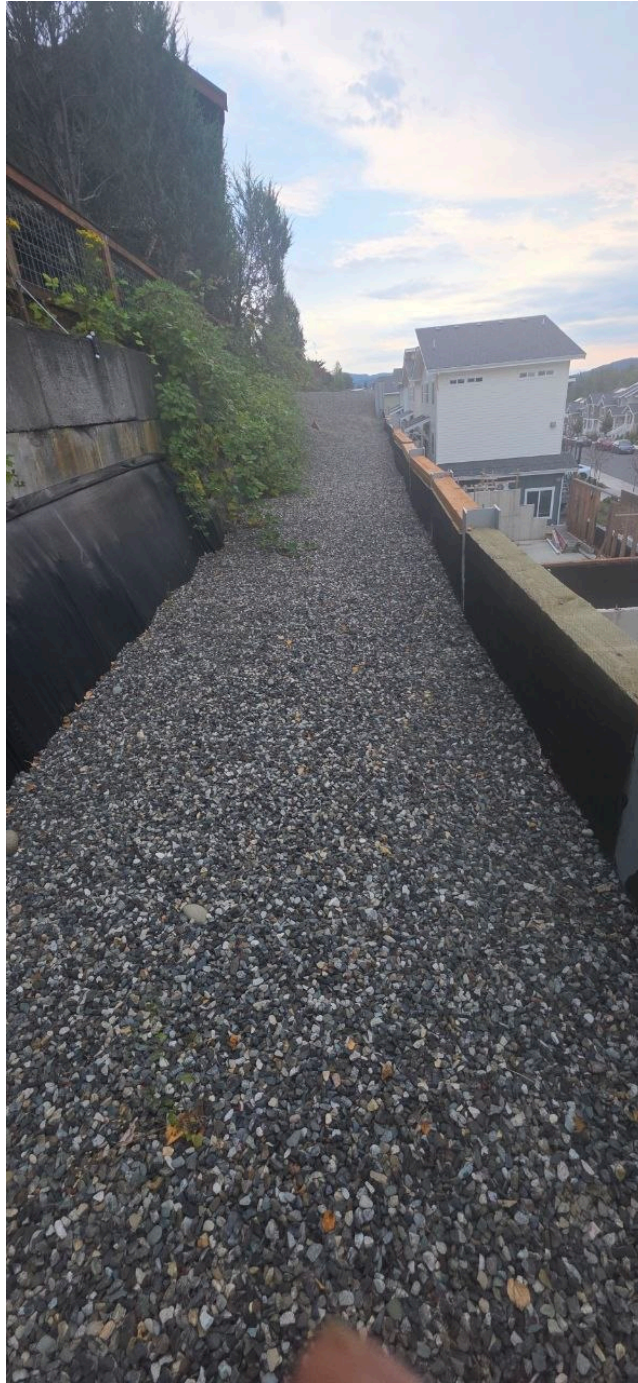
**P012** - Gravel fill above the wall.

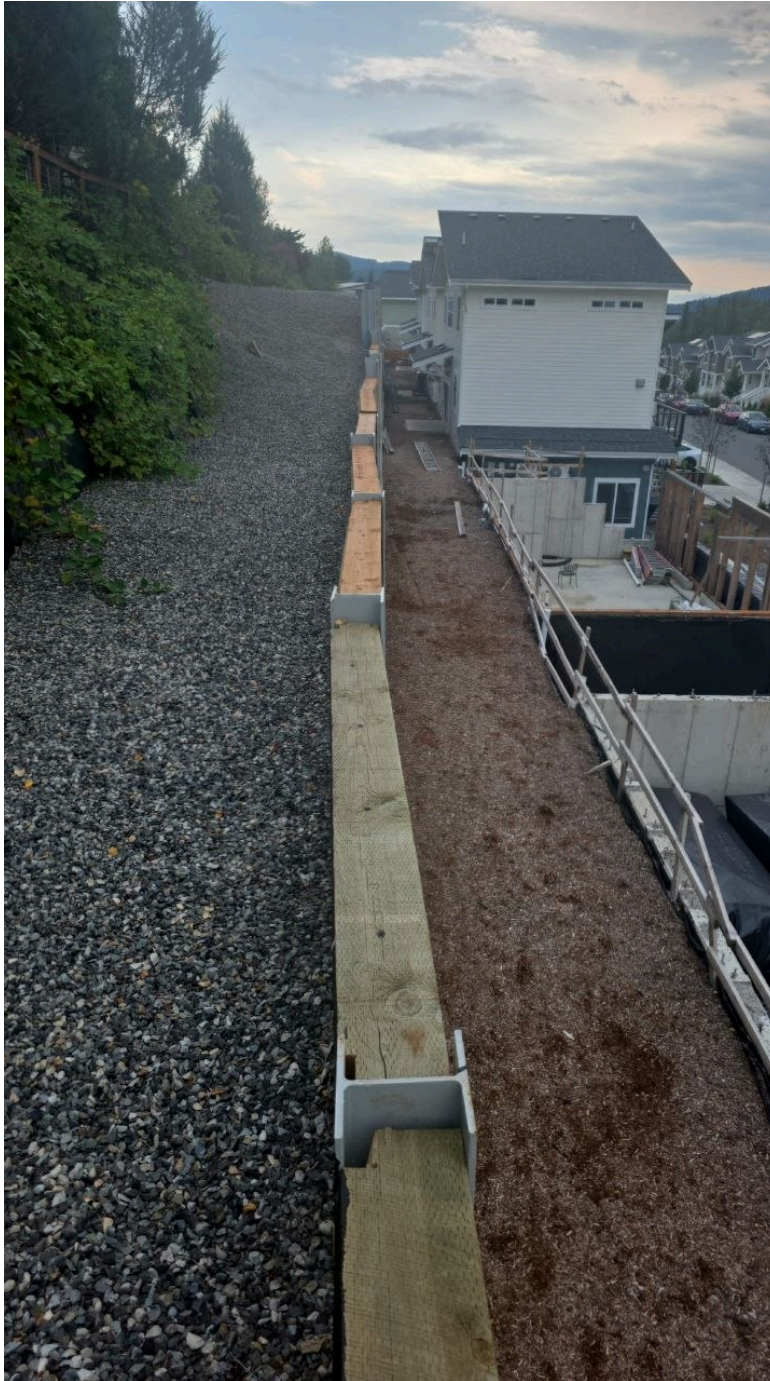
Dave later reported measuring soldier pile verticality approximately 3 feet above the connection to the concrete wall/wall-beam area. According to the field note, the measured piles leaned toward the uphill side by approximately 0.6 to 1.4 degrees.

Dave's field interpretation was that those measurements did not indicate clear evidence of outward wall movement due to backfill or excessive deflection of the soldier piles during backfilling. He also noted that the wall irregularity could be the result of poor initial alignment of soldier piles when they were placed in drilled shafts.

That interpretation should be confirmed against any available survey data, as-built records, pile-by-pile measurements, and construction sequence records. Without that additional information, the photographs and measurements support the observation that the wall line appears irregular, but they do not by themselves establish the timing or cause of that irregularity.

**P013** - Pile misalignment at the south end.

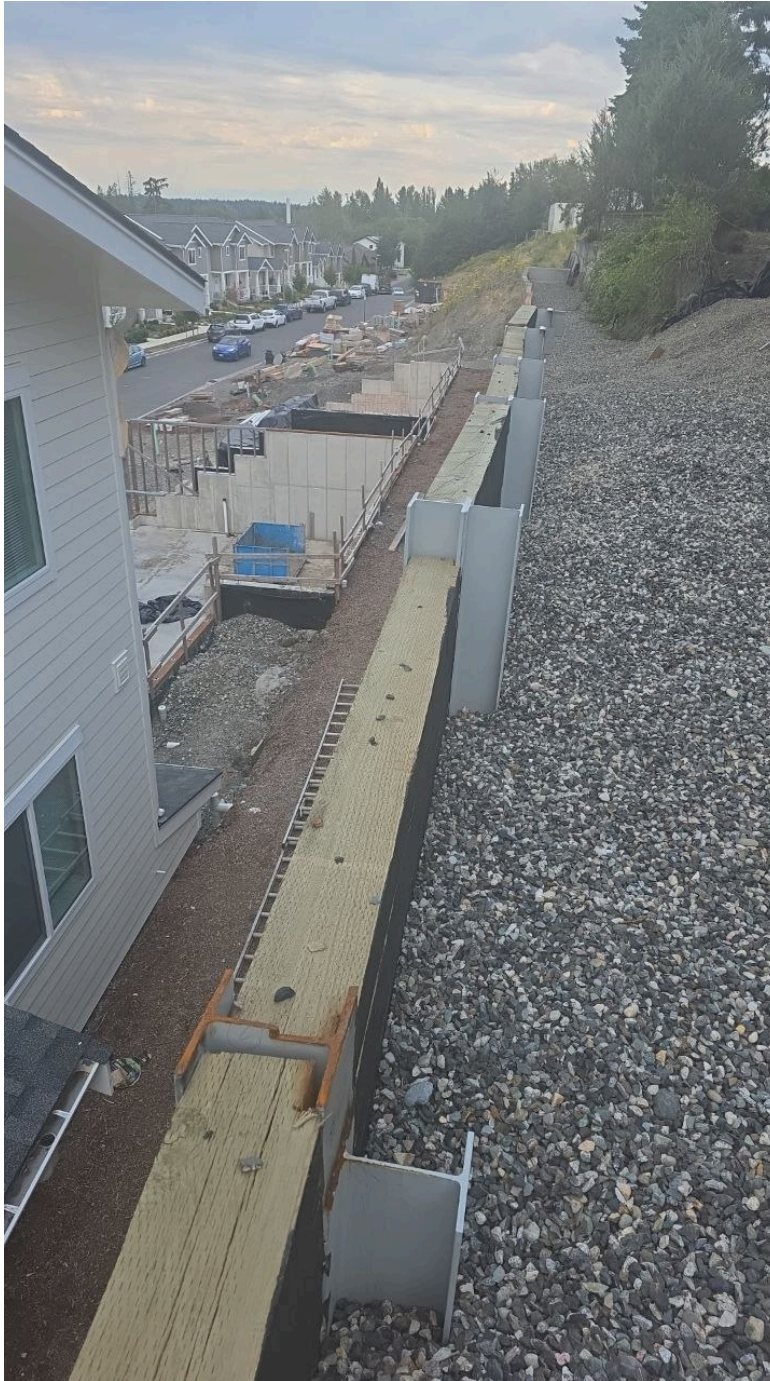
Photograph P014 was identified by Dave as showing double piles at the north end. The photograph documents paired steel pile elements and related top-of-wall conditions. No structural adequacy conclusion should be drawn from that photograph alone without comparison to the permitted design, retrofit drawings, and as-built records.

**P014** - Double piles at the north end.

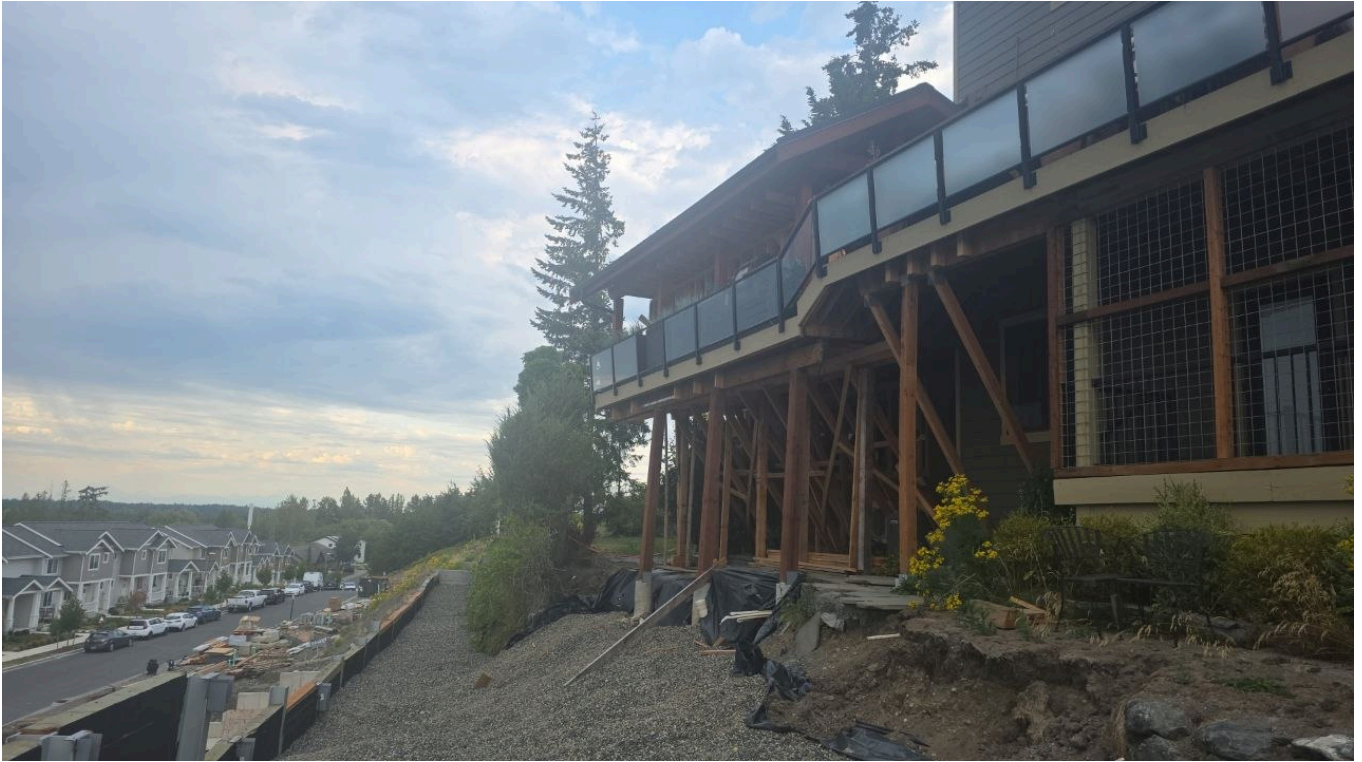
**P015** - House above the property propped up.

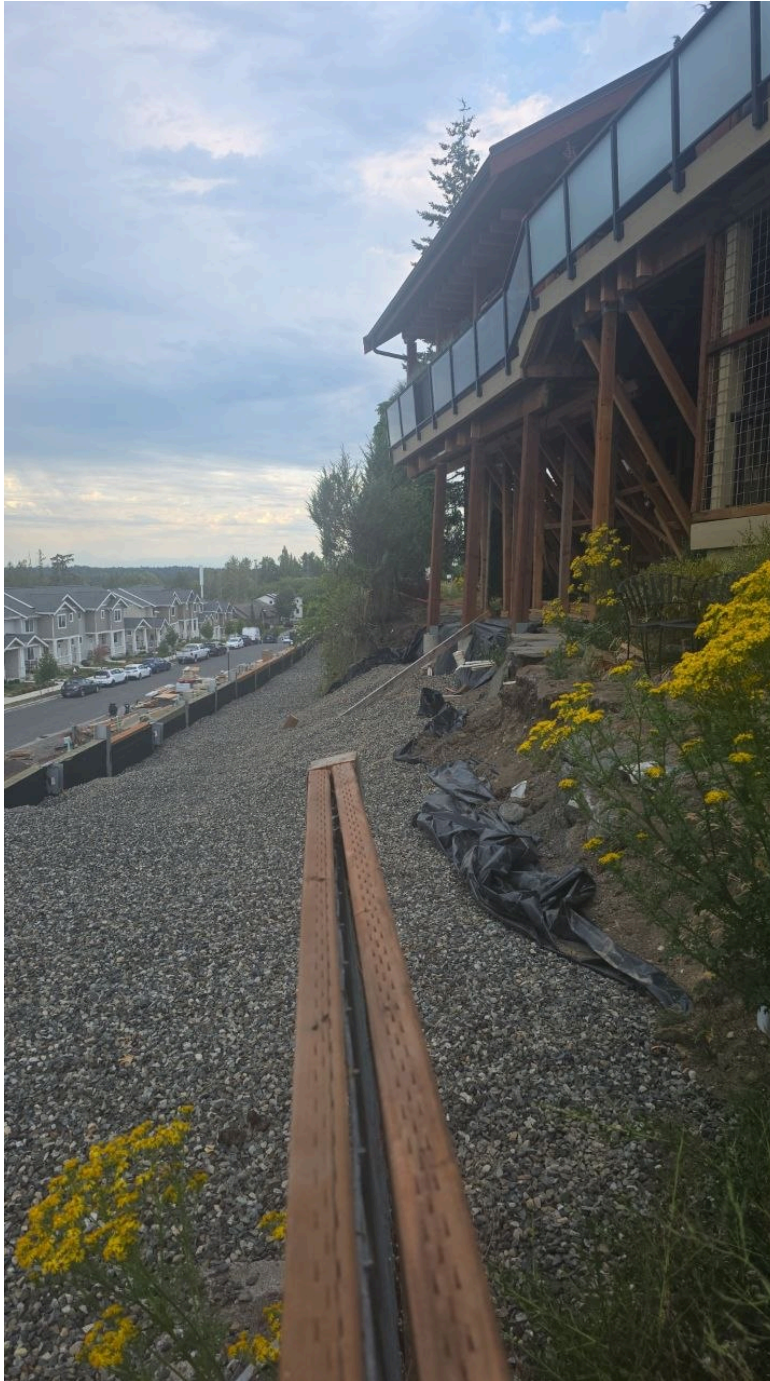
**P016** - Possible head scarp/failure area beyond property line, with Eco blocks missing; timing unknown.

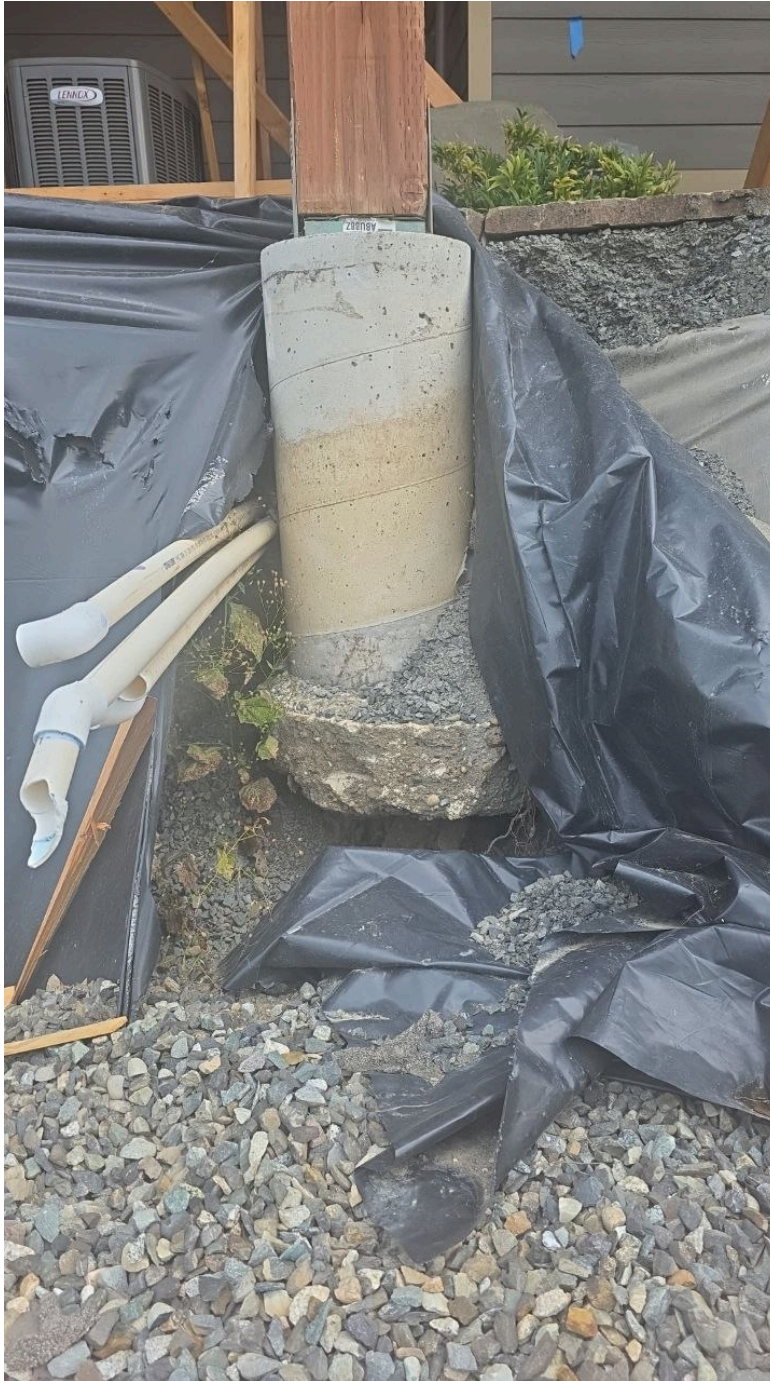
**P017** - Porch column foundation undermining.

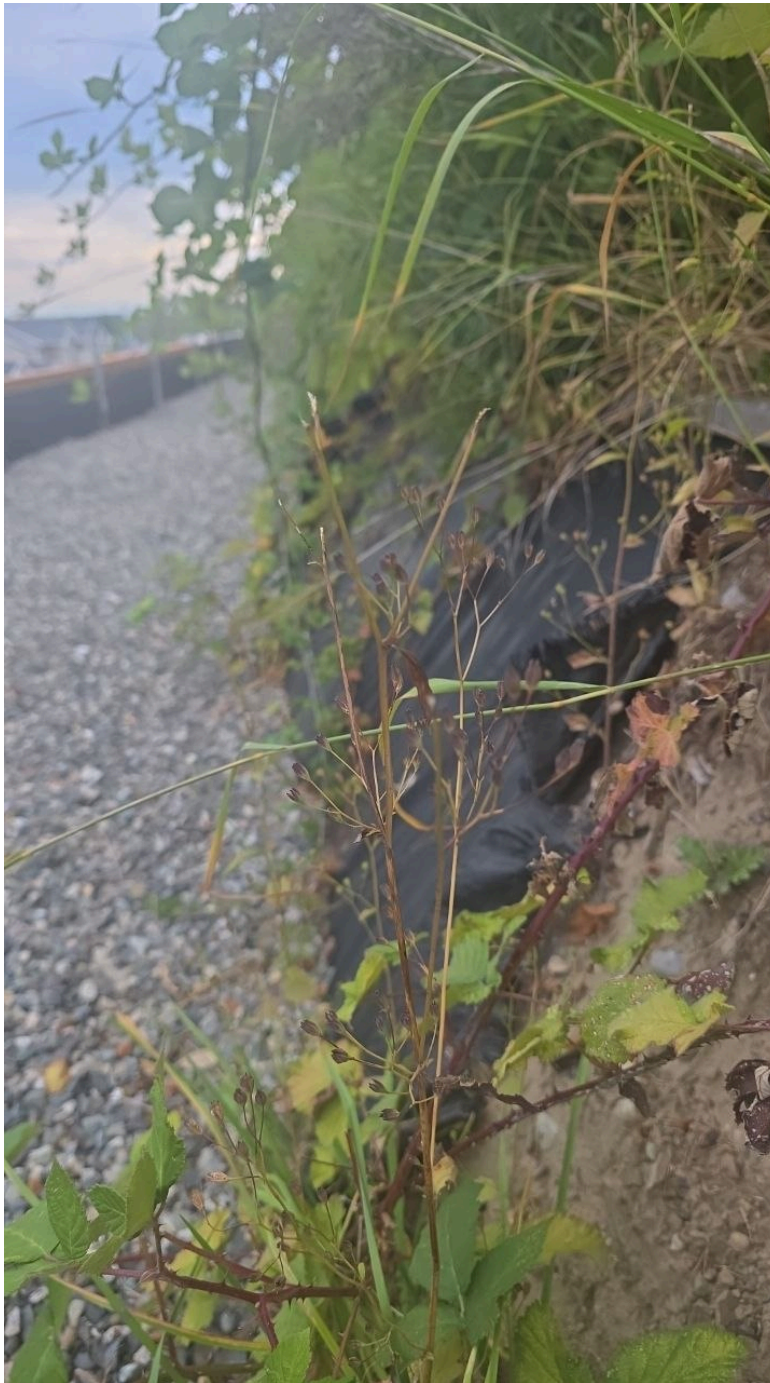
Dave reported that the back-cut slope at the area where black plastic or black erosion-control material covered part of the upper exposed slope appeared to indicate an original slope angle of approximately 55 to 70 degrees.

That field estimate appears to be related to the original back-cut condition shown in P018 and to the nearby uphill property/slope conditions shown in P015 , P016 , and P017 . Before using the angle estimate in any calculation, Dave should confirm the exact measurement location, method, instrument, and whether the angle was measured from horizontal.

**P018** - Original back-cut condition.
