# ROOF LEAKAGE REMEDIAL WORKS — IKEJA

RPT-2026-ROOF-001

11 August 2026

DOVA Futures Limited —  
Design-Build Team

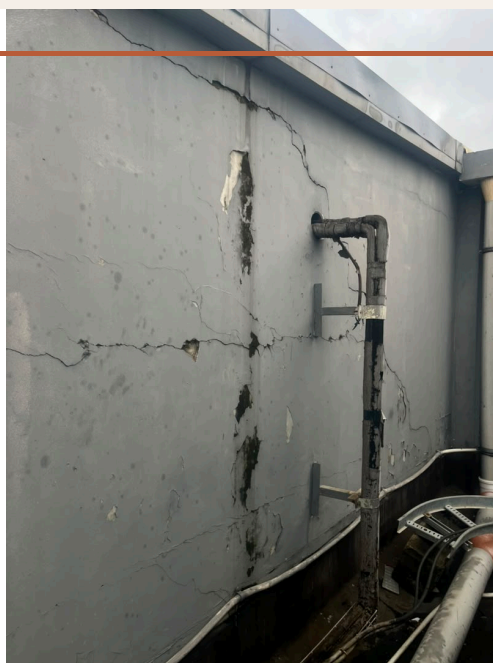
Visible water damage and cracking were observed at a roof-edge wall beneath the existing metal cap/coping, with previous fixing points and service penetrations present. The current assessment is based solely on visible inspection. The working proposal is to address the likely coping/blockwork leakage route first, then provide localised rescreeding and refelting at the slab-to-wall junction as a precaution. The attached wall image records the observed condition and is not, by itself, a definitive diagnosis.

- 01** The wall shows extensive cracking, local surface failure, staining and damp-related deterioration beneath the roof-edge cap.
- 02** The coping/blockwork interface, existing penetrations and defective roof-cap details are the leading visible indicators of a possible water-entry route.
- 03** The exact leakage path and the mechanism behind the wall cracking remain unconfirmed until the affected areas are opened, cleaned and investigated during the works.

Figure 1. Defective wall observed during visible inspection. This image records visible condition only and does not establish the definitive leakage path or structural cause.

1. Begin with Measure 1: expose and prepare the coping/blockwork, seal penetrations, investigate and repair the cracked wall, then reinstate the local waterproofing and continuous cap/coping. 2. Treat Measure 2 as a precautionary perimeter intervention: rescreed and refelt the slab-to-wall junction after confirming the measured extent on site. 3. During opening-up, trace the active water route and revise the repair sequence if the observed conditions identify a different cause. 4. Monitor the roof after completion before considering full-roof screeding.
