# ROOF LEAKAGE REMEDIAL WORKS — IKEJA CITY MALL

RPT-2026-ICM-ROOF-001

21 August 2026

DOVA Futures Limited

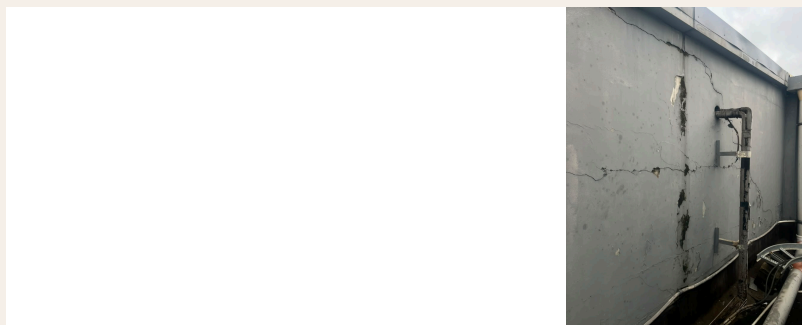
Visible water damage and cracking were observed at a roof-edge wall beneath the existing metal cap/coping, with previous fixing points and service penetrations present. The current assessment is based solely on visible inspection. The working proposal is to address the likely coping/blockwork leakage route first, then provide localised rescreeding and refelting at the slab-to-wall junction as a precaution. The attached wall image records the observed condition and is not, by itself, a definitive diagnosis.

- 01 The wall shows extensive cracking, local surface failure, staining and damp-related deterioration beneath the roof-edge cap.
- 02 The coping/blockwork interface, existing penetrations and defective roof-cap details are the leading visible indicators of a possible water-entry route.
- 03 The exact leakage path and the mechanism behind the wall cracking remain unconfirmed until the affected areas are opened, cleaned and investigated during the works.

Figure 1. Defective wall observed during visible inspection. This image records visible condition only and does not establish the definitive leakage path or structural cause.

1. **Repair and waterproof the affected roof-edge wall and metal coping.** Based on the visible inspection, rainwater flowing across the flat roof appears to be reaching the wall and entering through openings around old bolts, screws and other penetrations in the metal coping. The existing felt beneath this area also appears to have failed or does not extend far enough to provide adequate protection. The metal coping should therefore be carefully opened where necessary, all holes and penetrations sealed, the damaged wall repaired, and a new layer of bituminous felt installed with sufficient coverage and properly sealed laps. The coping should then be reinstated and sealed to prevent rainwater from entering through the top of the wall.

2. Treat Measure 2 as a precautionary perimeter intervention limited to approximately 1 metre up the wall and 1 metre onto the slab. Rescreed and refelt this slab-to-wall junction and lapping side only; the main slab area is excluded because its existing felt appeared satisfactory during visible inspection.

3. During opening-up, trace the active water route and revise the repair sequence if the observed conditions identify a different cause.
4. Monitor the roof after completion. If investigation shows that a wider slab treatment is required, record the finding and inform Broll Properties before any additional work proceeds.
