# ROOF LEAKAGE REMEDIAL WORKS — IKEJA CITY MALL

RPT-2026-ROOF-001

11 August 2026

DOVA Futures Limited —  
Design-Build Team

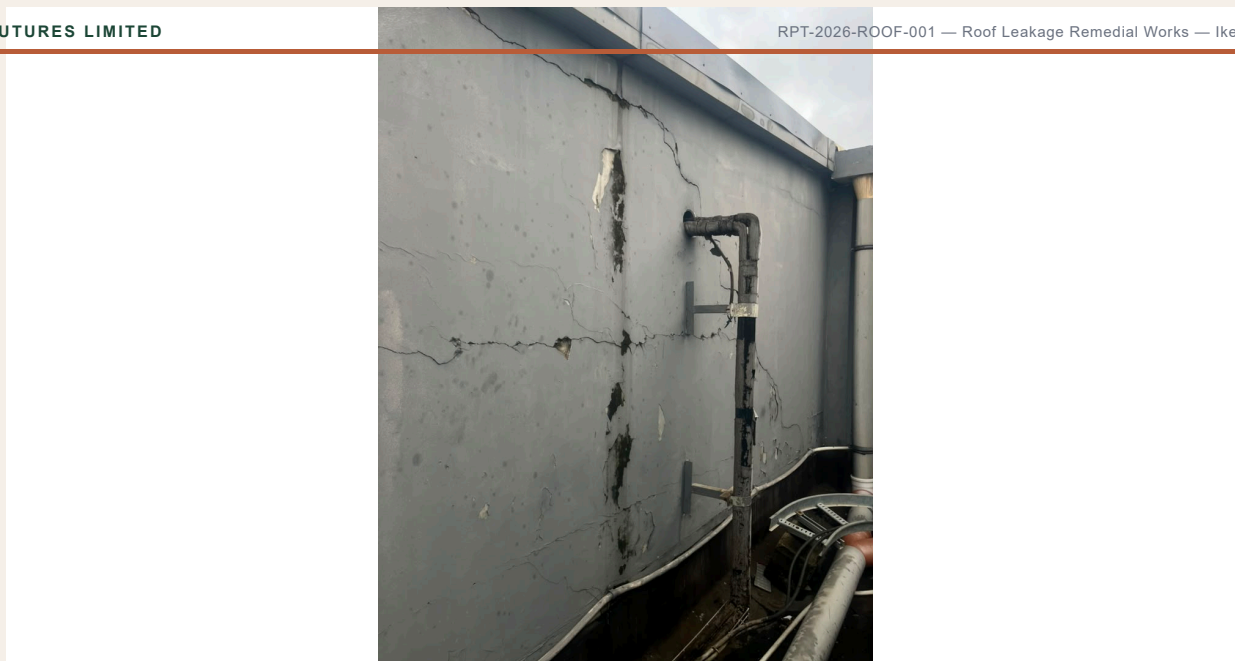
Visible water damage and cracking were observed at a roof-edge wall beneath the existing metal cap/coping, with previous fixing points and service penetrations present. The current assessment is based solely on visible inspection. The working proposal is to address the likely coping/blockwork leakage route first, then provide localised rescreeding and refelting at the slab-to-wall junction as a precaution. The attached wall image records the observed condition and is not, by itself, a definitive diagnosis.

- 01** The wall shows extensive cracking, local surface failure, staining and damp-related deterioration beneath the roof-edge cap.
- 02** The coping/blockwork interface, existing penetrations and defective roof-cap details are the leading visible indicators of a possible water-entry route.
- 03** The exact leakage path and the mechanism behind the wall cracking remain unconfirmed until the affected areas are opened, cleaned and investigated during the works.

Figure 1. Defective wall observed during visible inspection. This image records visible condition only and does not establish the definitive leakage path or structural cause.

1. Begin with Measure 1: expose and prepare the coping/blockwork, seal penetrations, investigate and repair the cracked wall, then reinstate the local waterproofing and continuous cap/coping. 2. Treat Measure 2 as a precautionary perimeter intervention: rescreed and refelt the slab-to-wall junction after confirming the measured extent on site. 3. During opening-up, trace the active water route and revise the repair sequence if the observed conditions identify a different cause. 4. Monitor the roof after completion before considering full-roof screeding.
