# ROOF LEAKAGE REMEDIAL WORKS — IKEJA CITY MALL

RPT-2026-ROOF-001

11 August 2026

DOVA Futures Limited — Design-Build Team

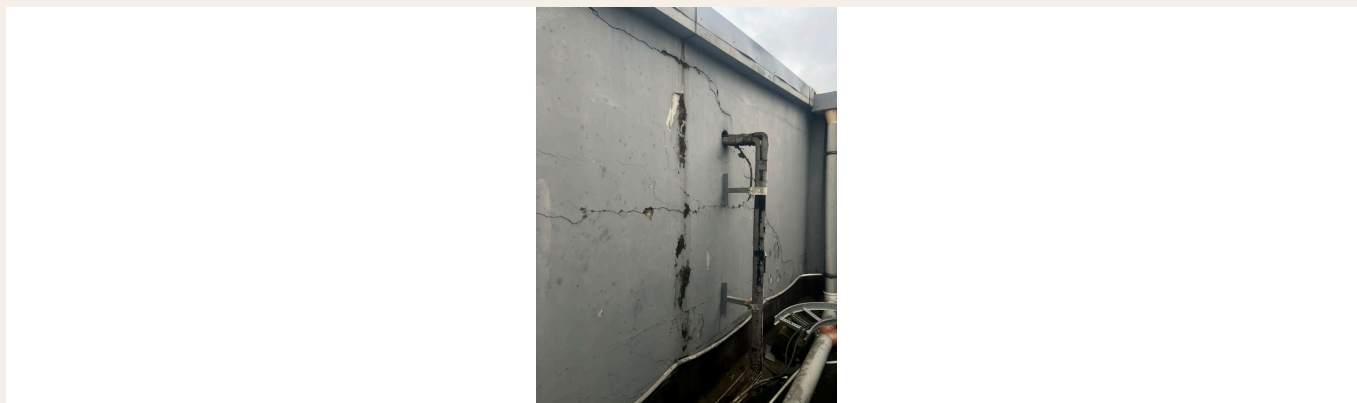
Visible water damage and cracking were observed at a roof-edge wall beneath the existing metal cap/coping, with previous fixing points and service penetrations present. The current assessment is based solely on visible inspection. The working proposal is to address the likely coping/blockwork leakage route first, then provide localised rescreeding and refelting at the slab-to-wall junction as a precaution. The attached wall image records the observed condition and is not, by itself, a definitive diagnosis.

- 01 The wall shows extensive cracking, local surface failure, staining and damp-related deterioration beneath the roof-edge cap.
- 02 The coping/blockwork interface, existing penetrations and defective roof-cap details are the leading visible indicators of a possible water-entry route.
- 03 The exact leakage path and the mechanism behind the wall cracking remain unconfirmed until the affected areas are opened, cleaned and investigated during the works.

Figure 1. Defective wall observed during visible inspection. This image records visible condition only and does not establish the definitive leakage path or structural cause.

1. Begin with Measure 1 by exposing and preparing the coping and blockwork, sealing penetrations, investigating and repairing the cracked wall, then reinstating the local waterproofing and continuous roof cap/coping.
2. Treat Measure 2 as a precautionary perimeter intervention: rescreed and refelt the slab-to-wall junction after confirming the measured extent on site.
3. During opening-up, trace the active water route and revise the repair sequence if the observed conditions identify a different cause.
4. Monitor the roof after completion before considering any full-roof screeding.
