PASO DEL ISTMO TOURISM

RECOMMENDATIONS FOR ROADWAY SIGNAGE
FROM SAN JUAN DEL SUR TO OSTIONAL AND
INTERPRETIVE PANELS AT LA FLOR WILDLIFE REFUGE

TECHNICAL REPORT

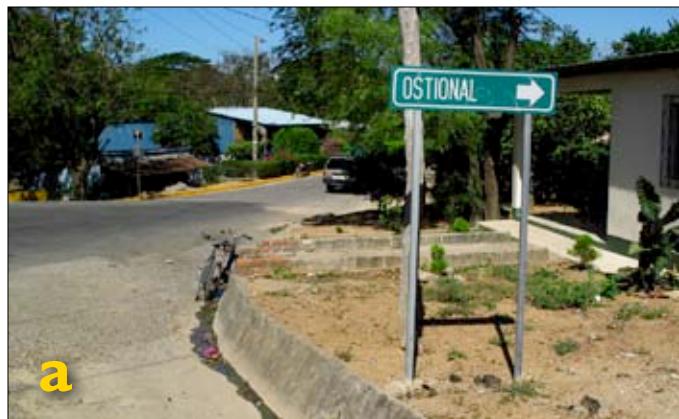
a

Figure I a-p shows examples of the current roadway signage from San Juan del Sur to El Ostional. There is currently one new metal roadway directional sign (for El Ostional) at the junction of the road going to Ostional on the eastern side of San Juan del Sur. This corner is also cluttered with commercial signs of various sizes and conditions promoting businesses to the south (Figure Ia & Ib).

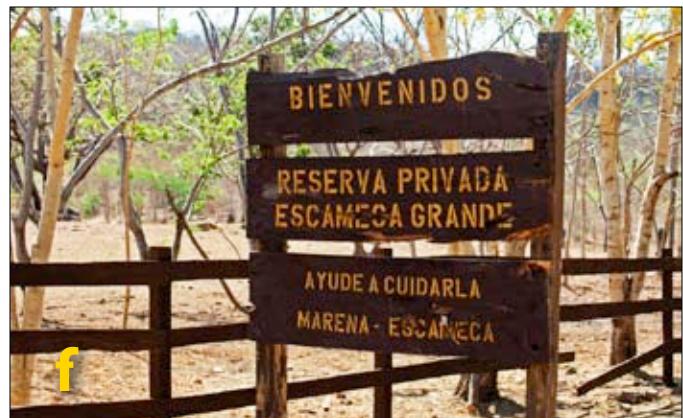
f

At Escameca Grande a wooden roadway sign is located at the entrance to a private reserve, Escameca Grande, that is partially rotted and should be replaced (Figure If).

3. Replace the existing roadway wooden sign at the Escameca Grande Private Reserve (point C).
4. Add a painted wooden sign at the entrance to the road to Playa Escamequita (point D) showing the direction and distance to the beach. This sign can be placed on a post or tree near the gate and oriented to face the road so it can be seen from both directions.

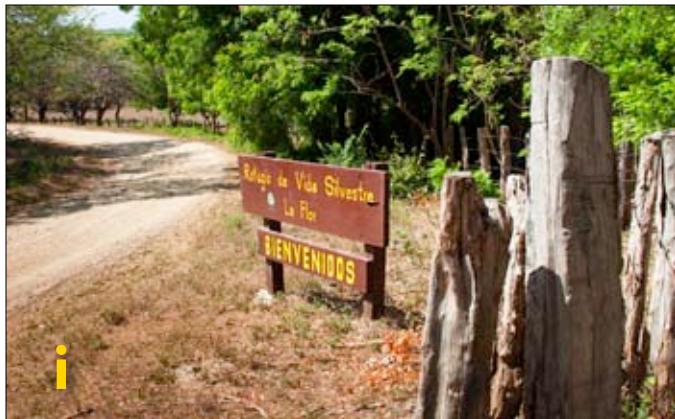
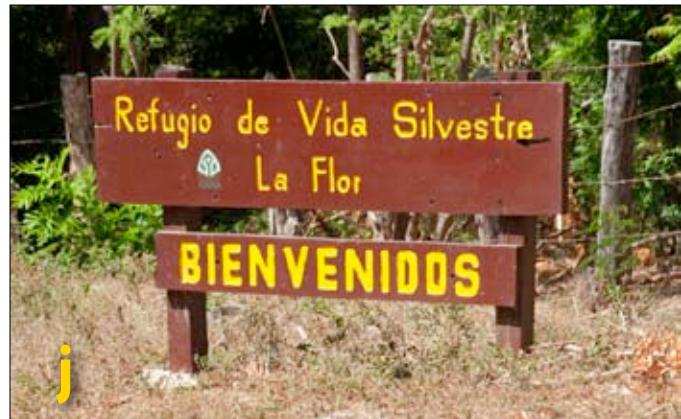
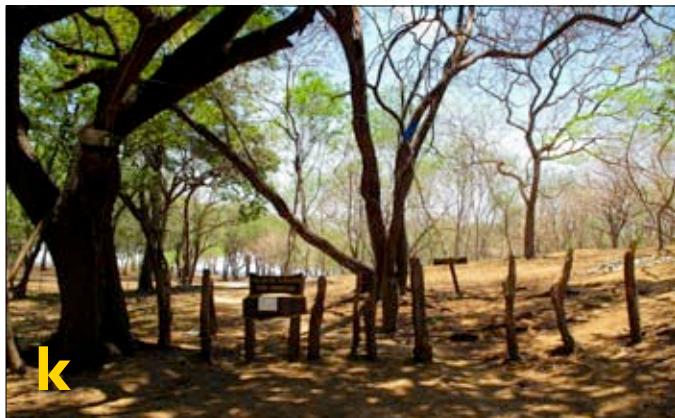
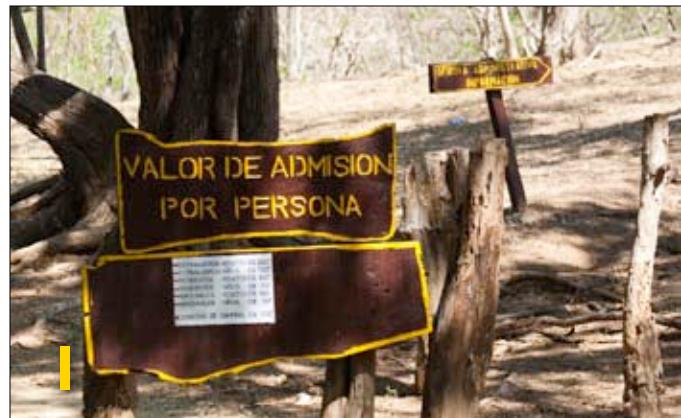
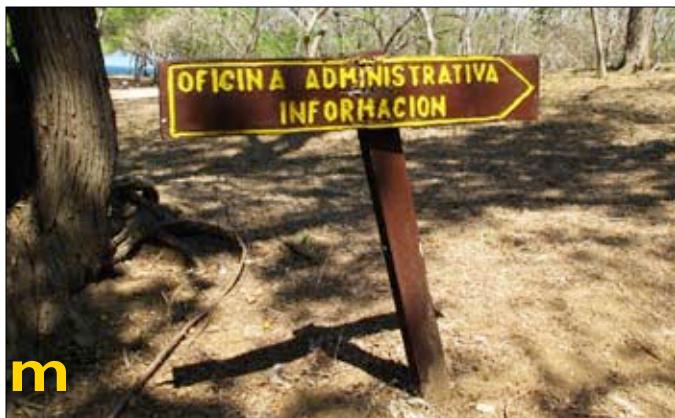
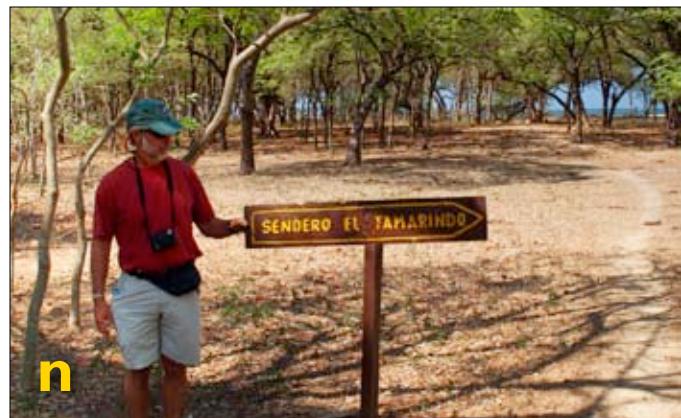
A few information signs, mostly in poor condition, exist at La Flor. An old wooden sign is located at the entrance to the Refuge; a small sign showing entrance fees and a small wooden arrow sign painted with, “Parquero” are located in the Parking lot; near the parking lot is a sign with, “Oficina Administrativa” and, “Información”; and at the beginning of the Los Tamarindo trail there is a wooden sign in very poor condition (the board has fallen off the post). In addition, there are no directional signs for the new public restrooms (Figure Ii to In).

Information on sea turtles is displayed on the wall of the administration building, but it is of mixed quality, in generally poor condition and, due to its location, it is not seen by most visitors (Figure Io to Ip).

The existing wooden welcome sign at the entrance should be replaced as per the recommendations in Section 4.0. In addition, the existing wooden signs for parking and entrance fees in the parking lot should be removed. A total of 3 new wooden signs are recommended for the Refuge (Table 2). These are illustrated in APPENDIX A and their locations are shown on Map 2.

Nearby we recommend the placement of a small wooden sign indicating the direction of the public bathrooms and office. This sign should be located at the trail to the administrative building. Also, two new small wooden trail signs are needed to identify the beginning of the Tammarindo and Los Cocos trails (these replace existing signs that are in poor condition).

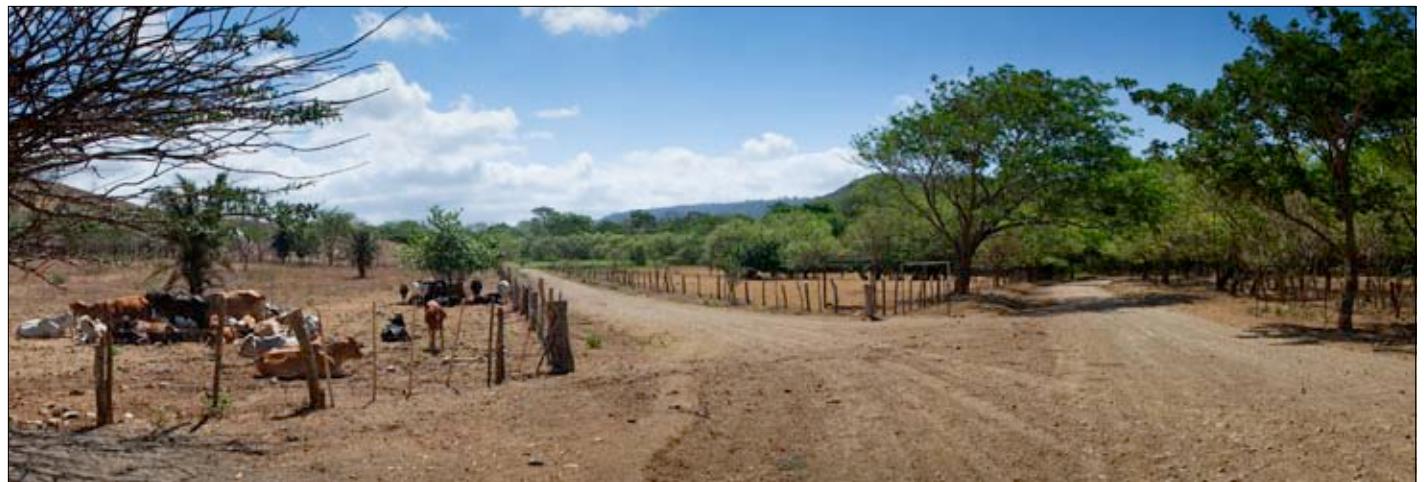
Currently, there is no signage at the roadway junctions.

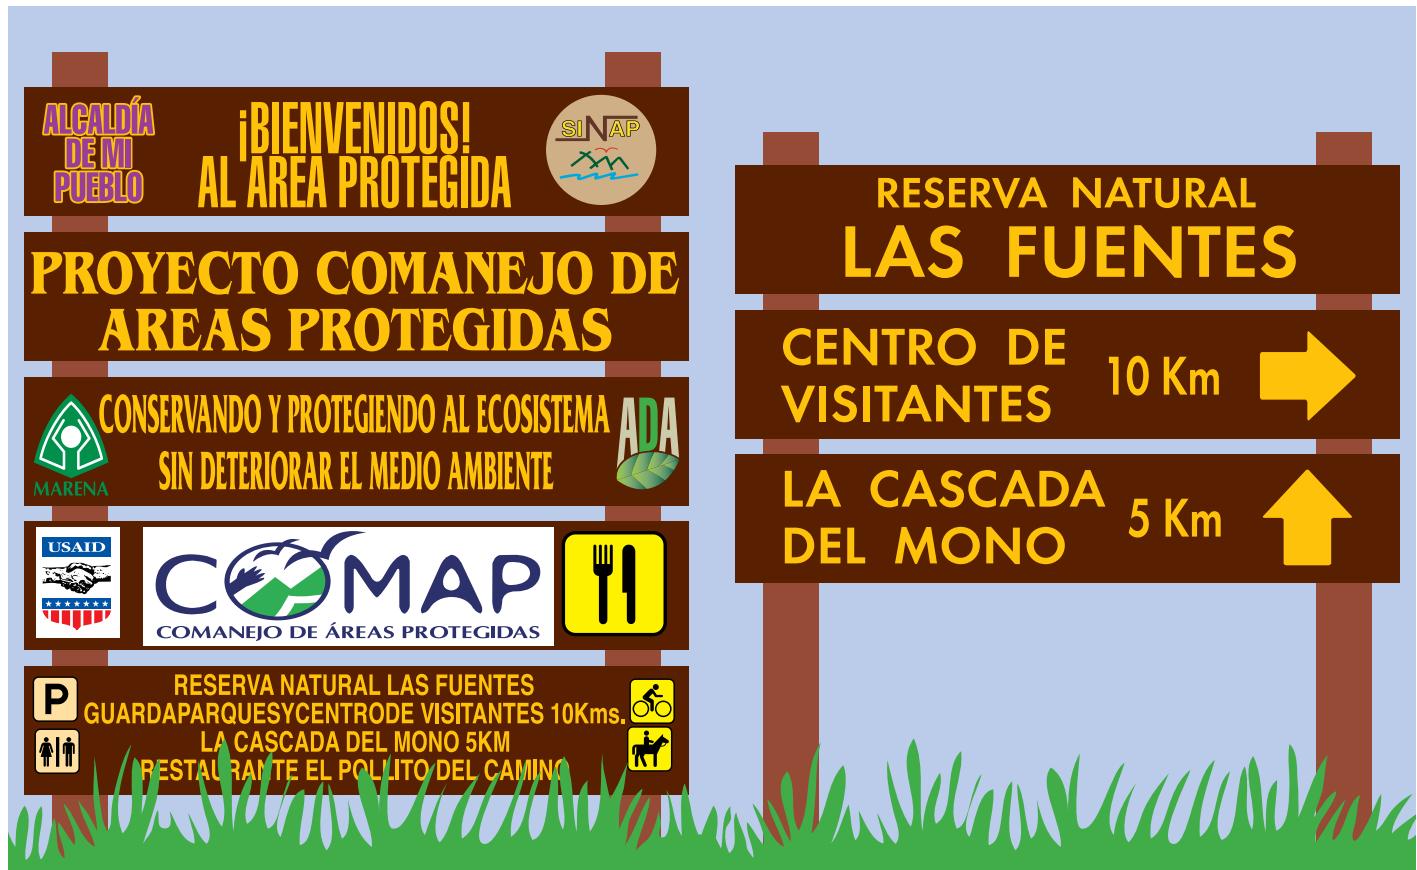
Figure 2. Example of bad and good sign design.

Proper sign design is essential for the sign to be an effective communication tool. Each sign should only provide the information needed by the motorist or park visitor under a given situation, condition or location. Signs should be designed so that they are safe. They should not be a distraction, especially for the motorist who must take his eyes off the road in order to view and understand the sign message. Figure 2 shows a graphic example of a poorly designed sign and a well designed sign.

a. Bad Sign

b. Good Sign

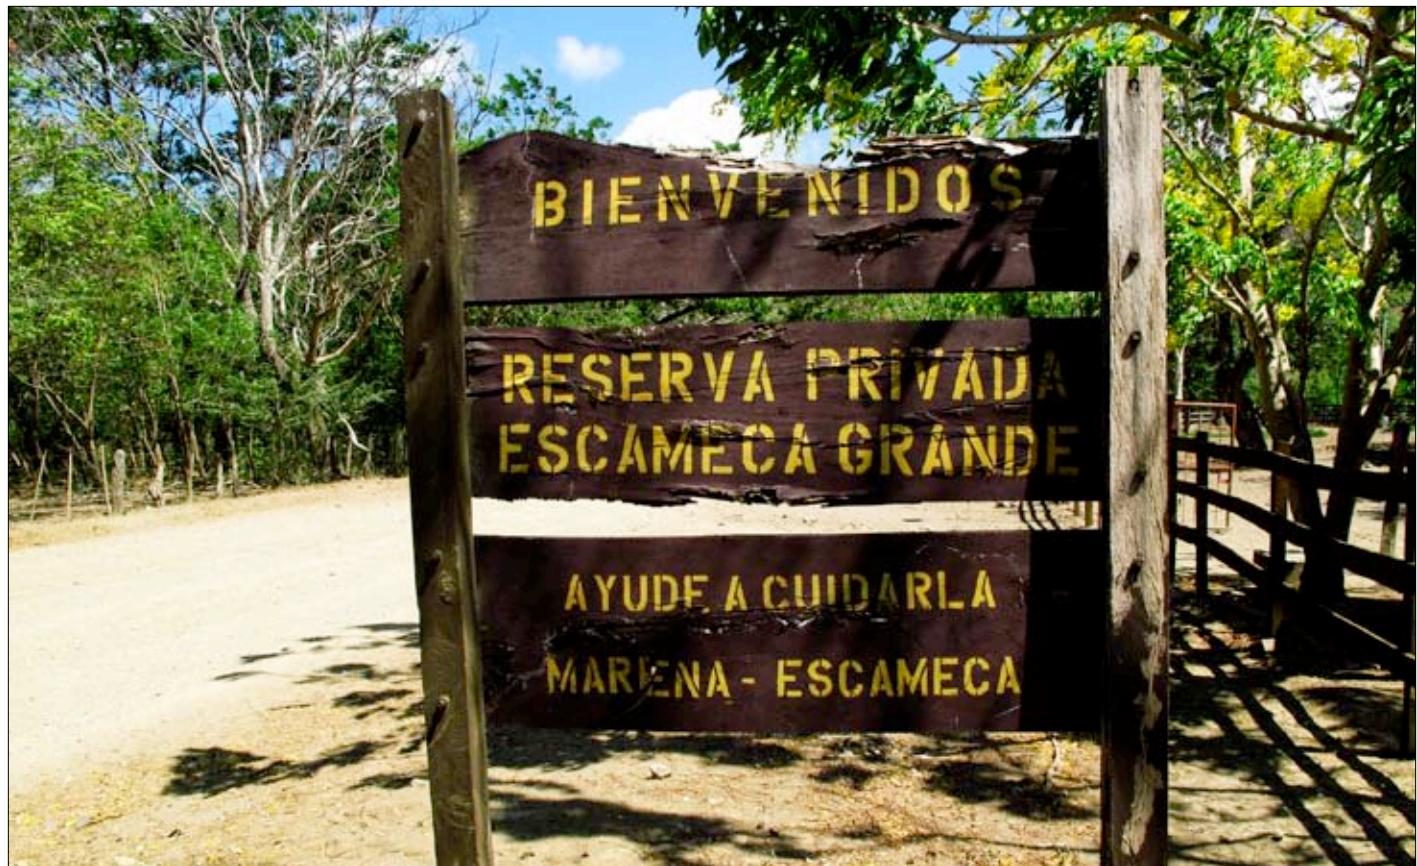
An old sign wore out by time. This signs need to be replaced every 4 to five years.
