CASTILLO SAN LORENZO PANAMA

Concepts for Interpretation and Site Planning: A Prelude to Master Planning

July 2001

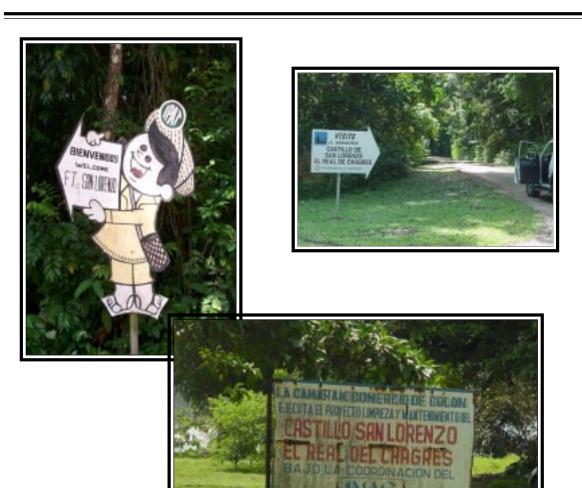
Figure 15. Existing Castillo San Lorenzo signs.

In lieu of a visitor orientation kiosk at the entrance to the site (which will take long-range planning to develop), a welcome sign could be placed at the turnoff road to the fort (Fig. 14). All other signs at that intersection should be removed, as they unnecessarily clutter the area and take away from the visitor experience. The existing vertical sign at the edge of the parking lot should also be removed (Fig. 15).

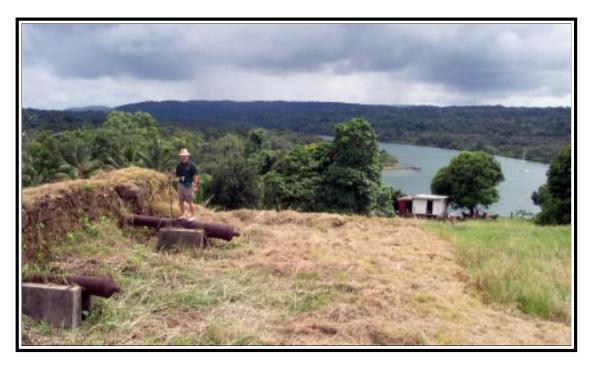
Figure 19. Another view of Chagres River from CSL (note mowed grass).

As an alternative to mowing and the use of herbicide, use goats and sheep for maintenance of non-native vegetation and evasive plant treatment in area of Castle (Figs. 18-19).

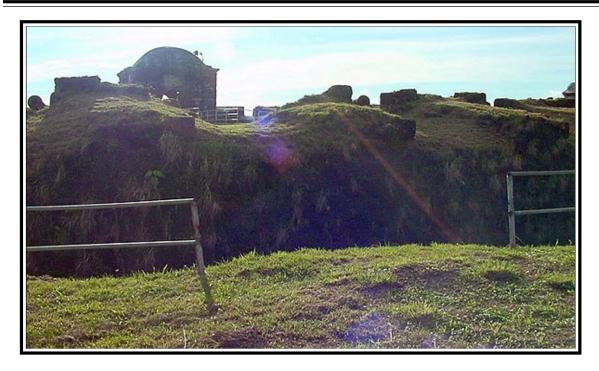
Figure 28. A good location for moat bridge.

A footbridge should be built across the moat so visitors are not required to walk up and down steep worn (slippery when wet) grades or unstable stairs (Fig. 26-30). The construction style of this bridge should be in harmony with that of the Castle, but also designed as to not be mistaken as original architecture. This footbridge should be replaced or reinforced before higher volumes of traffic are allowed to use it. In the long run it should be replaced with a period authentic connection.

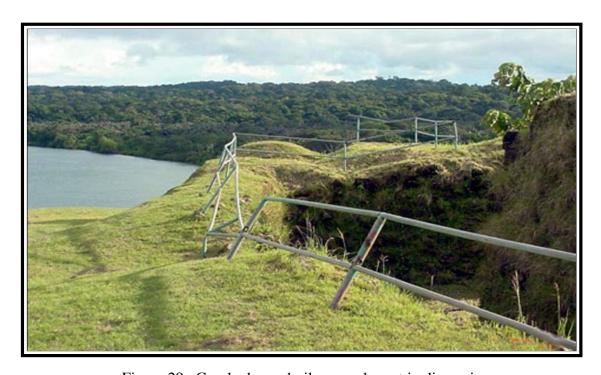
Figure 29. Crooked guardrails around moat in disrepair.

P. Improve Guard Rails

It is also important that all guardrails around the moat be either temporarily repaired or replaced with rails of an appropriate design and materials, compatible with the site character (Fig. 31). Also of great concern are ledges and top of walls where at present there are no controls to restrict visitors from getting to close to the edge (Fig. 32). Children are of particular concern because of their natural tendency to explore.

It is recommended that, as a minimum, temporary ropes with simple signs be placed to warn visitors of the hazards. In the long run, a guardrail system needs to be installed at

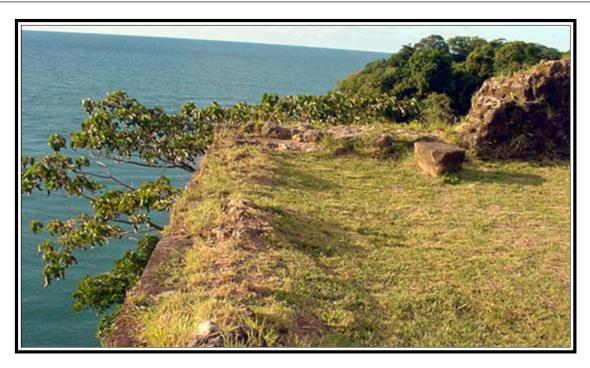
Figure 30. Unprotected edge of castle bluff.
