# RESSCOTT –INSPECTION REPORT

JOB #: IR-RES0323-41

**Checklist on Solar System:  
Inspection conducted on Solar System Components for  
60KW Hybrid Solar PV System**

| ADDRESS | 44 Mayfeild, Valsayn, Trinidad |

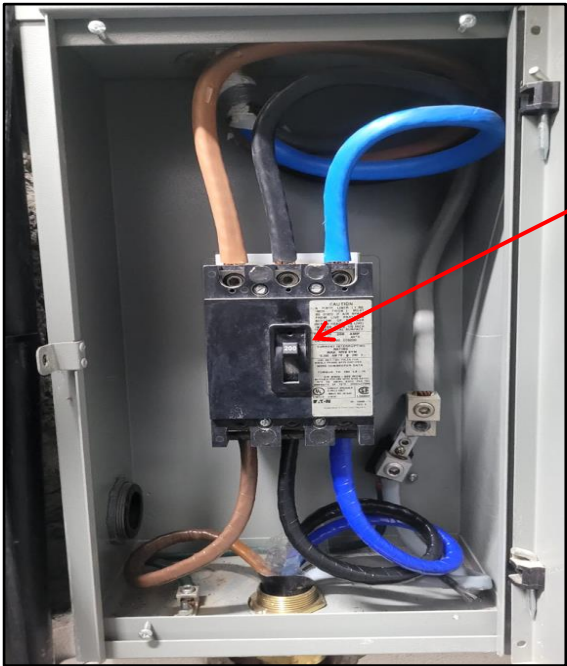
Main Disconnect, 200 Amp breaker from Utility connection. This breaker shut down the house or in case power goes off, the Back-up generator is initiated.

The back up generator does not affect the solar PV equipment.

Photo #2: Overview of Main disconnect Breaker

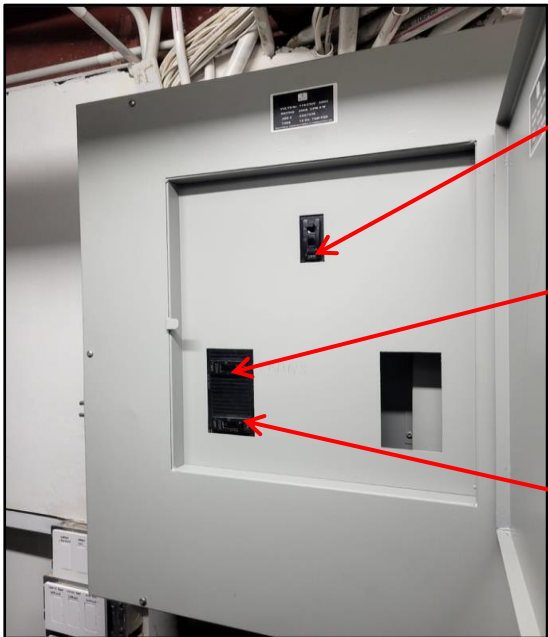
Main breaker 200 amp, Incoming from Main Utility breaker to split into distribution for transformer and loads

Isolator from Solar inverter Transformer

Isolator to main load distribution panel

Photo #3: Overview of Utility Splitter Breaker panel

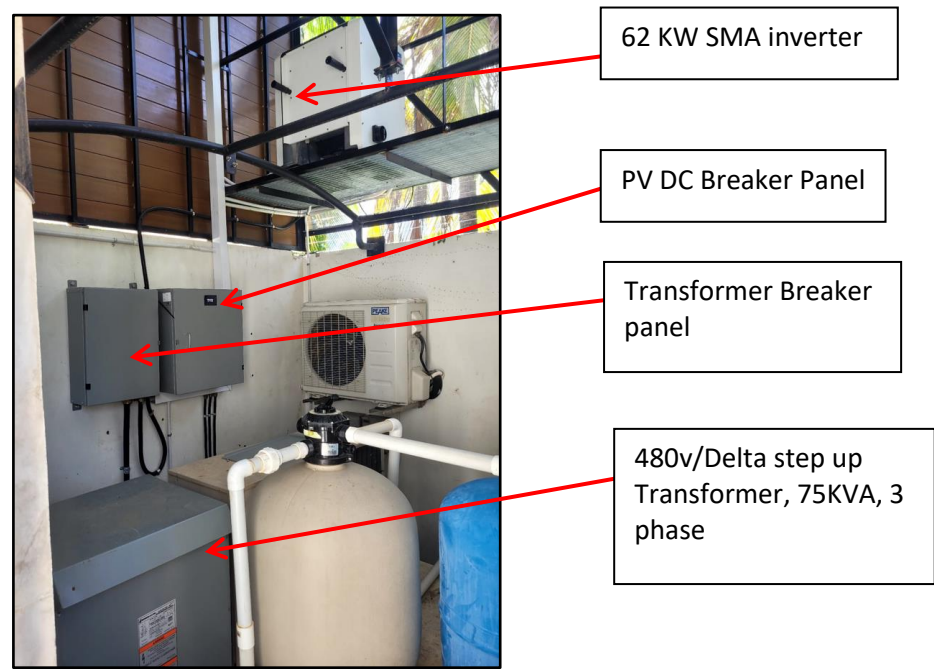
Photo #4: Overview of solar components

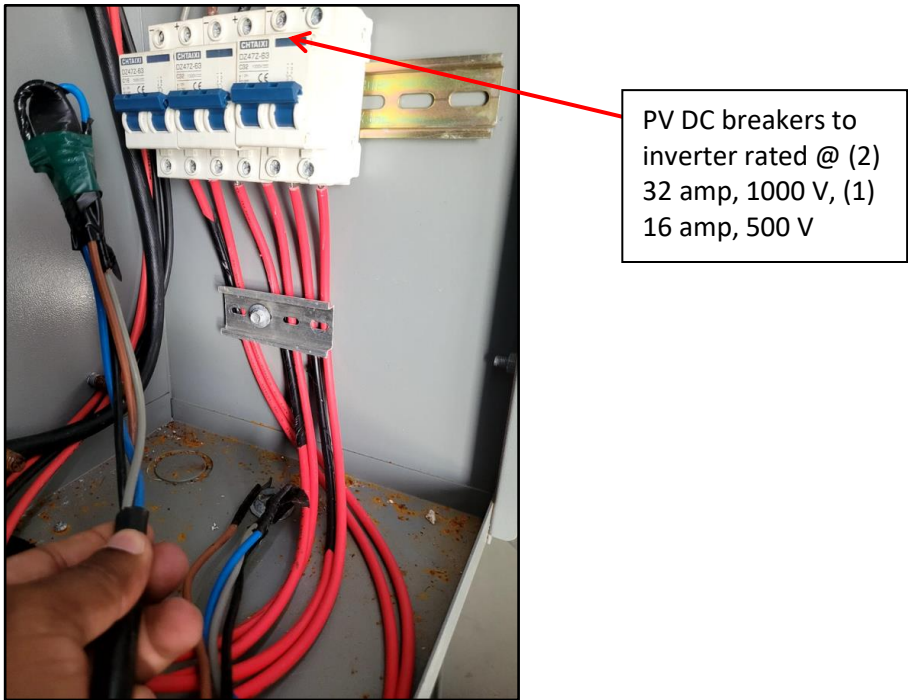
Photo #5: Overview of PV DC breakers

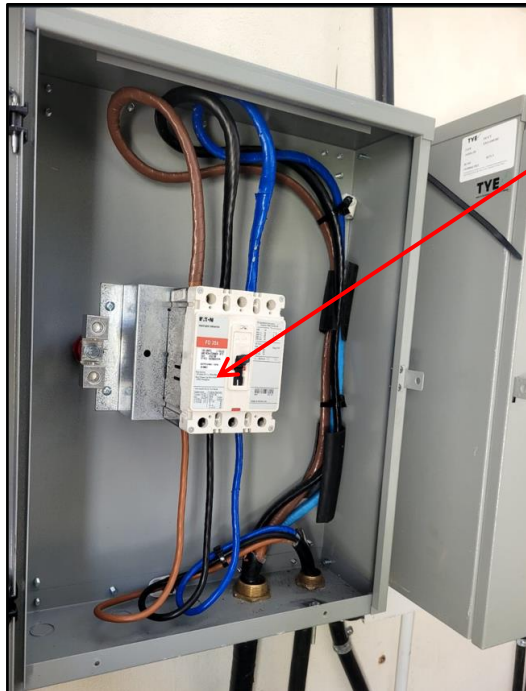
Shut down Isolator  
for transformer to  
inverter, switch can  
be used to shut down  
solar system

**Photo #6: Overview of shut down isolator, transformer to inverter**

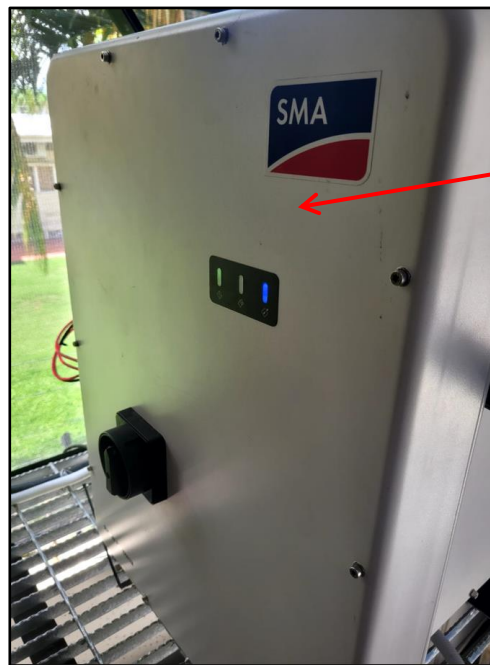
62 KW SMA  
inverter

**Photo #7: Overview of SMA Inverter**

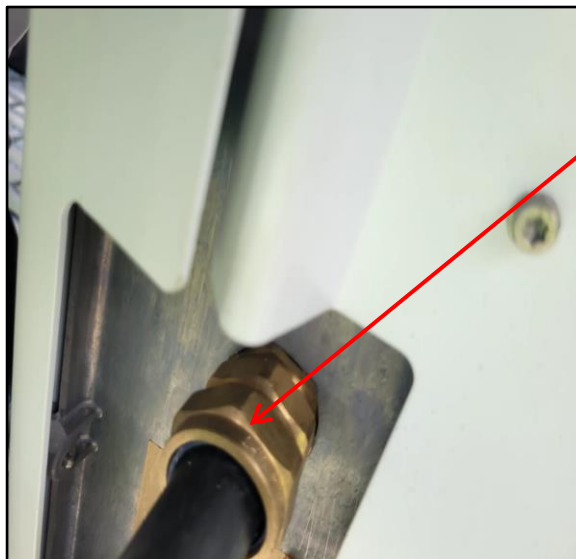
AC input to  
Inverter @ 480 V  
from step up  
transformer

**Photo #9: Overview of AC connection to inverter**

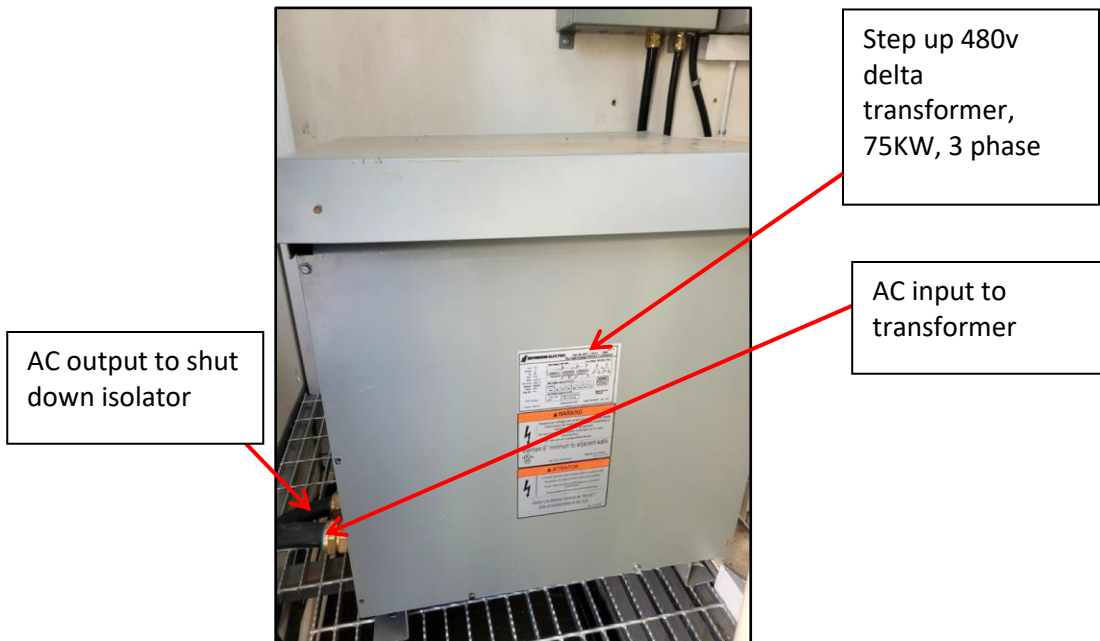
**Photo #10: Overview of Step-up Transformer**

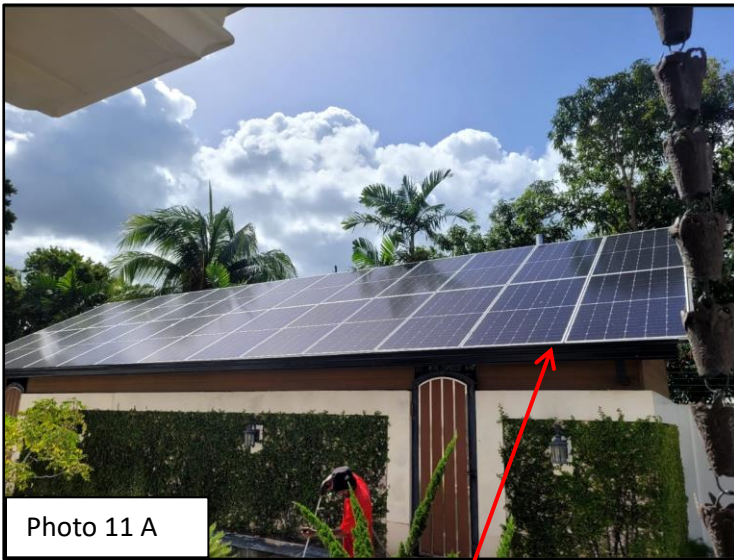
**Photo 11 A**

PV arrays, 570 W solar panels.

32 panels in total, consisting of:

- a) 2 strings @ 13 panels in one (1) String
- b) 1 string @ 6 PV panels. (see gazebo)

**Photo #11, A and B: Overview of PV array.**

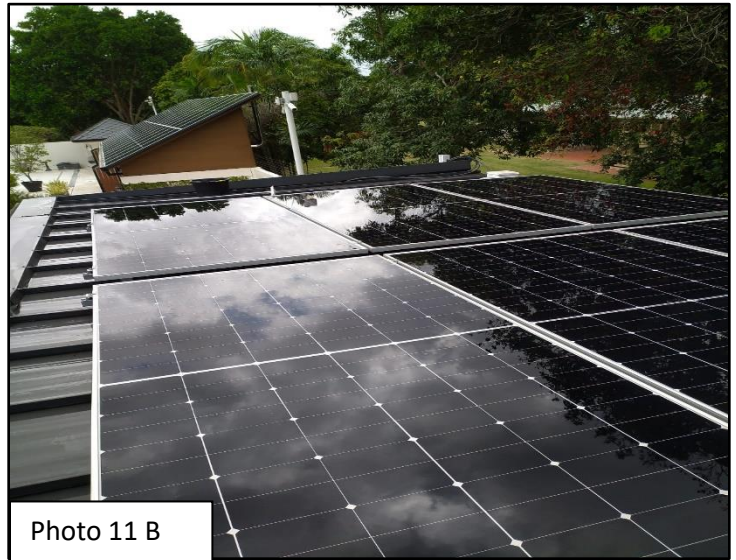
**Photo 11 B**

PV arrays, 570 W solar panels at Gazebo  
1 string @ 6 PV panels.
