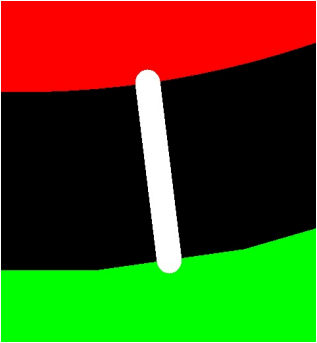
| ID | Check | Limits | Value | Issue | Image | Position | Qty | Level |
|---|---|---|---|---|---|---|---|---|
| 1 | Drill to Copper_NPTH-to-Copper | 8,10,12 | 0.25 mm | NPTH to copper spacing of 9.86mil was detected in your design. This could increase the risk of defects such as short circuits, which decrease manufacturing efficiency and yield, and affect the reliability of the boards. It is recommended to increase the spacing to at least 12 mil. | | 238.76,-105.75 | 7 | Warning |
