| <b>Customer Part Number</b> 228-1010-9001 | | <b>CAR#:</b> 8D-201910211 | |
| <b>Amphenol P/N</b> C91-147720-16P /(PT07C-20-16P) | | <b>Date:</b> 20191021 2020-0318 update | |
| Leak failure& Axial load test failure<br>Note: reference for 8D-2010905081 into 8D-201910211 | | Champion: Carl Chen – Sr. Quality Manager - ATZ<br><br>Team Leader: Cary Deng – Customer Quality Engineer | |

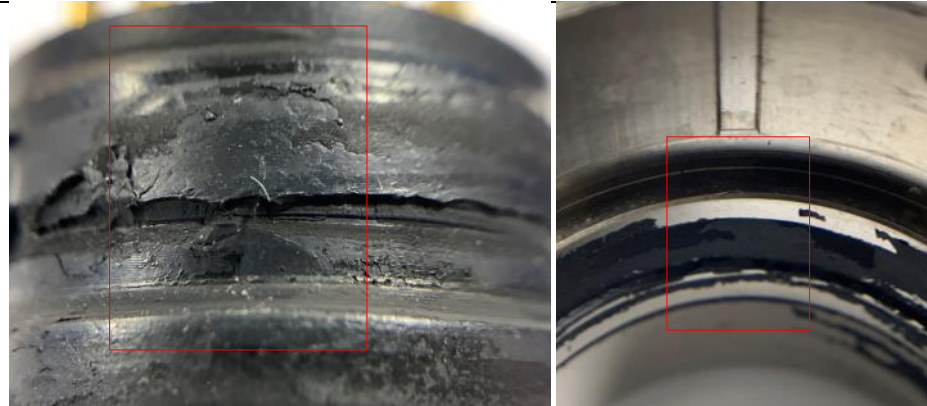
| Note: This connector was before improvement action (D-6 CA 201905081) and 100% inspection in Amphenol Zhuhai with 96kpa (or 14psi). | | | |
| <b>B - Disassembly the defect:</b><br>The connector was disassembled as below; there is insufficient primer around leakage area. This is the same as what we analyzed in May as above. | | | |

Failure 1: 1- To increase test pressure from 14psi to 30psi for 100% Air Leakage Test plus AQL 1.0 on Cold Temp Soak Test on next 3 lots

| D-6 Implemented Permanent Corrective Action: | When: | Who: | Follow up Result: | By: |
|---|---|---|---|---|
| Failure 1 1- Update WI to increase test pressure to 30PSI in Air Leakage Test and follow 9-3353-1 going forward. | 10-10 | DaYu | Completed | Cary D. |

| Failure 1 – Review Primer Application Process on all PT products; | 10-31 | DaYu | Completed | Cary D. |
| Failure 1: 1-Change WI to make sure enough primer application on all PT type C connector assemblies. | 10/28 | Jackson L. | Completed | |

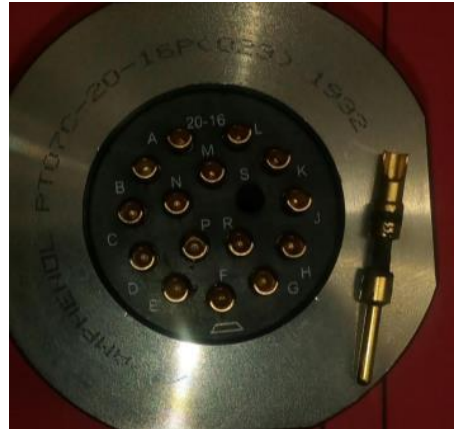
B-1 Reviewed the sample, the contact was pushed out as below after Axial Load Test.

The ID of the hole on the insert was at the high limit which the spec defined 1.55mm (.061) to 1.65mm (.063), actually it is 1.63mm to 1.65mm, there is a risk of lower retention force. The OD of the contact is in normal level, which spec define 0.066 inch to 0.070 inch, actually 0.068 inches to 0.069. The target conditions of contact and contact cavity are .066(min) on contact and .065(max) on insert are acceptable.

| | 1-Why→ | ←2-Why→ | ←3-Why→ | ←4-Why→ | ←5-Why |
|---|---|---|---|---|---|
| Direct Cause | Contact was pushed back in the contact cavity from insert; | The bond between insert & shell did not keep the contact stationary for the duration of test | The contact was able to move in the contact cavity | The ID of the contact cavity is at the high limit of the spec. | |

Failure 2: 1- To modify mold to guarantee the ID of the hole on the insert at the middle limit;

| D-6 Implemented Permanent Corrective Action: | When: | Who: | Follow up Result: | By: |
|---|---|---|---|---|
| Failure 2 1- To modify the insert mold to the middle limit of the spec; | 10-31 | YouChao | Completed | |

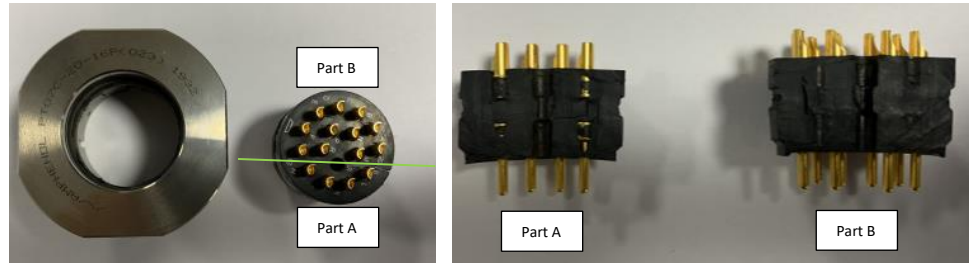
B-2.1 Disassembled the connector;

Disassembly insert from shell

Cut off the insert to two part

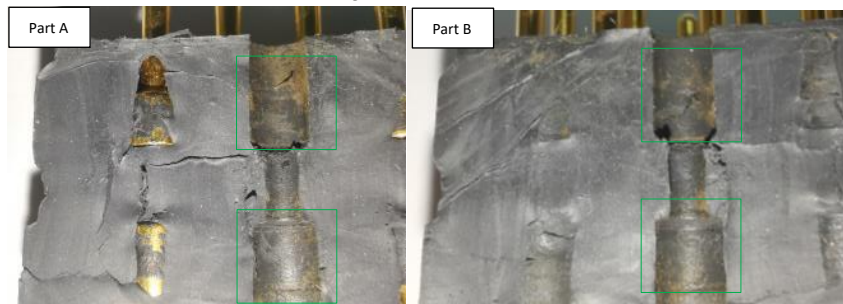
B-2.2 Reviewed on insert, there are glue on the insert;

**Result:** There are enough glue on insert and contacts; this is not believed to be the cause for contact pushed out from insert.

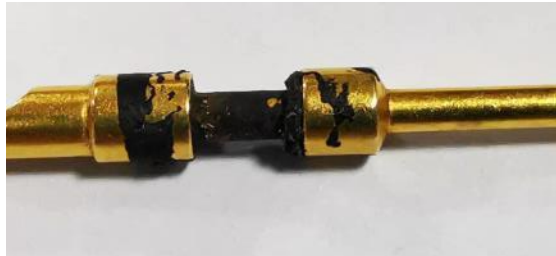
B-2.3 Reviewed on Contact, there are glue on it as below;
