# RE Wall Precautions before Monsoon

**GLOBE INFRA SOLUTION**

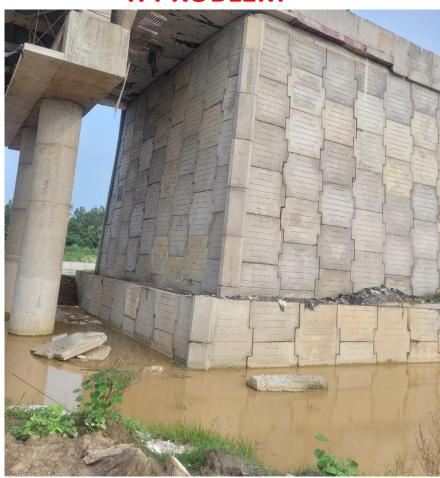
#### • General Condition - " RE Wall Prevention from Water Logging Post construction.

❖ Avoid water Logging near RE Wall.

Provide Earthen Berm or concrete protection over OGL or SRL. General Condition - " RE Wall Completed & Prevention From Rain Cut.

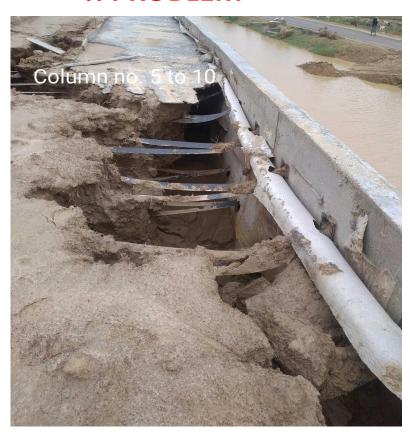
- Rain Cut in top layer Post Completion of RE Wall.
- Rain Run off Water disturbs RE Wall Backfill and try to percolate through drainage medium if not protected.

- ❖ Best Solution is to complete all Road Works with DBM top to prevent ingress of water.
- Second best is to erect FSCB and provide negative camber, in order to drain water away from RE panel towards median.

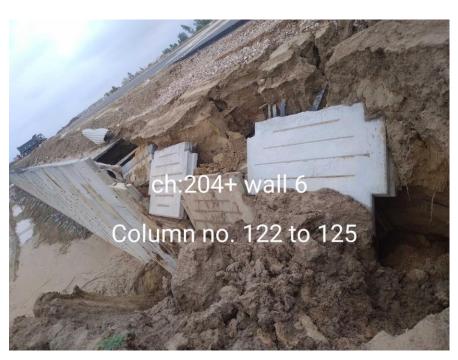
• General Condition - " RE Wall Execution Construction of RE WALL Toe End with Drainage Arrangement."

❖ Tail end of RE Wall is critical part of Structure. This is subjected to erosion if not Protected Suitably.

- RE Wall Toe Protection to be executed by Boulder Pitching or any hard Surface topping to avoid erosion and further Damage to Panel Fascia.
- The toe to be followed by Chute drain for drainage of runoff water.

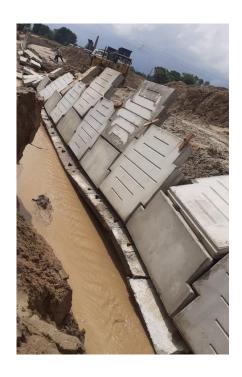
General Condition - "RE Wall Execution in Progress at intermediate level."

- RE Wall in Progressive / Construction Stage is to be protected on RE Panel Fascia ends.
- Compaction near to RE panels is less compared to centre of backfill. Hence water if not diverted will erode Soil fill near to Panel Fascia.

- Slope of Back Fill / Re Wall Bed to be towards Median ( Centre ) to Drain water away from RE Panel Fascia.
- Gradient of Slope towards End of RE wall to protect damage to Cross Wall.

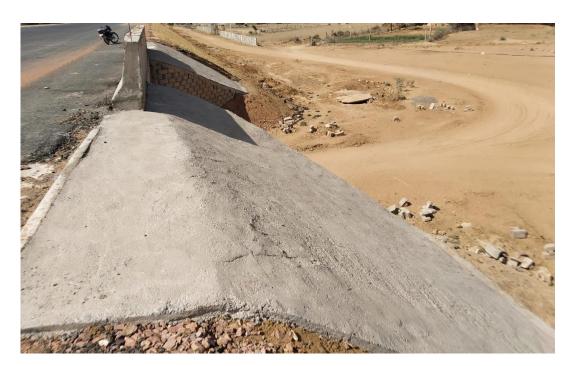
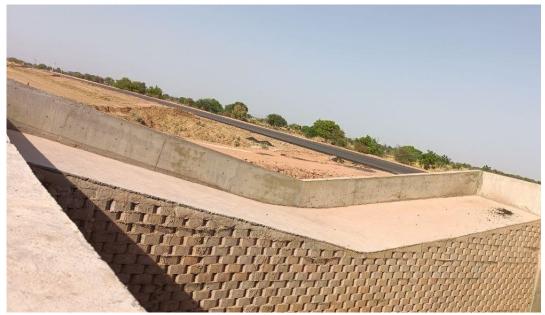
- General Precautions -
- Protection of RE Wall With Surcharge
  & Open Embankment
- ❖ Surcharge Over RE Wall acts as a catchment area in rainy season which allows Rain Water Ingress to Reinforced Soil Zone, The changes in pore water Pressure and loading conditions put RE Wall on risk of deformation.
- ❖ Solution is to provide hard surface Topping over any open embankment over RE Wall.
- ❖ Provide continuous Kerb & Chute Drain at regular intervals for drainage of Rain runoff water via Chute Drain or Down Take pipe.

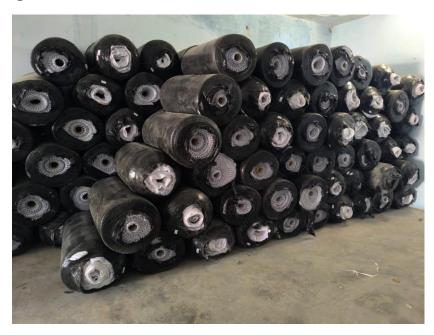
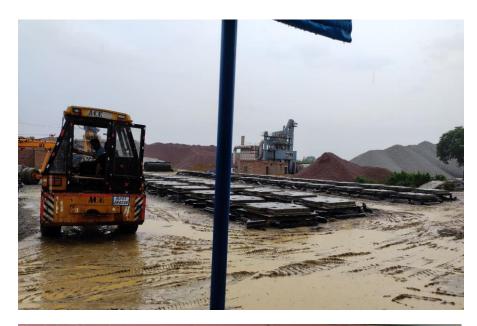
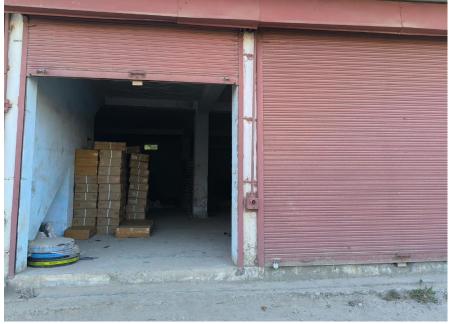
- General Precautions -
- Managing Casting Yard & Material Storage
- ❖ Elevated Surface for moulds. Keep moulds on Elevated levelling pad & maintain a uniform gradient in casting yard to avoid water ponding.
- ❖ Storage of all material in covered Shed with lock & key on High Ground with good road access.
