HITACHI MICROCOMPUTER TECHNICAL UPDATE

DATE	25 January 2001	No.		TN-SH7-272A/E
THEME	Bug of a serial data reception of the multiprocessor communication function at SCI			
CLASSIFICATION	☐ Spec change ☐ Limitation on Use ☐ Supplement of Documents			
PRODUCT NAME	HD6417750 ,HD6417750S ,HD6417751]	Lot Lot #All
REFERENCE DOCUMENTS	SH7750 series Hardware Manual SH7751 Hardware Manual	Re	v.	Effective Date
				Eternity

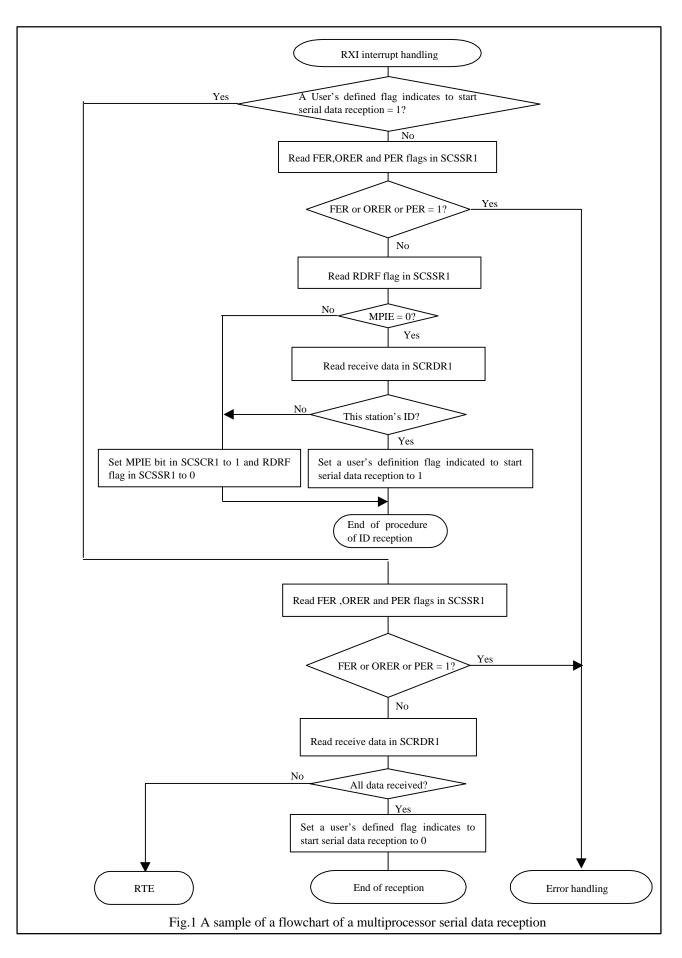
A sample of a flowchart of a multiprocessor serial data reception is shown in the following.

Use the following procedure for a serial data reception of the multiprocessor communication function.

In the processing of software to distinguish a receive data between this station's ID (MPB=1) and a valid data (MPB=0), please create a user's defined flag on a memory which indicates information about starting a serial data reception.
