HITACHI SEMICONDUCTOR TECHNICAL UPDATE

DATE	4th January, 1999	No.	TN-SH7-117 A Æ
THEME	The limitation of exception handling routine description		
CLASSIFICATION	☐ Spec. change ☐ Supplement of Documents	Limitation on Use	
PRODUCT NAME	HD6417091BP200, HD6417091RBP200, HD6417750BP200, HD6417750F167, HD6417750VF128		
REFERENCE DOCUMENTS	SH7750 Hardware manual		Effective Date eternity
			From

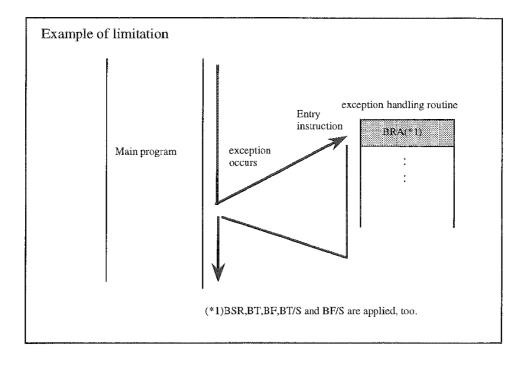
First instruction at the entry of exception handling routine may have mulfunction. The conditions are following.

- (1) PC-relative branch instruction located at the address of VBR+H'100, VBR+H'400 and VBR+H'600.
- (2) PC-relative branch instruction located at the address indicated by DBR.

Above (1) or (2) cases, location such a PC-relative branch instruction may have mulfunction.

- Do not use BRA,BSR,BT,BF,BT/S or BF/S instruction as the exception handling routine at the address
- VBR+H'100, VBR+H'400, VBR+H'600.
- Additionally, when utilizing the user debug support function(*1) setting the UBDE bit of the BRCR register to 1, do not put BRA,BSR,BT,BF,BT/S or BF/S instruction to the address indicated by DBR.
 - (*1) Please refer to Section 20.4 in SH-4 Hardware manual.
