# **Authorized Field Change**

AFC G-07912R

Subject: Inspect Drive Gear and/or Replace Power Steering Pump On MaxxForce 7 Engines

Model: 4300, CE Bus, BE Bus

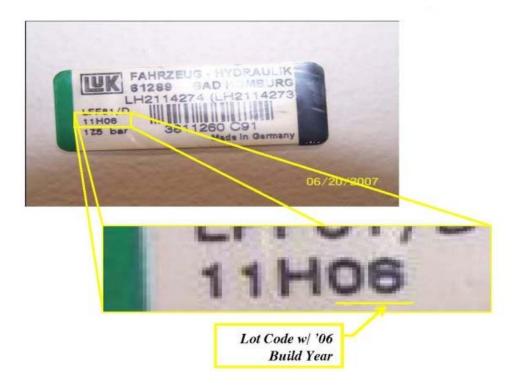
Figure 2

- 1. Inspect Power Steering Pump Label: if no lot code label is found on the pump or it has an '06 build year, replace the pump (see Figure 2).
- 2. If Label has a lot code with 07 build year, no repair is needed (see Figure 2).

- A. If pump replacement is required, inspect the drive gear teeth after removal of the power steering pump.
- B. If no gear tooth wear is found, only replace the power steering pump.
- C. If there is a indication that the tip of the teeth has wear that appears to be metal movement, or rolling over the tip of the tooth, open a tech service case file and you will be provided further instructions.
