IC Corporation

AUTHORIZED FIELD CHANGE

AFC # 03402 January 2004

Subject File: Flip Seat Cushion Width

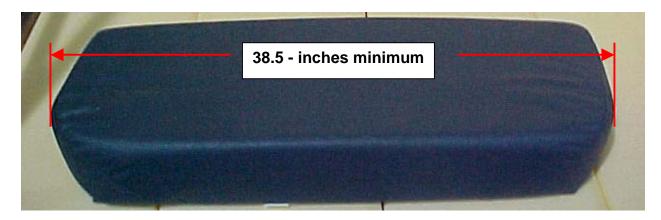
Inspect this unit by measuring the width of the flip seat cushion. See picture below for proper method of measurement. If the width does not meet the accepted 38.5-inch width requirement, please refer to the following repair procedure.
