## Engineering and scientific activities / studies in Antarctica

PIYUSH KUMAR AND R.N.WAGHMARE  
R & D E (Engrs.), Dighi, Pune - 411015

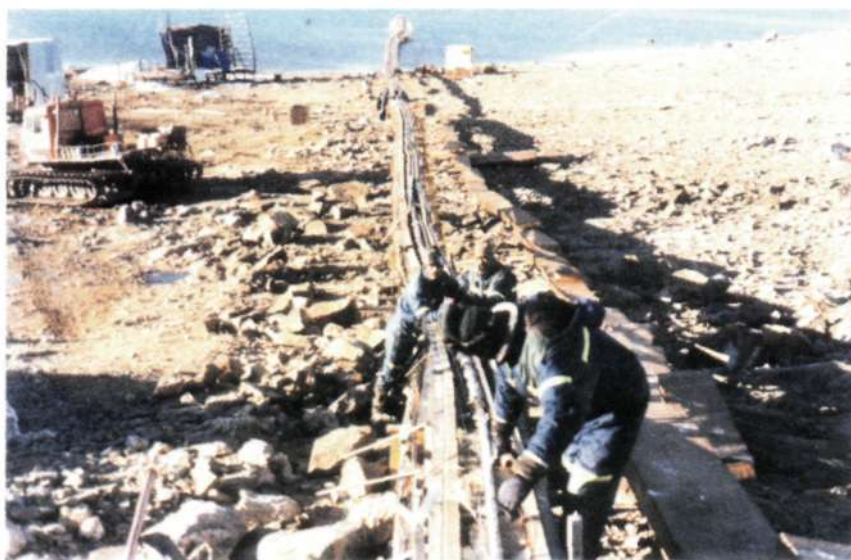
*Plate 1: Application of trace heating tape in the water supply line running from Priyadarshini lake to the Indian Research Station 'Maitri'.*

Then the power cable and trace heating cable was laid adjacent to the duct. The trace heating tape was laid down with additional length at the critical bends to cater for more heat load. The temperature indicating sensors were installed by using compensating cable for connecting sensors to the controller. Then supply cable, trace heaters and central cables were all connected to the respective junction boxes. One should take care while connecting the trace heating cables that the two bus bars of the trace heating are not to be shorted at free end. They are to be terminated to junction box or sealed with insulation tape / sealing tape. Next all the power cables or trace cables were properly terminated in the junction box without shorting to body and any loose connections as shown in the Plate no.1. Each approximately equal length of trace heating tape was given single phase supply from each of the three phase supply to balance the load on the generators. One section of trace heating tape was not giving desired heat output, so it was changed. Then the whole system was tested externally and was found to be working satisfactorily.

The working team was divided into three groups for completing each of the three sections of the pipeline. Though it was advised that the existing duct heating system should remain 'ON' for the time duct was open, but being the peak summer time, it was not necessary to circulate the hot water. Even without it, the work was progressing smoothly. The top cover of the ducts were dismantled and the work of installing the trace heating tape was initiated. The trace heating tape was initially fixed with glass tape on each of the two pipelines i.e. one 40 mm dia and other 25 mm dia. after which the aluminium adhesive foil was used to cover the entire pipeline which was mainly to act as insulation and as well as ensuring that the tracer was always in contact with the pipeline at all the places. Wherever there was a chance of water accumulation due to sag in the pipeline, additional tracer was provided by spiraling the same round the pipe.

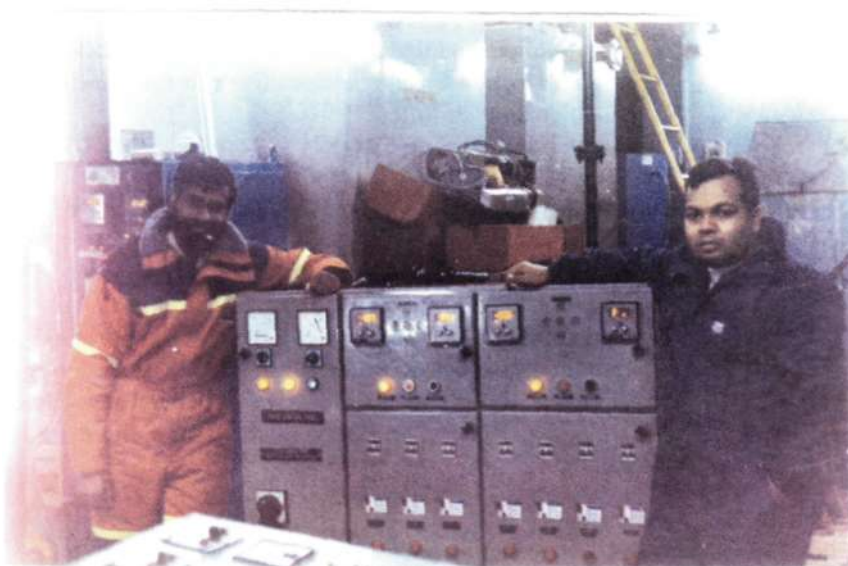
*Plate 2: The Newly installed control panel in working condition for trace heating the water supply line.*

After complete installation of the tracer, cables and control panel, the system was switched on. The system was found to be working satisfactorily. The same when found functional for a period of one week for its independent functioning without the hot water circulation, was put in regular use for the station water supply from 10 February, 1997 onwards as shown in Plate no.2. Once it was functioning continuously without any problem, the MEG solution was drained out and was stored in the drums.

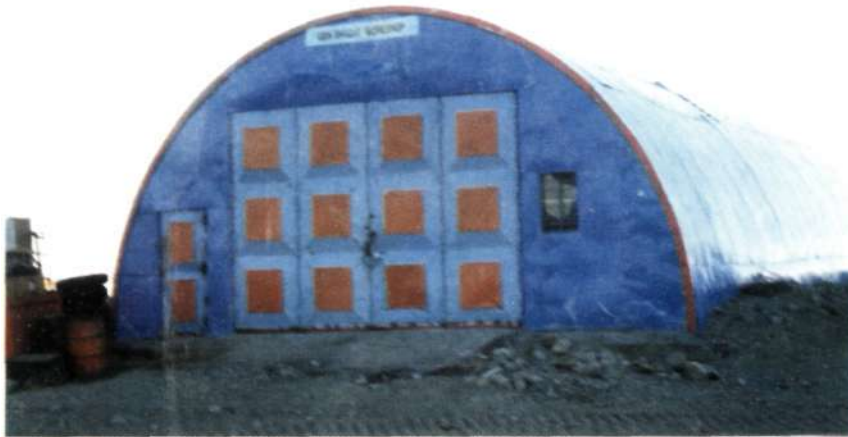
After the complete construction of the workshop shelter, users found it difficult to take the vehicles inside the workshop. The main door of the workshop shelter of the size 4m x 4m did not give sufficient space for the entry of the snow vehicles. Also in case if the work inside the workshop shelter was under way, there was no gate for users entry/exit except for the main door, the repeated opening/closing of which was quite cumbersome. So a requirement for more space i.e. a larger door with a wicket gate was projected by Department of Ocean Development to R&DE(Engrs.) during XV Antarctic expedition.

*Plate 3: The replaced door for the fully functional Vehicle Repair Workshop.*

The tower bolts assemblies were fixed at the top and bottom of the door panels by horizontal beams. The earlier door was replaced with the newly brought one. There was a slight modification here. The bottom channel on which the door frame stood was not completely plane & was slightly curved. So an additional & adequate size of channel was used to match the straight line of the bottom channel.

The trough sheets were fixed from both the ends of the arch towards the centre. Next the outer plain sheets were fixed in the same sequence. A few corrugated sheets on the roof, which were blown earlier, were replaced too. The Plate no.3 shows the door after completion.

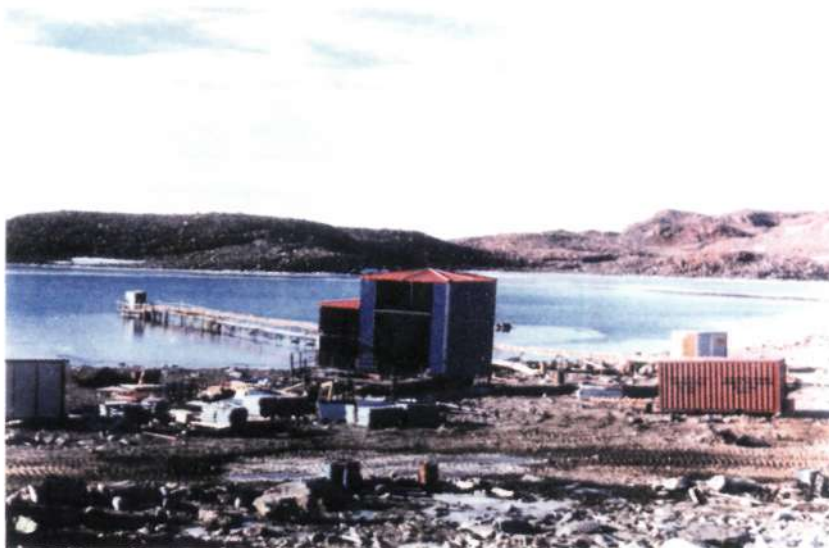
*Plate 4: The Balloon Launching Shelter in construction phase before the disaster struck*

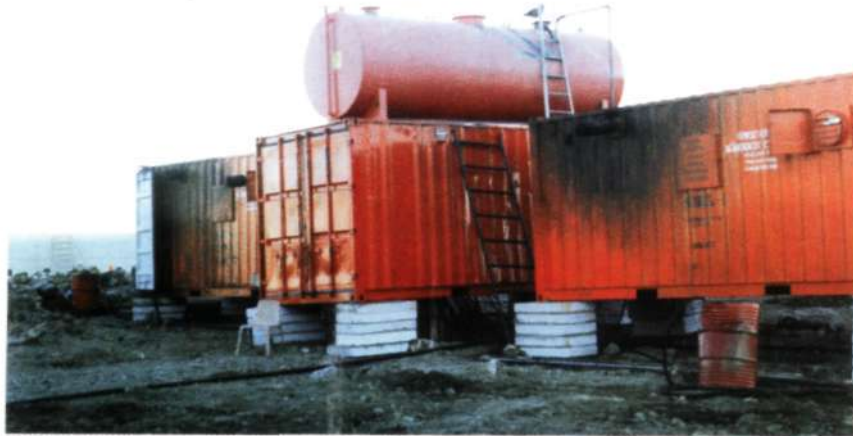
It was observed that these containers being smaller than the earlier ones, had a confined space with very little allowance for maneuvering and regular maintenance. Also it was preferred to have separate controllers for the two gensets.

*Plate 5: The re-inducted A-Block gensets in the newly brought containerised accommodation named as Surya Power House.*

There up on the gensets from A-Block were removed with the help of crane to the above mentioned containers. The overhead fuel tank capacity was found to be inadequate which required daily filling up of the tank. One 20 KL fuel tanker was placed with the help of the crane on top of the middle container. The fuel line was modified to suit the above fuel supply to the all overhead fuel tanks feeding the respective gensets. The exhaust of the newly placed genses also had to be a little modified as per the site requirements.

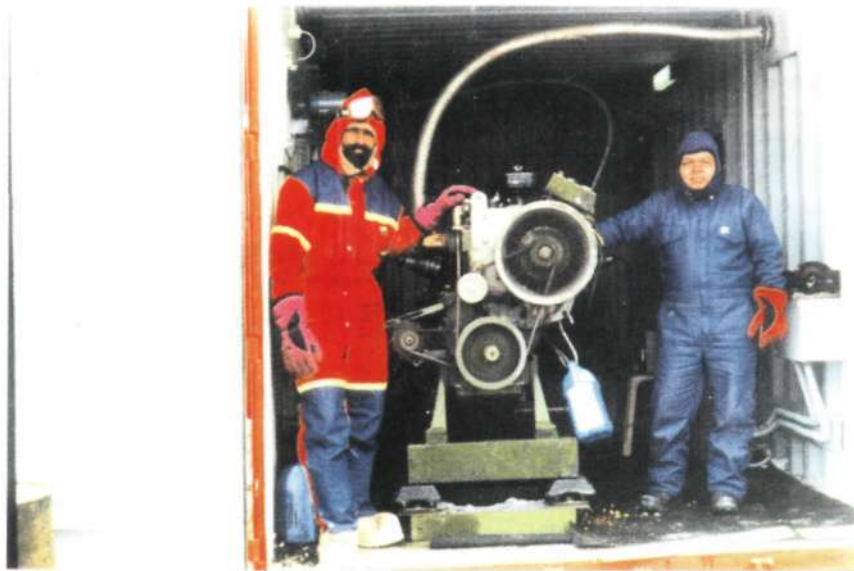
*Plate 6: The gensets in the Surya Power House in working condition.*

After overhauling all the gensets, the same were re-inducted into regular power supply to the station on 11 October, 1997, which can be observed from Plate no. 6. The new power station was nomenclatured as the "Surya Power House" containing four gensets.

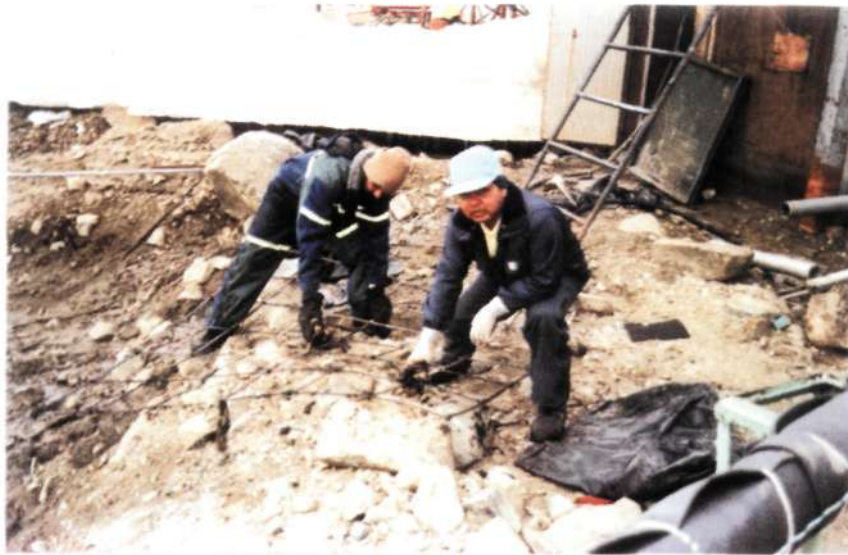
Thus throughout the period monitoring and data collection of Earth leakage voltage was done regularly. Sometimes leakage voltage shot upto 120 volts on searching it was found that the earthing circuit had got disconnected due to dozer movements all around for environmental clean-up. It was restored back to the normal. As a result there were improvement but still variations existed upto 24 to 40 volts during the summer period, as illustrated in figure 2. The primary cause established was that of due to the toilet burning process of summer huts. The corrective measures were taken. In winter also Earth Leakage voltage shot up to 24 Volts. The cause identified was the electrical supply to the burner of the Maitri toilet no.1, where the bare wire was coming in contact with the metal sheet constituting the toilet structure. The earthing system was restored back to the normal by suitably changing the wiring. At the end of the expedition the copper grid was taken out and maintenance work was carried out on it. Also the four gensets of A-Block which were de-inducted and re-inducted in Surya Power House, were also individually provided with earthing finally connected to the main earthing bus of the station.

*Plate 7: The Second copper grid being launched in the waste water disposal pit for effecient maintence of leakage earth voltage*

Also as it was seen that the conventional earthing could not be effective due to the permafrost level present below the ground. So two copper grids of the size 1.5 x 1 x 0.65 m were fabricated on site and laid down in the previous expeditions i.e. one in the Priyadarshini lake and other one in waste water ditch. Then an additional copper grid (of the size 6ft. x 6ft.) was put in the adjacent waste disposal pit in XVI Antarctic Expedition as shown in Plate no.7.
