## **Environmental Management Services at Maitri, Antarctica**

**G. Veerabhadraiah and Anil Jain**

Environment Division, Engineers India Ltd., New Delhi

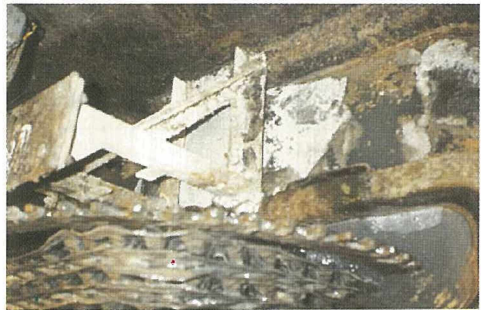
*Sludge bulking in Final settling tank of B1*

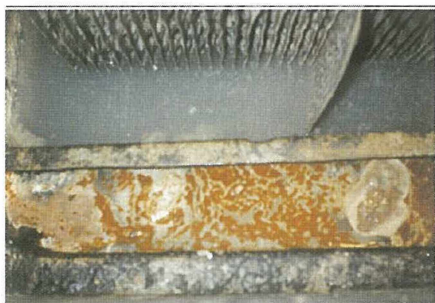
*Floating of oil & fat in primary settling tank*

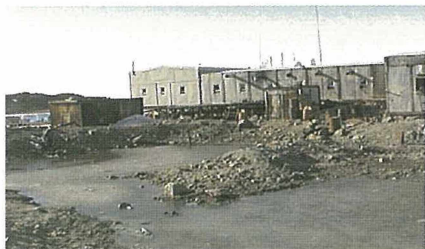
**Unlined Pond :** Since actual disposal point is far from the Treated Effluent Pond, It is essential for the same to have a protected walls to prevent percolation of the effluent to soil/water below it, infiltration of the water from below soil, overflow of its contents and entry of surface water into itself and the existing pond is not able to meet these criteria.

*Effluent Pond after the contents are pumped out*

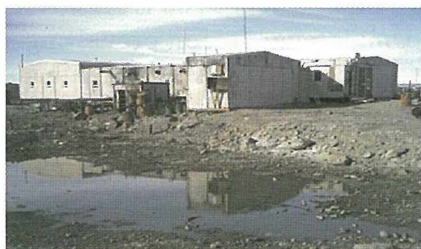
*Freezing of effluent in Effluent Pond*

- viii. Unlined and open Effluent Pond, causes freezing of the top content and seepage/infiltration of the polluted water to the Priyadarshini (Zub) lake.

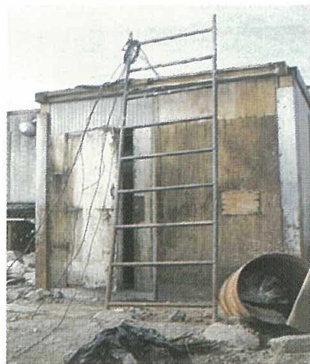
**Ineffective Housing Shelters:** The existing dedicated housing shelters were not from the unit suppliers nor they were meant for the units and were executed as stopgap arrangement from discarded panels of Maitri. Due to installation of the units on ground level, the shelters are subjected to the wrath of harsh weather over the time and the panels have been damaged. Space available inside the shelters is hardly adequate even for regular operation of the units, leave alone the maintenance requirements.

*B1 Housing Shelter*
