# EXPERIMENT - 1

## *Identification and Observation of Bad Designs*

This report documents five examples of bad design observed at VIT University, Vellore. Each entry includes a photograph, description, location, reasons the design is flawed, and a suggested improvement.

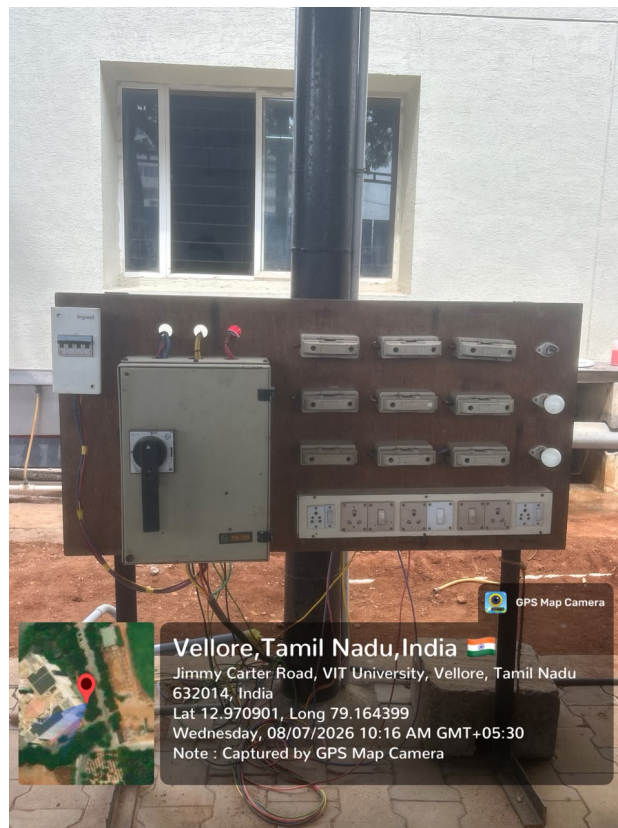
### **Bad Design 1: Exposed Outdoor Electrical Distribution Panel**

An outdoor electrical panel with multiple switches, an isolator, and a Legrand box mounted on a wooden board. Numerous wires hang loose and unsecured from the bottom of the panel, exposed to weather and foot traffic.

- Exposed, unsecured wiring poses electrocution risk
- No weatherproof enclosure despite outdoor placement

- Loose wires near ground level increase tripping/damage risk
- No visible warning/hazard signage

- Install a weatherproof (IP-rated) enclosure
- Route and secure wires using conduits or trunking
- Elevate wiring away from ground/foot traffic
- Add hazard warning signage and a restricted-access barrier

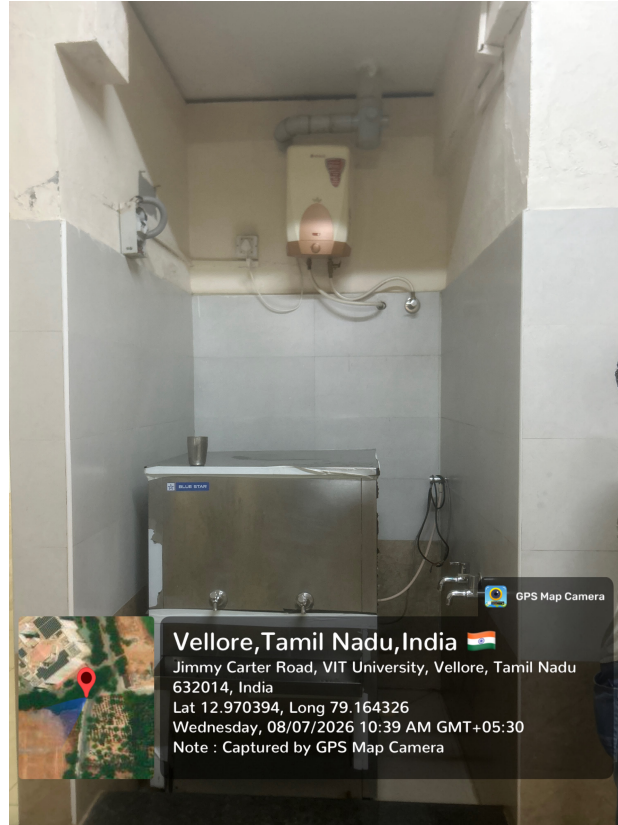
## Bad Design 3: Unsafe Water Heater Placement in Bathroom

An electric water heater (geyser) mounted directly above a wash area, with exposed wiring and a switch board on the wall of a wet zone, plus visibly unfinished/peeling wall plaster.

- Electrical wiring and switches exposed in a high-moisture area is a shock hazard
- Water heater positioned too high for safe/easy access to controls
- Poor wall finishing near electrical fittings increases risk of water seepage into wiring

- Use moisture-proof, sealed wiring and switch covers rated for wet areas
- Relocate switches outside the wet zone
- Properly seal/finish walls around electrical fittings
- Position heater at an accessible, code-compliant height

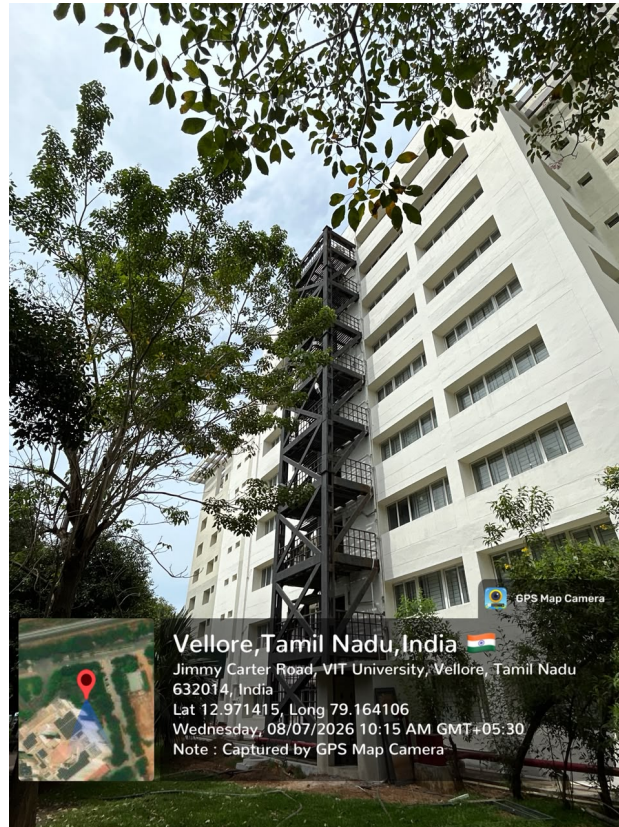
## Bad Design 4: External Fire-Escape Staircase Without Visible Safety Features

A tall, narrow metal fire-escape staircase attached to the exterior of a multi-story hostel/academic building, with no visible signage or lighting.

- No visible emergency signage indicating the staircase's purpose
- No visible lighting for nighttime/emergency use
- Narrow structure could bottleneck during mass evacuation
- Overhanging tree branches obstruct part of the structure

- Add illuminated "Fire Exit" signage at each level
- Install emergency lighting along the staircase
- Trim surrounding vegetation for clear access
- Widen or add a second escape route for large occupancy buildings

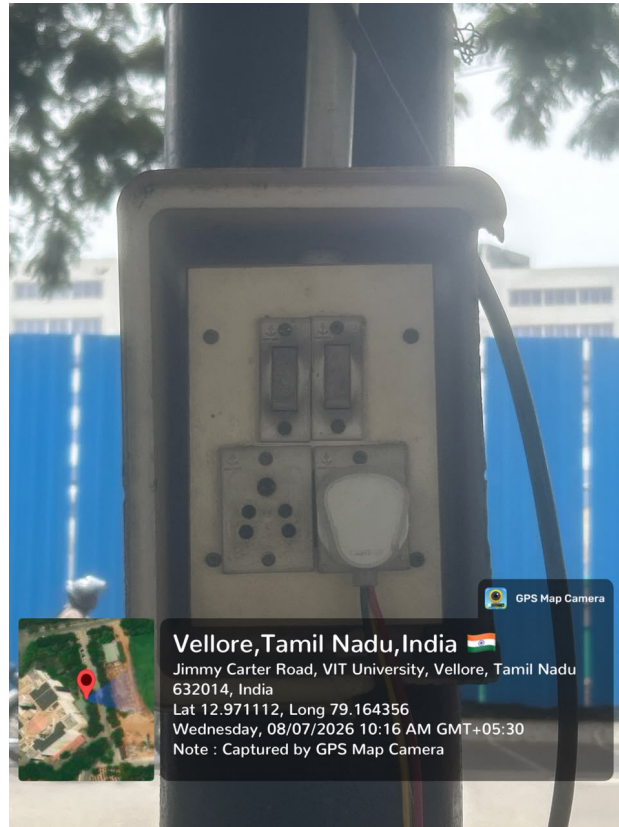
## Bad Design 6: Exposed Outdoor Switch/Socket Board with Loose Wiring

An outdoor switch and socket board mounted directly on a pole at chest height, holding two switches, a multi-pin socket, and a power plug. The wiring dangles loosely from the bottom of the board, unshielded from rain and dust, and the unit sits right beside an active construction barricade.

- Exposed wiring is a safety hazard, especially in rain
- No protective housing or weatherproof cover on the board
- Positioned in a high-traffic zone next to construction barricades
- Sockets exposed to dust/moisture, reducing safety and lifespan

- Install a weatherproof, IP65-rated enclosure
- Route all wiring through conduit instead of leaving it loose
- Relocate the board away from the active construction/pedestrian zone
- Add a lockable cover or door to the board

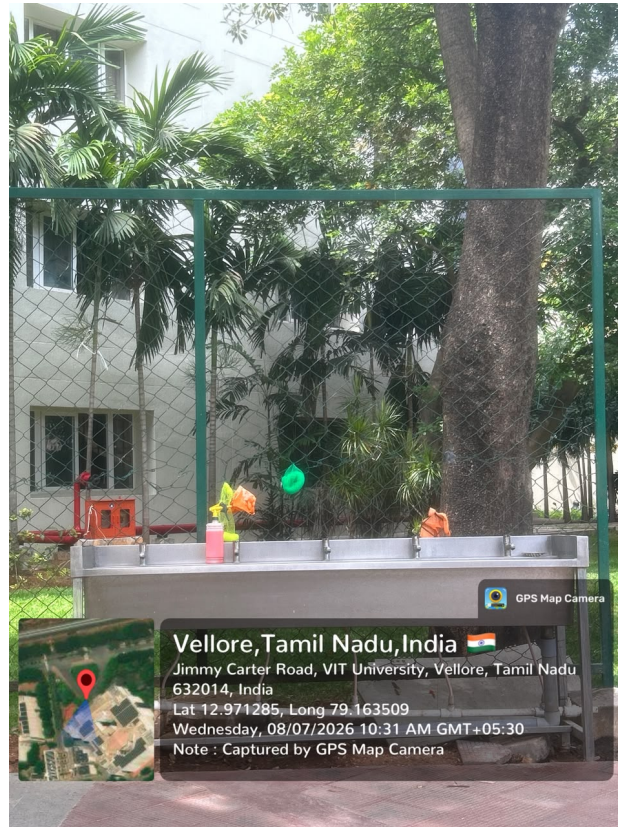
## Bad Design 7: Overgrown Enclosure Blocking Fire Hose Cabinet and Water Station

A steel outdoor drinking-water/wash station with multiple taps sits inside a small fenced enclosure that has become overgrown with trees and shrubs. A fire hose cabinet is mounted directly behind the station, with vegetation partially blocking access to it. Personal items (a bottle, rags) are left cluttered on top of the station.

- Overgrown vegetation obstructs quick access to the fire hose cabinet in an emergency
- Water taps positioned close to landscaping risk debris/leaves entering the water
- Clutter left on the station is unhygienic for a shared drinking-water point
- Unmaintained fenced enclosure can trap stagnant water and encourage mosquitoes

- Regularly trim vegetation to keep fire safety equipment clearly accessible
- Maintain a clear boundary between the drinking-water station and landscaping
- Enforce cleanliness and disallow personal items on the shared station

- Maintain fencing and drainage within the enclosure
