# EXPERIMENT - 1

## *Identification and Observation of Bad Designs*

This report documents five examples of bad design observed at VIT University, Vellore. Each entry includes a photograph, description, location, reasons the design is flawed, and a suggested improvement.

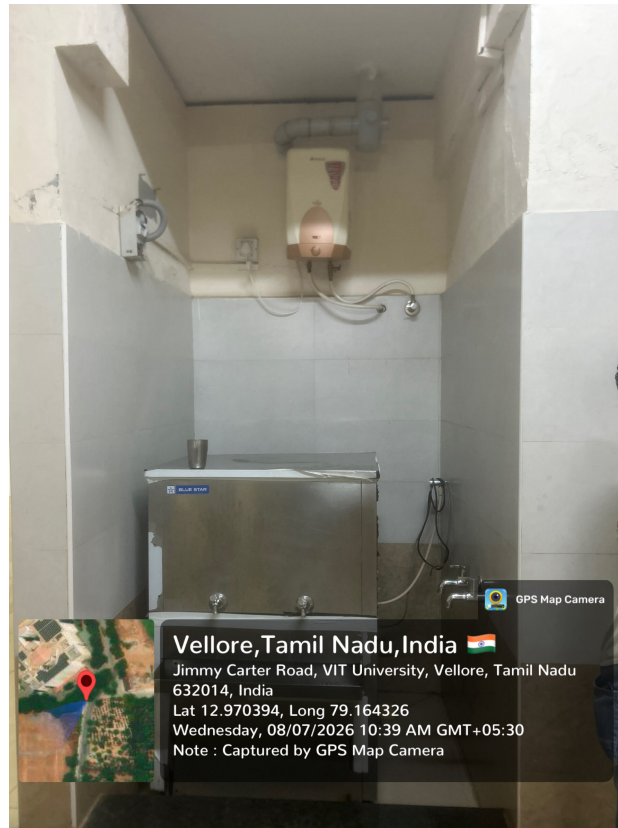
## Bad Design 3: Unsafe Water Heater Placement in Bathroom

An electric water heater (geyser) mounted directly above a wash area, with exposed wiring and a switch board on the wall of a wet zone, plus visibly unfinished/peeling wall plaster.

- Electrical wiring and switches exposed in a high-moisture area is a shock hazard
- Water heater positioned too high for safe/easy access to controls
- Poor wall finishing near electrical fittings increases risk of water seepage into wiring

- Use moisture-proof, sealed wiring and switch covers rated for wet areas
- Relocate switches outside the wet zone
- Properly seal/finish walls around electrical fittings
- Position heater at an accessible, code-compliant height
