Crash Storyline

Crash ID: 182471 Trip ID: 1468197334 Crash Time: 8/30/2020, 15:08:30 Driver: Said Crash Location: TX-8 Beltway, Houston, TX 77067, USA Confirmed: - -

Crash ID: 2929 Trip ID: 1102223 Driver: rrjmhn Crash Time: 5/29/2020, 17:03:57

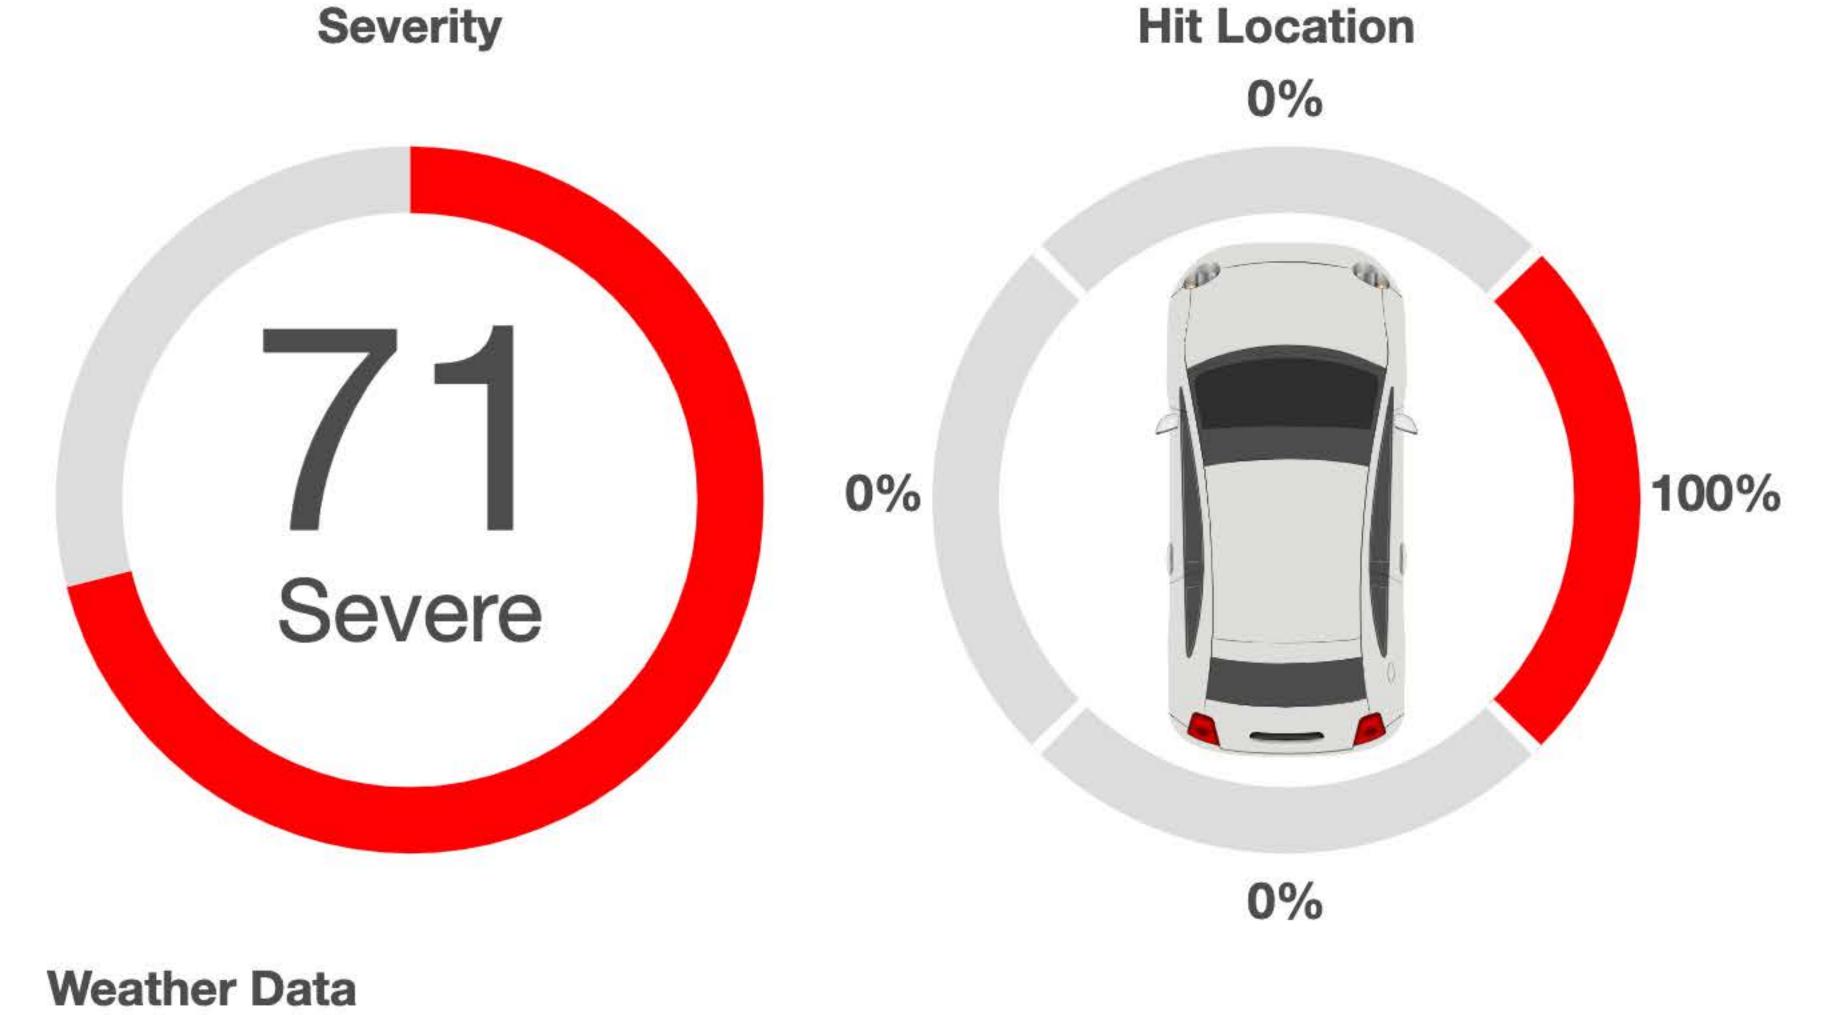
Crash Description The driver was traveling South along North Sam Houston Parkway West at 58 km/h at

15:08:28 on 2020/08/30. The driver then began braking prior to the impact. At 15:08:30 a collision occurred on the right side of the vehicle while the vehicle was traveling at 12 km/h. The collision event ended at 15:08:32 when the vehicle reached a speed of 1 km/h. The driver continued driving after the crash event toward their destination.

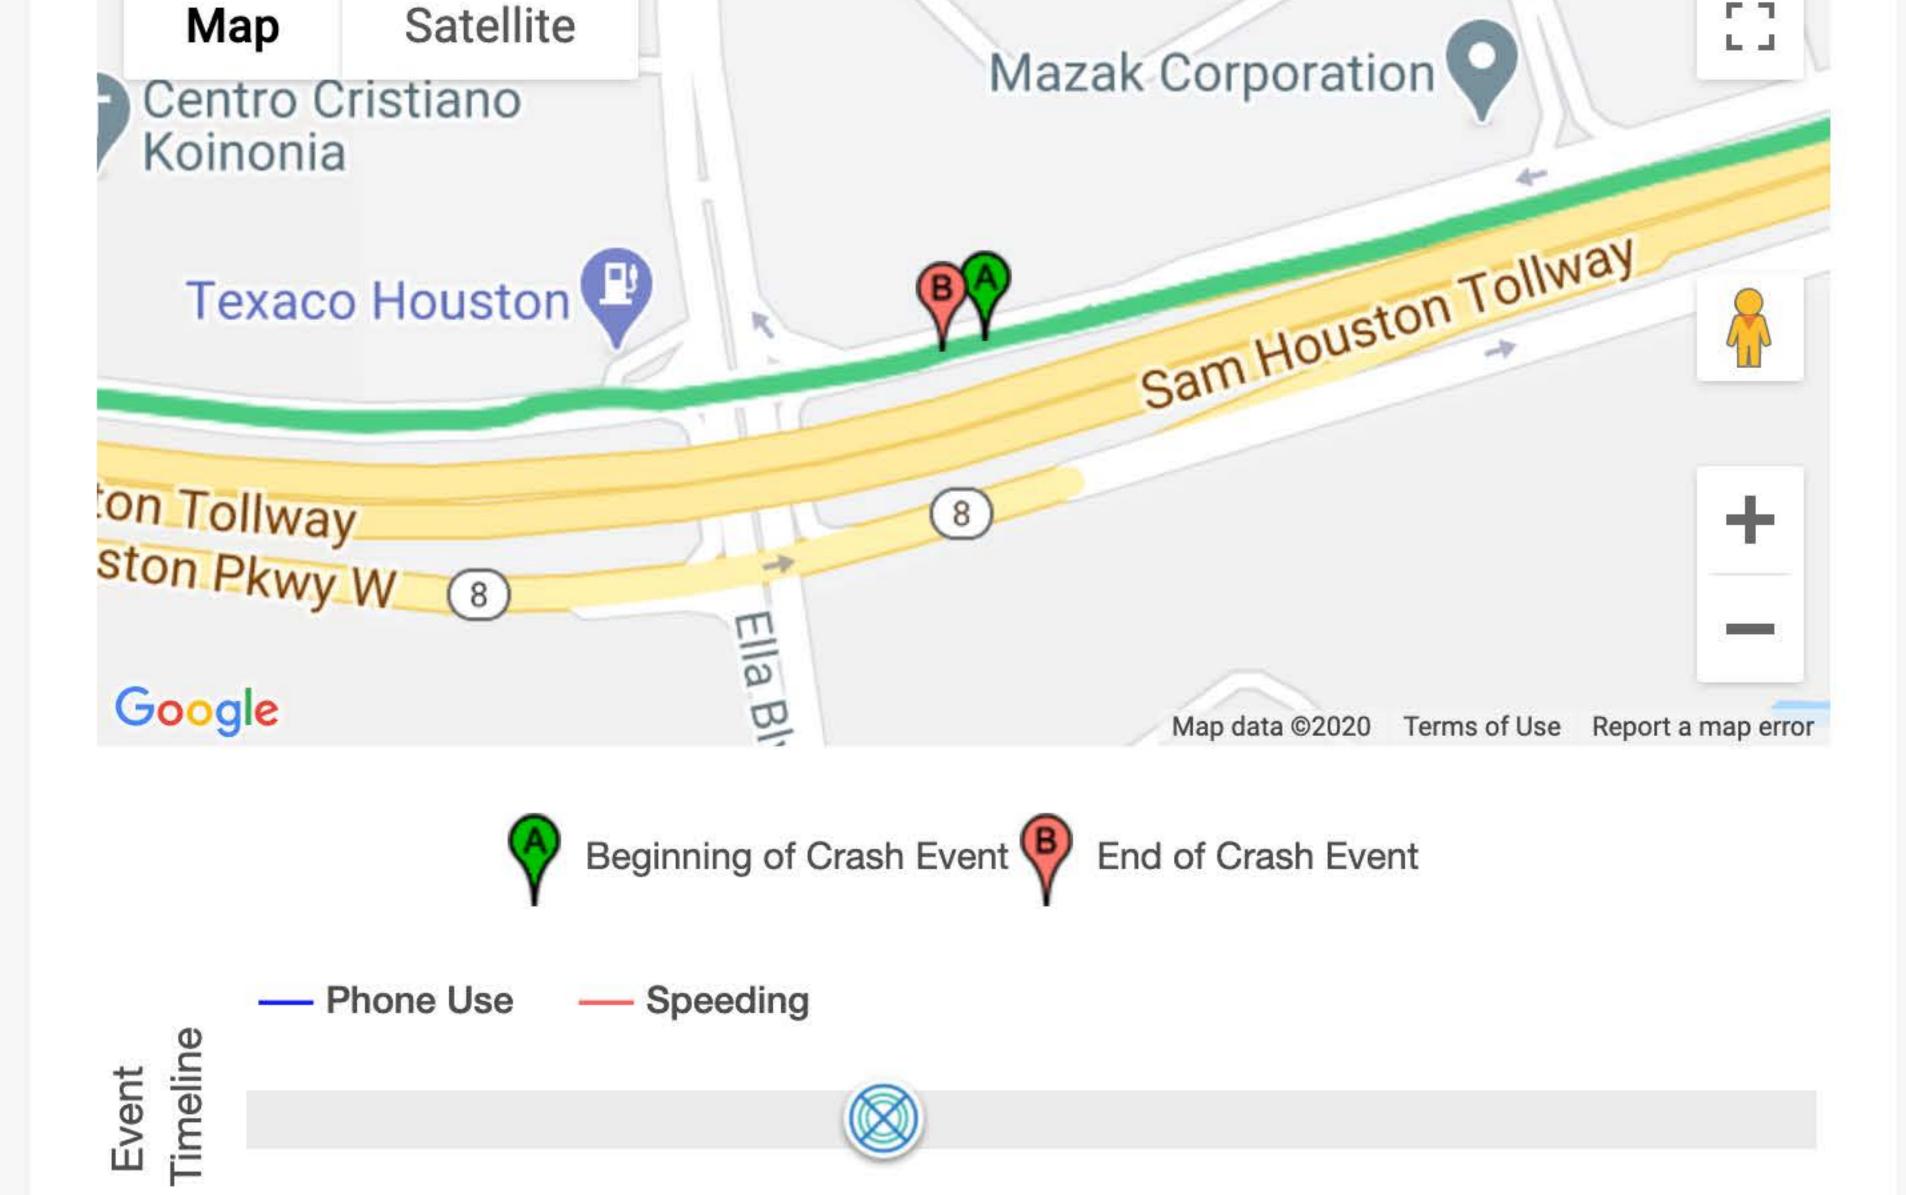
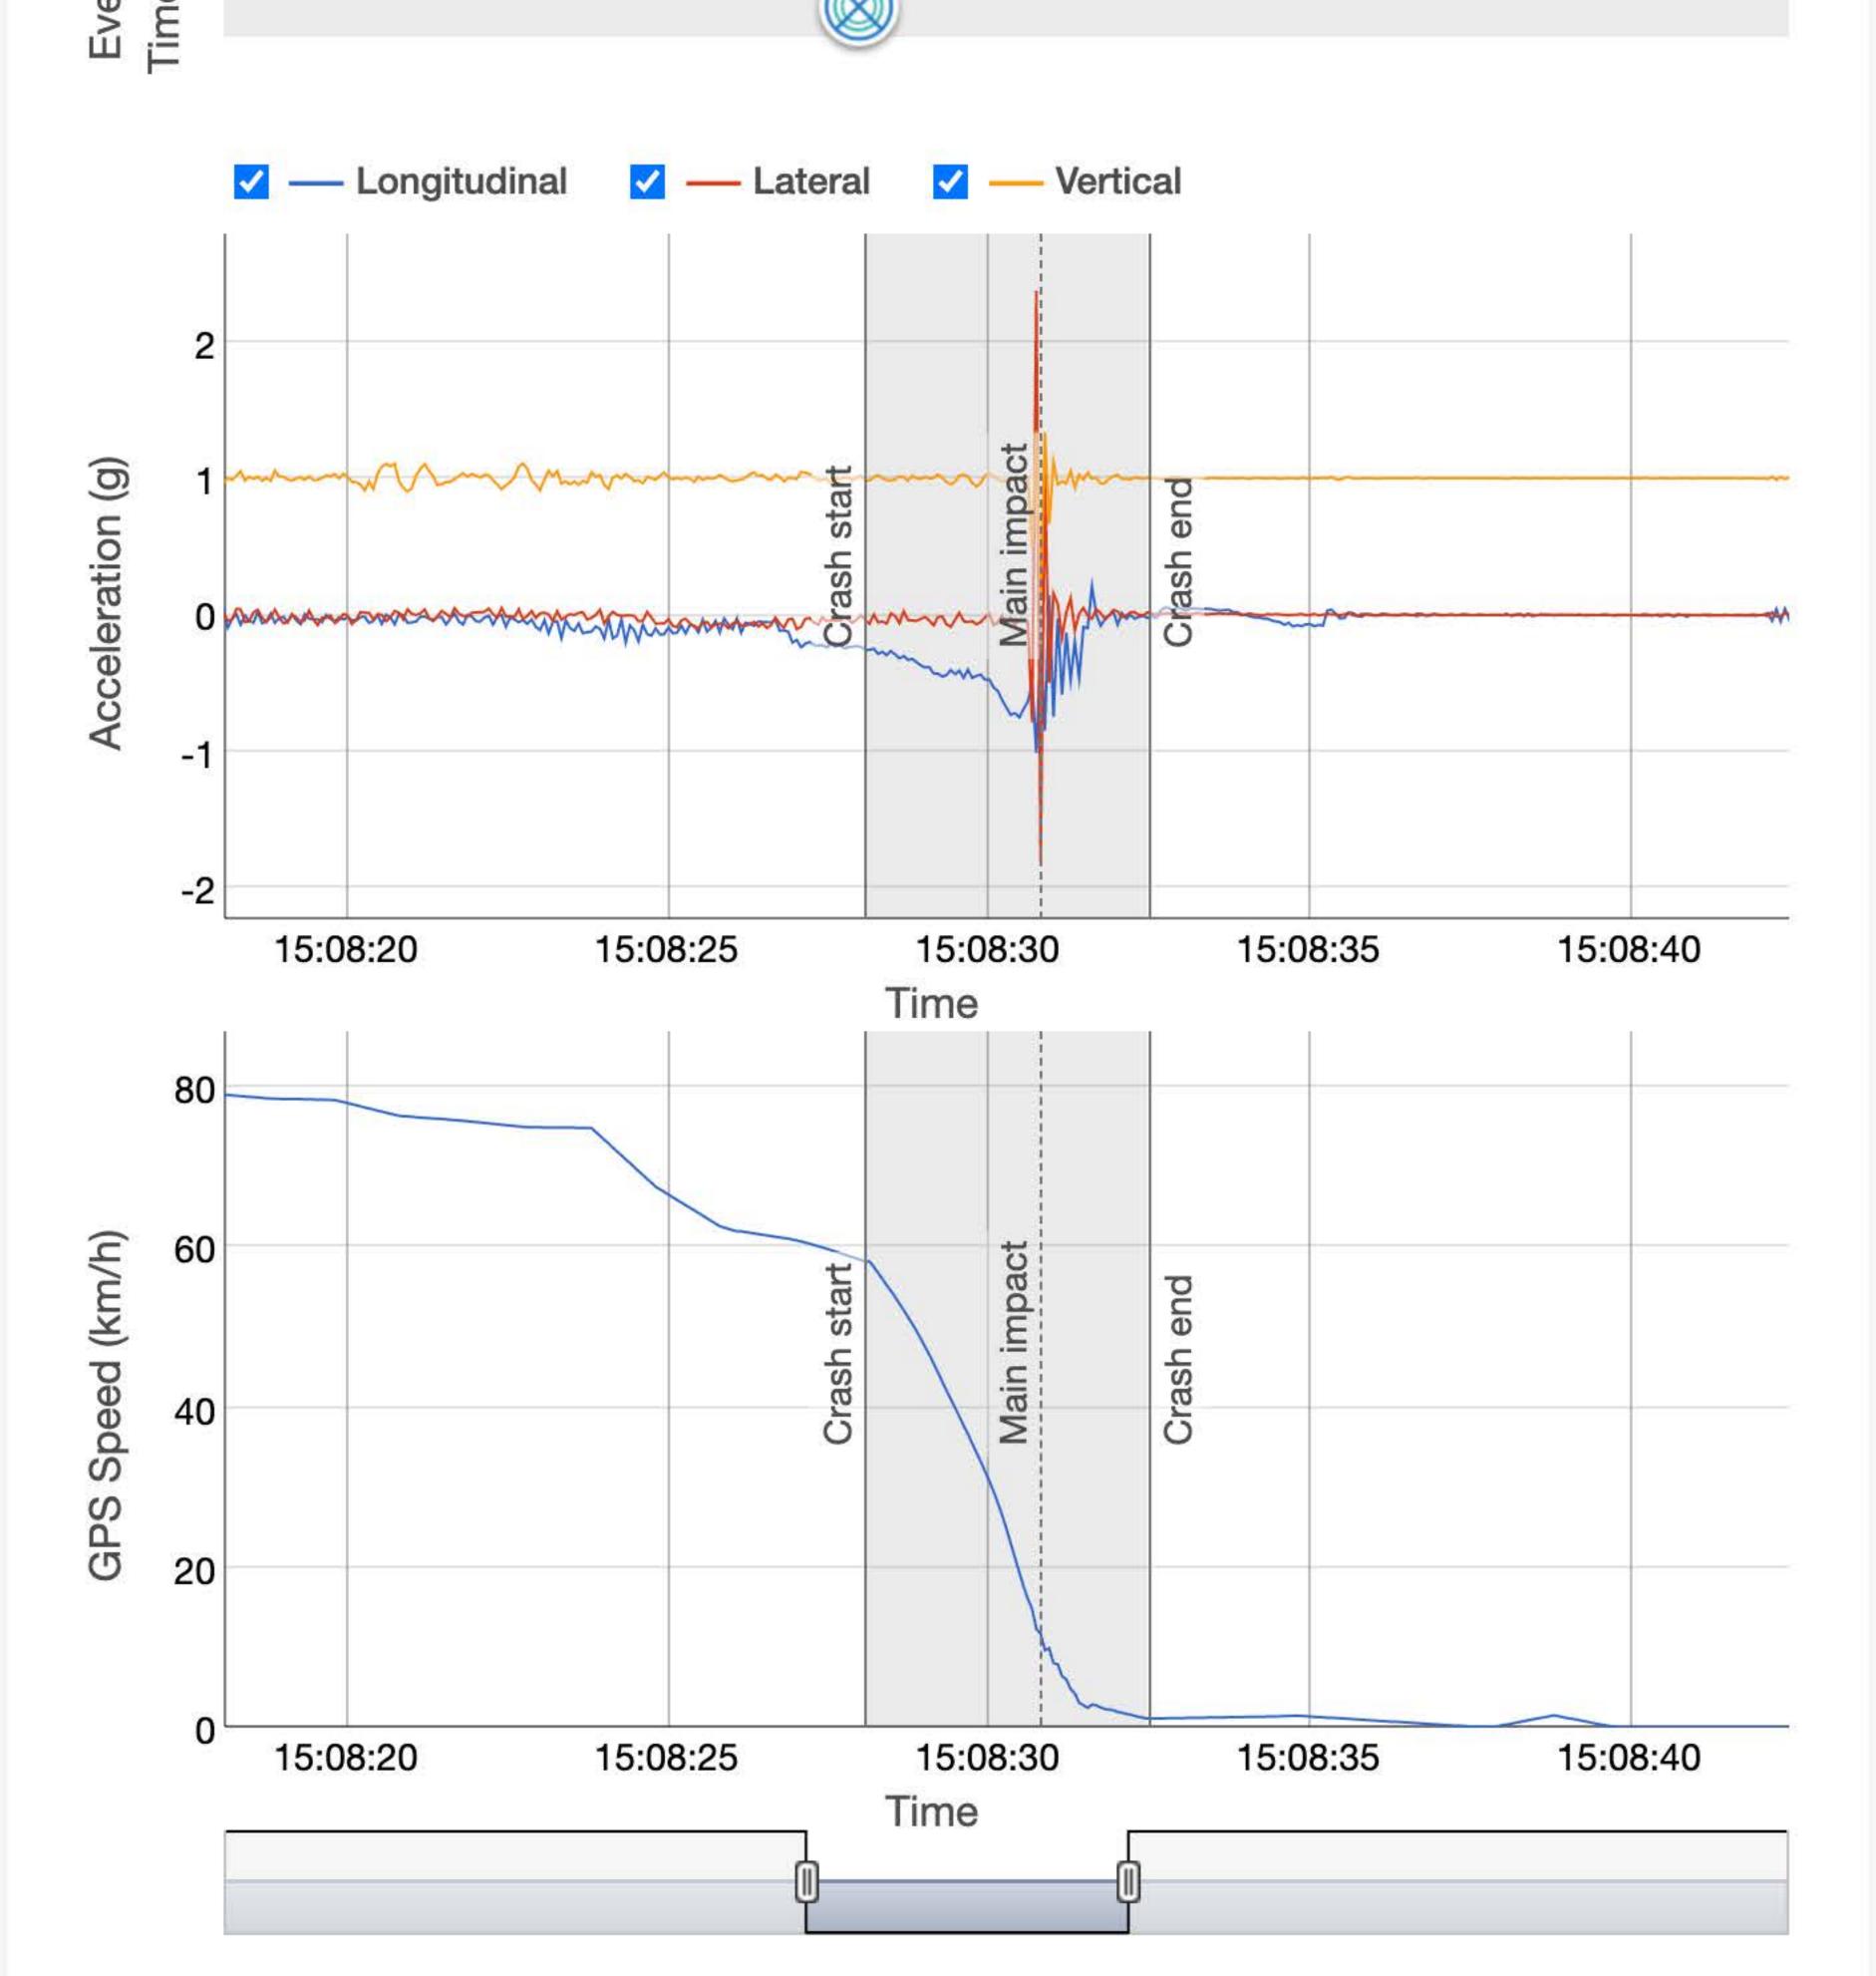
Number of Impacts:	
Speed Before Crash:	58 km/h
Speed at Impact:	12 km/h
Speed After Crash:	1 km/h
Delta-V:	-57 km/h
Mean Acceleration:	-0.41 g
Heading at Impact:	South
Crash Duration:	4.4s
Мар

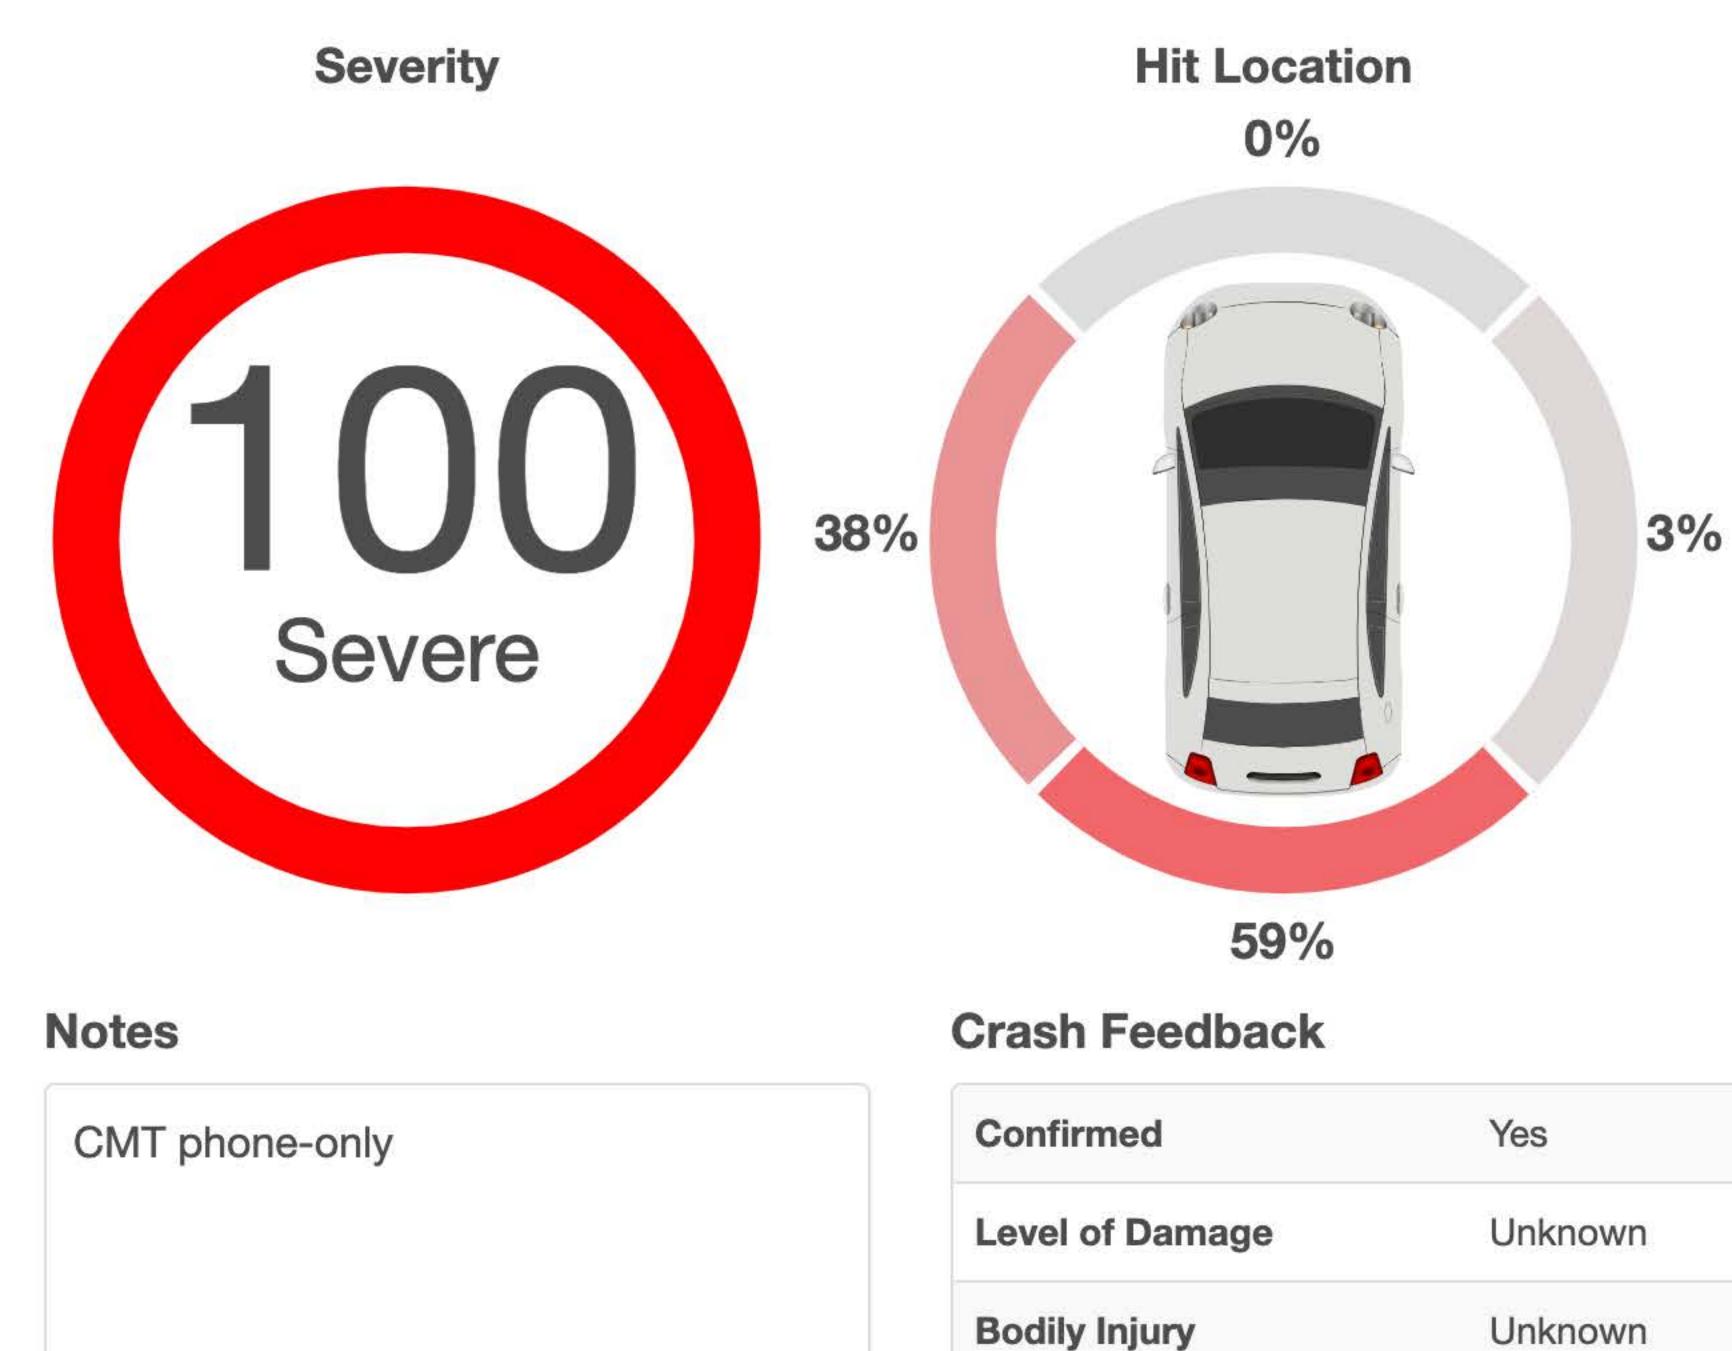
Crash Description The driver was traveling South along Wilbur Cross Highway at 81 mph at 17:03:55 on

2020/05/29. The driver then began braking prior to the impact. At 17:03:57 a collision occurred on the rear side of the vehicle while the vehicle was traveling at 66 mph. The driver was speeding prior to the impact. The collision event ended at 17:04:04 when the vehicle reached a speed of 15 mph. The airbag deployed at 17:04:04. The driver did not continue on their trip after the crash event.
