# Initial Scene Sketch and Event Timeline

| Document ID | Incident | Record type | Status |
|---|---|---|---|
| R3-START-002 | R3 carrier beam - 10/14/2024 | Application test evidence | Synthetic / controlled |

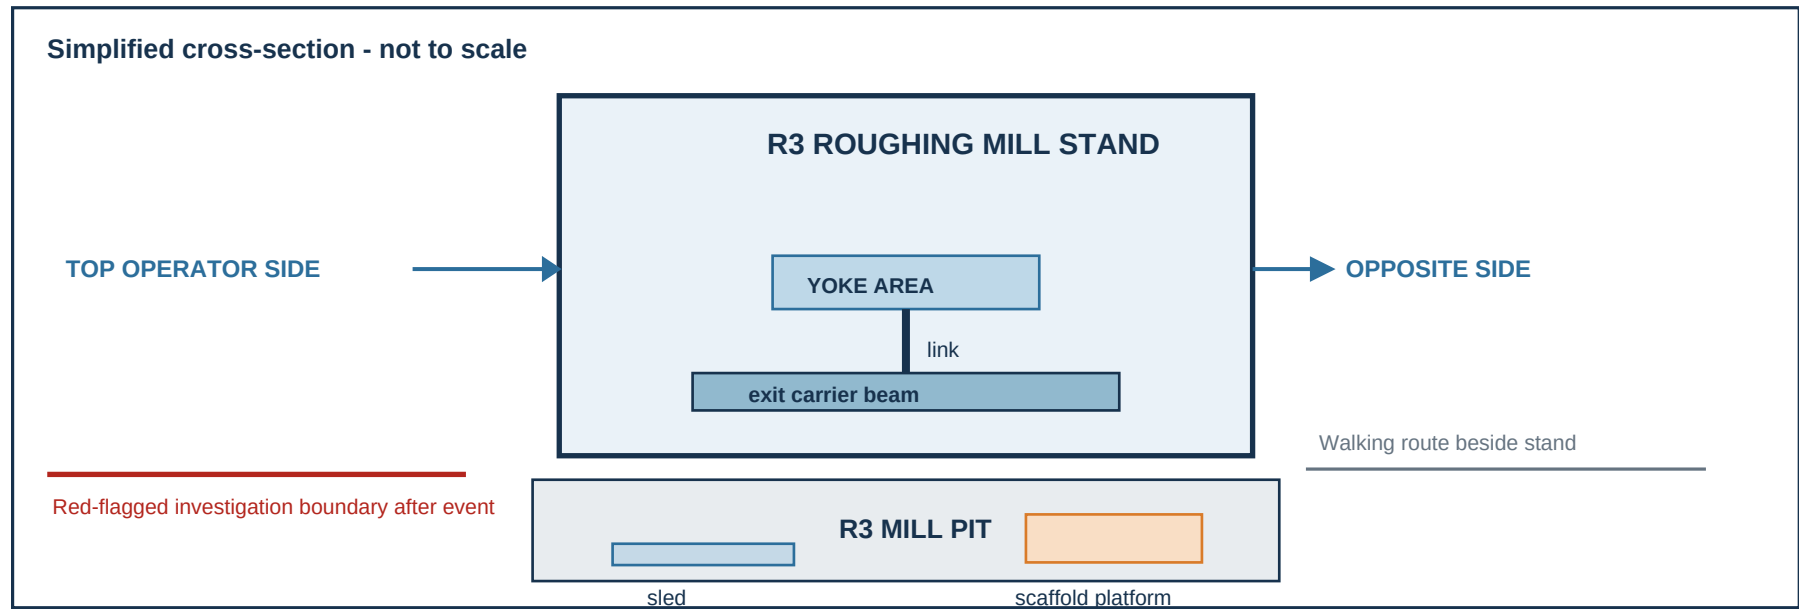
### Known sequence from preliminary reporting; exact transition mechanism remains open

- The yoke and link seating surfaces are not visible in this sketch.
- The witnesses' exact sight lines are not established.
- No pre-event photograph is included.
- The fall path is reported, not reconstructed.
